**UPDATED PRELIMINARY GEOTECHNICAL INVESTIGATION
PROPOSED MALLARD POINTE RESIDENTIAL
DEVELOPMENT
MALLARD ROAD
BELVEDERE, CALIFORNIA**

October 19, 2022

Job No. 3068.001

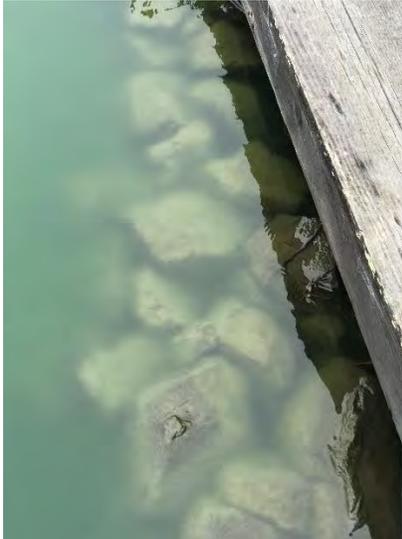
1-3 Mallard Drive

We performed a site reconnaissance on August 27, 2020 to observe and evaluate the existing bulkhead conditions along the Belvedere Lagoon frontage of the subject properties. The initial intent of the inspection was to evaluate a global repair plan for the old, 2 to 3 feet high, wooden bulkheads using a new retaining structure on the water side of the bulkheads. Upon inspection, it became apparent that landscape improvements and site conditions in the rear yards were variable, and a majority of the old wood bulkheads had either been partially buried and supported by rip-rap, or in some cases, wooden bulkheads were removed and replaced entirely with rip rap. Examples of existing conditions are shown below.

It was also noted during our site inspection that generally adverse surface drainage conditions exists in most yards and posts that support decks in the lagoon are in poor condition.
