GEOTECHNICAL REPORTS DATED
11/6/18, 7/9/15 AND 6/8/01

November 6, 2018
File 1-186-br

*GEOTECHNICAL FEASIBILITY
AMD NEGATIVE DECLARATION
PROPOSED DOWNSLOPE DWELLING
ON SLOPES BELOW PROJECTION FROM
TOYON DRIVE REVERSE CURVE
200 TOYON DRIVE
FAIRFAX, CALIFORNIA*

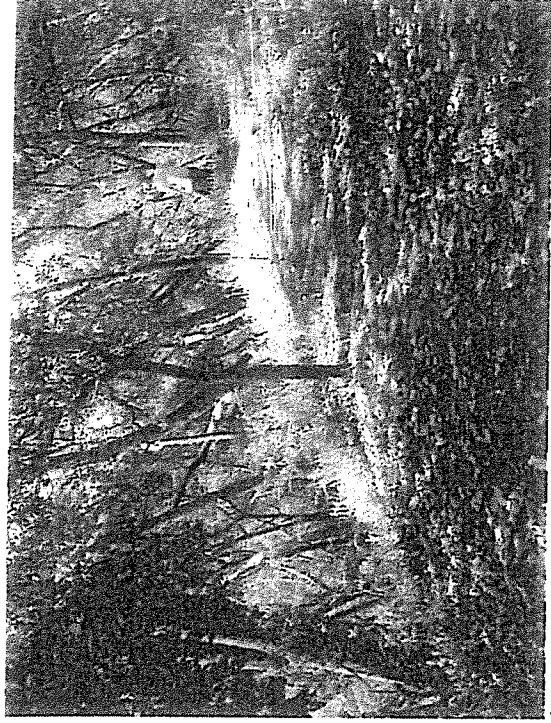
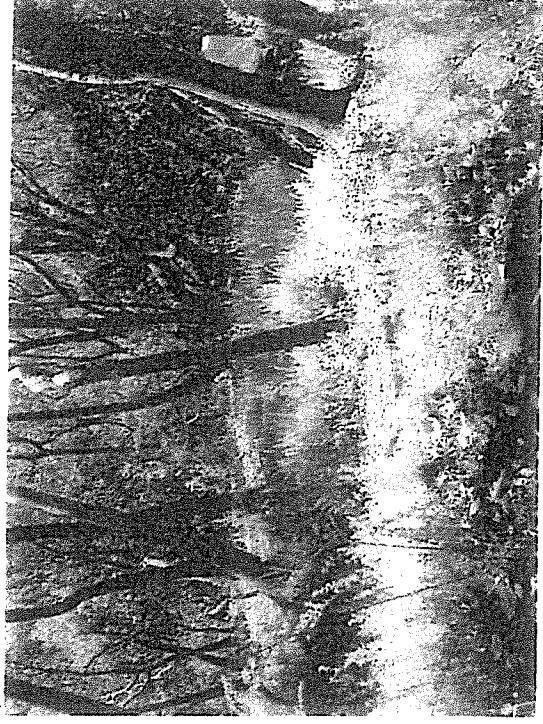
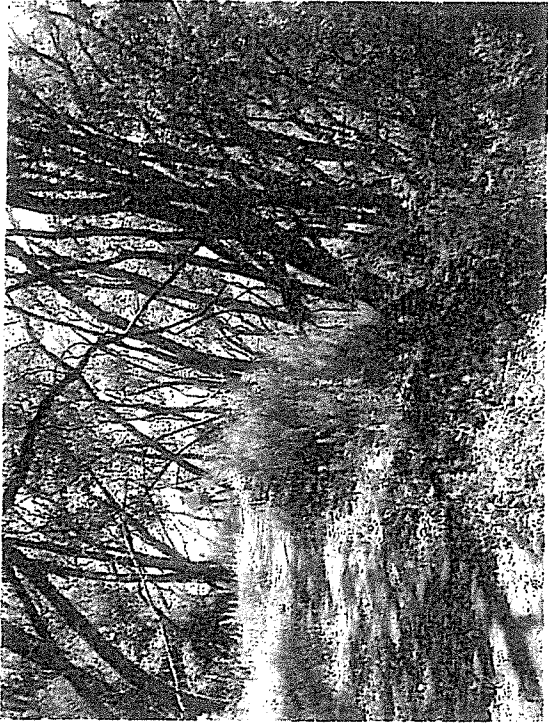
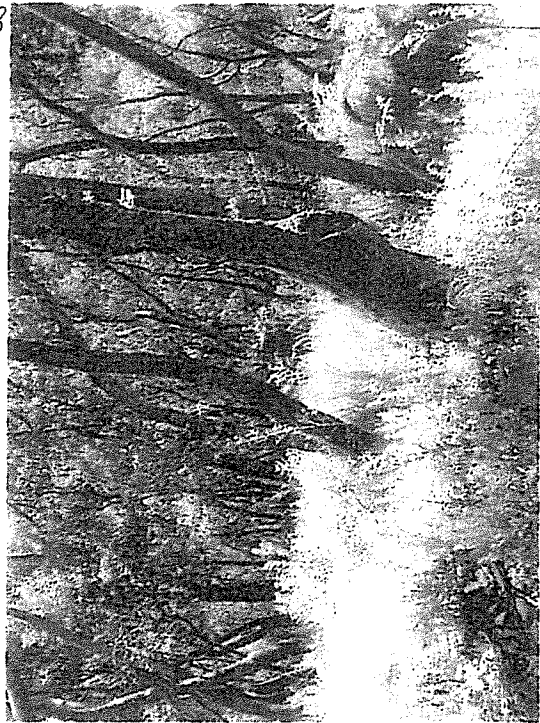
Photos Keyed To Site Plan

Topographic irregularities within the swale and along the roadway shoulders indicate soil creep, along with shallow surficial sliding. We found no indication that these features penetrate significantly below the bedrock surface, or that they indicate deep-seated instability. Oak and bay trees up to 40 inches in diameter within this swale suggest the absence of recent slide activity.

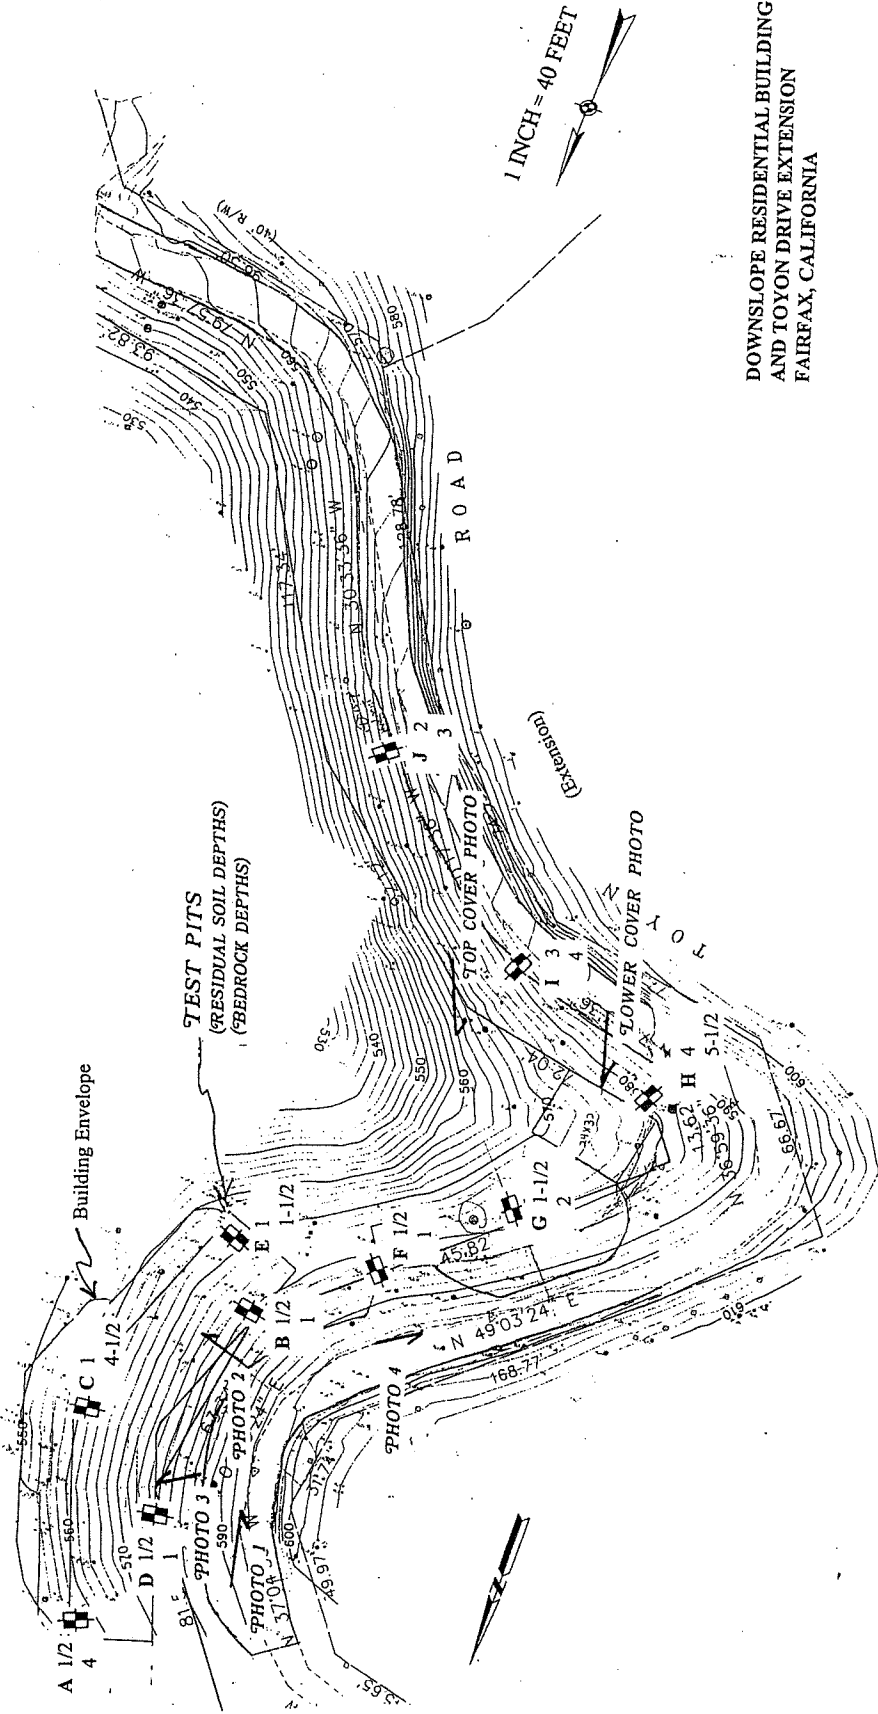
FIG 1

- 1.0-1.6 BEDROCK--Tan sandstone, highly weathered and fractured, grades less weathered with depth. Sounds 1 inch from 1.5 ft.
- TP C** Near Downslope Midpoint of Dwelling, --Elev + 561

- 0-1.0 COLLUVIUM--Brown to tan sandy silt with sandstone fragments and roots, sounds 30 inches from grade, P=2 to 3.
- 1.0-4.5 RESIDUAL--Tan to rusty clayey sand, weakly cemented with traces of lithology and zones of deeply weathered sandstone. Sounds 10 inches from 4 ft.

- 4.5-5.3 BEDROCK--Tan to rusty sandstone, deeply weathered, grades less weathered with depth, sounds 3 inch from 5 ft.
