LOT 2 FORESTRY PLAN  
SCALE 1"=10'

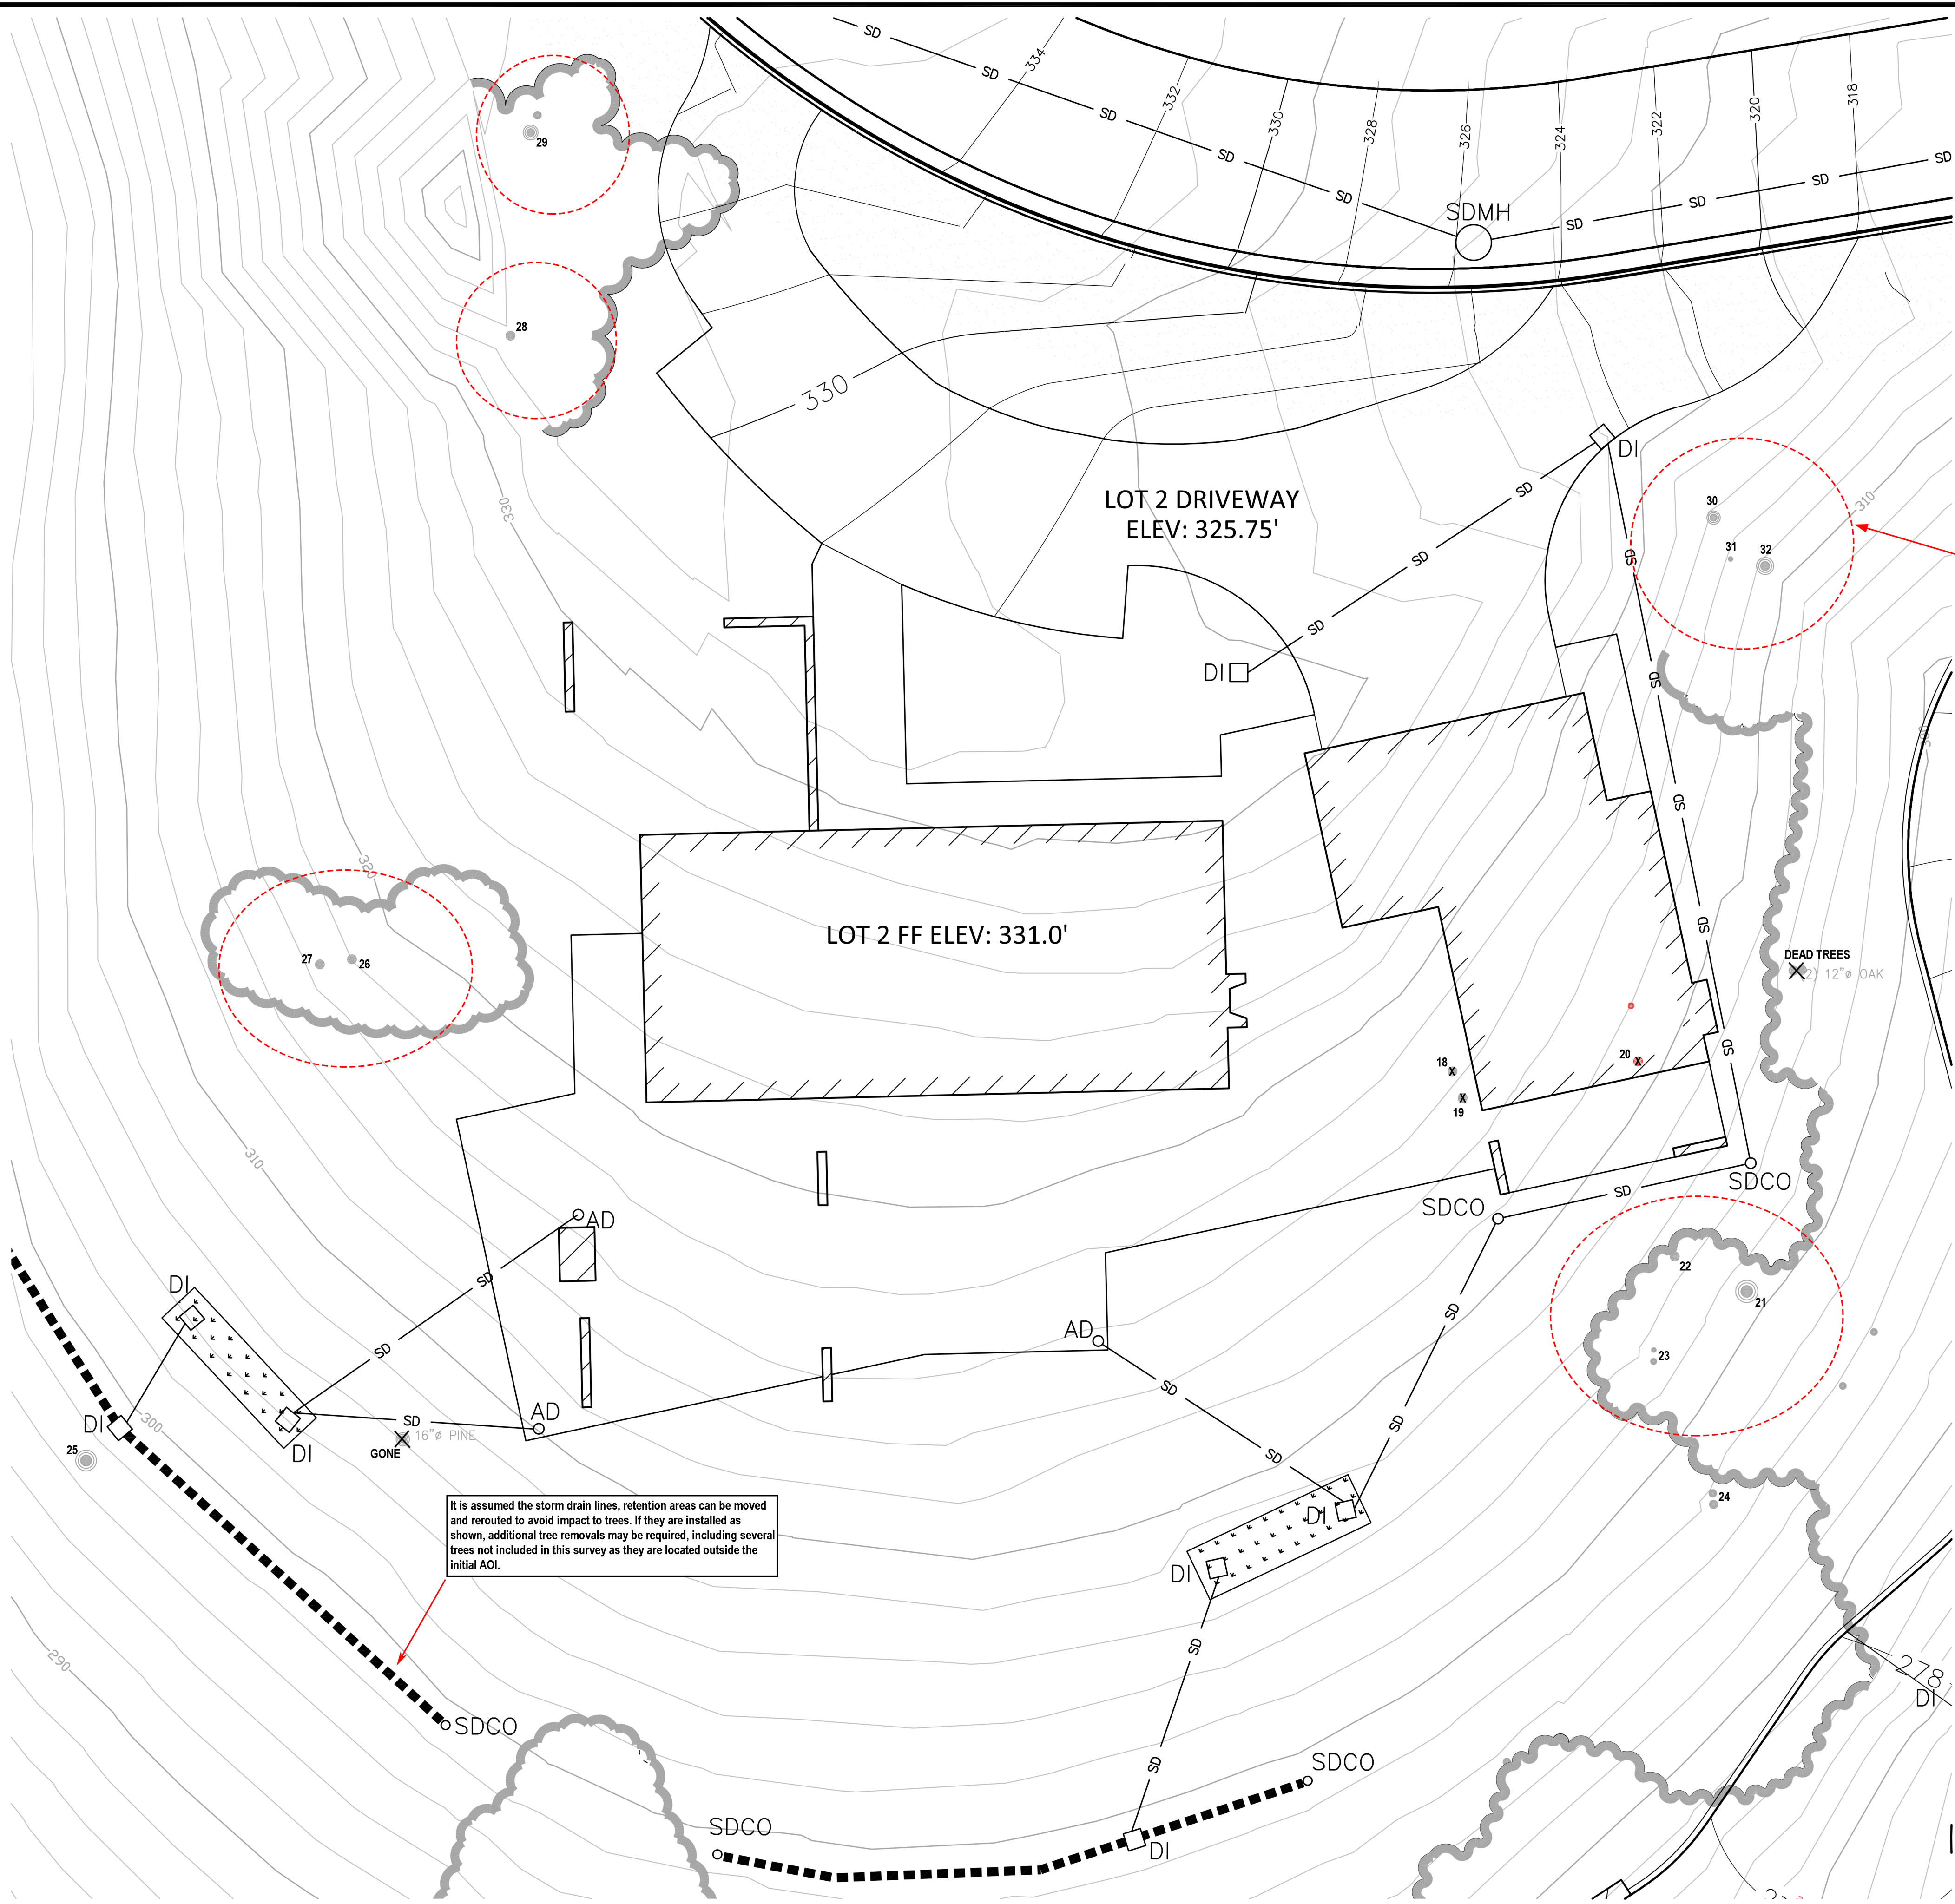
Dashed red line indicates the minimum root zone area to be protected. This area can be protected by either excluding workers from the area using at least 4' high metal deer fencing or, if excluding is not practical, a combination of soil and trunk armoring may be used. If fencing is used, it shall be erected by the contractor prior to demolition and inspected by the Project Arborist. See above images for examples of trunk and soil armoring. Specifications for both can be found in the report that is to accompany this map.

Tree Number	Common Name	Latin Name	Diameter			Health	Structure	Comments	Removal
			Stem 1	Stem 2	Stem 3				
18	Italian Stone pine	<i>Pinus pinea</i>	8.6			Fair	Fair		X
19	Italian Stone pine	<i>Pinus pinea</i>	10.2	8.4		Fair	Poor to Fair	Poor (narrow angled) attachment of stems at 1 foot above grade.	X
20	Valley oak	<i>Quercus lobata</i>	14			Poor to Fair	Poor to Fair	The canopy is sparse and sprouting epicormically along branches, a sign of stress. Scattered dieback of small diameter twigs. There is a falling tree against the lower main stem.	X
21	Valley oak	<i>Quercus lobata</i>	16	14	8	Fair	Fair	Scattered dieback of small diameter twigs throughout the canopy, likely signs of residual drought stress.	
22	Italian Stone pine	<i>Pinus pinea</i>	4.2			Fair	Fair	Leans out from under canopy of adjacent oak tree. Poor attachment of stems near grade.	
23	Italian Stone pine	<i>Pinus pinea</i>	8.2	6.2		Fair	Poor to Fair	Narrow angled branch attachments.

24	Italian Stone pine	<i>Pinus pinea</i>	9.7			Fair	Poor to Fair	Canopy is composed of multiple stems with a common attachment at 8 feet above grade.	
25	Italian Stone pine	<i>Pinus pinea</i>	23			Fair	Poor to Fair	Sparse canopy and stunted foliage. Likely suffering from residual drought stress.	
26	Valley oak	<i>Quercus lobata</i>	10.6			Fair	Fair	Sparse canopy and stunted foliage, likely signs of residual drought stress.	
27	Valley oak	<i>Quercus lobata</i>	9.7	6.5		Fair	Fair	Crowded branch structure. Fill soil on lower main stem. Diameter taken below fork.	
28	coast live oak	<i>Quercus agrifolia</i>	18			Fair to Good	Fair	The tree has multiple decay cavities along the main stem at old branch/soar failures. Strong canopy symmetry away from existing road.	
29	coast live oak	<i>Quercus agrifolia</i>	21.3			Fair to Good	Poor	Sparse canopy.	
30	Valley oak	<i>Quercus lobata</i>	10	10.6		Poor to fair.	Fair.	Small suppressed tree.

31	coast live oak	<i>Quercus agrifolia</i>	6.1			Fair to Good	Fair to good.	Somewhat sparse canopy. Diameter estimated due to poison oak.	
32	Valley oak	<i>Quercus lobata</i>	20.0	16.0	8.0	Fair		Total Removals	3
