FORESTRY PLAN - LOT 3

MARINDA HEIGHTS SUBDIVISION

CITY OF FAIRFAX

URBAN FORESTRY ASSOCIATES, INC.

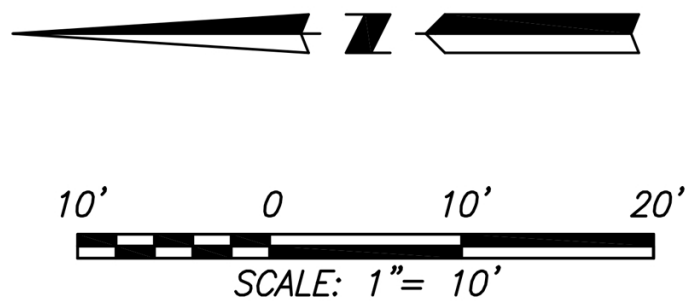
LOT 3 FORESTRY PLAN  
SCALE 1"=10'

Dashed red line indicates the minimum root zone area to be protected.  
This area can be protected by either excluding workers from the area using at least 4' high metal deer fencing or, if excluding is not practical, a combination of soil and trunk armoring may be used.  
If fencing is used, it shall be erected by the contractor prior to demolition and inspected by the Project Arborist.  
See below images for examples of trunk and soil armoring. Specifications for both can be found in the report that is to accompany this map.
