URBAN FORESTRY ASSOCIATES, INC.
 (619) 661-8222 • www.urbanforestry.com

FORESTRY PLAN - LOT 4
 MARINDA HEIGHTS SUBDIVISION
 APN: 001-150-12, 001-171-51, 001-251-31, 001-160-09
 CALIFORNIA

SHEET
 T-4

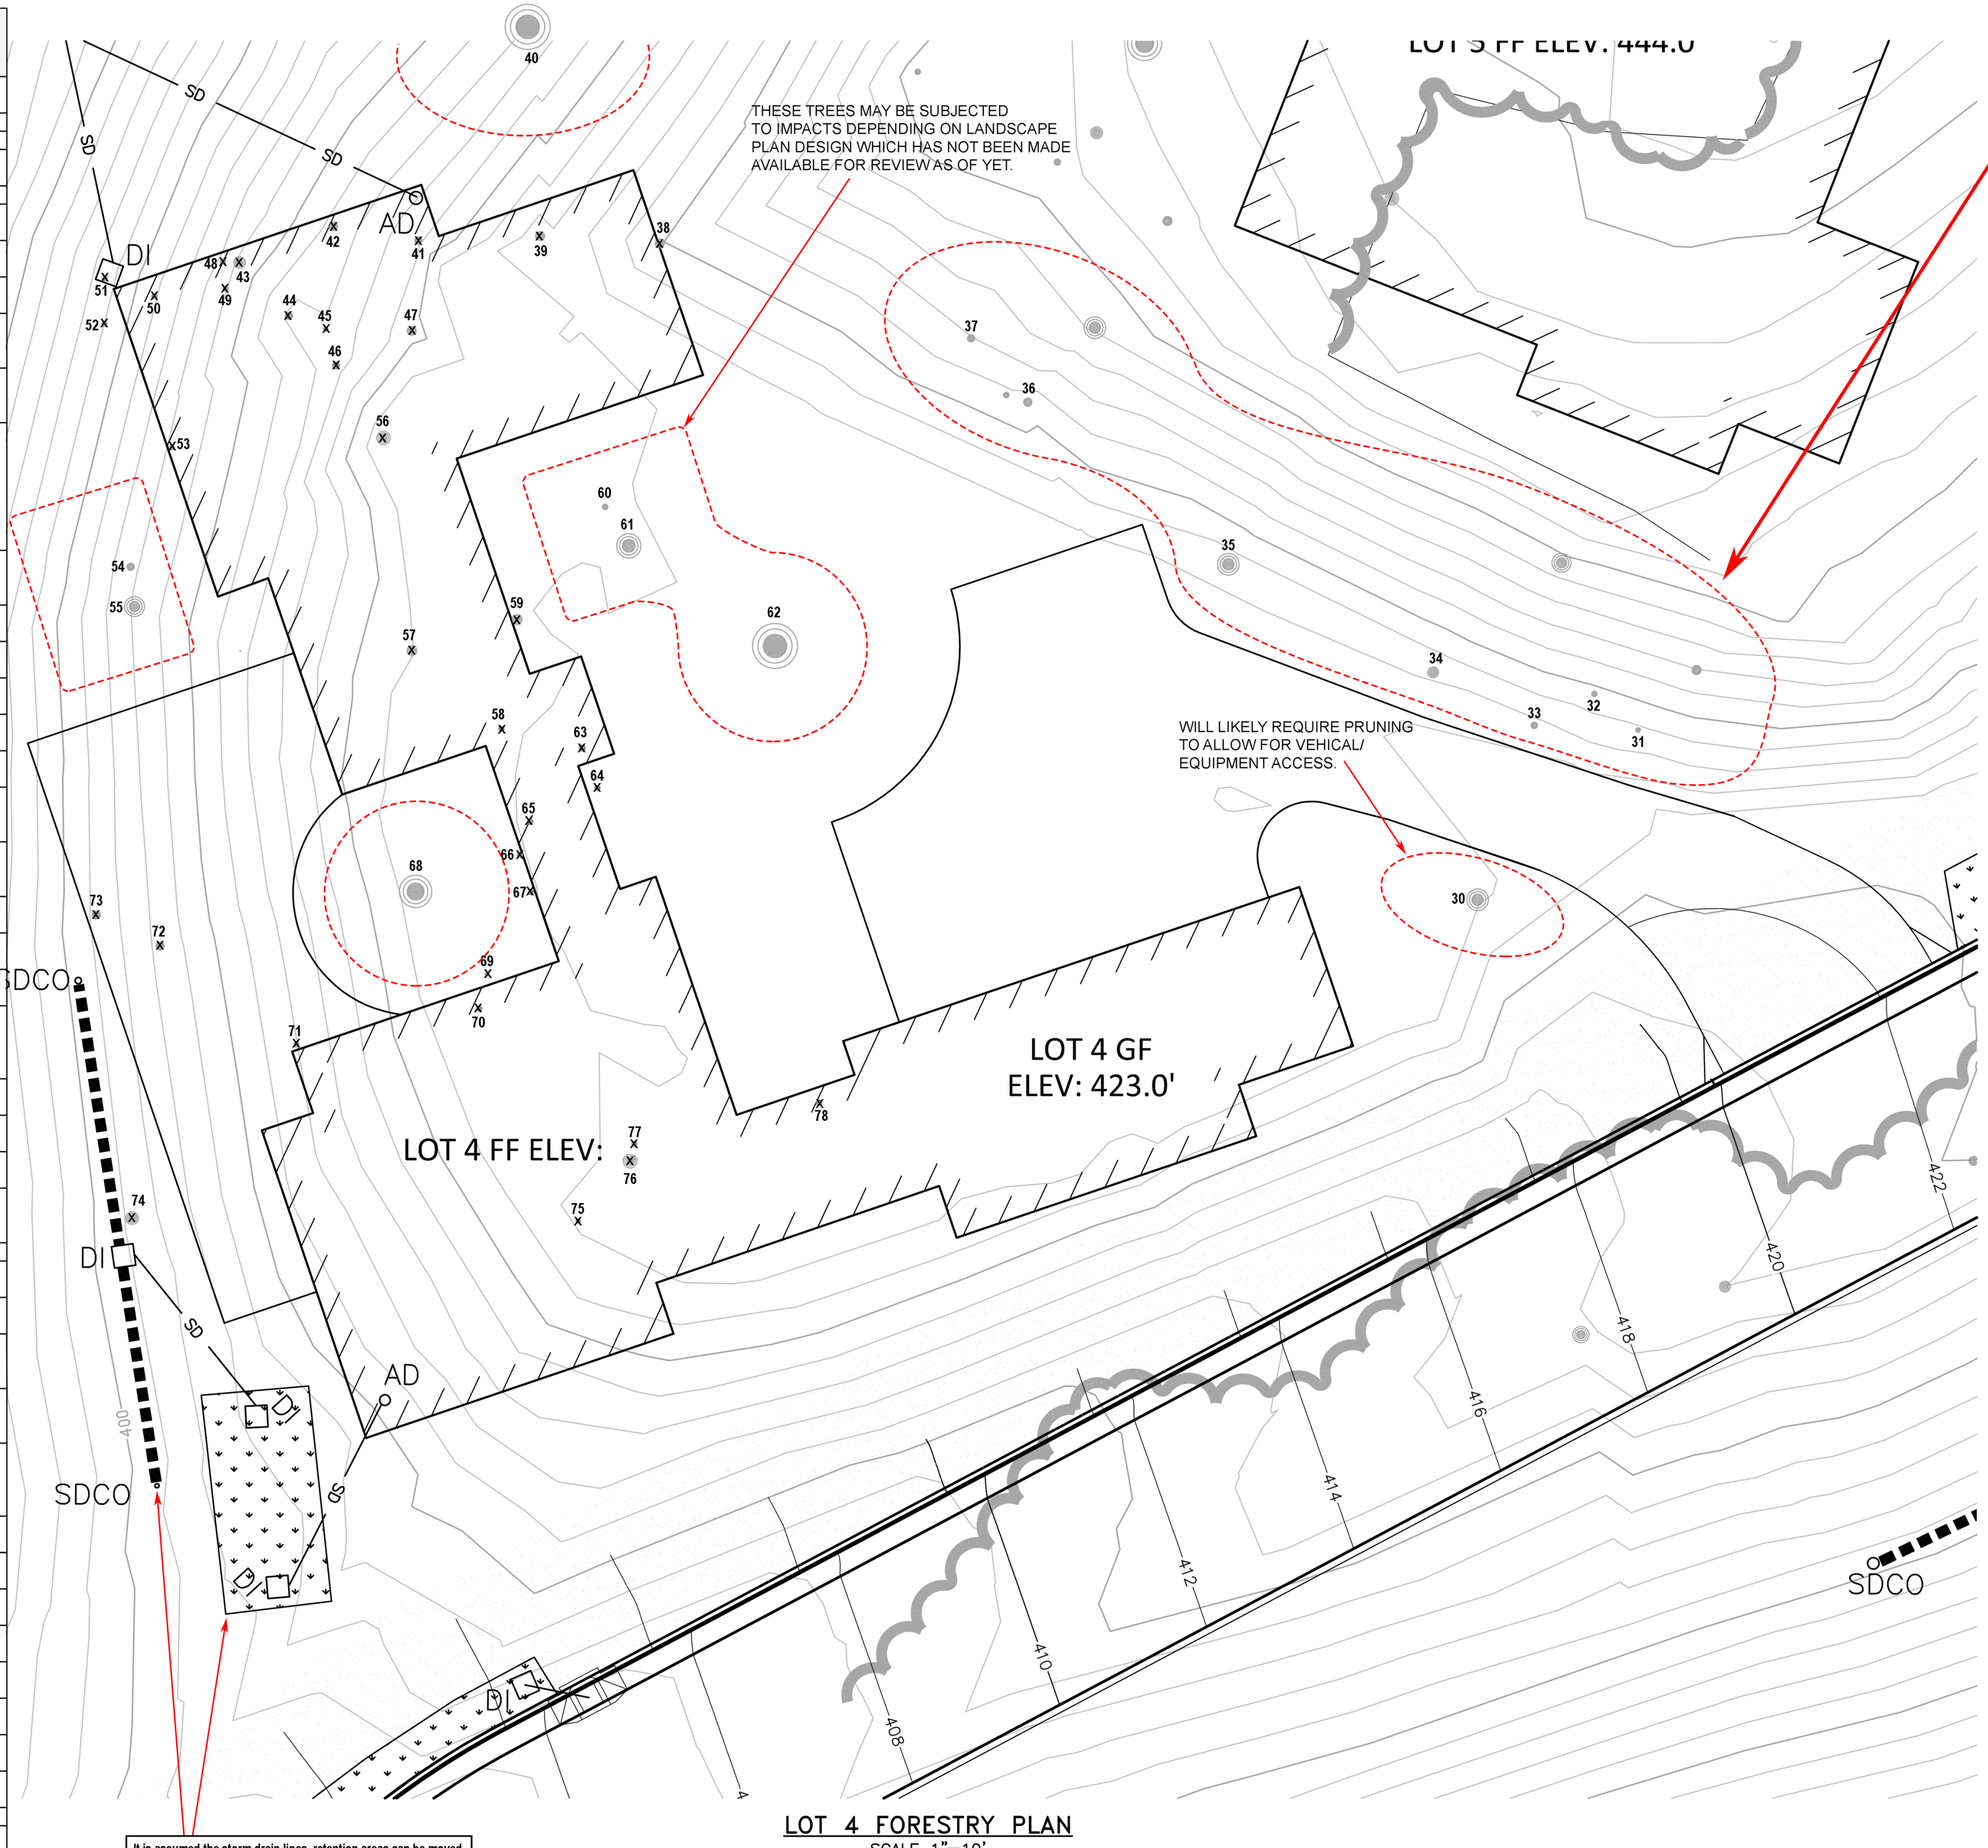
Tree Tag Number	Common Name	Latin Name	Diameter			Health	Structure	Comments	Removal
			Stem 1	Stem 2	Stem 3				
30	coast live oak	<i>Quercus agrifolia</i>	8.1	6.5	6.1	Fair	Fair	Located approx 2 feet from existing driveway. Was poorly pruned recently to clear the road.	
31	coast live oak	<i>Quercus agrifolia</i>	4.8	3.1		Fair	Fair		
32	coast live oak	<i>Quercus agrifolia</i>	5.2			Fair	Fair		
33	coast live oak	<i>Quercus agrifolia</i>	6.2	3.4		Fair	Fair	Canopy encroaches on existing driveway. Was recently pruned to clear the drive.	
34	coast live oak	<i>Quercus agrifolia</i>	6.3	5.3		Fair	Fair	Canopy encroaches on existing driveway.	
35	coast live oak	<i>Quercus agrifolia</i>	7.5	6.5	4.2	Fair to Good	Fair	Canopy extends in to building envelope. May require pruning for development.	
36	coast live oak	<i>Quercus agrifolia</i>	8.2	5.2		Fair to Good	Fair	Canopy symmetry downslope under the shade of larger trees.

37	coast live oak	<i>Quercus agrifolia</i>	7.3			Fair to Good	Fair	Slight lean and canopy symmetry downslope.	
38	coast live oak	<i>Quercus agrifolia</i>	9.2			Fair	Fair	Asymmetric canopy due to previously sharing canopy space with an adjacent oak. Wildlife nest in canopy.	x
39	coast live oak	<i>Quercus agrifolia</i>	9.9			Poor to Fair	Poor to Fair	Heavily symptomatic of sudden oak death. Bleeding cankers span much of the vascular system.	x
40	coast live oak	<i>Quercus agrifolia</i>	15.2	13.6	13.2	Fair	Fair	It is a large tree with multiple systems arising from a somewhat common attachment near grade. Moderate amount of dead branches in the lower canopy. Will require pruning for development. Surrounding trees are symptomatic of sudden oak death. Base of the tree covered in fill soil.	
41	coast live oak	<i>Quercus agrifolia</i>	9.3			Fair to Good	Fair	Copious soil and debris was recently deposited on the roots and main stem, presumably by large equipment clearing the pad.	x

42	coast live oak	<i>Quercus agrifolia</i>	8.9	5.1		Fair to Good	Fair	Moderate deadwood in lower canopy. There is a fallen tree beside the tree.	x
43	Madrone	<i>Arbutus menziesii</i>	9.2	4.7		Fair to Good	Fair to Good		x
44	coast live oak	<i>Quercus agrifolia</i>	8.7			Fair	Fair	Somewhat suppressed. Canopy is limited and asymmetric due to high density in this area.	x
45	coast live oak	<i>Quercus agrifolia</i>	4.7			Fair	Fair	Leans and symmetry downslope. It is suppressed by adjacent trees.	x
46	Madrone	<i>Arbutus menziesii</i>	9.6			Poor to Fair	Poor to Fair	The subordinate stem is mostly dead.	x
47	coast live oak	<i>Quercus agrifolia</i>	10			Fair	Fair	The main stem in route system was recently buried in soil and debris presumably during clearance of the building pad.	x
48	coast live oak	<i>Quercus agrifolia</i>	4.8			Poor	Poor	It is a small suppressed tree. Much of the vascular tissue is dead as indicated by bark checkering.	x

49	coast live oak	<i>Quercus agrifolia</i>	5			Fair	Fair	Somewhat limited canopy and leggy structure due to competition with adjacent trees.	x
50	coast live oak	<i>Quercus agrifolia</i>	6.2			Fair	Fair	Subordinate stems are dead. Leggy structure due to competition.	x
51	coast live oak	<i>Quercus agrifolia</i>	8.5			Fair to Good	Fair to Good	Upright canopy. Moderate deadwood in lower canopy.	x
52	coast live oak	<i>Quercus agrifolia</i>	12.4	8.5	4.4	Fair to Good	Fair	Acute attachment of downslope stem at 1' above grade. Canopy symmetry is oriented downslope. Light pruning may be necessary for development.	x
53	coast live oak	<i>Quercus agrifolia</i>	5.2			Fair to Good	Fair to Good	Narrow, upright canopy.	x
54	coast live oak	<i>Quercus agrifolia</i>	9.6			Fair to Good	Fair	Canopy symmetry downslope, away from building envelope.	
55	coast live oak	<i>Quercus agrifolia</i>	11			Fair to Good	Fair to Good	Upright canopy. Symmetry away from building envelope.

56	Grey pine	<i>Pinus sabiniana</i>	17.2			Fair	Poor to Fair	Poorly angled branch attachments. The canopy is sparsely foliated. Base of tree covered with soil and debris.	x
57	coast live oak	<i>Quercus agrifolia</i>	10.3	8.3		Fair	Fair	Canopy extends into building envelope.	x
58	coast live oak	<i>Quercus agrifolia</i>	6.9			Fair to Good	Fair	Directly within building envelope.	x
59	California bay laurel	<i>Umbellularia californica</i>	4.5	3.2		Fair	Fair	Narrow upright canopy.	x
60	coast live oak	<i>Quercus agrifolia</i>	5.1			Fair	Fair	Narrow upright canopy. Bleeding on the lower main stem, possibly from borer. Mechanical damage on main stem.	
61	coast live oak	<i>Quercus agrifolia</i>	8.7	7.3		Fair to Good	Fair	Narrow attachment of stems at grade. Bleeding on larger stem though not consistent with Phytophthora.	
62	Madrone	<i>Arbutus menziesii</i>	8.9	8.8	7.4	Fair to Good	Fair	Normal amount of deadwood in canopy. The tree display is relatively good health and vigor. Will require proper cultural care to maintain as a permanent fixture in the landscape.

63	coast live oak	<i>Quercus agrifolia</i>	6	5.8		Fair	Fair	Copious small diameter dead twigs in lower canopy.	x
64	coast live oak	<i>Quercus agrifolia</i>	5.2			Fair	Fair	Sharp bend in main stem with canopy symmetry towards proposed driveway.	x
65	coast live oak	<i>Quercus agrifolia</i>	7			Fair	Fair	Somewhat suppressed by adjacent trees. Canopy symmetry east.	x
66	coast live oak	<i>Quercus agrifolia</i>	4.2			Fair	Fair	Limited and upright canopy influenced by competition with adjacent trees.	x
67	coast live oak	<i>Quercus agrifolia</i>	6.8			Fair to Good	Fair	Canopy symmetry east under the canopy of Tree 68.	x
68	coast live oak	<i>Quercus agrifolia</i>	17.7	13.2	7.5	Fair to Good	Fair	Crowded branch structure. Narrow attachment of largest stem could be mitigated with pruning.	
69	California bay laurel	<i>Umbellularia californica</i>	4.2			Fair to Good	Fair	Small, suppressed tree. Foliage is symptomatic of sudden oak death.	x

70	California bay laurel	<i>Umbellularia californica</i>	5			Fair to Good	Fair	Foliage symptomatic of sod.	x
71	coast live oak	<i>Quercus agrifolia</i>	9.2			Fair	Fair	Moderate foliage disease on leaves.	x
72	Toyon	<i>Heteromeles arbutifolia</i>	4.3			Fair to Good	Fair	Typical shrubby form.	x
73	California bay laurel	<i>Umbellularia californica</i>	10.7			Fair to Good	Fair	Leaves symptomatic of SOD.	x
74	Valley oak	<i>Quercus lobata</i>	18.2			Fair	Fair	Somewhat stunted due to site constraints. Strong canopy symmetry upslope. Will require pruning for development.	x
75	coast live oak	<i>Quercus agrifolia</i>	5.6			Fair	Poor to Fair	Strong bend in main stem due to location under larger oak.	x
76	coast live oak	<i>Quercus agrifolia</i>	9.3	7.8		Fair to Good	Fair	Directly within envelope.	x
77	coast live oak	<i>Quercus agrifolia</i>	4.4			Fair	Fair	Leans under the canopy of Tree 76.	x
78	Toyon	<i>Heteromeles arbutifolia</i>	5.9	3.3		Fair	Fair		x

Total Removals									34

Dashed red line indicates the minimum root zone area to be protected. This area can be protected by either excluding workers from the area using at least 4' high metal deer fencing or, if excluding is not practical, a combination of soil and trunk armoring may be used. If fencing is used, it shall be erected by the contractor prior to demolition and inspected by the Project Arborist. See below images for examples of trunk and soil armoring. Specifications for both can be found in the report that is to accompany this map.
