APP.	NO.	DATE	REVISION	SHEET
	1			
	2			
	3			
	4			
FORESTRY PLAN - LOT 5				
MARINDA HEIGHTS SUBDIVISION				
APN: 001-150-12, 001-171-51, 001-251-31, 001-160-09				
CITY OF FAIRFAX				
CALIFORNIA				
URBAN FORESTRY ASSOCIATES, INC.				
(415) 842-2222 • info@urbanforestry.com				
Scale: 1"=10'				
Date: OCTOBER 2017				
T-5

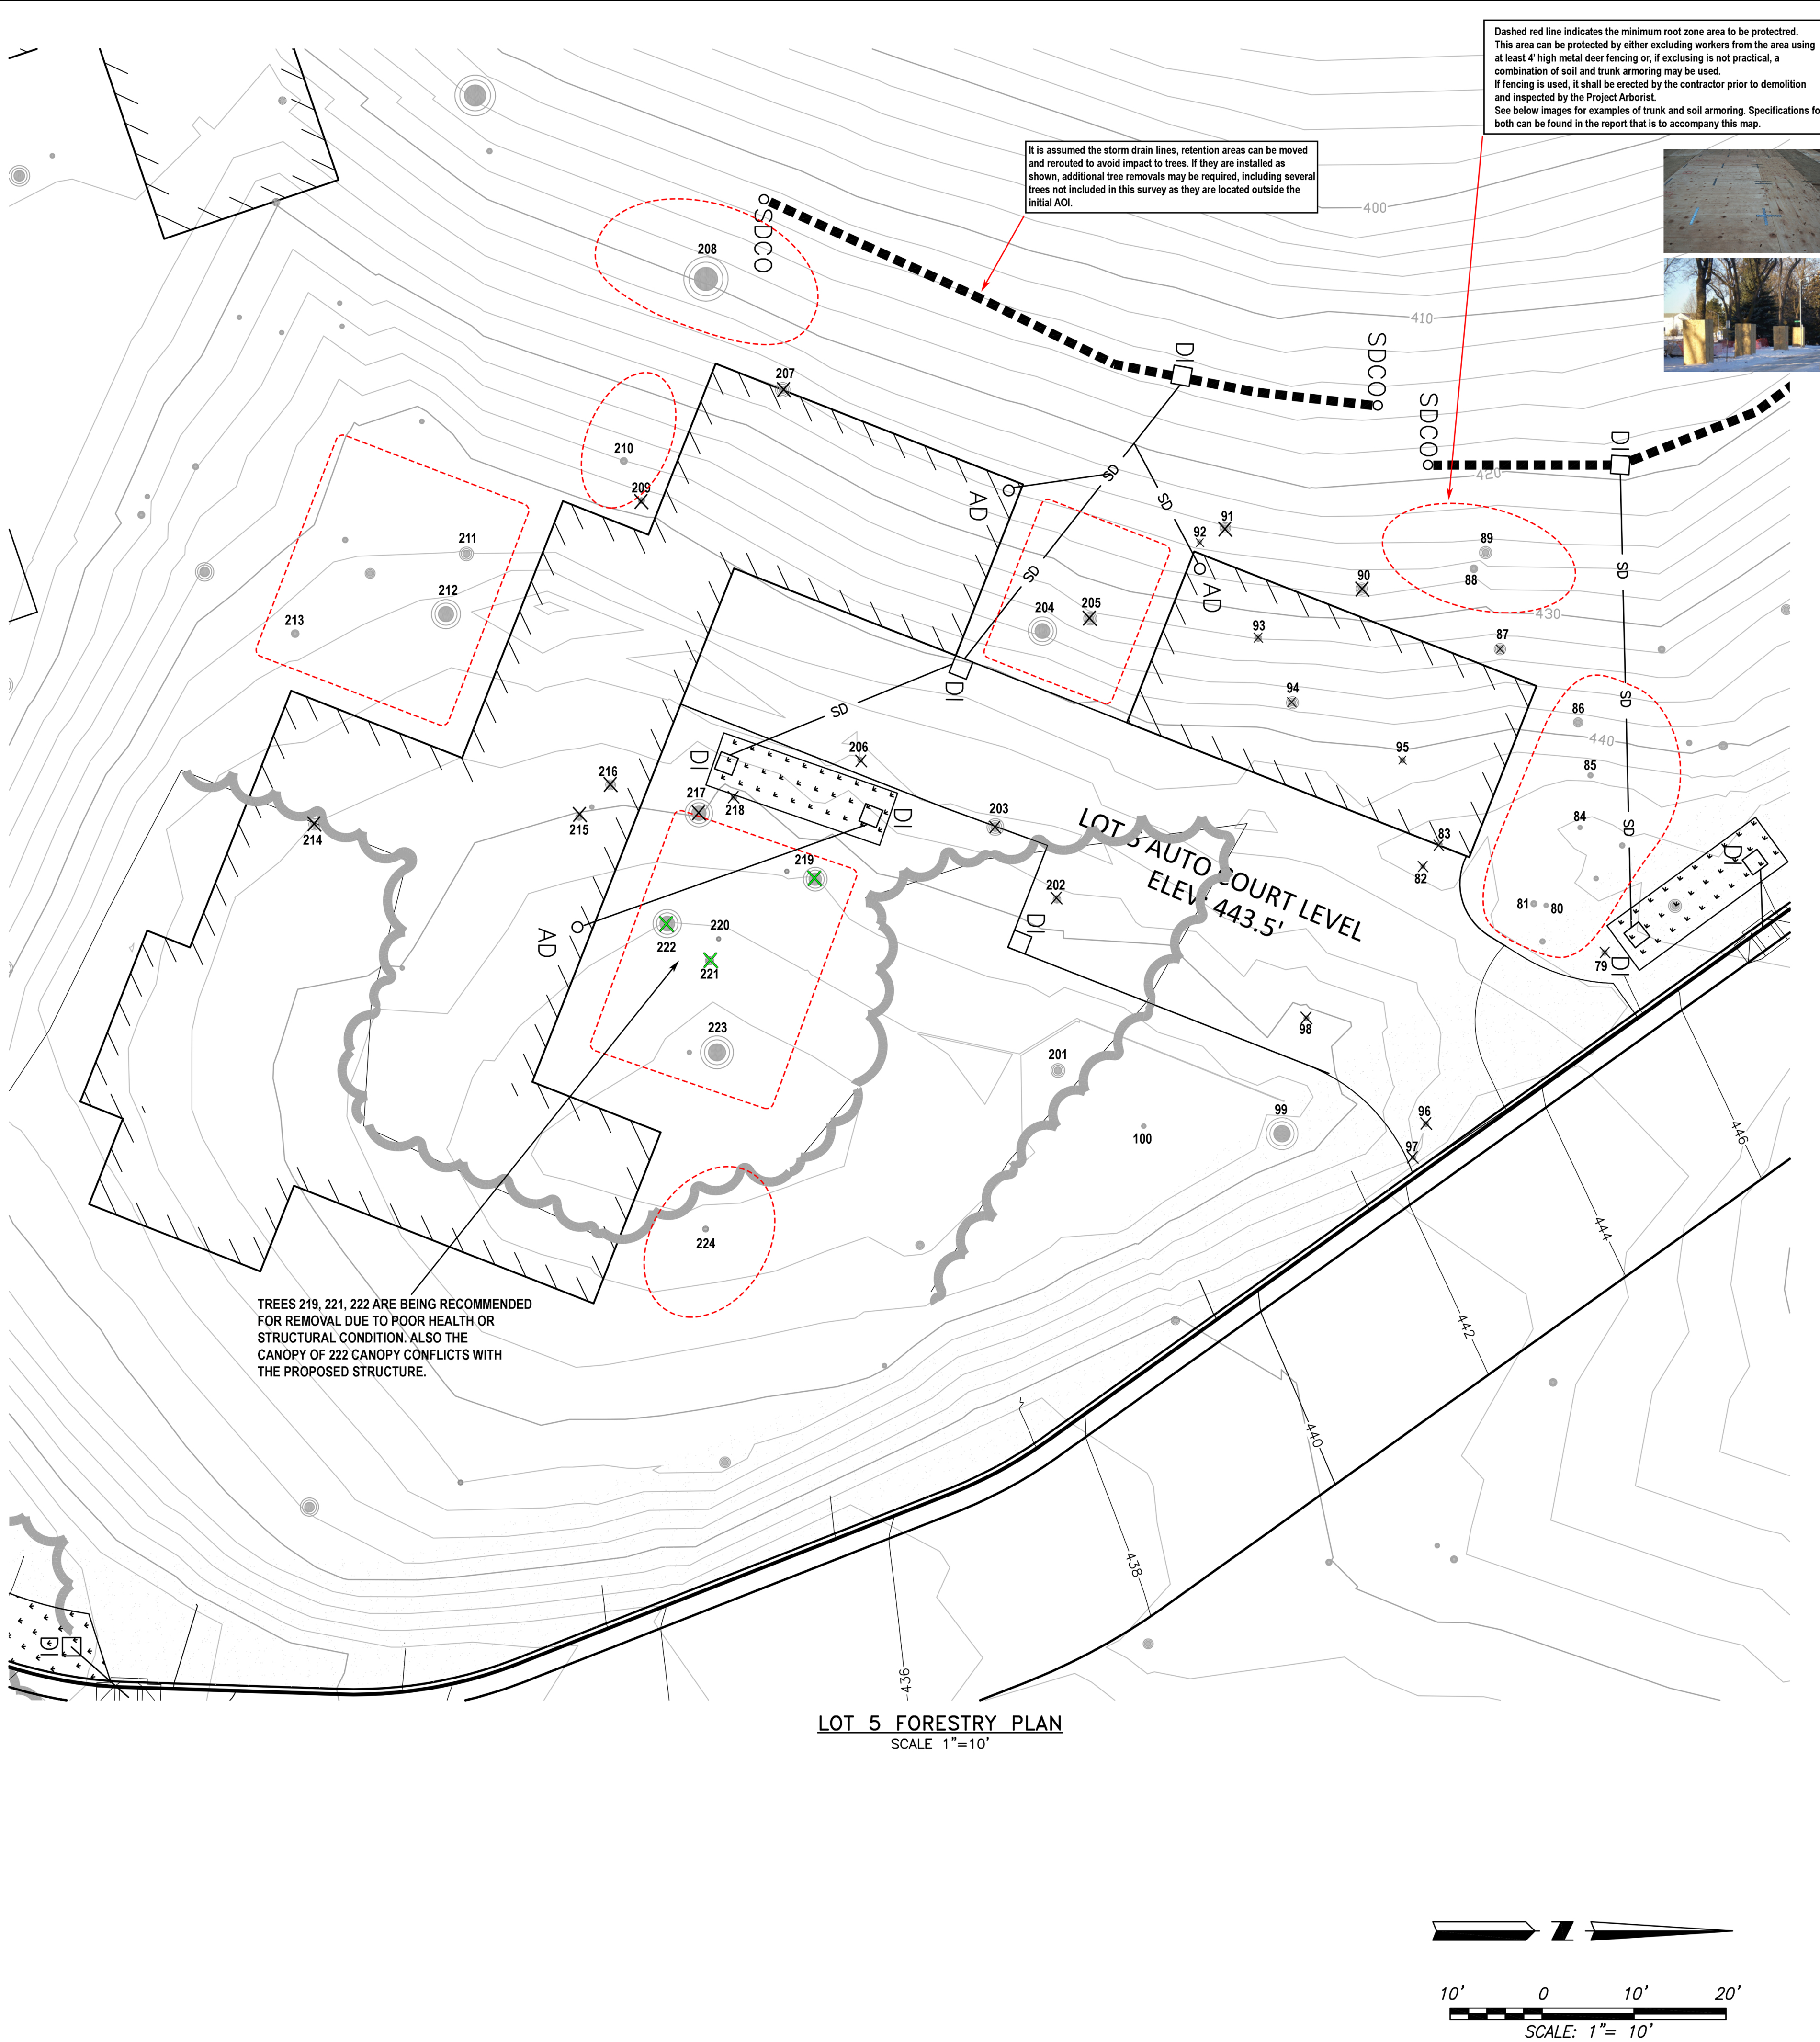
Tree Tag Number	Common Name	Latin Name	Diameter			Health	Structure	Comments	Removal
			Stem 1	Stem 2	Stem 3				
79	coast live oak	<i>Quercus agrifolia</i>	8.9			Fair	Fair	Mechanical damage at 12' on branch over existing driveway.	x
80	coast live oak	<i>Quercus agrifolia</i>	7.8			Fair		Main stem in direct contact with Tree 81. Canopy symmetry away from driveway.	
81	coast live oak	<i>Quercus agrifolia</i>	7.8	5.6		Fair	Fair	Upright canopy. Shares a base with Tree 80.	
82	coast live oak	<i>Quercus agrifolia</i>	7.8			Fair	Fair	Severe mechanical damage on main stem.	x
83	coast live oak	<i>Quercus agrifolia</i>	8.2			Fair	Fair	Canopy symmetry away from driveway. There is a pile of fill soil at its base.	x
84	coast live oak	<i>Quercus agrifolia</i>	8			Fair	Fair	Moderate deadwood in lower canopy. Canopy symmetry down slope.	
85	coast live oak	<i>Quercus agrifolia</i>	12.2			Fair to Good	Fair to Good	Canopy symmetry downslope. Moderate deadwood in lower canopy.

86	coast live oak	<i>Quercus agrifolia</i>	9.9			Fair to Good	Fair	Lean and canopy symmetry downslope.	
87	coast live oak	<i>Quercus agrifolia</i>	9	8.2		Fair to Good	Fair	Common attachment of stems at approximately 1' above grade. Wildlife nest at tree base. Larger stem extends upslope into building envelope.	x
88	coast live oak	<i>Quercus agrifolia</i>	11			Fair to Good	Fair	Canopy symmetry downslope away from building envelope.	
89	coast live oak	<i>Quercus agrifolia</i>	10.1	5.4	4.7	Fair to Good	Fair	Canopy symmetry downslope under the canopy of tree 88.	
90	coast live oak	<i>Quercus agrifolia</i>	7.1	5.4	4.4	Fair to Good	Fair	Dominant stem extends upslope into building envelope. Moderate deadwood in lower canopy.	x
91	coast live oak	<i>Quercus agrifolia</i>	8.3	6	5.9	Fair	Fair	Somewhat suppressed. Lean and canopy cemetery down slope away from building envelope.	x
92	coast live oak	<i>Quercus agrifolia</i>	5			Poor to Fair	Poor to Fair	Heavily suppressed. The canopy is sparsely foliated.	x

93	coast live oak	<i>Quercus agrifolia</i>	7.8	4.6		Fair to Good	Fair	Canopy symmetry downslope. Located directly within building envelope.	x
94	coast live oak	<i>Quercus agrifolia</i>	10.1	6.3	5.1	Fair to Good	Fair	Soil and debris against tree base.	x
95	coast live oak	<i>Quercus agrifolia</i>	9.6			Fair to Good	Fair to Good	Canopy symmetry mostly away from driveway.	x
96	coast live oak	<i>Quercus agrifolia</i>	8.3			Fair	Fair	Base of tree embedded with soil.	x
97	coast live oak	<i>Quercus agrifolia</i>	5.6			Fair	Fair	Leans across slope into the canopy of Tree 96. Leggy structure.	x
98	Madrone	<i>Arbutus menziesii</i>	7.4	3.8		Fair	Fair	Lean to the north.	x
99	Madrone	<i>Arbutus menziesii</i>	11.3	7	7	Fair	Fair	Approximately 7 stems arising from a common base. A few stems were fire damaged.	
100	coast live oak	<i>Quercus agrifolia</i>	6.3	3.1		Fair	Poor to Fair	The tree is essentially sprout growth from an old stump. There is a sizable decay cavity in the base of main stem.

201	coast live oak	<i>Quercus agrifolia</i>	16.2			Poor to Fair	Poor to Fair	Leans northeast. The roots were damaged when a fire break was cut with a bulldozer. The canopy is sparse and lacking vigor.	
202	coast live oak	<i>Quercus agrifolia</i>	5.2	4		Fair	Fair	This tree was damaged by heavy equipment presumably when a fire break was cut with a bull dozer.	x
203	coast live oak	<i>Quercus agrifolia</i>	13.3	10.6		Fair to Good	Fair	The root system was damaged when a cut was made to level the building pad or for a fire break.	x
204	coast live oak	<i>Quercus agrifolia</i>	18.5	11.5	9	Fair to Good	Fair	Approx. 6 stems with a common base near grade. Soil and debris has partially buried the root crown. The main stem is set back from the existing driveway approx. 5'.	
205	coast live oak	<i>Quercus agrifolia</i>	8	7.3		Fair	Poor to Fair	Heavy lean across slope. A scaffold limb was headed back to clear the driveway.	x

206	coast live oak	<i>Quercus agrifolia</i>	8.6			Fair	Fair	Located on cut bank. Appears to have been damaged mechanically when the pad was graded.	x
207	coast live oak	<i>Quercus agrifolia</i>	13	9.4	7.8	Fair to Good	Fair	Tree base is buried with soil and debris. Lean and canopy symmetry predominantly upslope.	x
208	coast live oak	<i>Quercus agrifolia</i>	13.6	13.3	11.5	Fair to Good	Fair	It is a large well structured tree. The upslope portion of the tree base is buried with soil and debris.	
209	coast live oak	<i>Quercus agrifolia</i>	9.5			Fair	Fair	Lower trunk buried with soil and debris. Upright canopy form.	x
210	coast live oak	<i>Quercus agrifolia</i>	9.2			Fair	Fair	Upright canopy form. Lower trunk buried with soil and debris. Leans and canopy symmetry downslope.	
211	Pacific madrone	<i>Arbutus menziesii</i>	14.0	10.0		Fair	Fair	Leans heavily west under the canopy of T-212.	
212	coast live oak	<i>Quercus agrifolia</i>	25.5	15.5	12	Fair to Good	Fair	The upslope face of the trunk is buried with soil. There are multiple dead branches over 3" diameter in the lower canopy.

213	coast live oak	<i>Quercus agrifolia</i>	9.5			Fair to Good	Fair	Strong lean south.	
214	Valley oak	<i>Quercus lobata</i>	12			Poor to Fair	Fair	The canopy is very sparse. Moderate oak gall wasp activity.	x
215	coast live oak	<i>Quercus agrifolia</i>	12.6			Fair to Good	Fair	Lean and canopy symmetry south.	x
216	coast live oak	<i>Quercus agrifolia</i>	6.4	6.3		Fair	Poor to Fair	Acute angle attachment of stems at grade. Southwest lean.	x
217	Madrone	<i>Arbutus menziesii</i>	13	12.2	10.2	Fair to Good	Fair	Minor fire scar and associated decay at the north face of trunk near grade.	x
218	coast live oak	<i>Quercus agrifolia</i>	7.1			Fair	Fair	Lean and canopy symmetry southeast.	x
219	coast live oak	<i>Quercus agrifolia</i>	10.7	10	6.9	Fair	Poor to Fair	The measured stems were once apart of a large multiple stem tree. The tree split apart in the distant past. The most viable living portion of the tree was tagged.

220	Madrone	<i>Arbutus menziesii</i>	6.2	3.1		Fair to Good	Fair to Good	The canopy is full and vigorous and lacking typical fungal issues.	
221	coast live oak	<i>Quercus agrifolia</i>	14.3			Poor to Fair	Poor	Strong south lean. The canopy is stunted and sparsely foliated. There is a decay cavity on the top of the main scaffold limb at approx. 20' above grade.	
222	coast live oak	<i>Quercus agrifolia</i>	23.3	13.3	9	Fair	Poor to Fair	Strong lean southeast. The canopy is severely asymmetric the lowest scaffold limb hangs low approximately 2' above grade.	
223	coast live oak	<i>Quercus agrifolia</i>	23.6	17.3		Fair	Poor to Fair	The tree has experienced multiple large branch failures. At least four decay cavities exist where large failures have occurred.	
224	coast live oak	<i>Quercus agrifolia</i>	9.1			Fair	Fair to Good	Balanced canopy. Approx. 20' spread.	
Total Removals									24
