\\INFO\Documents\jobs\2015\15-163\_Rothman\DWG\ARBORIST PLAN.dwg, 9/5/2017 10:02:52 AM, Janice Bluebeam PDF, ARCH-D, 24.00, x, 35.00, Inches, 1:1

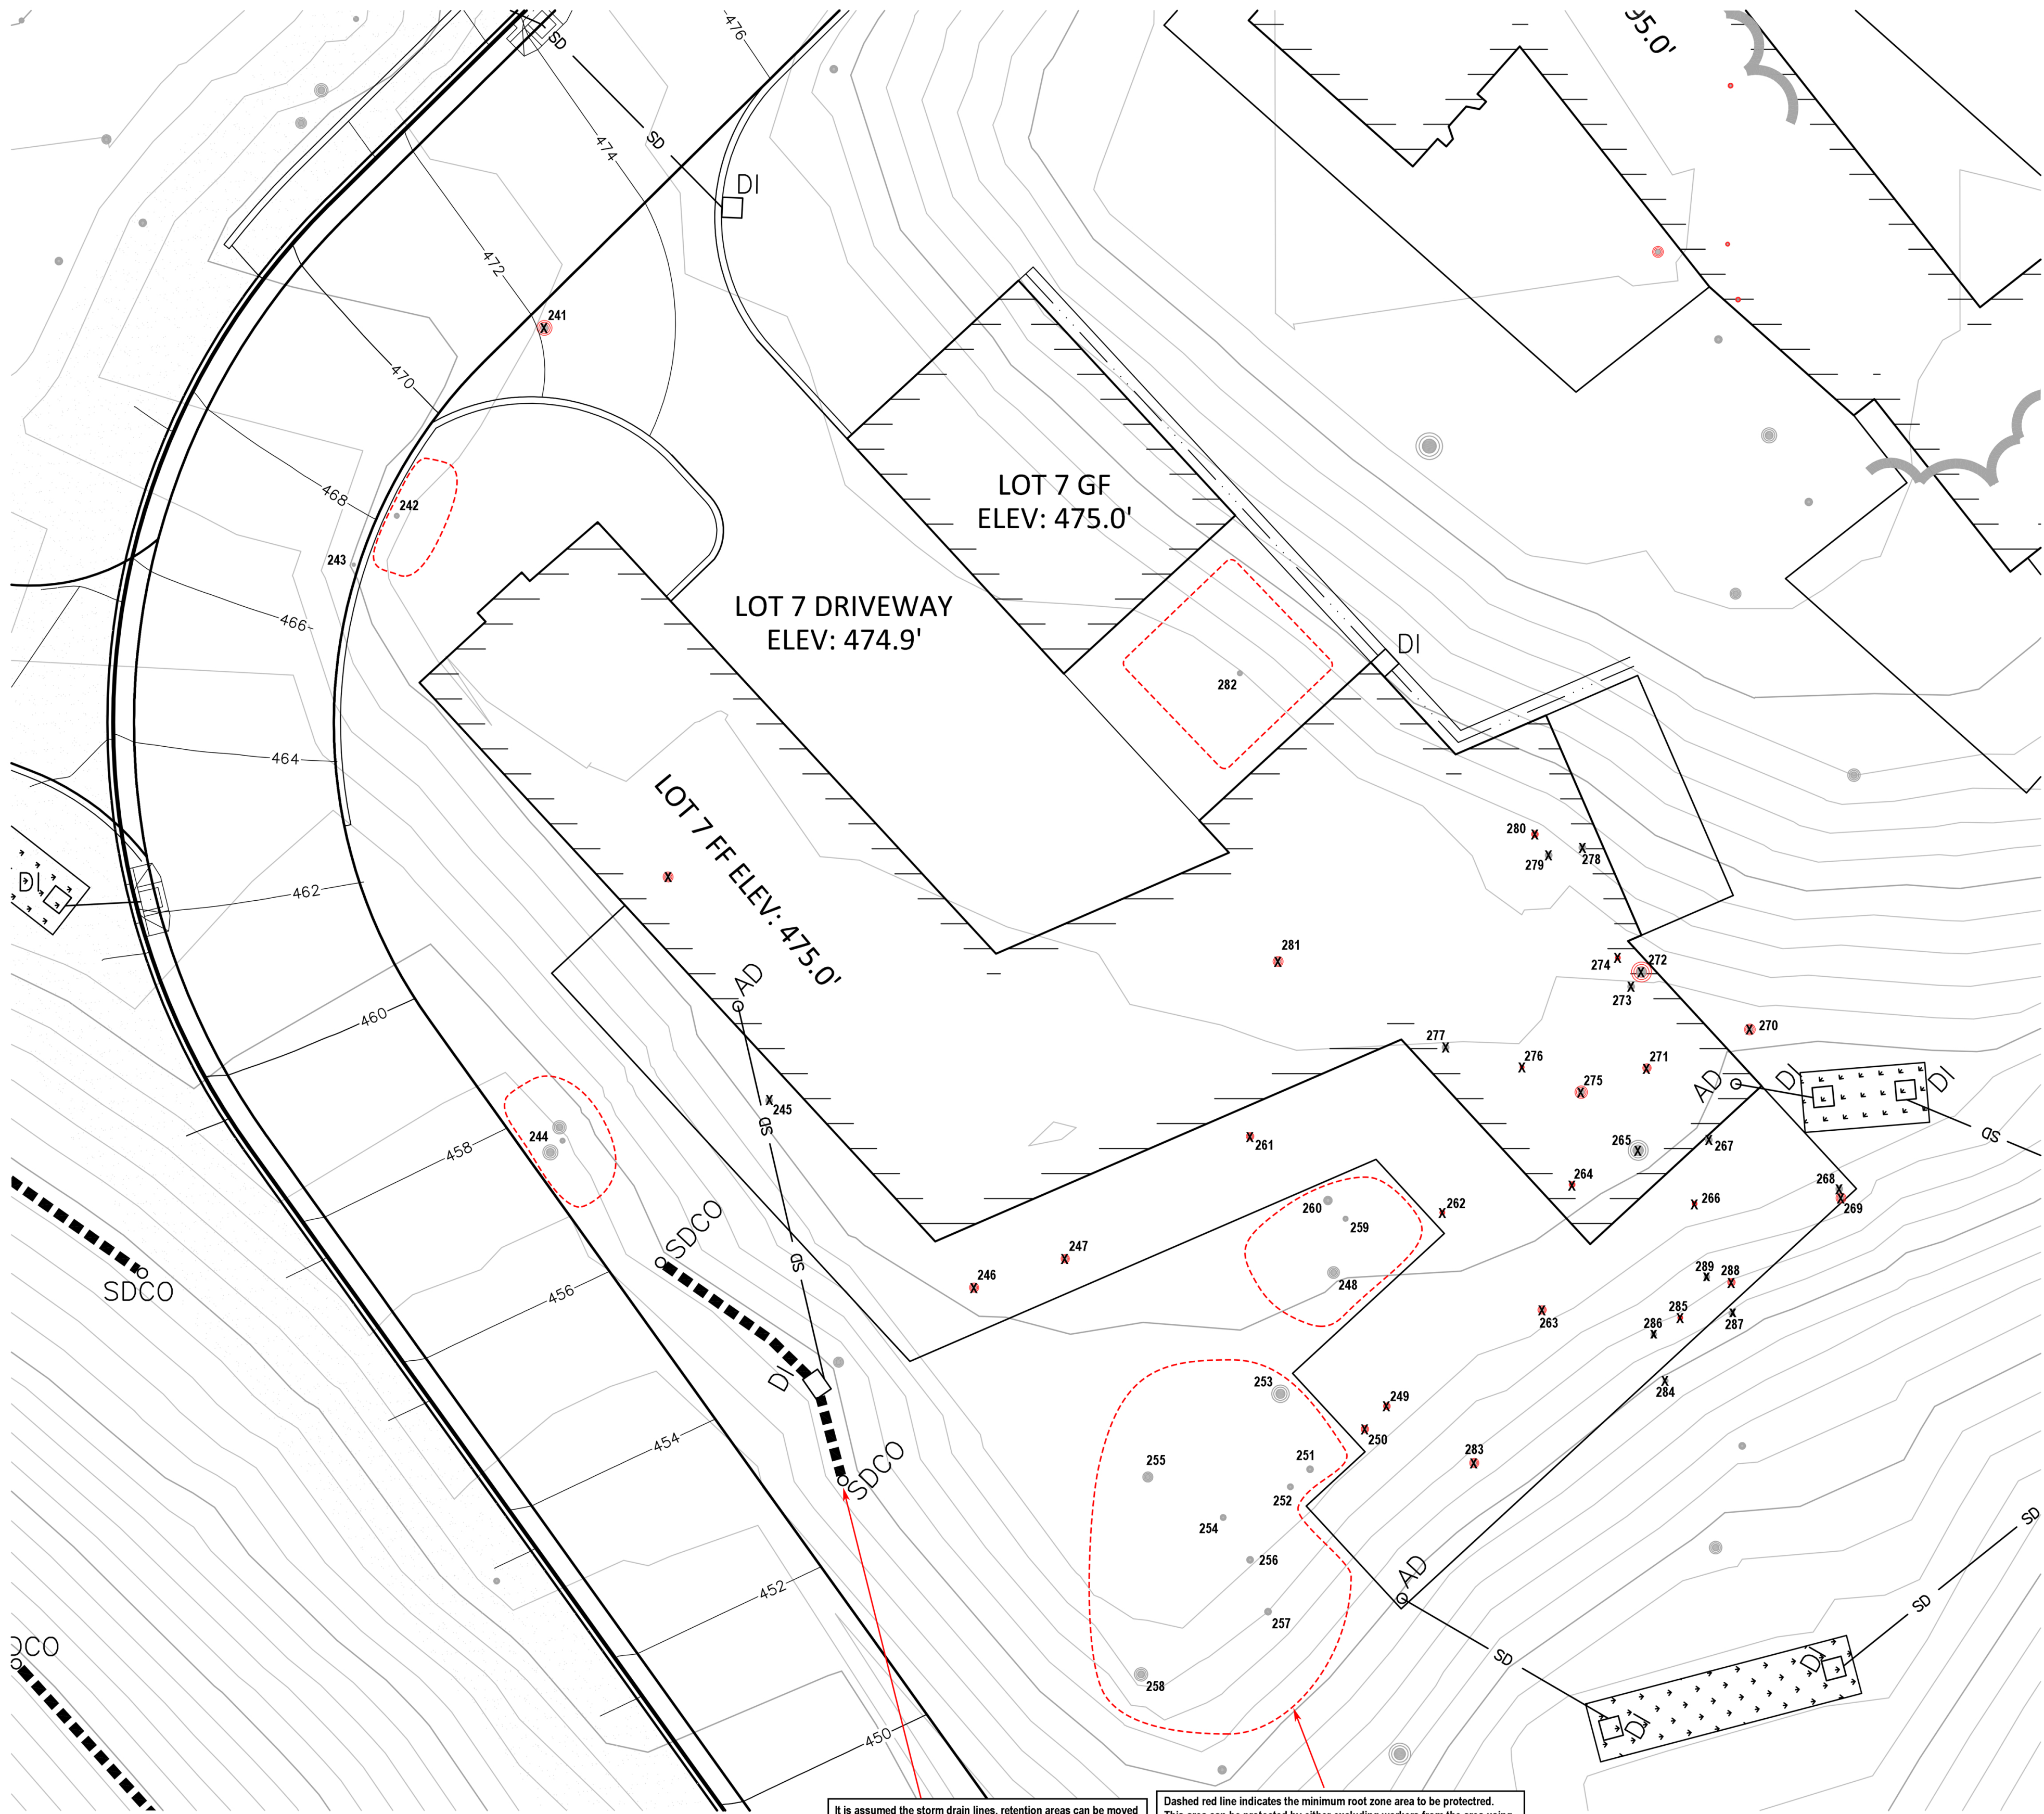
Tree Tag Number	Common Name	Latin Name	Diameter			Health	Structure	Comments	Removal
			Stem 1	Stem 2	Stem 3				
241	coast live oak	<i>Quercus agrifolia</i>	7	6.8	5.5	Fair	Fair	Balanced canopy spreading approx. 20'.	X
242	coast live oak	<i>Quercus agrifolia</i>	8.3	6.2	3	Fair	Fair	Multiple stems arising from grade. Balanced canopy with a spread of approx. 15'.	
243	coast live oak	<i>Quercus agrifolia</i>	5.5	3.8		Fair	Fair	Canopy oriented away from building envelope, toward main road.	
244	coast live oak	<i>Quercus agrifolia</i>	9.5	8.7	7.3	Fair to Good	Fair	Canopy symmetry favored downslope.	
245	coast live oak	<i>Quercus agrifolia</i>	5.6			Fair to Good	Fair	Surrounded by brush and small oaks.	X
246	coast live oak	<i>Quercus agrifolia</i>	7.9	5.9		Fair	Fair to Good	Somewhat sparse canopy.	X
247	coast live oak	<i>Quercus agrifolia</i>	6.5	4.9		Fair to Good	Fair to Good	Copious small diameter deadwood in canopy.	X

248	coast live oak	<i>Quercus agrifolia</i>	11.3	7.7		Fair to Good	Fair to Good	Copious deadwood in lower canopy.	
249	coast live oak	<i>Quercus agrifolia</i>	6.2			Fair	Fair	Suppressed. Somewhat sparse canopy.	X
250	coast live oak	<i>Quercus agrifolia</i>	6.9			Fair	Fair	Upright canopy form. The canopy is somewhat sparse.	X
251	coast live oak	<i>Quercus agrifolia</i>	7.8			Fair	Fair	Canopy symmetry southeast. Canopy is upright and narrow.	
252	coast live oak	<i>Quercus agrifolia</i>	6.2			Fair	Fair	Somewhat suppressed. The canopy is narrow and upright with symmetry south, southeast.	
253	coast live oak	<i>Quercus agrifolia</i>	8.3	8.3	7.1	Fair to Good	Fair	Multiple dead branch oaks in lower canopy. Narrow angle of attachment of stems at 1' above grade.	
254	coast live oak	<i>Quercus agrifolia</i>	7.1			Fair	Fair	Upright canopy due to competition.	
255	coast live oak	<i>Quercus agrifolia</i>	6.8	2	2	Fair	Fair	Multiple stems arising from grade.

256	coast live oak	<i>Quercus agrifolia</i>	5.8			Fair	Fair	Somewhat suppressed.	
257	coast live oak	<i>Quercus agrifolia</i>	7.9			Fair to Good	Fair to Good	Relatively balanced canopy despite tight spacing with adjacent trees.	
258	coast live oak	<i>Quercus agrifolia</i>	8	7.3		Fair to Good	Fair	Balanced canopy with an approximate spread of 20'.	
259	coast live oak	<i>Quercus agrifolia</i>	6.1			Fair	Fair	Somewhat suppressed.	
260	coast live oak	<i>Quercus agrifolia</i>	6.8	6.3	4.2	Fair to Good	Fair	Canopy symmetry northwest.	
261	coast live oak	<i>Quercus agrifolia</i>	5.2	4		Fair	Fair	Shrubby form. Multiple low hanging branches.	X
262	coast live oak	<i>Quercus agrifolia</i>	4.6			Fair to Good	Fair	Narrow canopy and upright form.	X
263	coast live oak	<i>Quercus agrifolia</i>	8.3	4.3		Fair	Fair	Slight lean and canopy symmetry southwest.	X
264	coast live oak	<i>Quercus agrifolia</i>	8			Fair	Fair	Suppressed by adjacent trees. Slight lean and canopy symmetry southwest.	X

265	Madrone	<i>Arbutus menziesii</i>	11	10.6	10.4	Fair	Fair	Typical amounts of deadwood in canopy.	X
266	California bay laurel	<i>Umbellularia californica</i>	4.3	3.4		Fair to Good	Fair	Leaves symptomatic of SOD.	X
267	California bay laurel	<i>Umbellularia californica</i>	4.2			Fair	Fair	Heavily suppressed.	X
268	coast live oak	<i>Quercus agrifolia</i>	5.8			Fair to Good	Fair	Strong lean and canopy symmetry downslope.	X
269	coast live oak	<i>Quercus agrifolia</i>	5.8			Fair	Fair		
270	coast live oak	<i>Quercus agrifolia</i>	10.2	6		Fair to Good	Fair to Good	Canopy symmetry northeast away from building envelope.	X
271	coast live oak	<i>Quercus agrifolia</i>	7.2			Fair to Good	Fair	Slight lean and canopy symmetry northwest.	X
272	coast live oak	<i>Quercus agrifolia</i>	11.5			Fair to Good	Fair to Good	Strong leans canopy symmetry upslope.	X
273	coast live oak	<i>Quercus agrifolia</i>	10.4			Fair to Good	Fair to Good		X

274	coast live oak	<i>Quercus agrifolia</i>	5.2	3		Poor to Fair	Poor to Fair	Heavily suppressed. The canopy is sparse.	X
275	coast live oak	<i>Quercus agrifolia</i>	15.9			Fair to Good	Fair	Copious deadwood in lower canopy.	X
276	coast live oak	<i>Quercus agrifolia</i>	4.8			Fair	Fair	West lean.	X
277	coast live oak	<i>Quercus agrifolia</i>	6.3			Fair to Good	Fair	West lean. Somewhat suppressed under the canopy of Tree 276.	X
278	coast live oak	<i>Quercus agrifolia</i>	7.2			Fair to Good	Fair	It's canopy is upright and limited due to tight spacing with adjacent trees.	X
279	coast live oak	<i>Quercus agrifolia</i>	6.2			Poor to Fair	Fair	Bleeding on lower main stem is consistent with SOD.	X
280	coast live oak	<i>Quercus agrifolia</i>	7.2	6.8	6.5	Poor to Fair	Fair	Girdling on main stem is consistent with SOD. Adjacent bay tree leaves are also symptomatic.	X
281	coast live oak	<i>Quercus agrifolia</i>	5	5	3	Fair	Fair	Two largest stems meet at grade.	X

282	coast live oak	<i>Quercus agrifolia</i>	7.3			Fair to Good	Fair	Canopy is balanced with approximate spread of 15'.	
283	coast live oak	<i>Quercus agrifolia</i>	11.3	8.0		Poor to Fair	Fair	Sparse canopy.	X
284	coast live oak	<i>Quercus agrifolia</i>	8.1			Fair	Fair	Lean downslope.	X
285	coast live oak	<i>Quercus agrifolia</i>	6.2			Fair	Fair	Leggy structure.	X
286	coast live oak	<i>Quercus agrifolia</i>	5.5			Fair	Fair	Leggy structure. The canopy is somewhat sparse.	X
287	coast live oak	<i>Quercus agrifolia</i>	5.5			Fair	Fair	Leggy. Leans downslope.	X
288	coast live oak	<i>Quercus agrifolia</i>	8.8			Fair	Fair	Leans downslope.	X
289	coast live oak	<i>Quercus agrifolia</i>	4.7			Fair	Fair	Leggy structure.	X
Total Removals									34

It is assumed the storm drain lines, retention areas can be moved and rerouted to avoid impact to trees. If they are installed as shown, additional tree removals may be required, including several trees not included in this survey as they are located outside the initial AOI.

Dashed red line indicates the minimum root zone area to be protected. This area can be protected by either excluding workers from the area using at least 4' high metal deer fencing or, if excluding is not practical, a combination of soil and trunk armoring may be used. If fencing is used, it shall be erected by the contractor prior to demolition and inspected by the Project Arborist. See below images for examples of trunk and soil armoring. Specifications for both can be found in the report that is to accompany this map.
