Re: First Planning-Level Geologic, Geotechnical, and Civil Engineering Review  
New Single-Family Residence  
88 Toyon Drive (APN 003-081-39)  
Fairfax, California

GEOTECHNICAL RECONNAISSANCE  
88 TOYON DRIVE  
FAIRFAX, CALIFORNIA

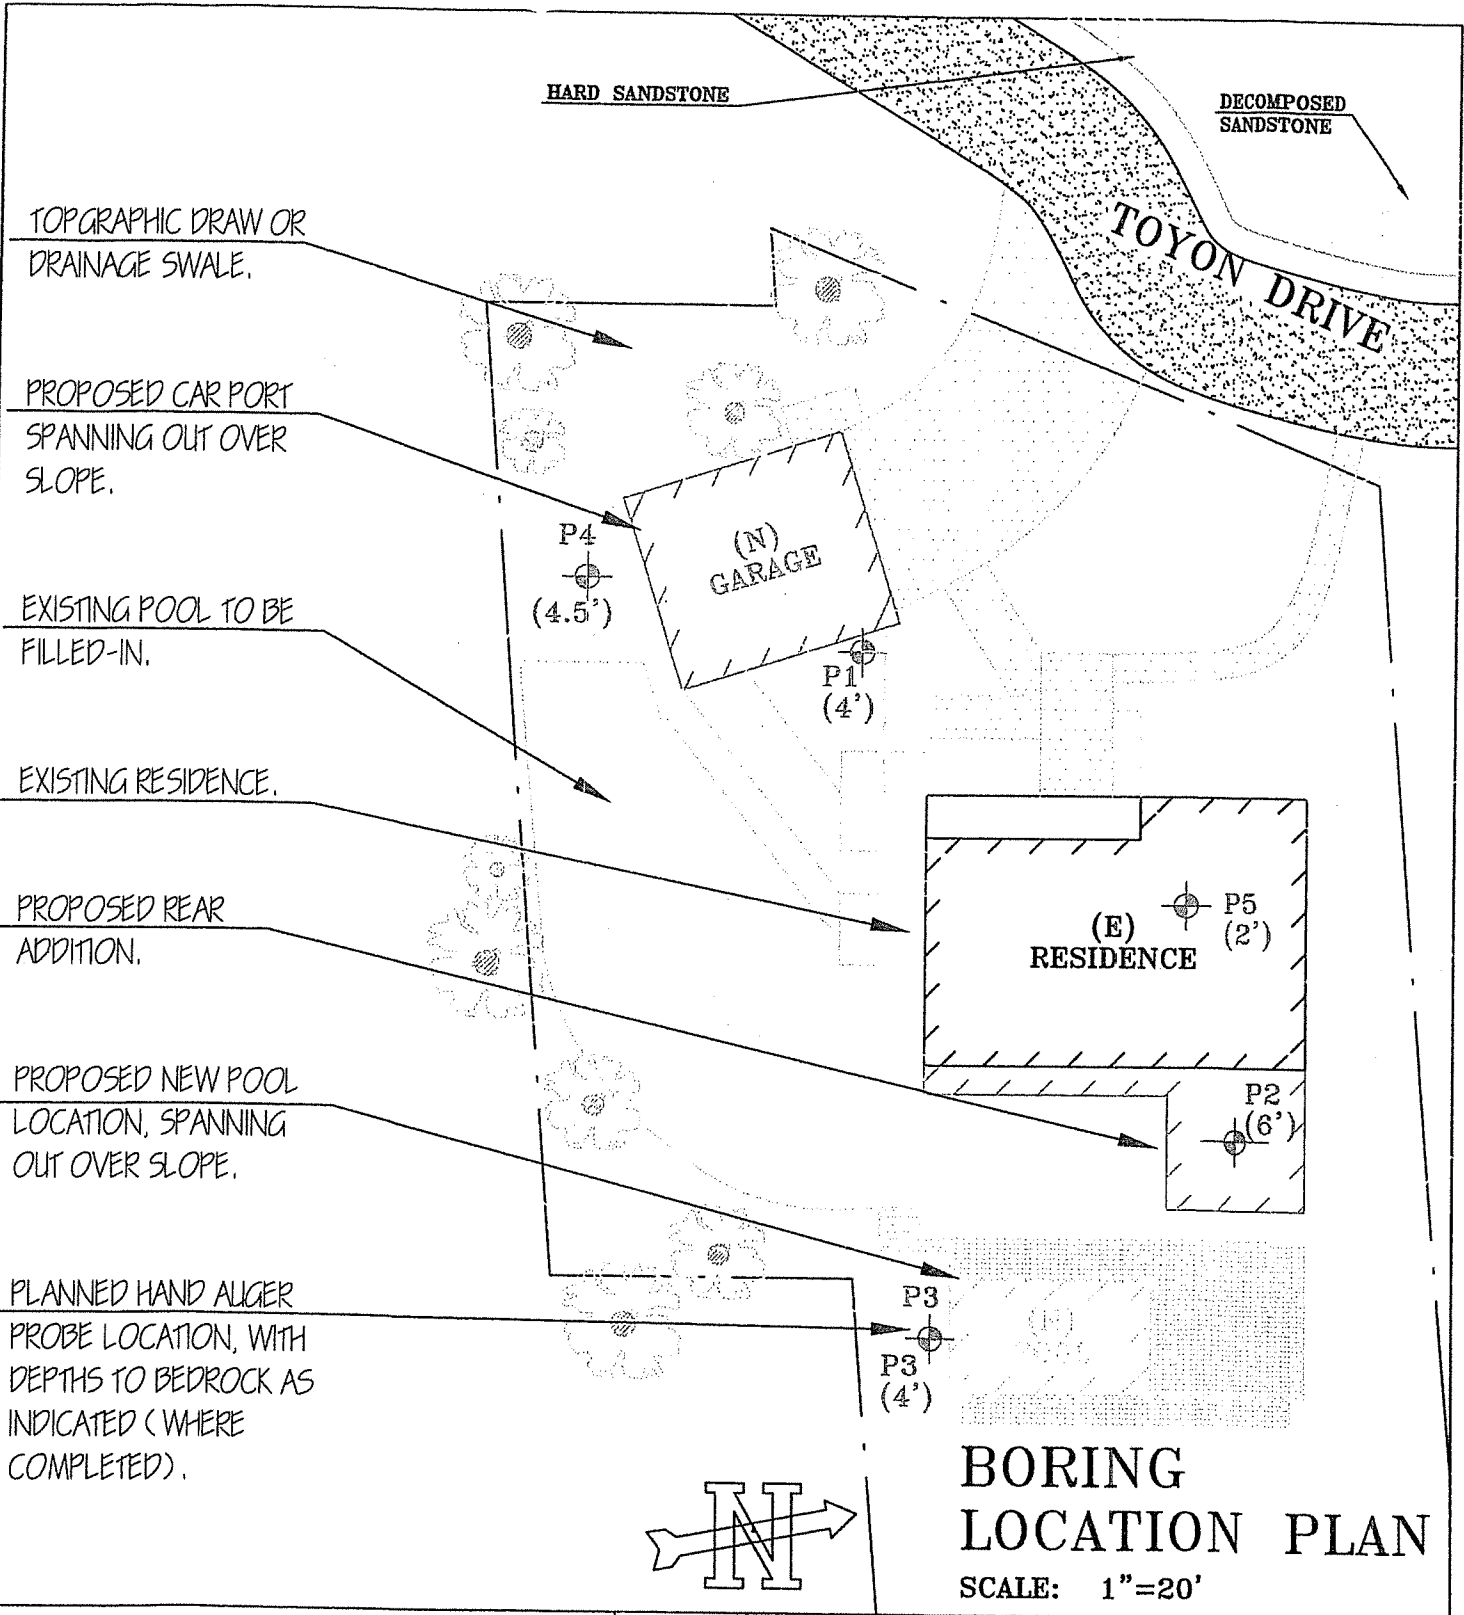
**BORING LOCATION PLAN**  
 SCALE: 1"=20'

P1, near the forward edge of the proposed carport, encountered approximately 2 feet of loose silty fill topsoil, underlain by one foot of residual soil consisting of mottled grey brown clayey Silt was unearthed. Yellow tan weathered sandstone bedrock was encountered at 3 feet, grading to hard grey sandstone at 4 feet where the probe met refusal. Probe P4, located within the defined swale at the rear of the proposed carport, unearthed 4.5 feet of fill or colluvial soils, consisting of mottled grey-brown silty Clay with sandstone fragments similar to P2. Hard grey sandstone bedrock was encountered at 4.5 feet.

The probe immediately below the house, P2, encountered 5 feet of loose grey brown Silt with rock fragments, which was judged to be fill and topsoil. This material was underlain by natural residual soil consisting of light grey brown Silt, which graded to weathered Shale bedrock at 6 feet. The probe was terminated at 7 feet. P3, located further down the slope
