BIRKHOFF, HENDRICKS & CARTER, L.L.P. PROFESSIONAL ENGINEERS

Re: Lemontree Drainage Analysis Final Report and Concept Plan

Subject: Lemontree Estates & Kingswood Estates – Supplemental Drainage Analysis

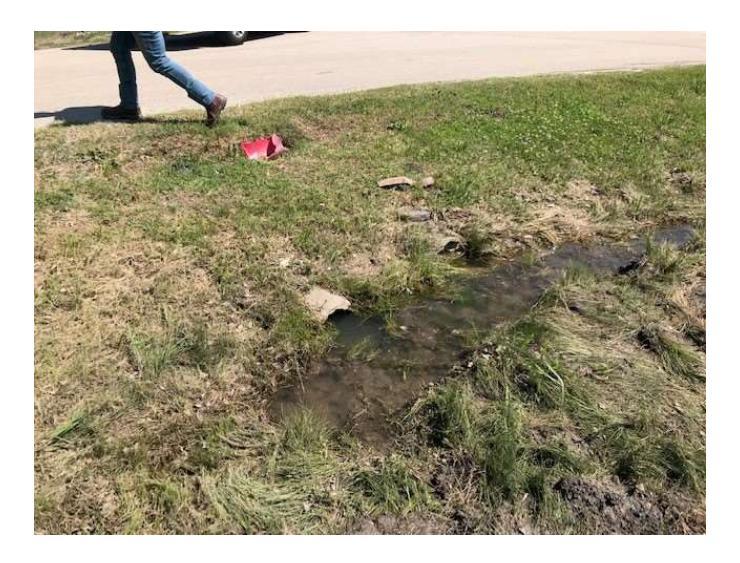
Runoff from the Lovejoy High School site flows overland to a roadside ditch along the west side of Citrus Way. The ditch west of Citrus Way flows south to a culvert under Mandarin Cove at the southwest corner of the Lemontree Estates Addition. The culverts under Mandarin Cove are damaged and are undersized for a 100-year flow rate. The runoff then flows east in a roadside ditch along the south side of Citrus Way and through a series of driveway culverts that are also undersized for a 100-year flow rate. Several of the driveway culverts downstream of Mandarin Cove are also sloping the wrong way (against flow).

Image 1: Downstream Face of Mandarin Cove Culvert

- 1. Recalculate the total flow in the roadside ditch west of Citrus Way, including the offsite area from the Lovejoy High School and onsite area within the Lemontree Estates Addition, using current engineering design requirements for runoff coefficients, time of concentration and storm intensities.
- 2. At a minimum, we recommend reconstructing the roadside ditch for about 200 feet on each side of Mandarin Cove and replacing the culverts at Mandarin Cove based on the design criteria selected by the City of Lucas.
- 3. A drainage improvements project could also be considered to reconstruct the roadside ditch along the south side of Citrus Way and the driveway culverts from Mandarin Cove to Orchard Lane based on the design criteria selected by the City of Lucas.

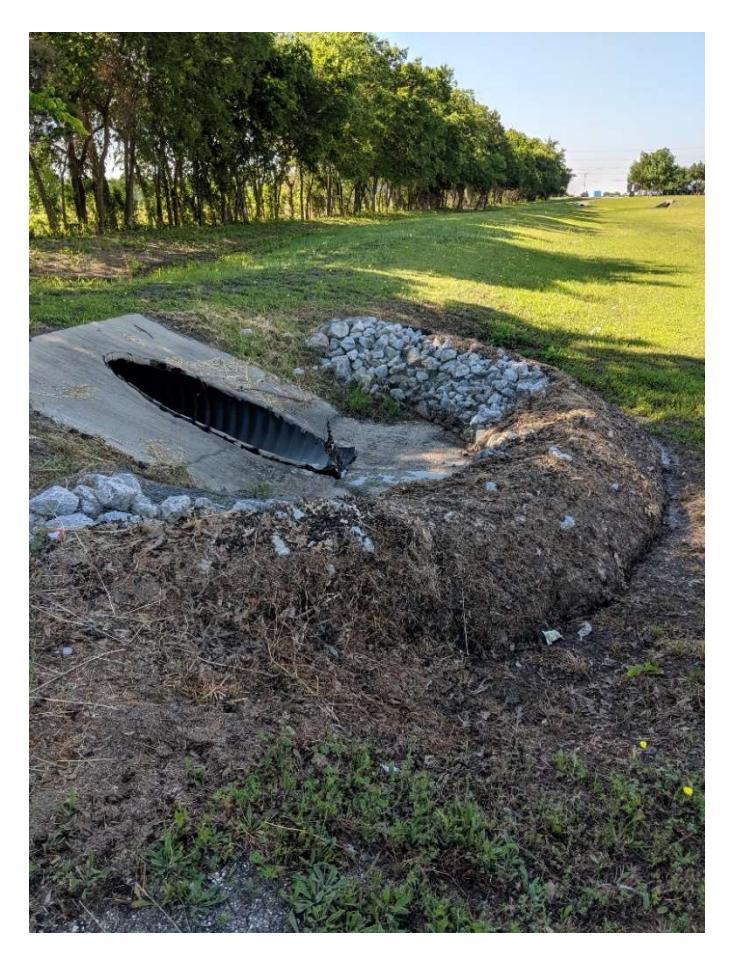
During our site investigation it was observed that the pond is discharged via a 36-inch HDPE pipe without any restrictor plate. We also observed an erosion control device at the upstream side of the outfall (shown below).

Field surveys indicate low spots in the middle of the berm for the detention pond has near the outfall culvert as much as a foot lower than the north and south ends of the berm. Rock rip rap has been placed on the east side of the berm in this location indicating that water is going over the berm undetained and creating a potentially erosive situation. The Lovejoy High School record drawings include volumetric calculations for the pond and the pond may not be functioning as it was designed based on our observations.

Image 2: Lovejoy High School Pond Outfall

- 1. Additional surveys and analysis of the pond should be performed to determine if adequate storage is currently provided and if the existing outfall structure should be modified to perform as it was originally designed. Our concept plan exhibit recommends, at a minimum, raising the berm along the east side of the detention pond to be at least 1-foot above the 100-year water surface elevation based on the plans.
- 2. The Lovejoy High School detention pond should be analyzed to determine any improvements necessary to perform in accordance with the design criteria selected by the City of Lucas. This could include performance based on a number of design storms, including more frequently occurring events.
- 3. A detention pond improvements project could be constructed based on the design criteria selected by the City of Lucas.

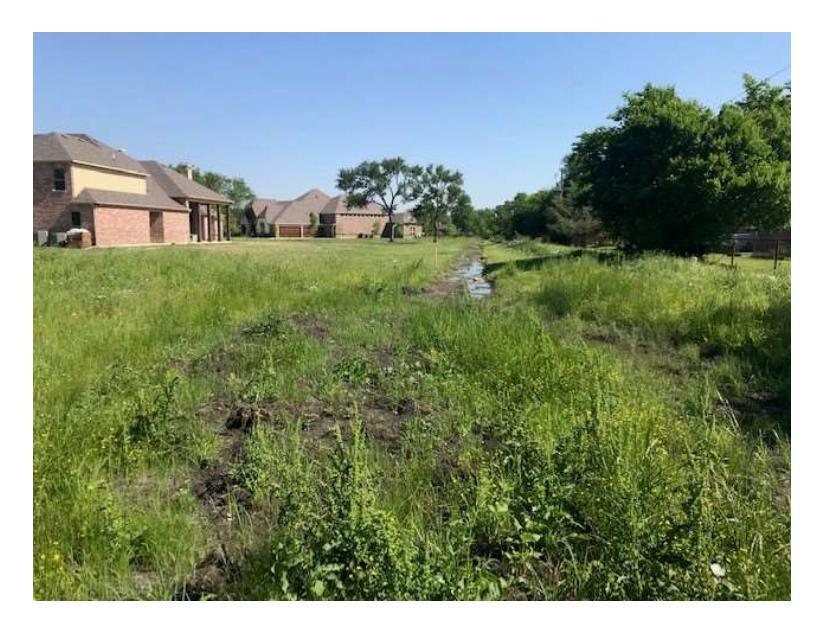
The record drawings for Rimrock Estates demonstrate runoff passing through the development via a series of ponds. Pond A is at the downstream limits of the development and is within a drainage easement on two residential lots. The outfall constructed for Pond A does not match the record drawings which may cause the water surface elevation to be higher than anticipated. This condition coupled with a potentially higher release

rate from the high school detention pond upstream of this development could cause the Pond A water surface to be higher and potentially have adverse impacts on the two residential lots.

The discharge from Pond B flows eastward in a swale labeled Pond A which turns northward along the east property line of the Rimrock Estates Addition flowing to a point where the drainage swale turns east towards Orchard Road.

Image 3: Rimrock Estates Pond A (Looking North)

- 1. The proper function of the Lovejoy High School detention pond is a crucial element for the proper function of the detention ponds constructed in the Rimrock Estates Addition and therefore addressing any detention pond performance issues would be highly recommended.
- 2. Additional surveys and analysis of the drainage swale downstream of Pond B could be performed to determine the anticipated 100-year depth of flow in "Pond A" to determine if improvements would be required to provide necessary free-board to adjacent properties within the Rimrock Estates Addition.

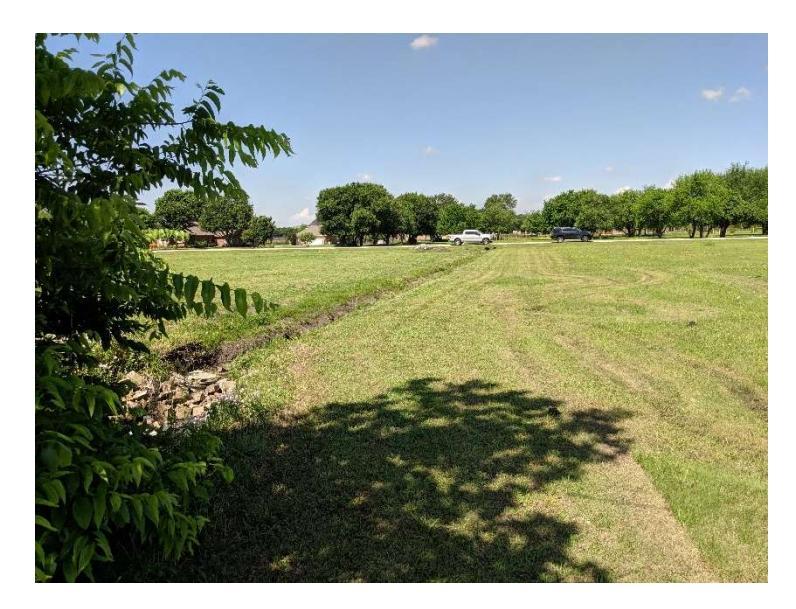
The property owners on the north and south side of the channel downstream (east) of the Orchard Road culverts met with us while walking the drainage course and indicated that mowing the channel was difficult due to the steep side slopes. We observed a water depth of 1 to 2 -inches from the west property line of the Lemontree Country Estates Addition to just before the east property line. We observed some channel scour and concrete rubble had been dumped in this location.

Image 4: Channel Downstream of Orchard Road (Looking Upstream / West)

The property owner on the north side of the channel indicated there was frequent standing water on the northeast corner of his property and added that the channel does not drain to the east of his property like it did several years ago. We observed standing water east of Orchard Road along the north side of this property.

- 1. Additional surveys and analysis could be performed on the channel and culverts crossing Orchard Road to determine any improvements necessary to perform in accordance with the design criteria selected by the City of Lucas. Our concept plan recommends at a minimum that the the side slopes of the open channel be flattened to 4:1 or flatter. The channel could also be graded steeper to drain better, if permission to grade on to the adjacent tract downstream (east) could be obtained.
- 2. Debris, trash removal and minimal grading could help alleviate the standing water experienced by the property owner on the north side of the channel (east of Orchard Road).
