Geotechnical Evaluation of Ross Valley Detention Basins
(Except Phoenix Lake)

**GEOTECHNICAL AND GEOLOGIC FEASIBILITY STUDY
LOMA ALTA, LEFTY GOMEZ FIELD, MEMORIAL PARK
AND RED HILL PARK DETENTION BASINS
WATERSHED FLOOD DAMAGE REDUCTION &
CREEK MANAGEMENT STUDY
MARIN COUNTY, CALIFORNIA**

April 6, 2010

Project 960.05

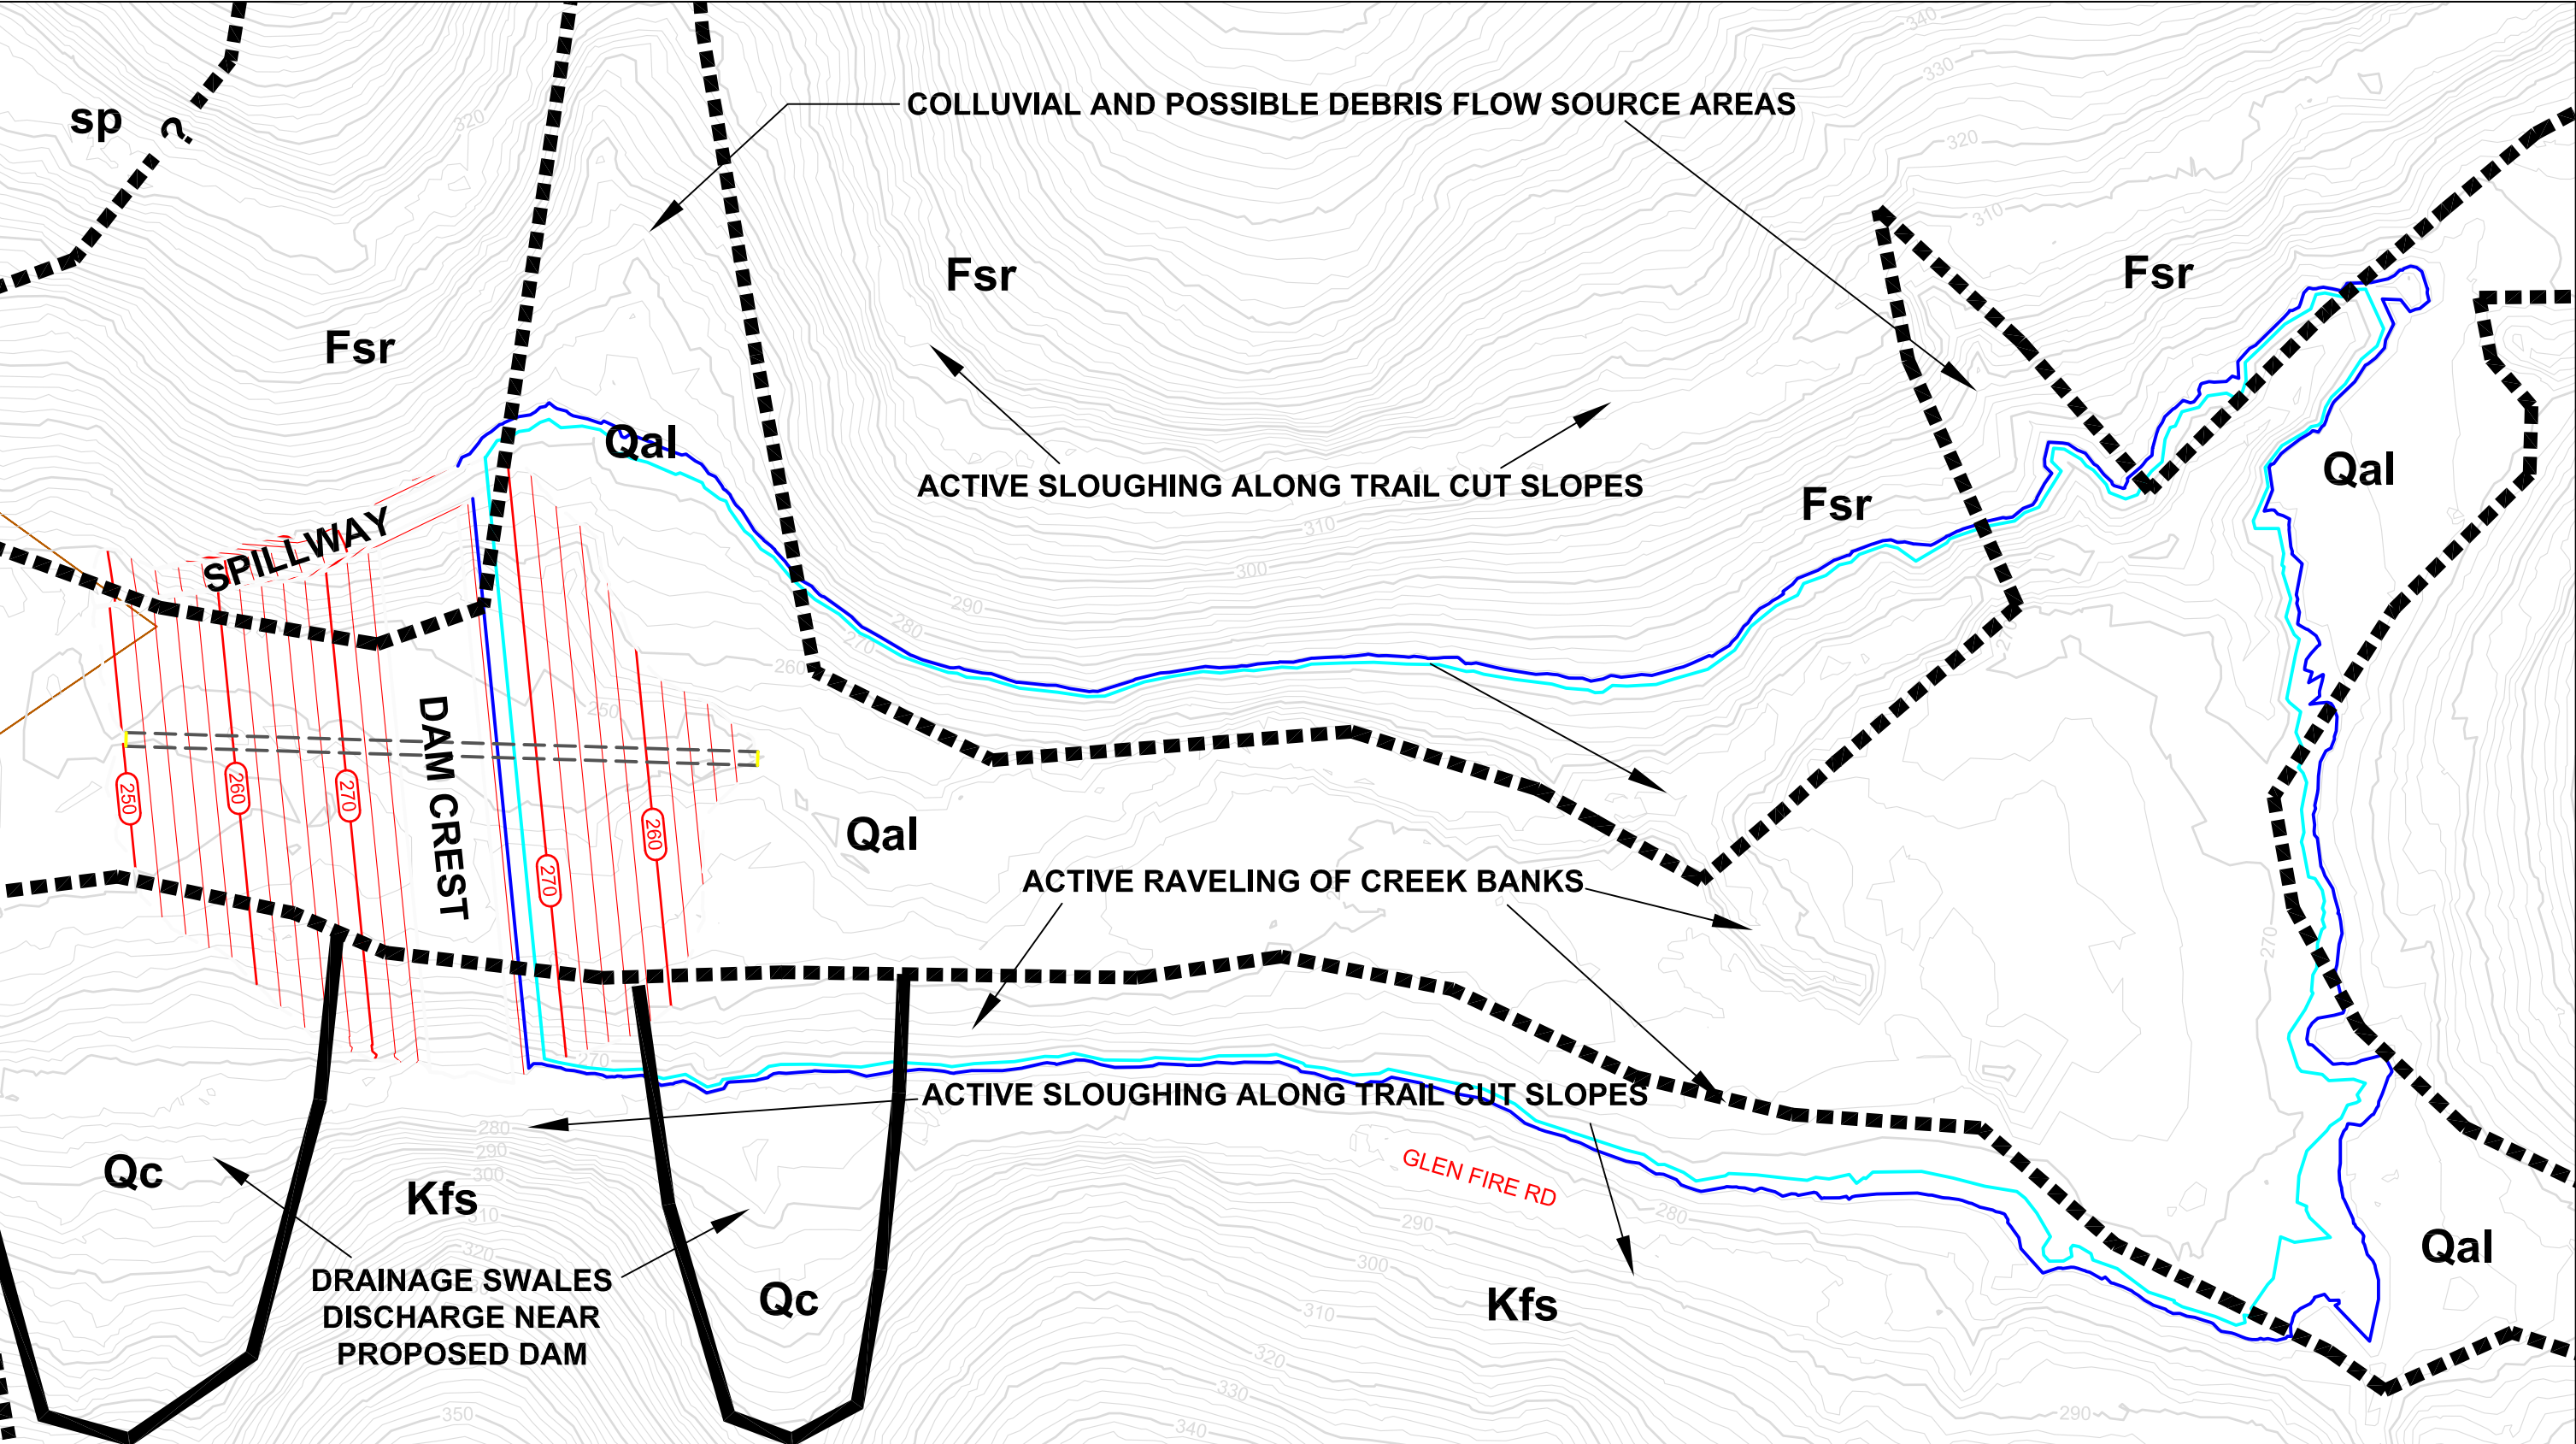
3

We did observe a drainage channel on the slope east of the proposed dam which is relatively steep and, were the dam constructed in the proposed location, would discharge runoff across the downstream face of the dam, likely resulting in adverse erosion patterns which could affect the stability and lifespan of the dam. Significant geologic features observed during our site reconnaissance are shown on Figure 3.

Location	Mitigation measures required
Loma Alta DB	<i>Existing erosion features should be repaired and stabilized as part of the detention basin construction. Careful attention should be given to the collection and control of surface drainage from the adjacent slopes to minimize erosion of embankment, slopes and reduce sedimentation within the basin. Erosion-control measures are discussed in further detail in Section V of this report. More detailed site-specific mitigation recommendations will be presented in a design-level Geotechnical Investigation Report.</i>
Lefty Gomez Field DB Memorial Park DB Red Hill Park DB	<i>Erosion-control measures including erosion control mats and planting should be implemented on all slopes to prevent loss of material. More detailed site-specific mitigation recommendations will be presented in a design-level Geotechnical Investigation Report.</i>

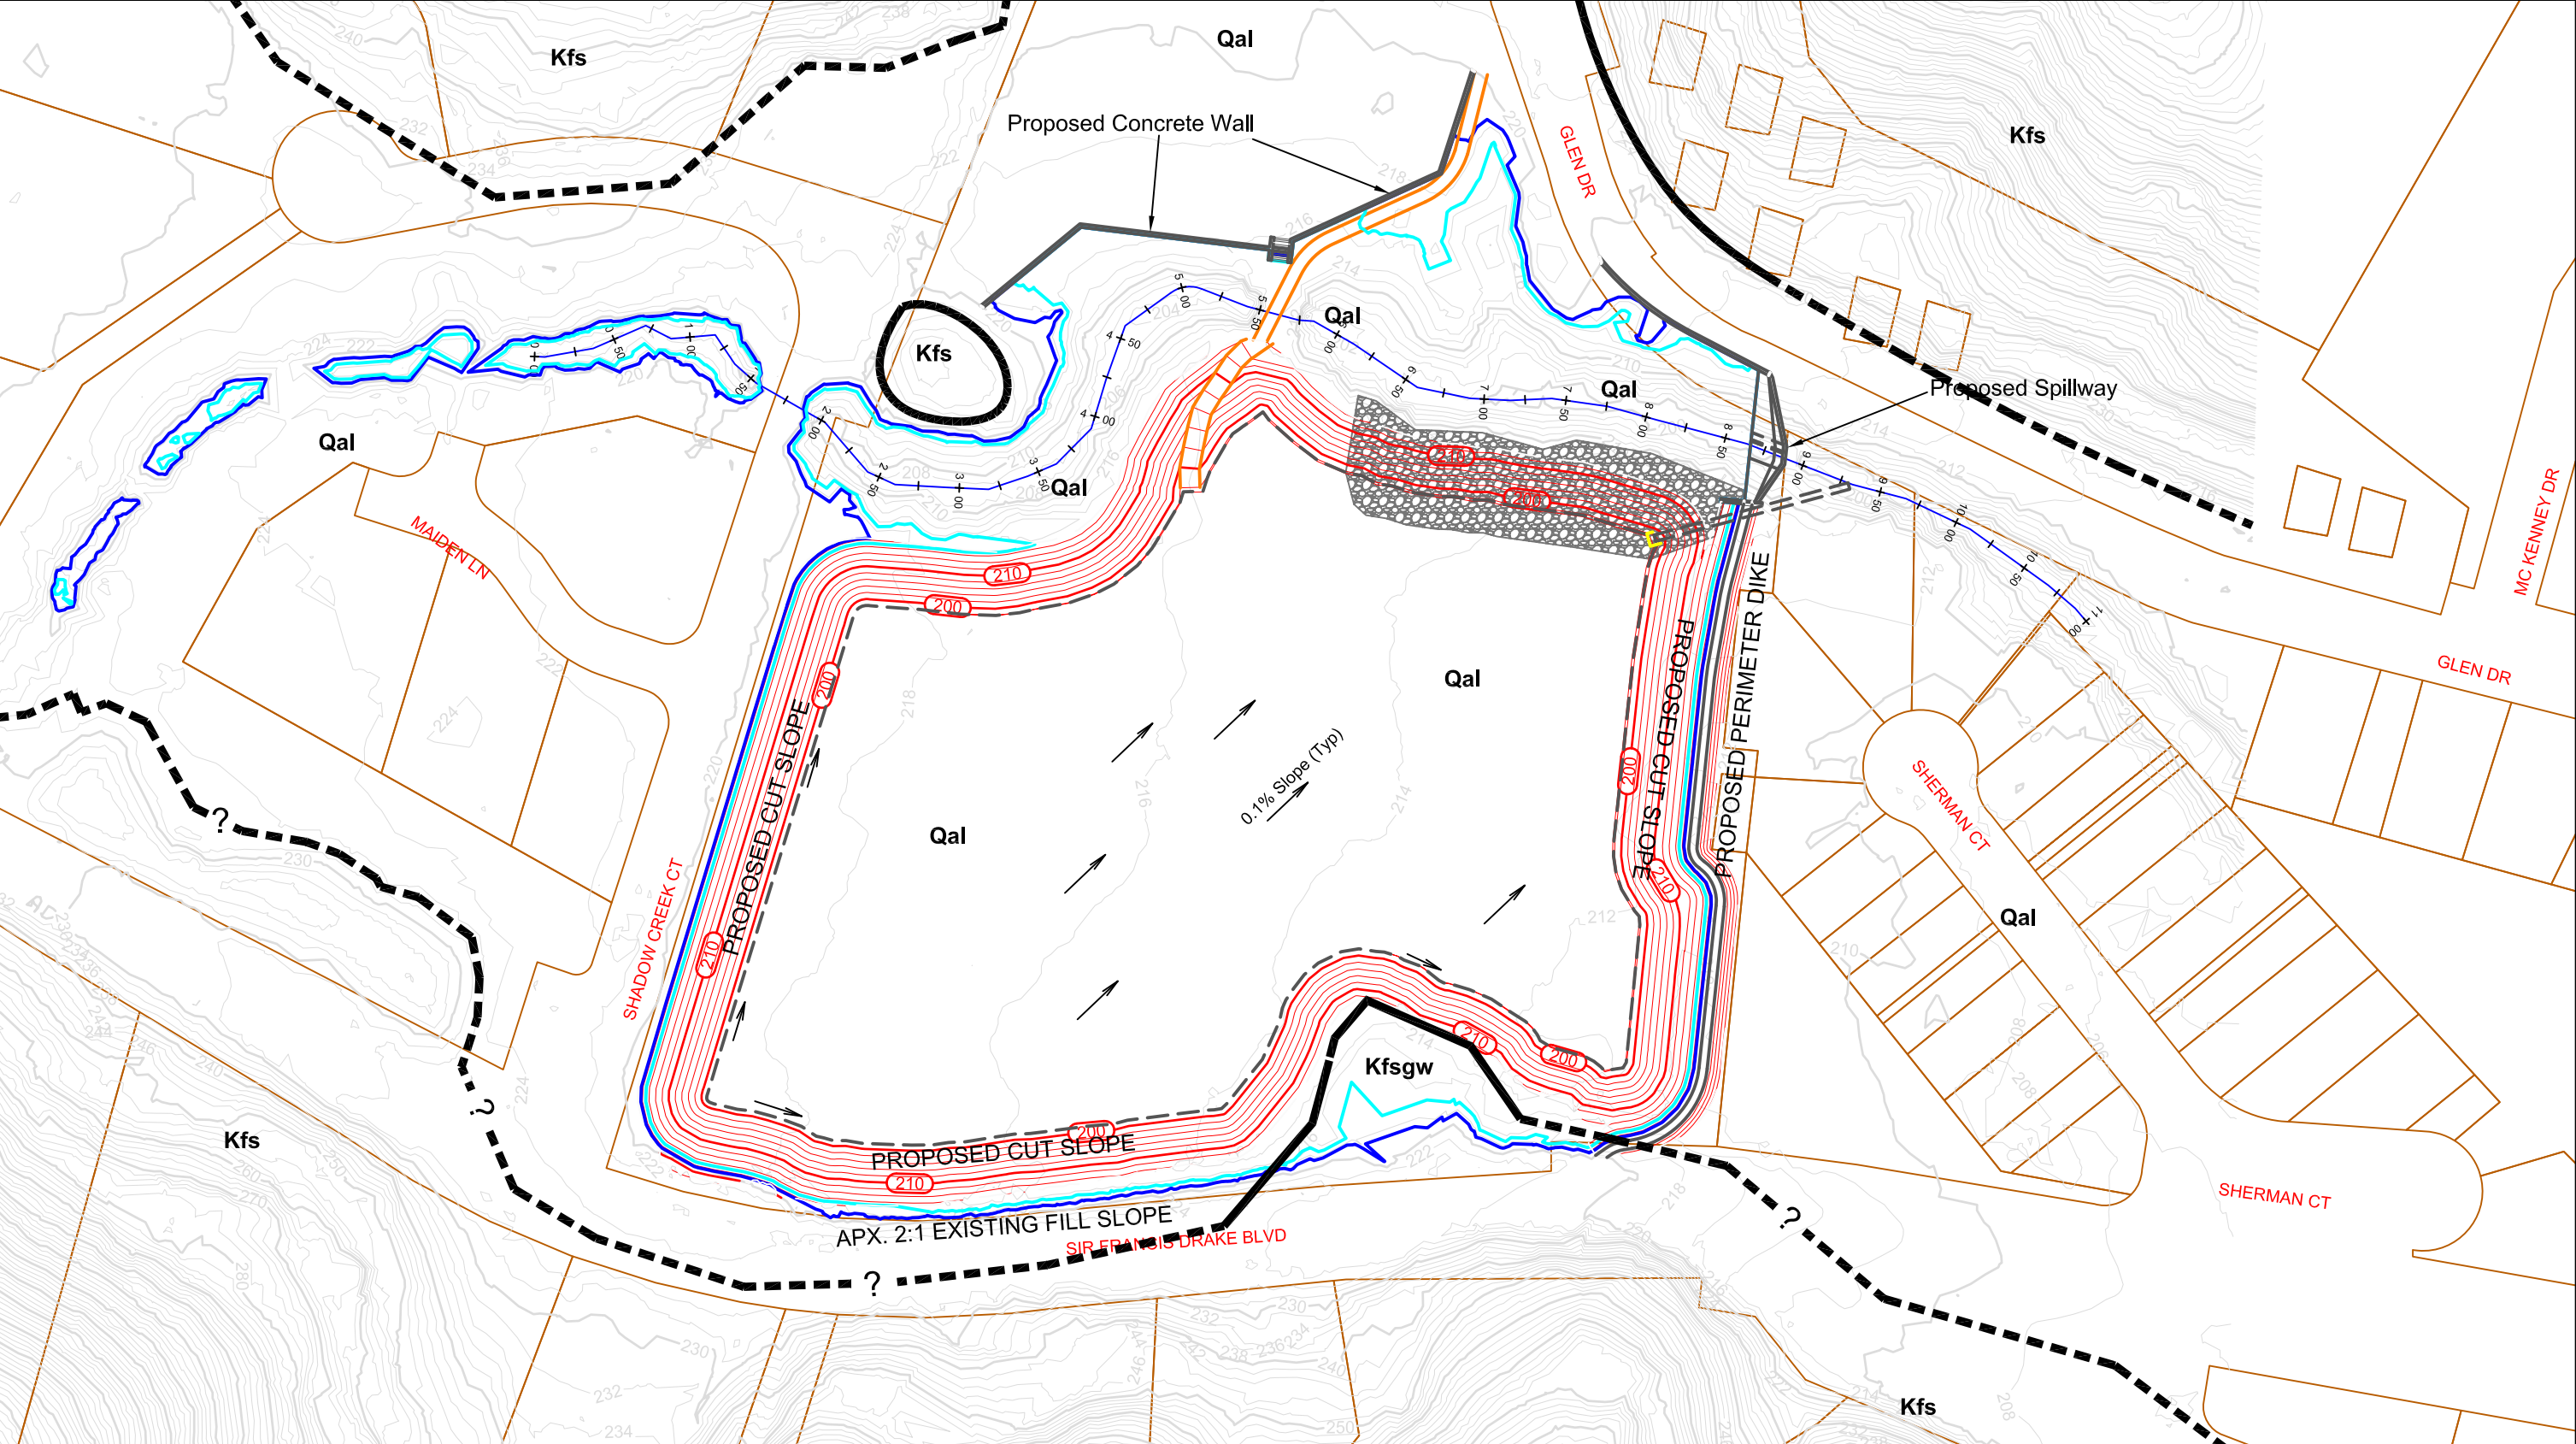
Lefty Gomez Field DB is bounded by Sir Francis Drake Avenue to the south, Shadow Creek Court to the west, and Fairfax Creek to the north. The west side of the field abuts a residential development built along Sherman Court in the late 1960s and early 1970s. We observed a large outcrop of relatively fresh Franciscan graywacke at the south end of the field, but did not observe in-situ bedrock elsewhere on the site, including at the location of the proposed spillway at the northeast corner of the site. The field currently sits approximately 10 feet above the flowline of the creek, and our observations suggest most of the excavation required to lower the field elevation would be in alluvial deposits with bedrock in the southern portion. Geologic features observed are shown on Figure 4.

Location	Mitigation measures required
Loma Alta DB Memorial Park DB Red Hill Park DB	<i>No mitigation measures are required.</i>
Lefty Gomez Field DB	<i>Construction of the detention basin will eliminate the southern creek bank. Also, construction of a concrete retaining wall along the northern bank as indicated on preliminary plans will mitigate the potential for cracking and lurching in a seismic event. More detailed site-specific mitigation recommendations will be presented in a design-level Geotechnical Investigation Report.</i>

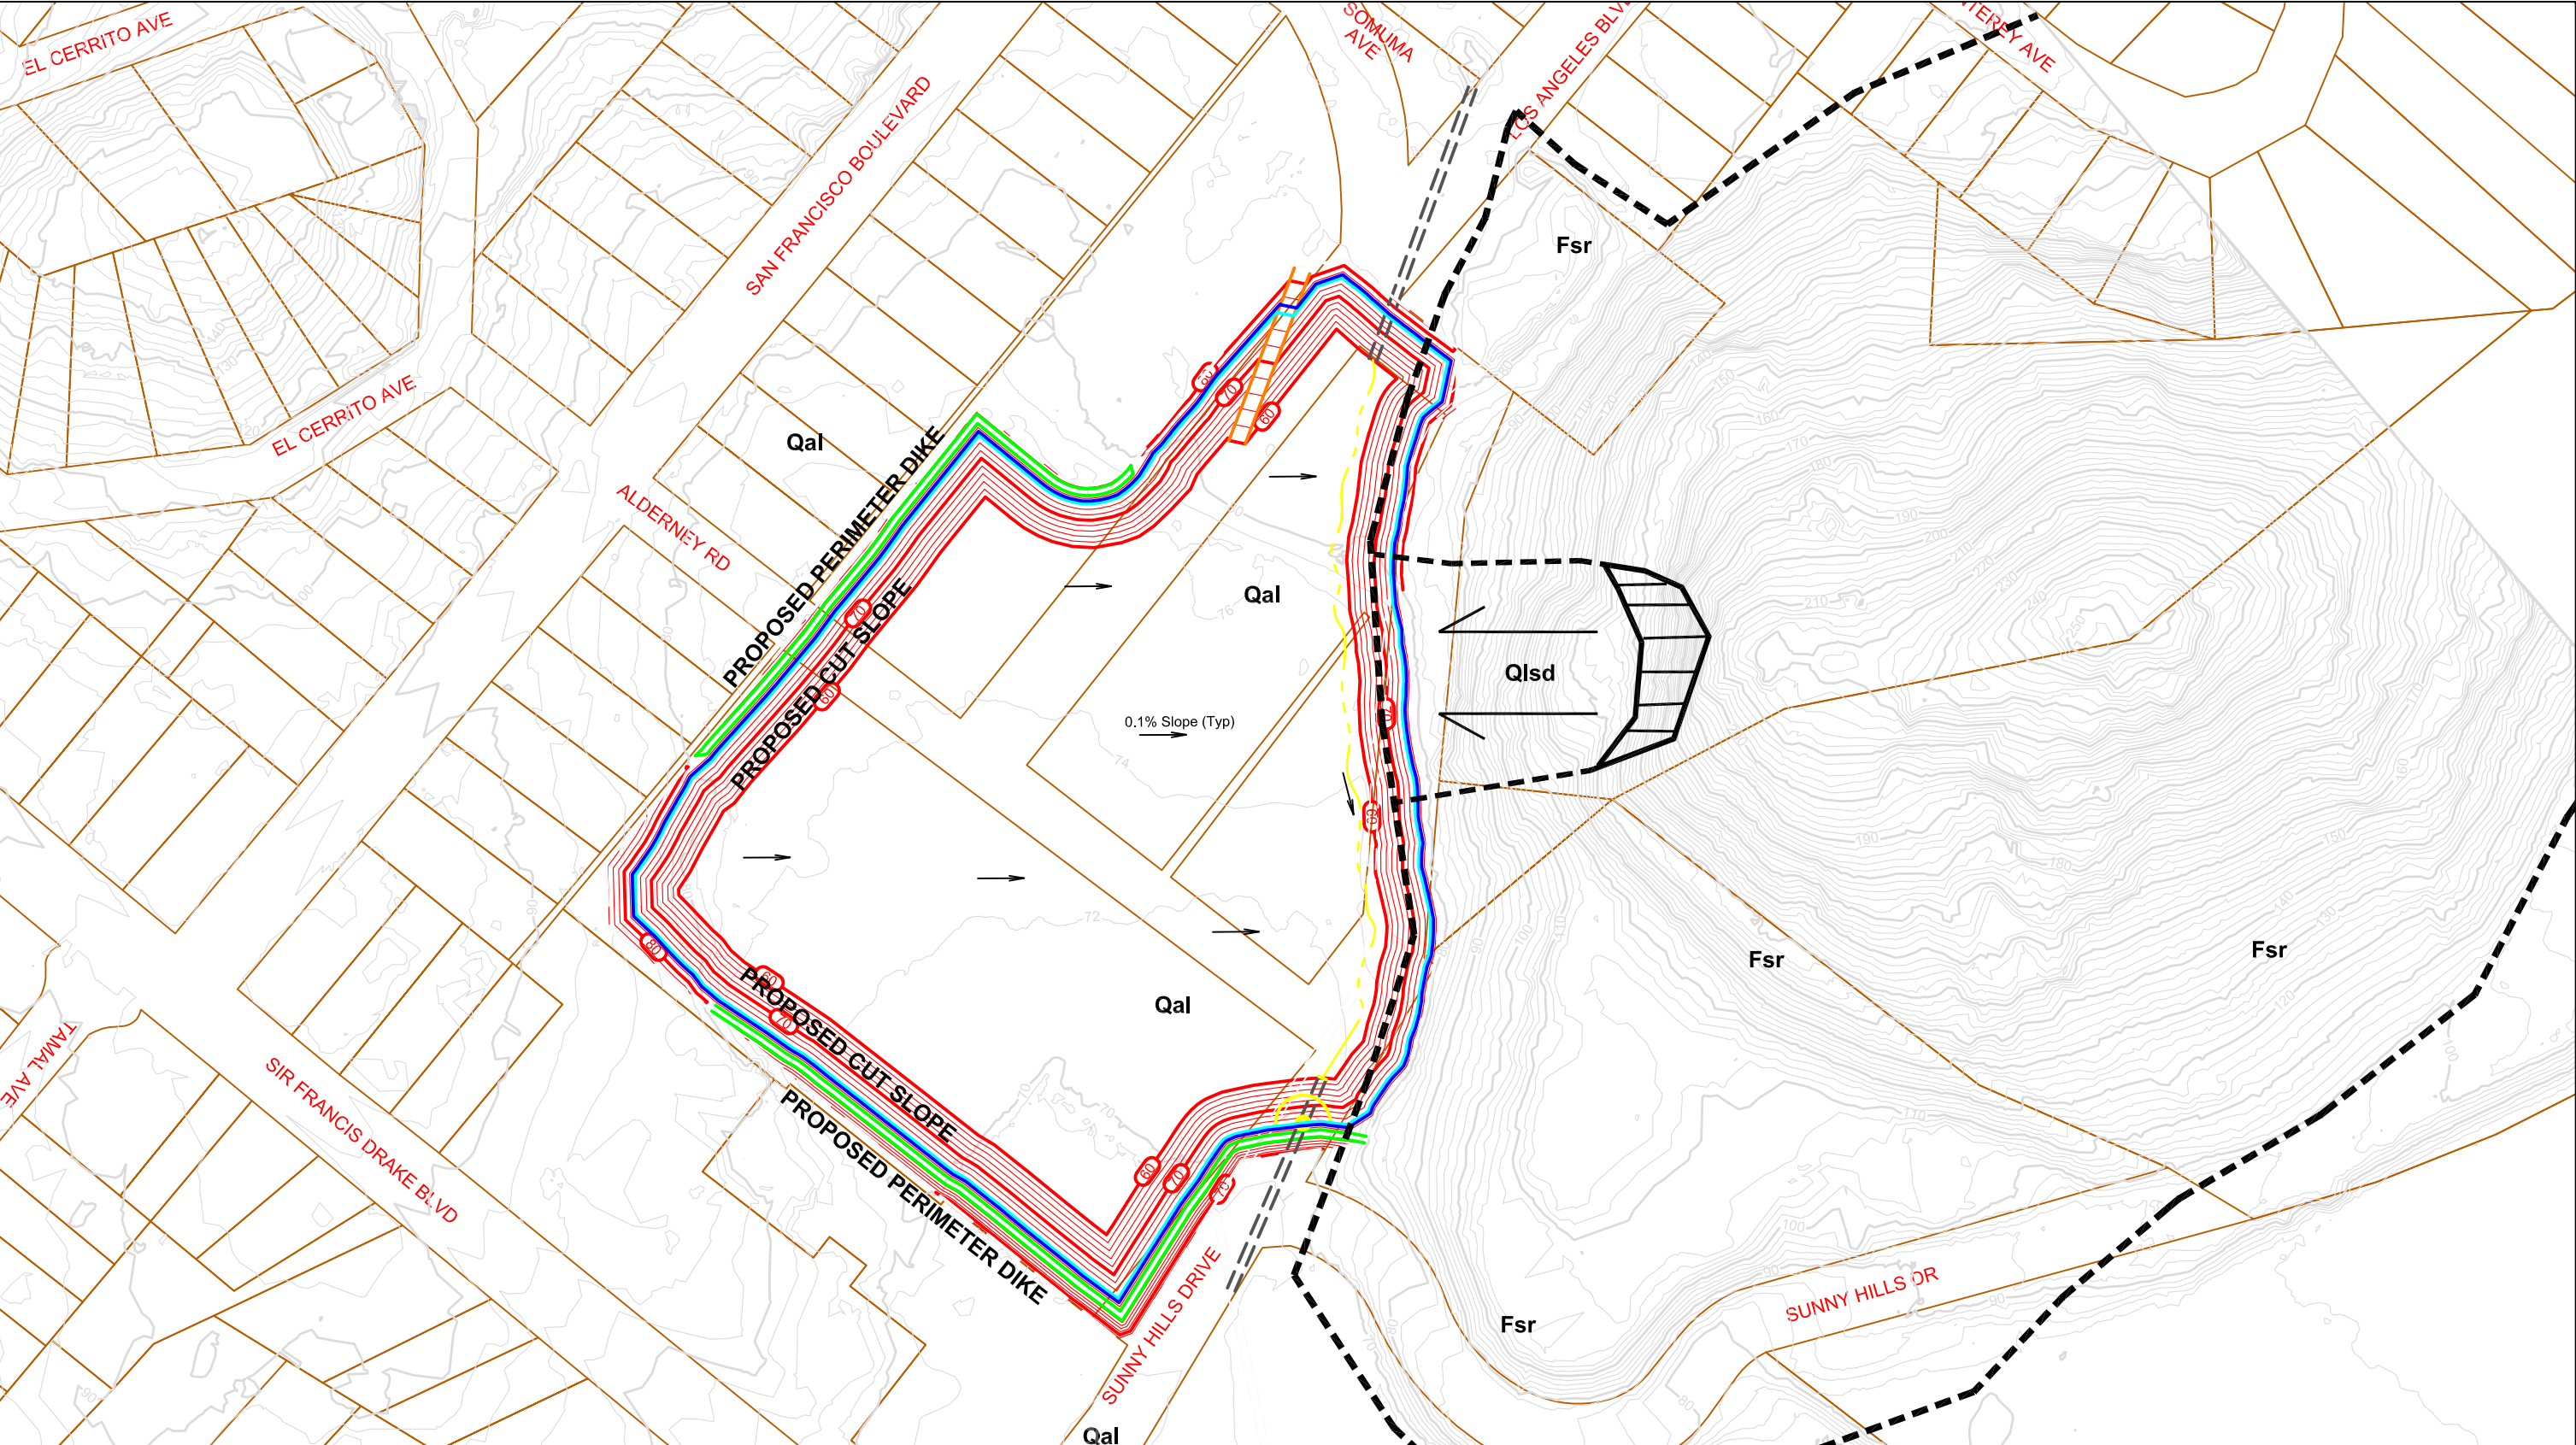
Memorial Park DB consists of a natural grass athletic field, a relatively new playground, tennis courts, and ancillary improvements. It is bounded on the south, west and north by commercial and residential development, and on the east by a steep, heavily vegetated slope. The slope is at an approximate inclination of 1.5:1 (horizontal:vertical), except at the base, where approximately 8 to 10 feet of soil is retained by large eucalyptus trees, forming a vertical face roughly 8 feet tall. About 100 feet above the vertical face, we observed a large headscarp, measuring roughly 20 feet tall and 150 feet across, marking the uppermost extend of an older landslide. We did not observe evidence of recent movement such as ground cracks, leaning trees, or excessive seepage, and the slide debris is covered with vertical eucalyptus trees on the order of 60 to 80 feet tall, suggesting the slide predates the trees. The composition of the slide debris suggests bedrock composed of Franciscan sandstone, which is consistent with the mapped geology. Aside from the steep slope east of the site, we did not observe any evidence of large-scale slope instability. Significant geologic features observed are shown on Figure 5.

Memorial Park DB is bounded on the east by a relatively steep slope which shows evidence of previous instability and landsliding. Although the observed landslide area appears inactive, the soil and slope conditions are susceptible to reactivation and instability during drawdown of impounded flood waters. Therefore the potential for localized slope instability at the site is moderate to high.
