**Creekwood Development  
Tree Protection and Removal Plan**

March 16, 2021

270 & 280 CASA GRANDE ROAD  
TREE PROTECTION/REMOVAL PLAN

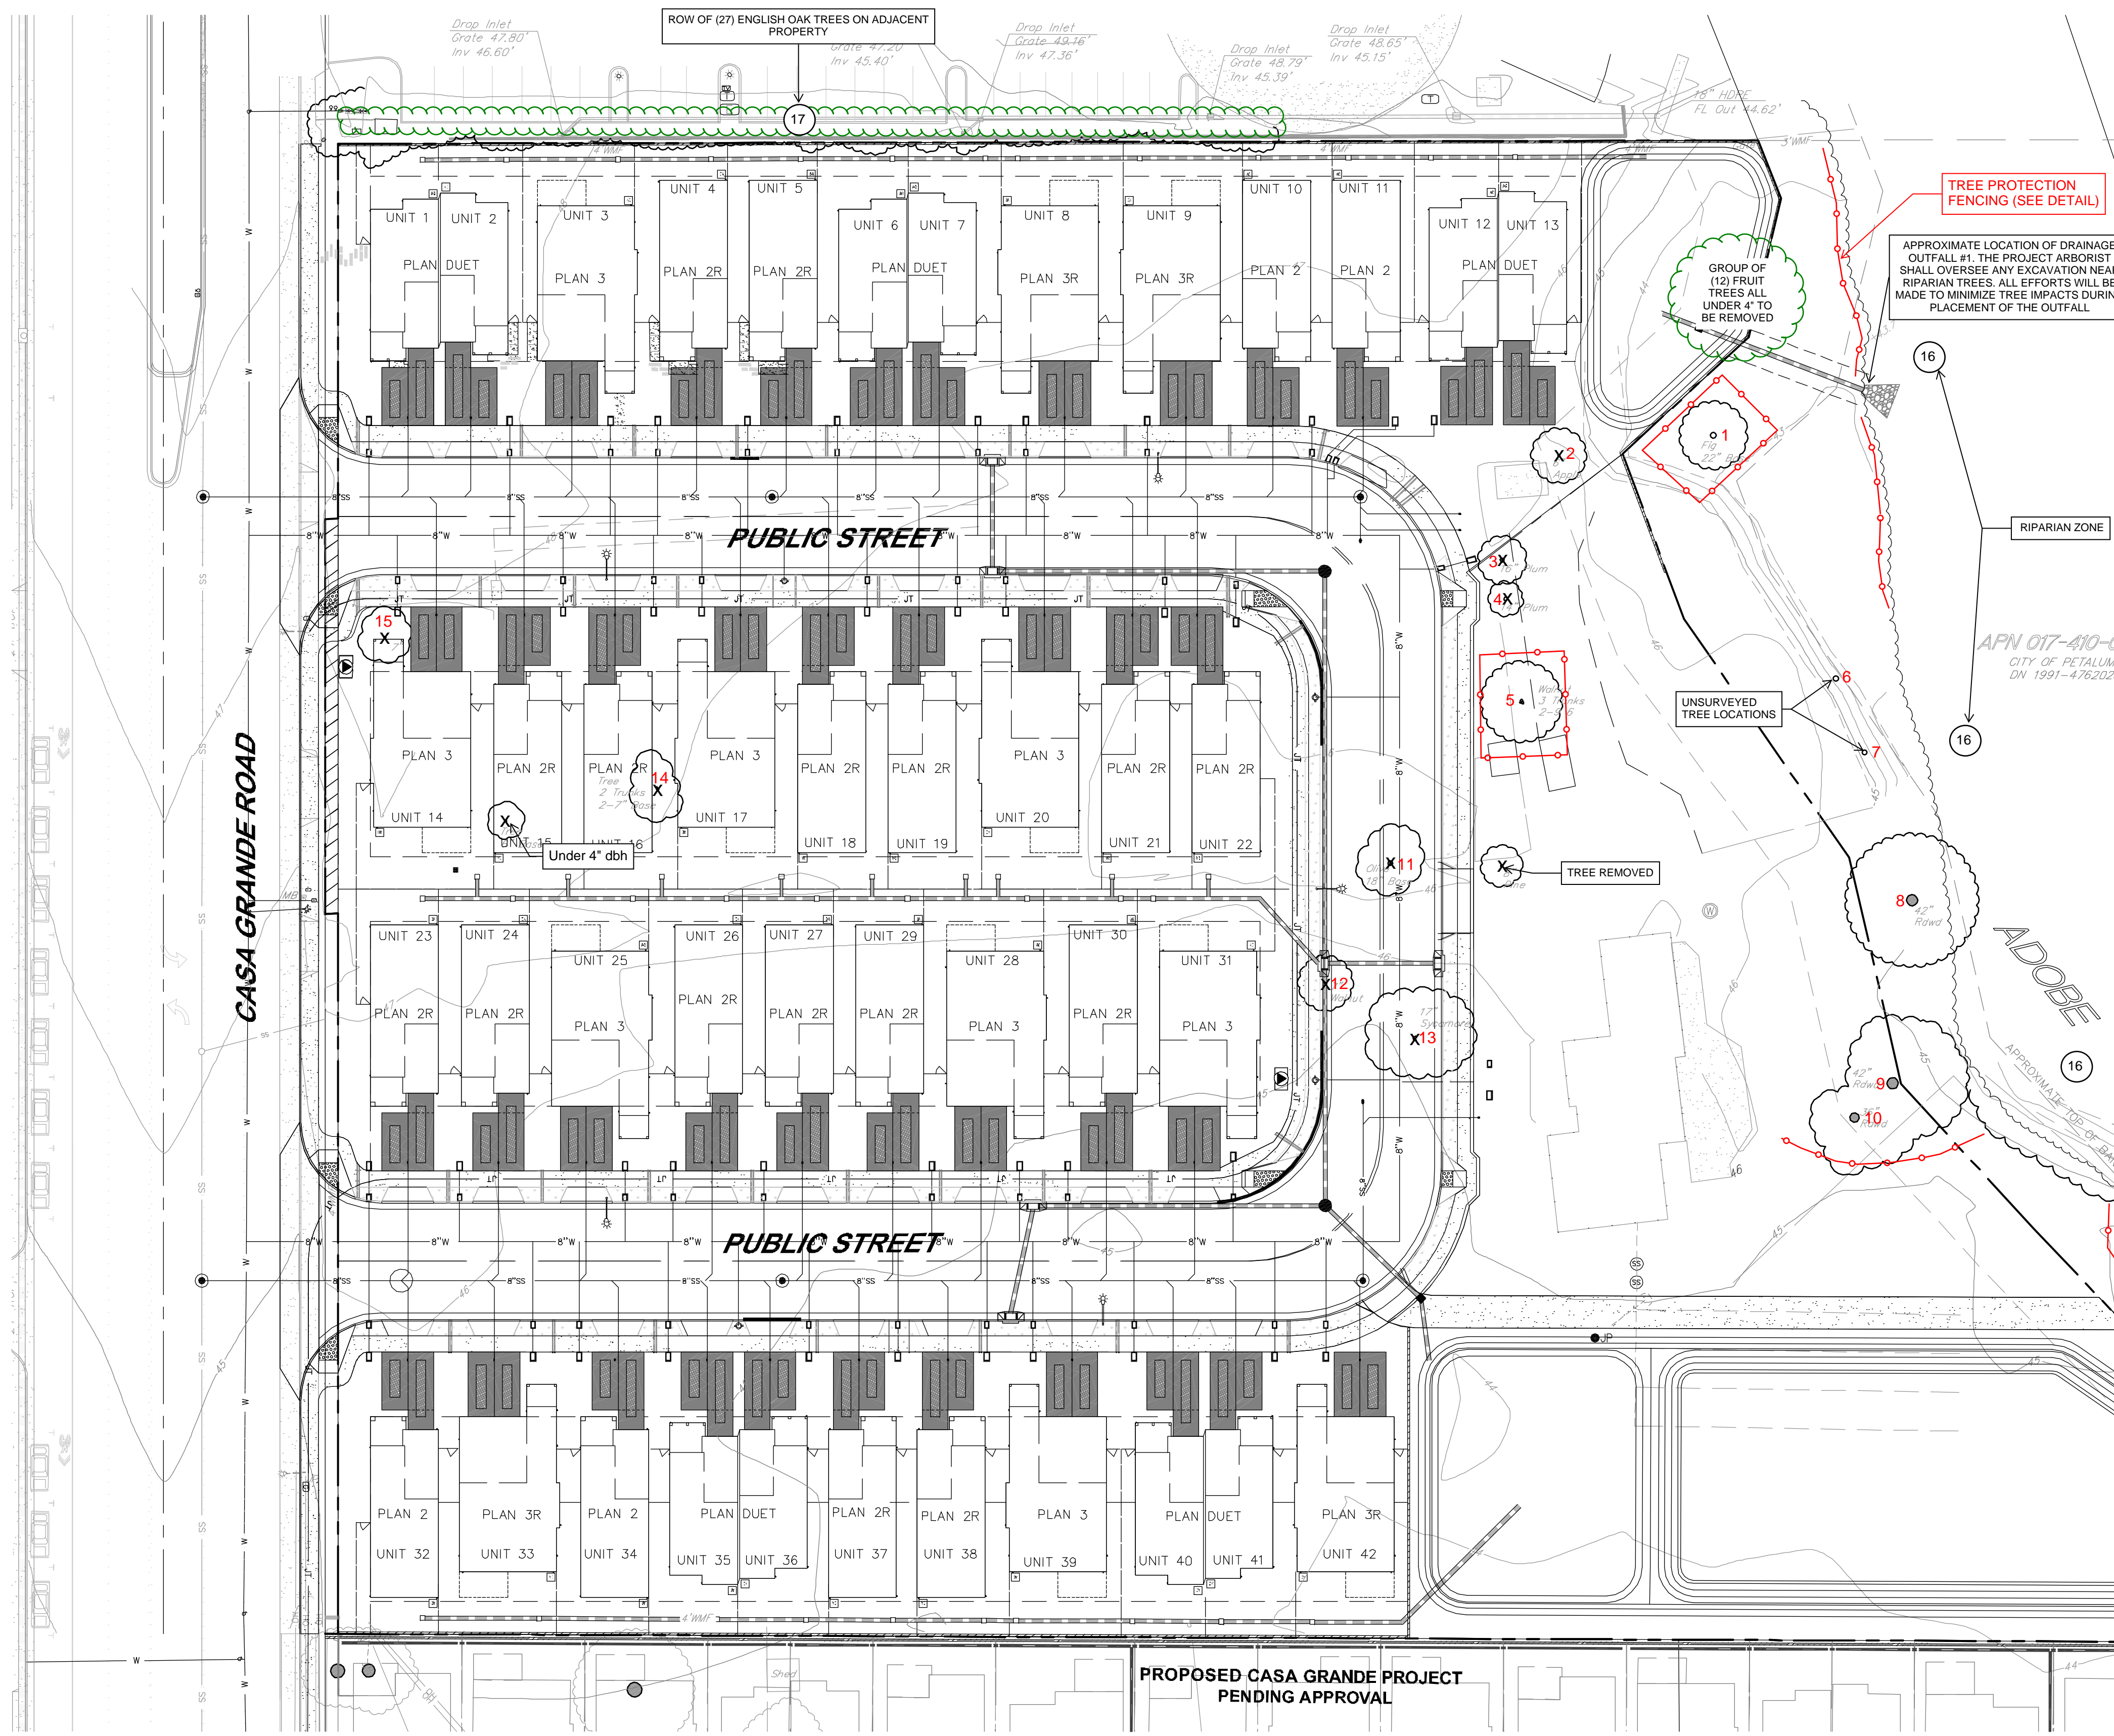
Tree #	Common Name	Botanical Name	Trunk Diameter(s) (Inches)	Condition & Structure (1-5)	Protected Status	Comments	Recommendation
1	Edible Fig	Ficus carica	7, 6.4, 6.2	5	Unprotected	Sun burn and associated necrosis on main trunk in footprint of development.	Preserve and protect with fencing.
2	Apple	Malus domestica	6	4	Unprotected	Near footprint of development.	Whole tree removal.
3	Plum sp.	Prunus sp.	14.5	4	Unprotected	Near footprint of development.	Whole tree removal.
4	Plum sp.	Prunus sp.	11.5	3	Unprotected	Near footprint of development.	Whole tree removal.
5	English Walnut	Juglans regia	8.5, 7.5, 5.5	5	Unprotected	Near footprint of development.	Preserve and protect with fencing.
6	Edible Fig	Ficus carica	8, 6.5	5	Unprotected	Outside footprint of development.	Preserve.
7	Edible Fig	Ficus carica	10	5	Unprotected	Outside footprint of development.	Preserve.
8	Coast Redwood	Sequoia sempervirens	37	5	Protected	Outside footprint of development.	Preserve.

9	Coast Redwood	Sequoia sempervirens	38	4	Protected	The tree bifurcates at approximately 25 feet above grade. The stems are codominant and there is bark pressed between the two stems. Outside footprint of development.	Preserve and protect with fencing.
10	Coast Redwood	Sequoia sempervirens	33	4	Protected	Outside footprint of development.	Preserve and protect with fencing.
11	Olive	Olea europaea	6, 6, 4	5	Unprotected	In footprint of development.	Whole tree removal.
12	English Walnut	Juglans regia	7	5	Unprotected	In footprint of development.	Whole tree removal.
13	Sweetgum	Liquidambar styraciflua	14	4	Unprotected	In footprint of development.	Whole tree removal.
14	Photinia	Photinia fraseri	7, 5, 4	4	Unprotected	In footprint of development.	Whole tree removal.
15	Crape Myrtle	Lagerstraeemia sp.	6	4	Unprotected	In footprint of development.	Whole tree removal.
16	Riparian zone	Various native species		4	Protected	The riparian zone is populated with native tree and plant species. The predominant tree species are Willow (Salix sp.), Buckeye (Aesculus californica), Coast live oak (Quercus agrifolia), Toyon (Heteromeles arbutifolia). In general trees are in good health and the vast majority will not be impacted by development. Two outfall locations (see map) will be installed within the riparian zone, which will require project arborist involvement.	Preserve and protect with fencing. Consult project arborist for input on best outfall locations.

17	Row of upright English oaks	Quercus robur 'Fastigata'	4 to 12	5	Unprotected	Outside footprint of development. Small diameter limbs extend over property line.	Preserve. Existing fence is sufficient protection.

4-foot-tall wire deer fencing shall be used to create the **tree protection zones**, installed as shown on the Arborist's Map. Fencing shall be supported with 6' metal t-stakes and installed 6-foot on center. Laminated signage shall be attached to fencing and read "Warning Tree Protection Zone Keep Out". Signage shall be kept visible and intact throughout the project. Failure to comply with the tree protection plan may result in a stop work order.
