Historic Resource Evaluation

196 Spain Street East,

Sonoma, California

27 December 2023

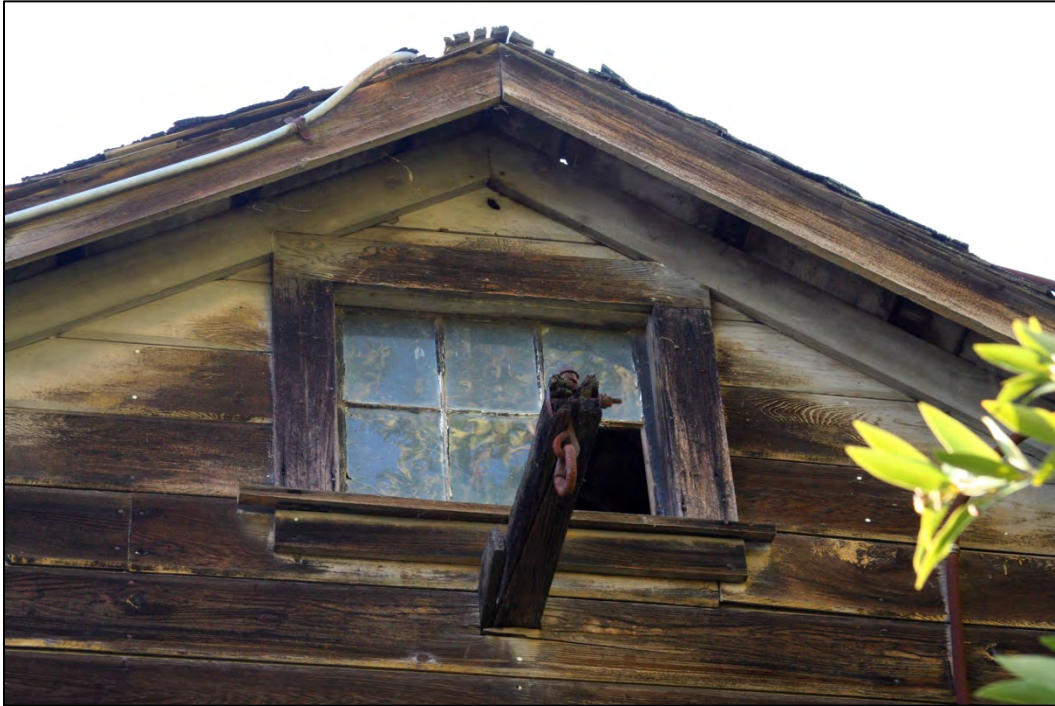
Figure 29: Dairy barn, east elevation gable detail

On the east gable, remnants of a pulley and tackle system are present above a hay door (see figures 28 and 29). At the ground level, a vehicle bay with no door and no trim is cut into the southeast corner of the gambrel roof section. At the northeast corner, on the shed addition, a large sliding door provides access to an oversized bay (see figure 34). A smaller, sliding door in a state of great deterioration is located at the northwest corner of the northern shed addition. A wood pedestrian door with beaded vertical boards and horizontal battens is roughly centered on the south side of the original section of the gambrel roof block and is sheltered under the collapsing shed roof addition.

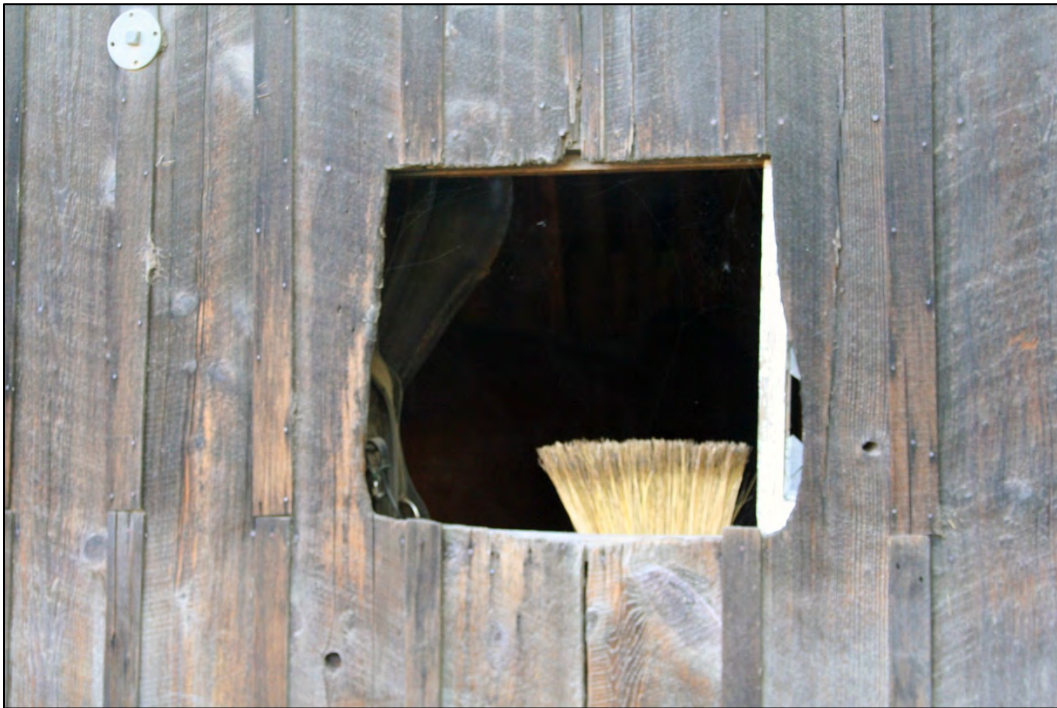
Figure 46: Horse barn, opening

Numerous openings for access to the loft, ventilation and light have been cut into the building in a somewhat haphazard fashion (see figure 46). An additional shed-roof lean-to extends across the entire west side and has no walls (see figure 48).

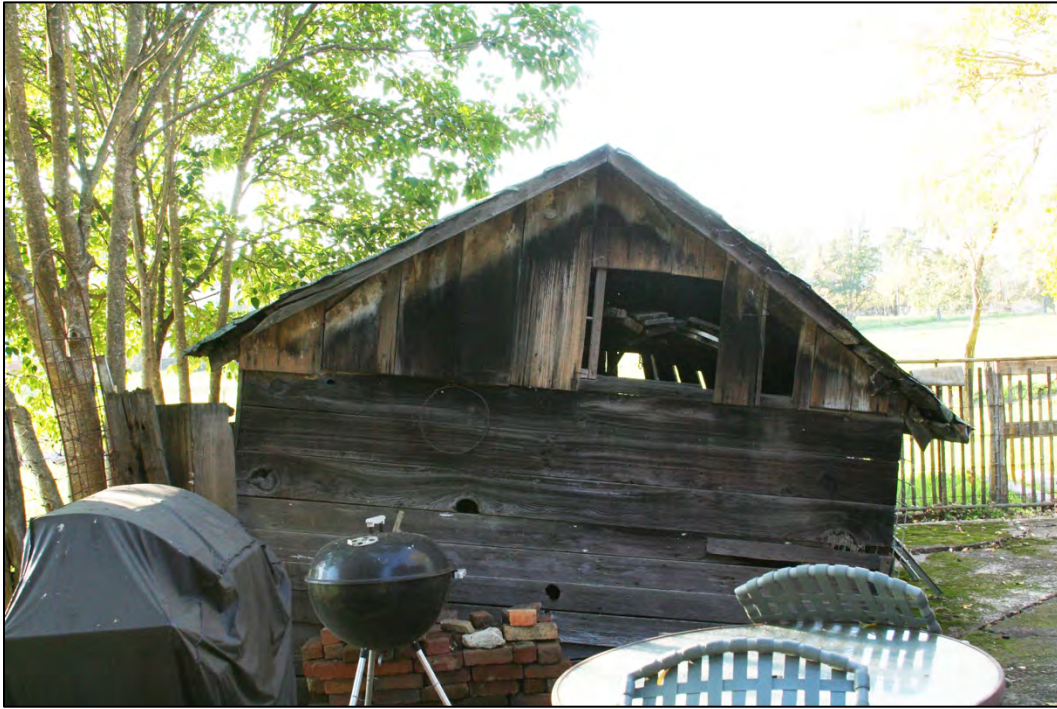
Figure 54: Outbuilding (dilapidated)
