# Penn State

## University Park Campus

### Stormwater Guidance, Policies, and Master Plan

Latest Revision  
December 2016

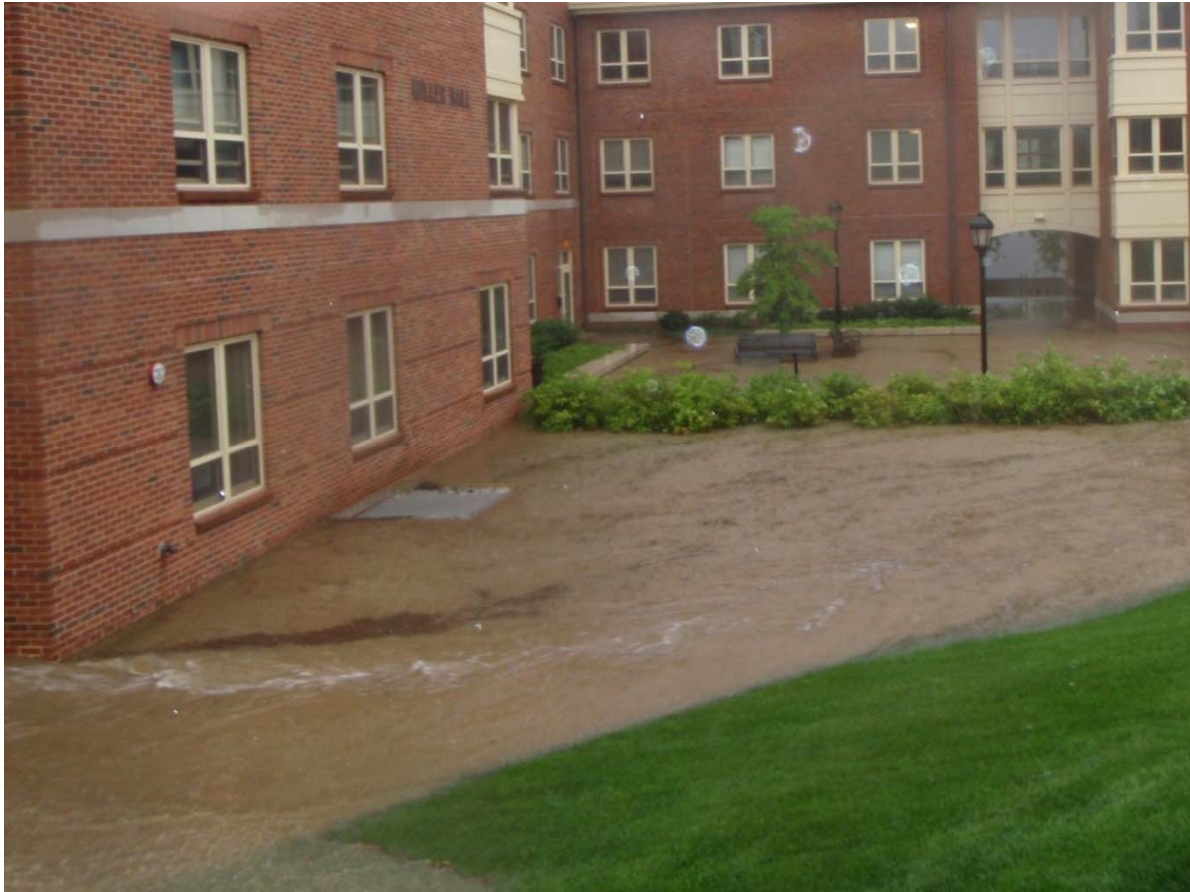
Figure 4.a. Example of Nuisance Flooding on Campus

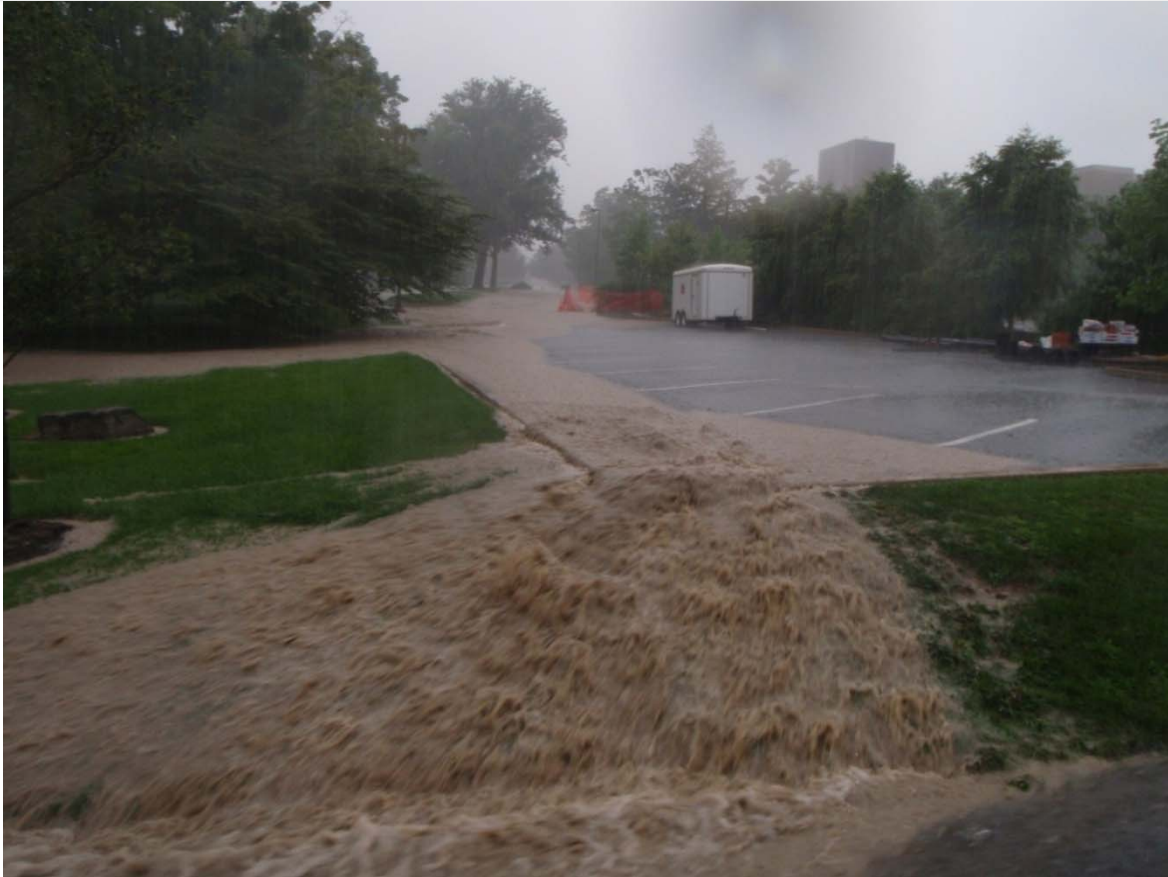
Figure 4.b. Case 1 Type Flooding along Bigler Road

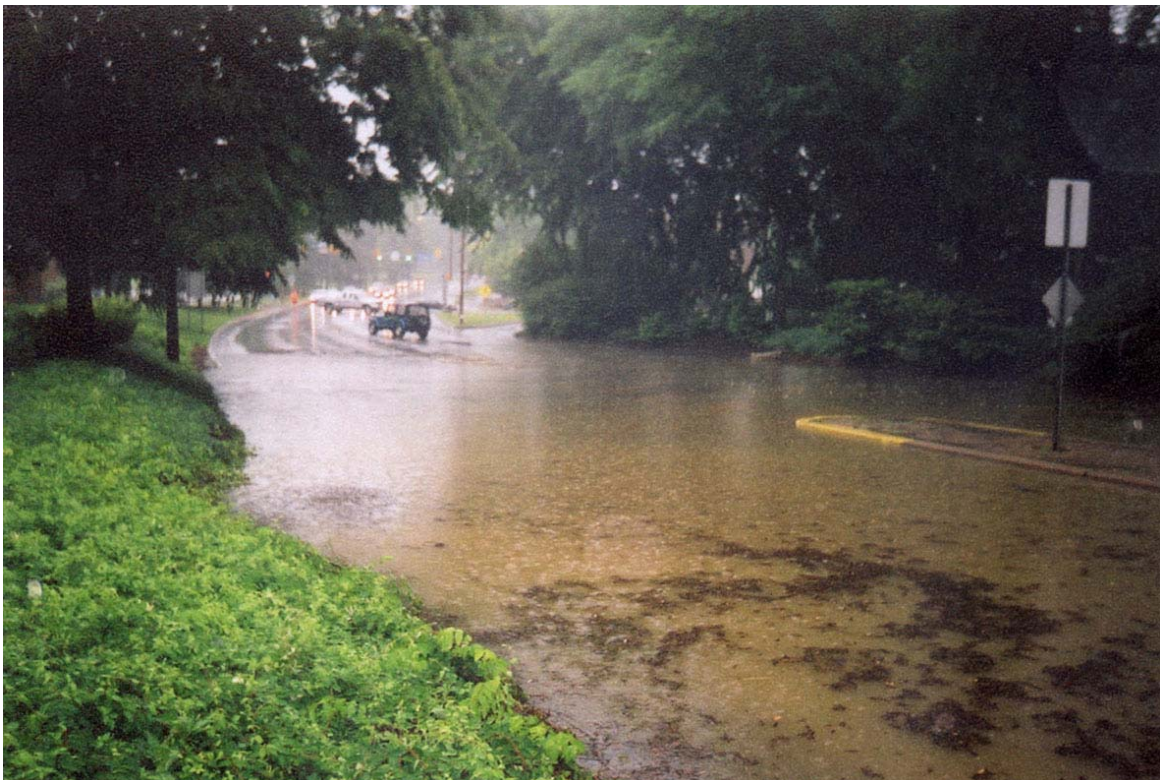
Figure 4.c. Case 2 Type Flooding along Atherton Street

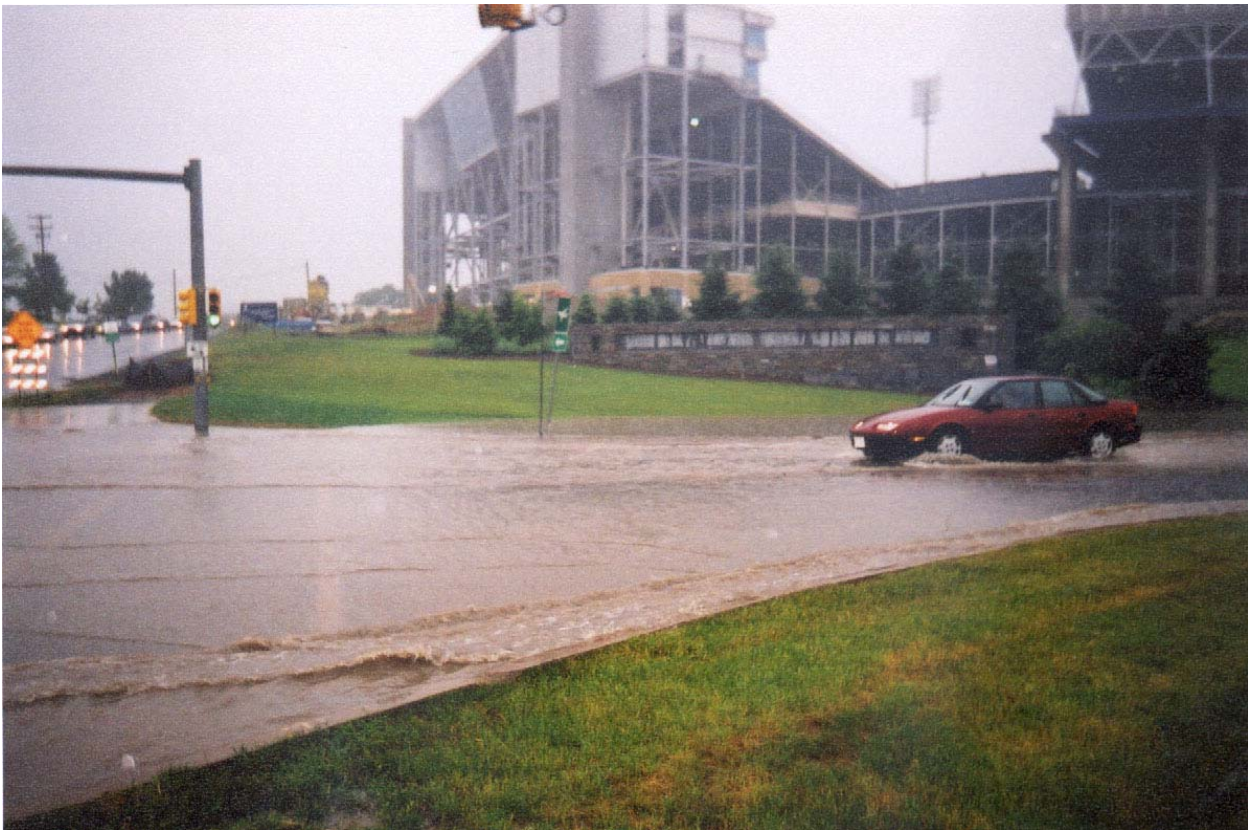
Prior to 2002, the intersection of Park Avenue and Fox Hollow Road flooded frequently during high intensity rainfall events as seen in Figure 4.h. The University Installed over 2,100 lf of 42” storm drain piping in conjunction with a \$3,000,000 storm drain project downstream, which included water quality, and quantity controls. In 2003, Phase 3 of this project repaired and replaced the 10 ft wide and 8 feet deep eroded gully below the Office of Physical Plant (OPP) and Fleet Services, which can be seen in Figure 4.i.

Figure 4.h. Flooding of the Intersection of Fox Hollow Road and Park Avenue

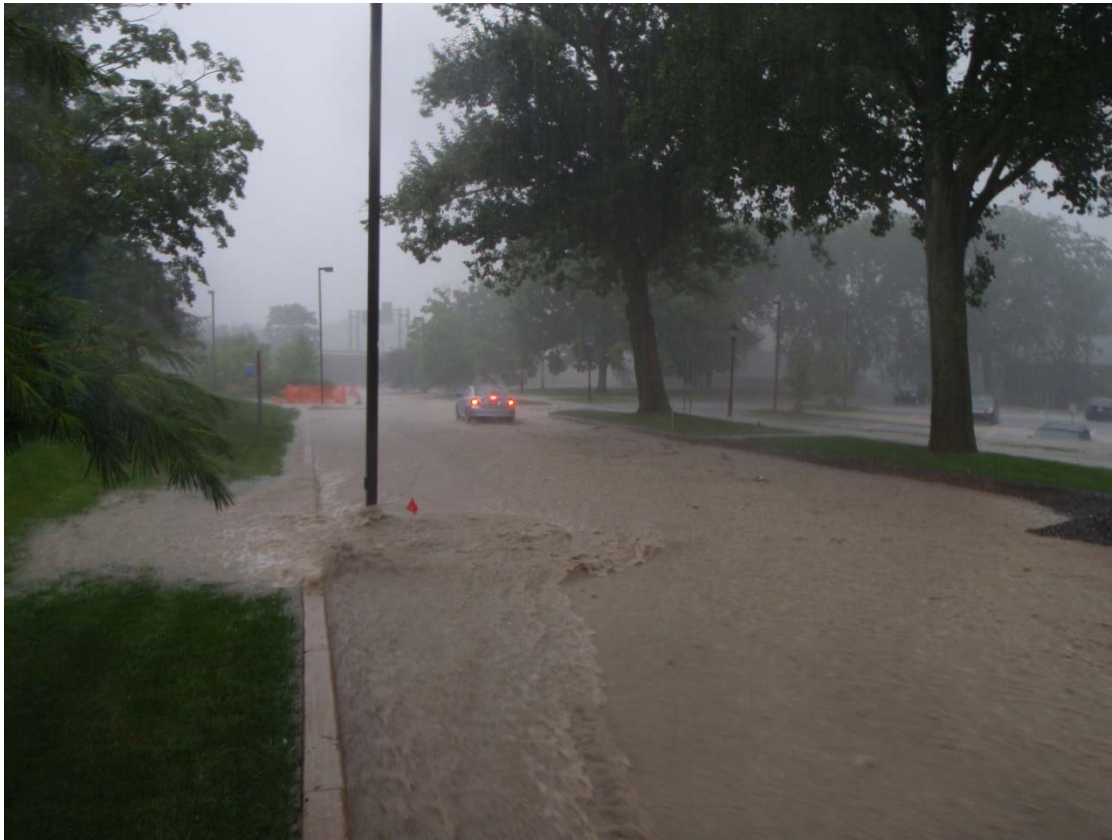
Figure 4.j. Flooding of Lower Bigler Road

In 2015, the University installed approximately 1,000 lf of 42" and 48" storm drains to remedy flooding along the lower portion of Bigler Road, which was a significant life safety issue as seen in Figure 4.j. It's anticipated that the second Phase of the project will continue up McKean Road extension going towards East Area Locker Room.

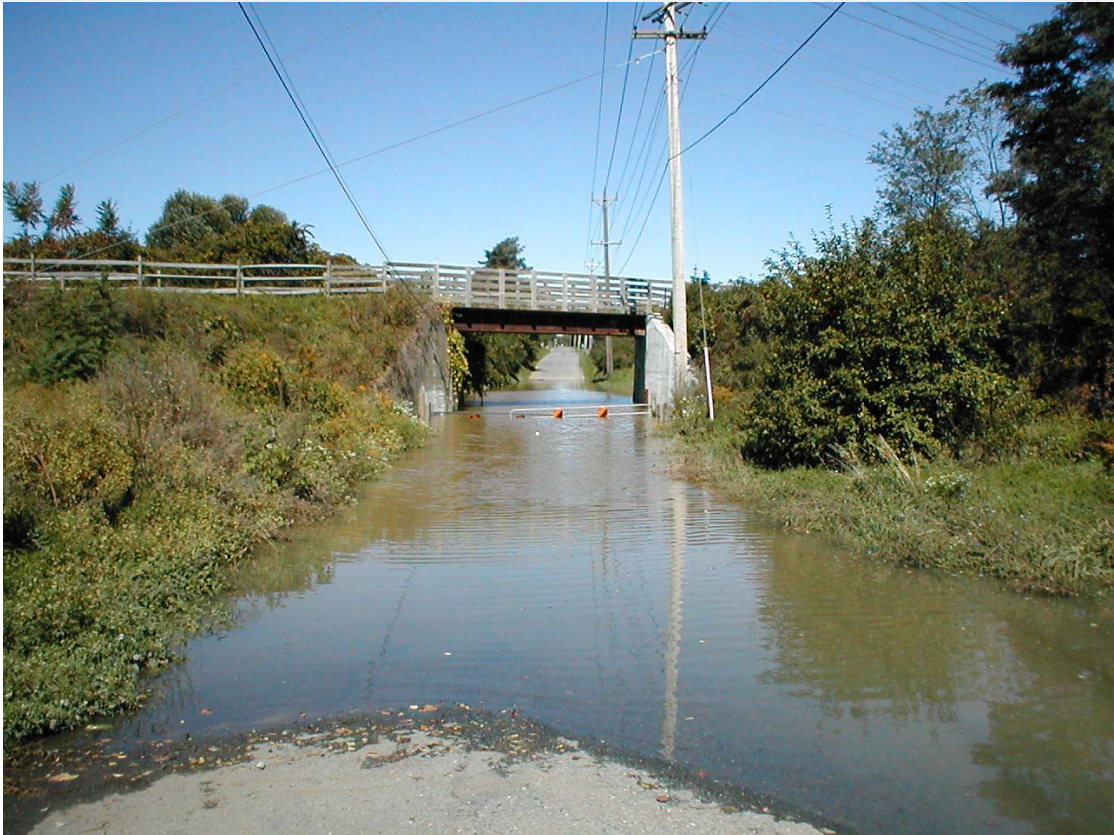
Figure 4.k. Flooding of the Corl Street Underpass in West Campus

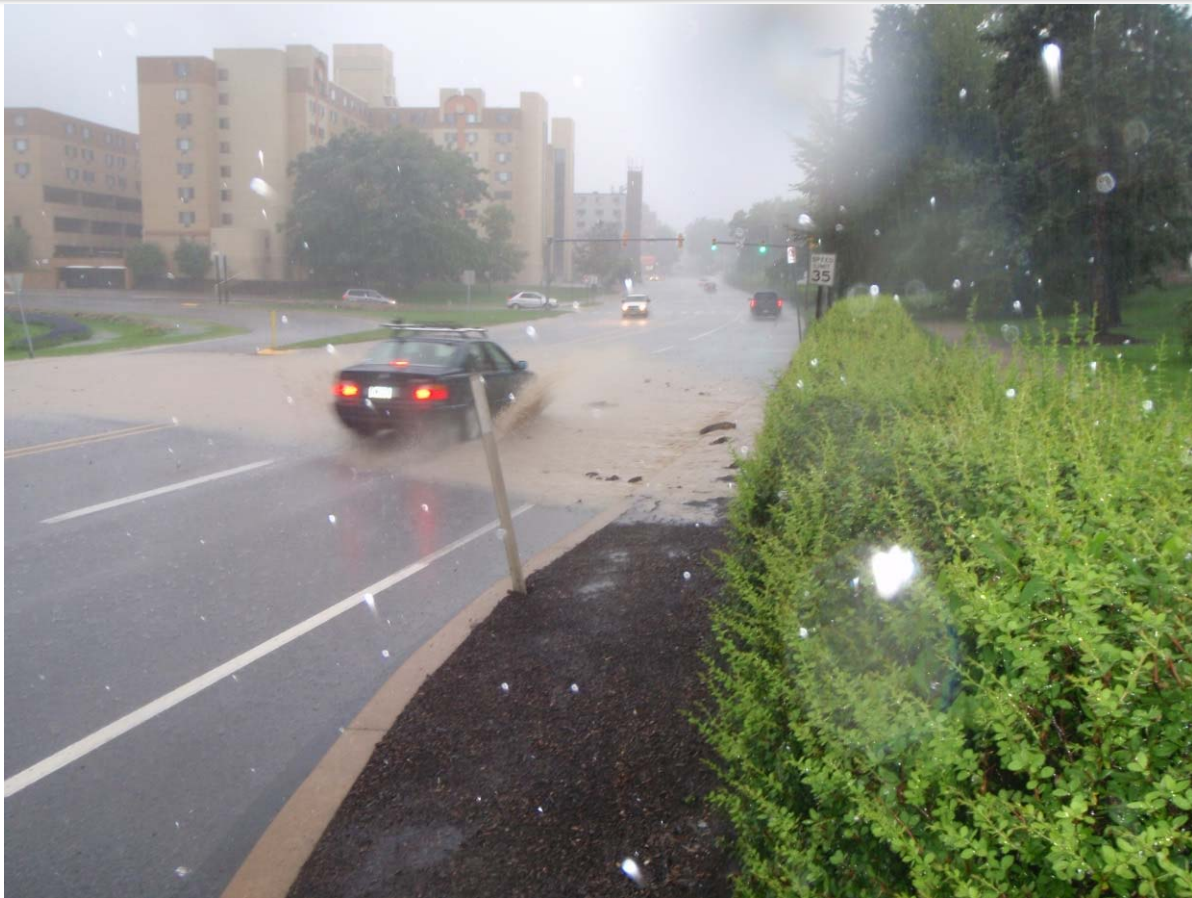
Figure 6.e. Flooding of College Ave at the University Cloverleaf from Bigler Road Runoff

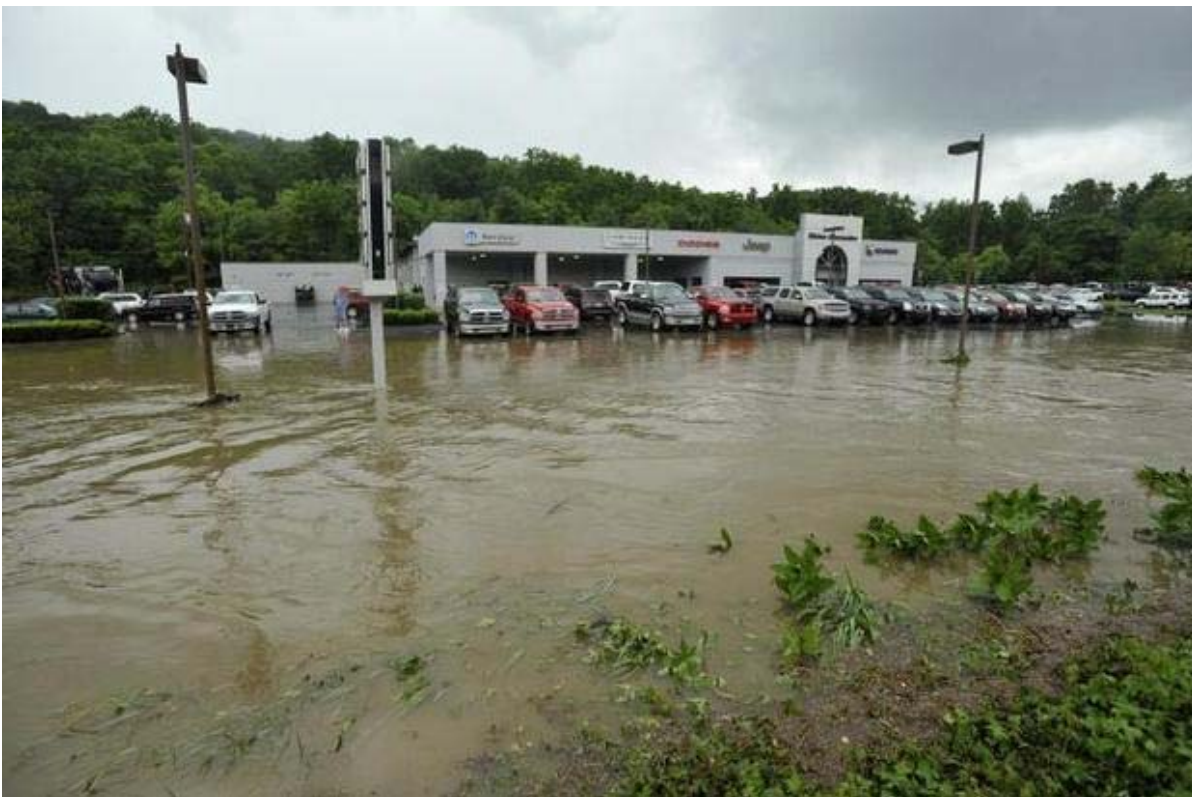
Figure 6.f. Flooding at Blaze Alexander on June 25<sup>th</sup>, 2014

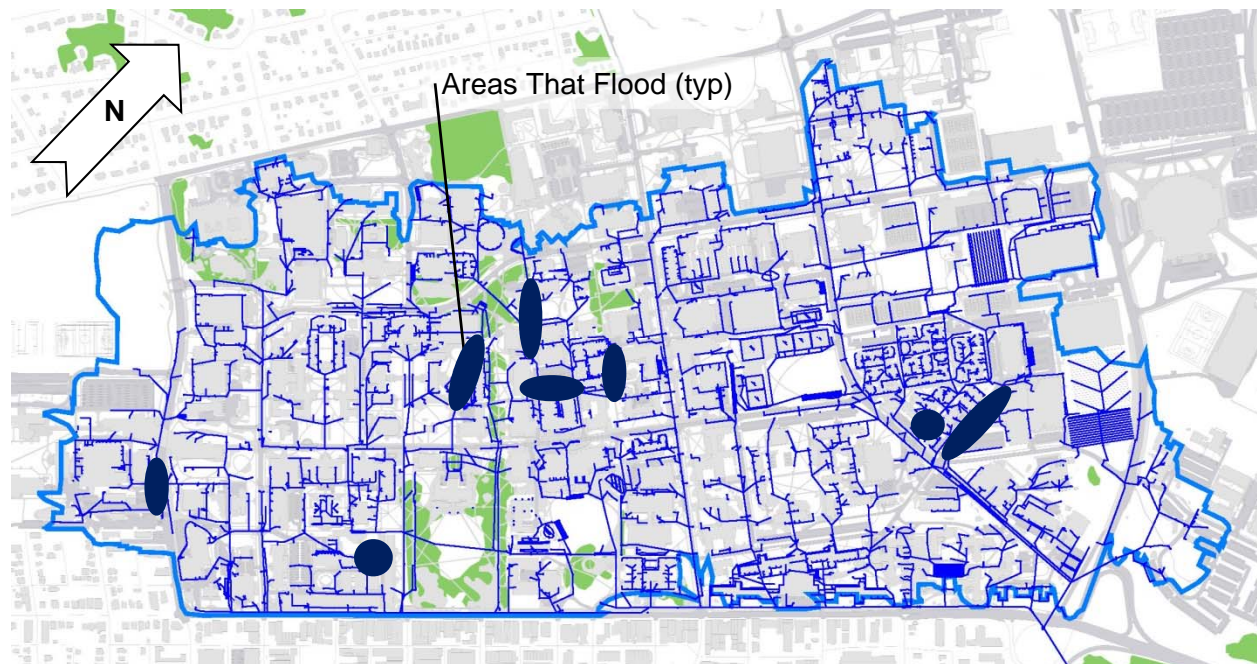
Figure 6.g. Areas that Flood Due to Storm Drain Capacity Limitations

These problems are also not the same level of severity nor do they all have the same life safety considerations. The worst flooding occurs at numbers 1 (Atherton St), 3 (Trunk D), and 7/8 (McKean Street and the Nittany Apartments). Frequently problems are related to adverse pipes (run up hill), siphons, or major bellies. Where some of these pipe issues occur can generally be seen in Figure 6.h.

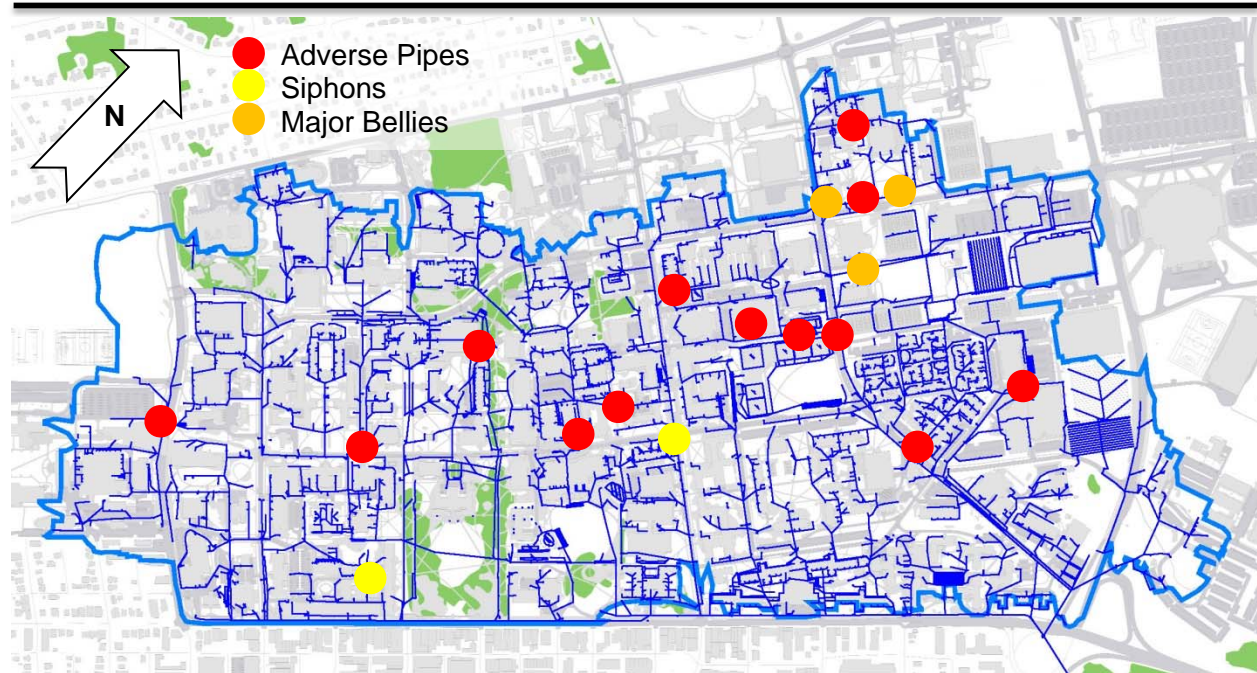
Figure 6.h. Known Adverse Pipe, Siphons, and Major Bellies in the Storm Drain System

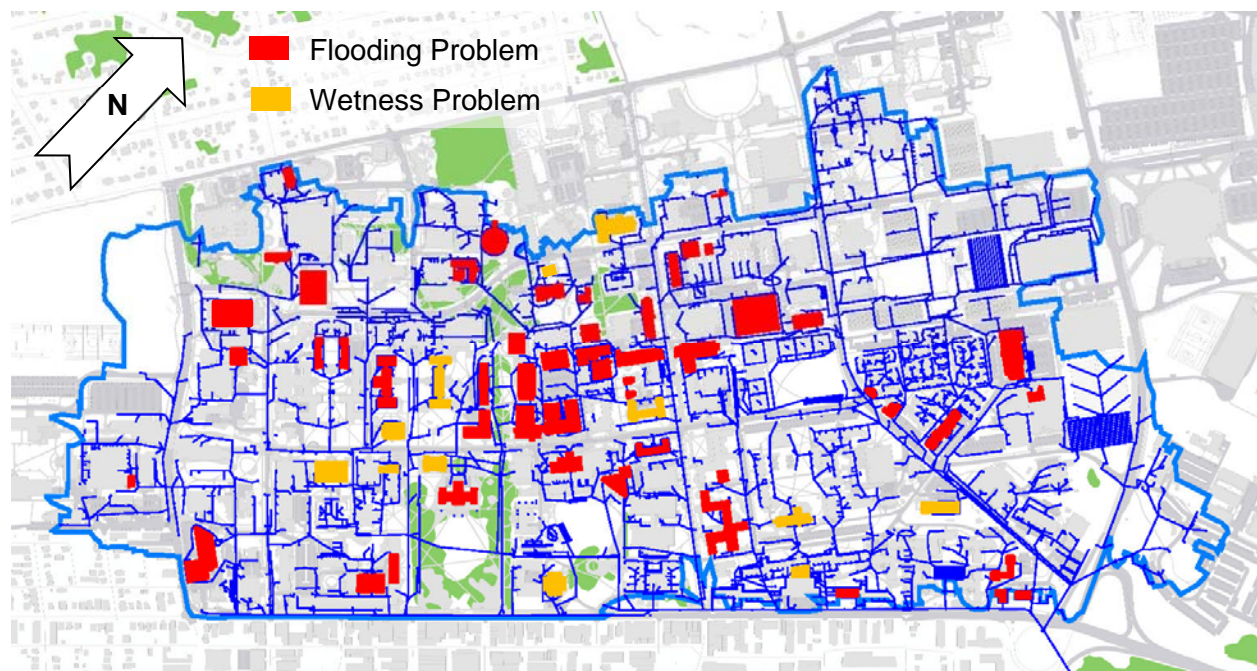
Buildings that have had some type of flooding/wetness issue in the Main Campus Basin within the last five years are shown in Figure 6.i. Buildings that have had water entry at doors, windows, or due to roof leaks or mechanical failure are not included in Figure 6.i. From this figure it should be obvious that extensive stormwater problems occur, but several of them can be considered design related or due to a building issue that can be resolved without alterations to the larger conveyance system. Many of these issues have since been resolved. This is another reason why all projects should contact Engineering Services for additional information.

Figure 6.i. Buildings with Reported Flooding and Wetness Problems in the Last Five Years

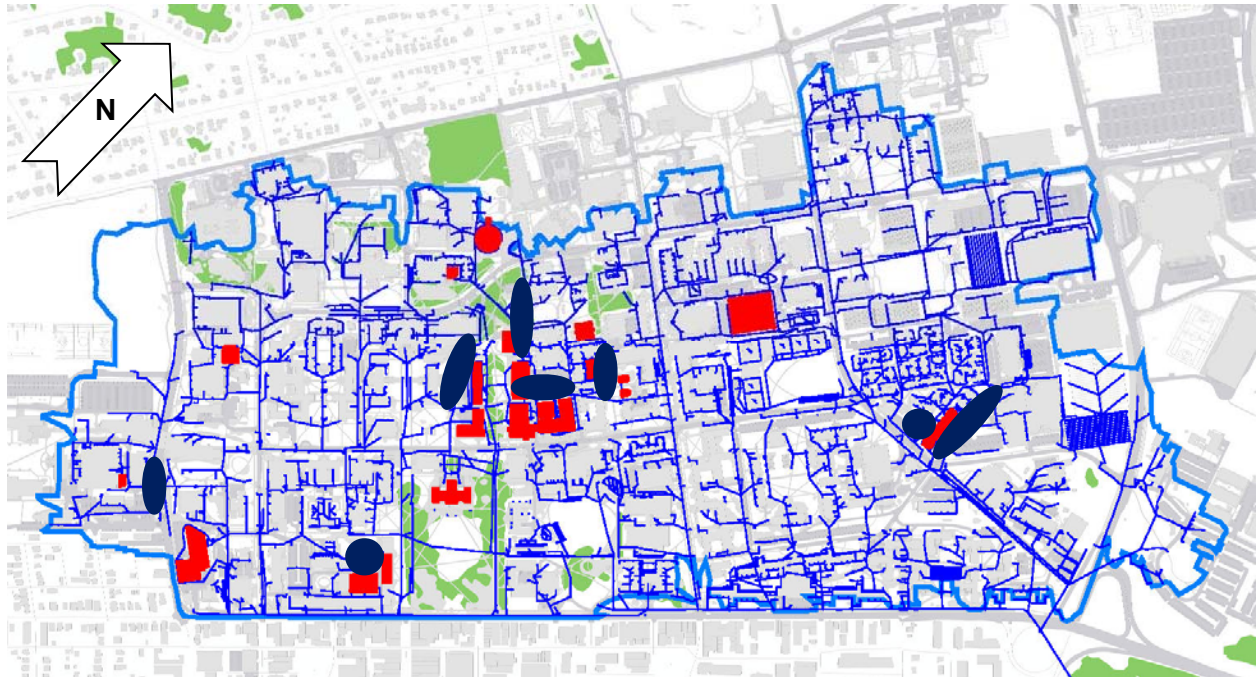
- 1) Old Main, which is due to a suspected rain water conductor issue and clogging of drains to one of the drywells.
- 2) Rec Hall B, which is due to poor site/entrance design and no local inlets.
- 3) Eisenhower Chapel, which is due to the building being underground.
- 4) The Forum, which is due to the ramp and a cross connection.
- 5) Eisenhower Parking Deck, which is due to an adverse building storm line under the slab.
- 6) Pond Lab, which is due primarily to a historical drywell.

Figure 6.j. Common Major Flooding of Buildings and Storm Drain Capacity Issue Locations

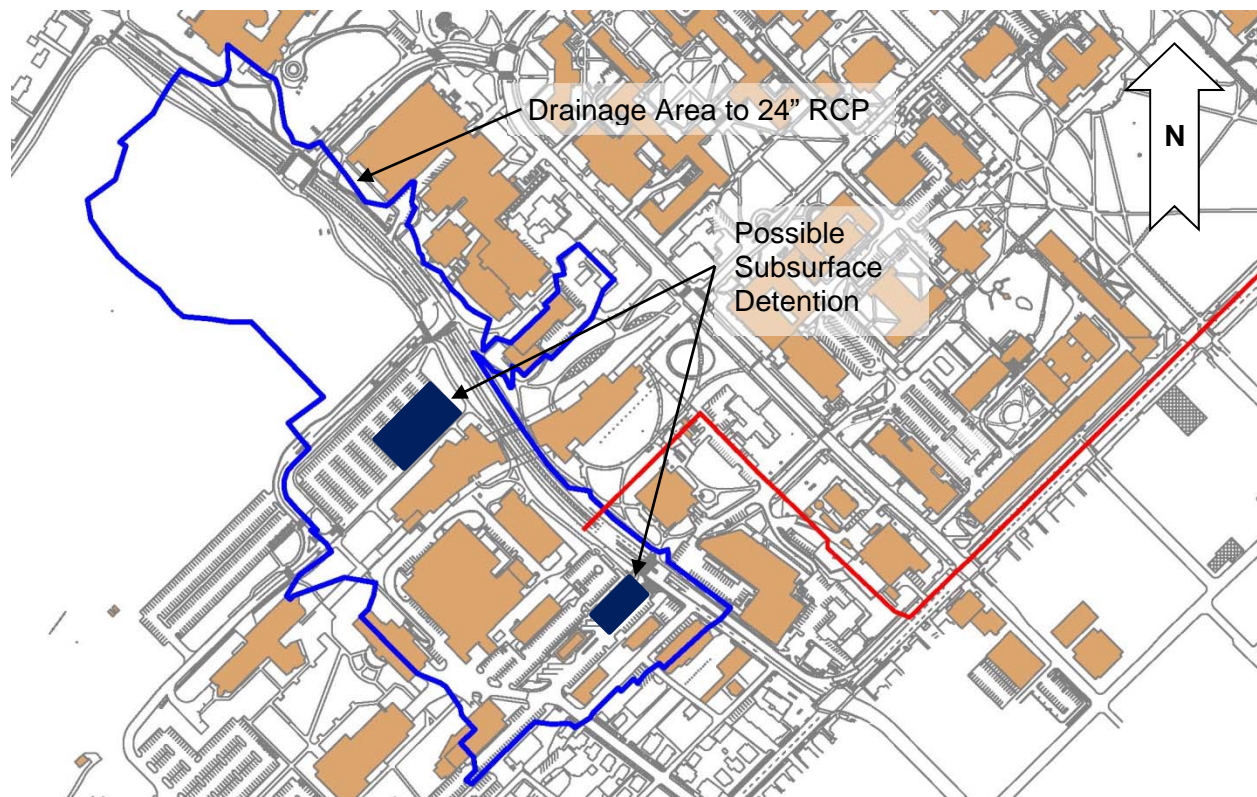
Figure 6.m. Atherton Street Possible Subsurface Detention Facility Locations

While the downstream conveyance systems are already taxed; and therefore, pipes logically cannot be increased to push flooding safely downstream, PennDOT is currently conducting stormwater conveyance improvements along Atherton Street. Until such a time, no University efforts should be conducted. The possible solutions are to provide detention storage somewhere instead of on the roadway, remove large amounts of imperviousness, or divert runoff to the West Campus Watershed. Retrofitting the entire area with green practices or attempting stormwater reuse for extreme event control is unpractical in this area. Therefore, the only viable option is to provide subsurface detention storage, which would need to be located in multiple areas most likely under the parking areas. This can be done when the area is redeveloped or when the northern parking lot is repaved. Projects could be done in phases controls on the north or south sides are not dependent on each other.

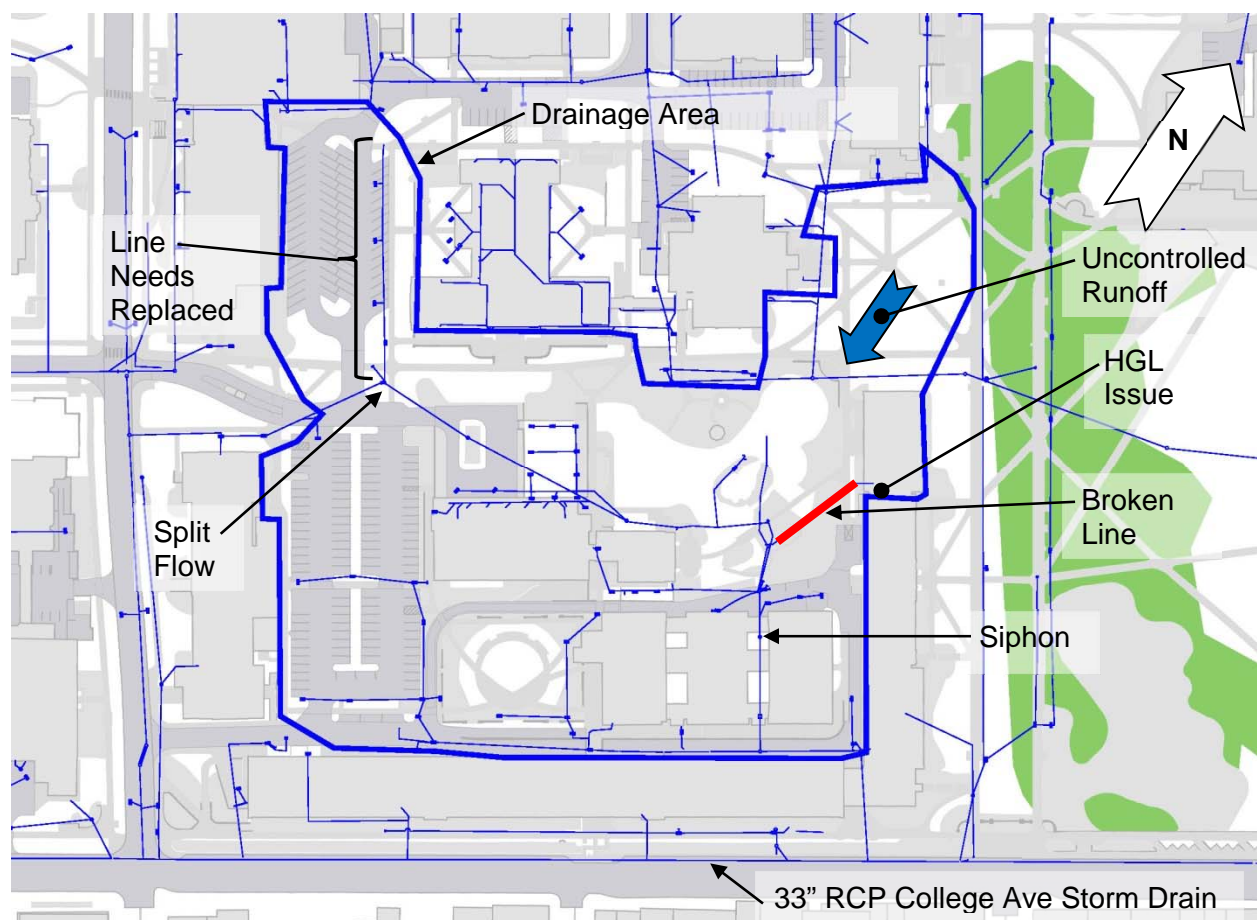
In 2013, the University attempted to develop designs to route a new storm drain on the west side of the Sackett Building towards the 33" RCP in College Ave, thereby bypassing the siphon and the broken line. It was determined that too many utilities (electric and telecom, etc.) were in the way physically preventing such a route. In 2015 a sump pump was also installed inside the door at the bottom of the stairwell, which is flooding.

Figure 6.n. Stormwater Issues Around the Sackett Building

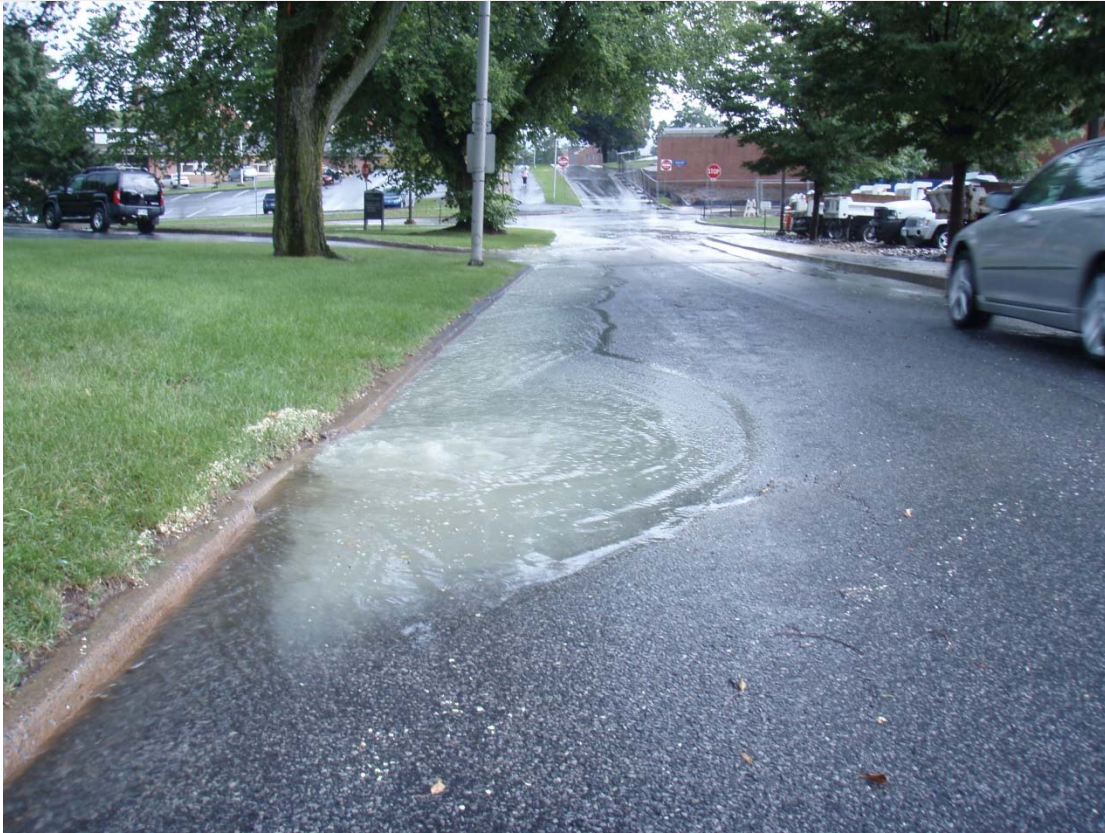
Figure 6.v. Surcharging of Mckean Road Inlet for a Moderate Rainfall Event

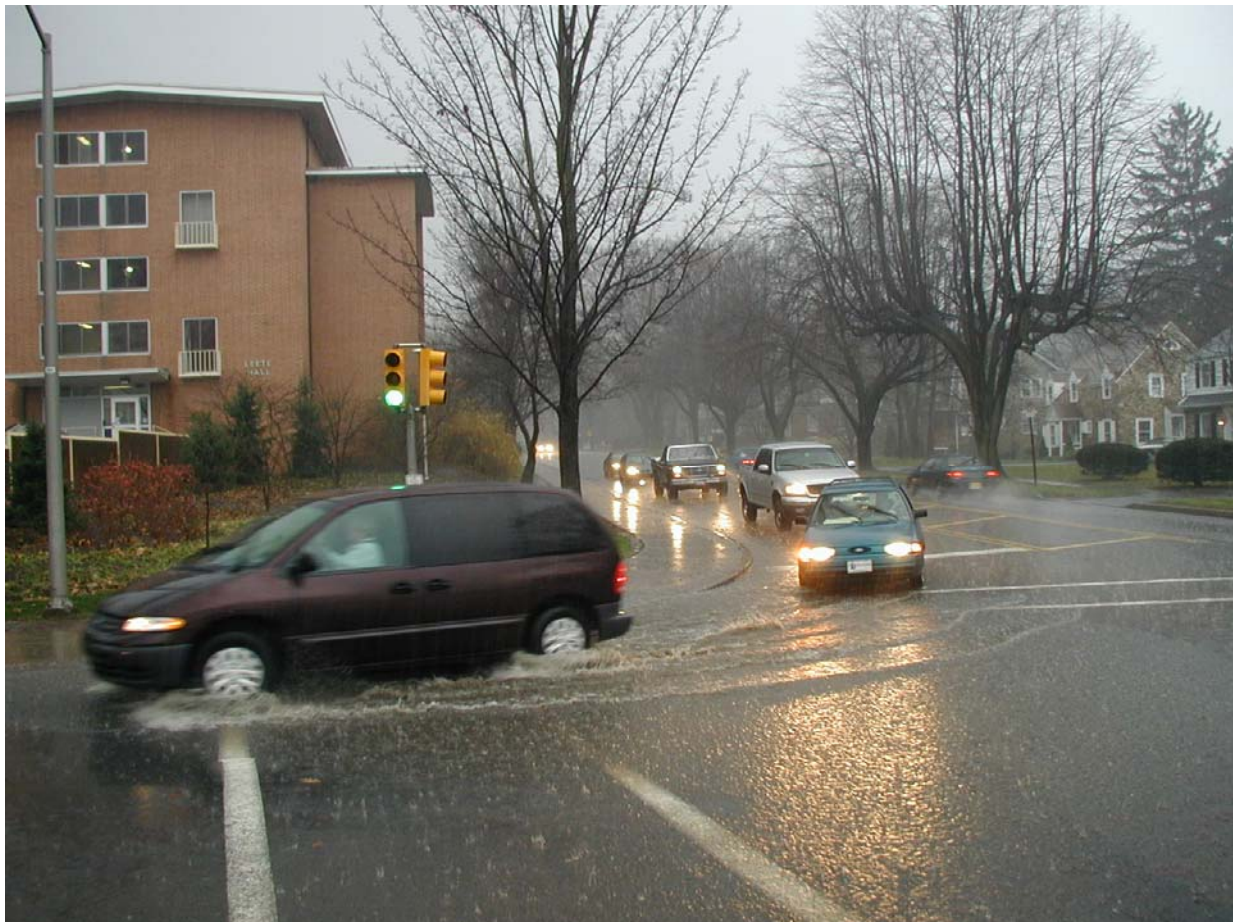
Figure 7.d. Typical Flooding at the Intersection of Park Avenue and Shortlidge Road  
Section 7-5

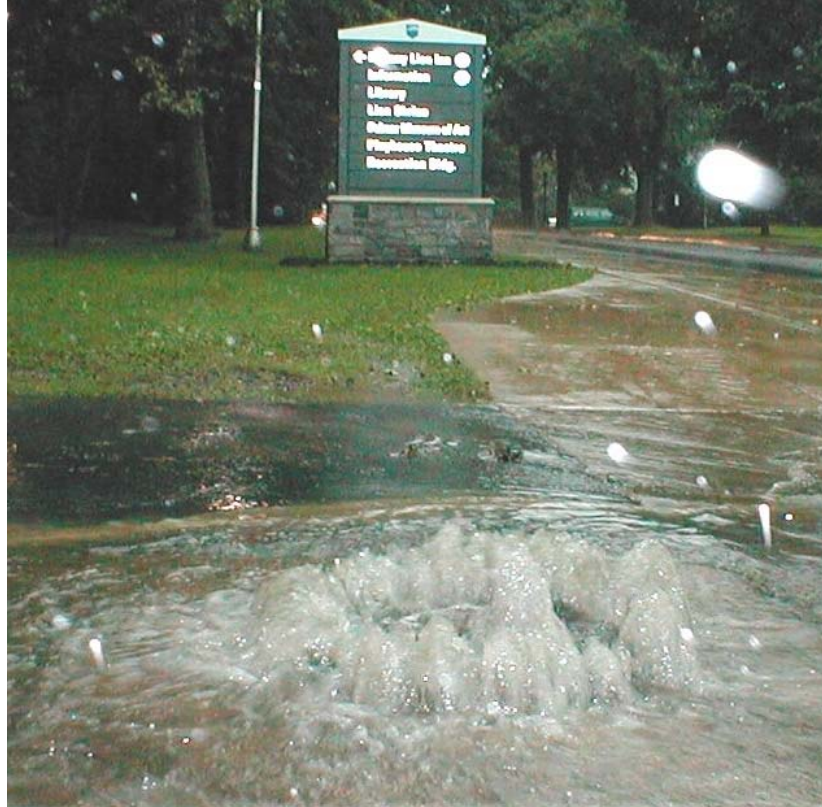
Figure 7.e. Surcharging at STMH125 along Park Avenue

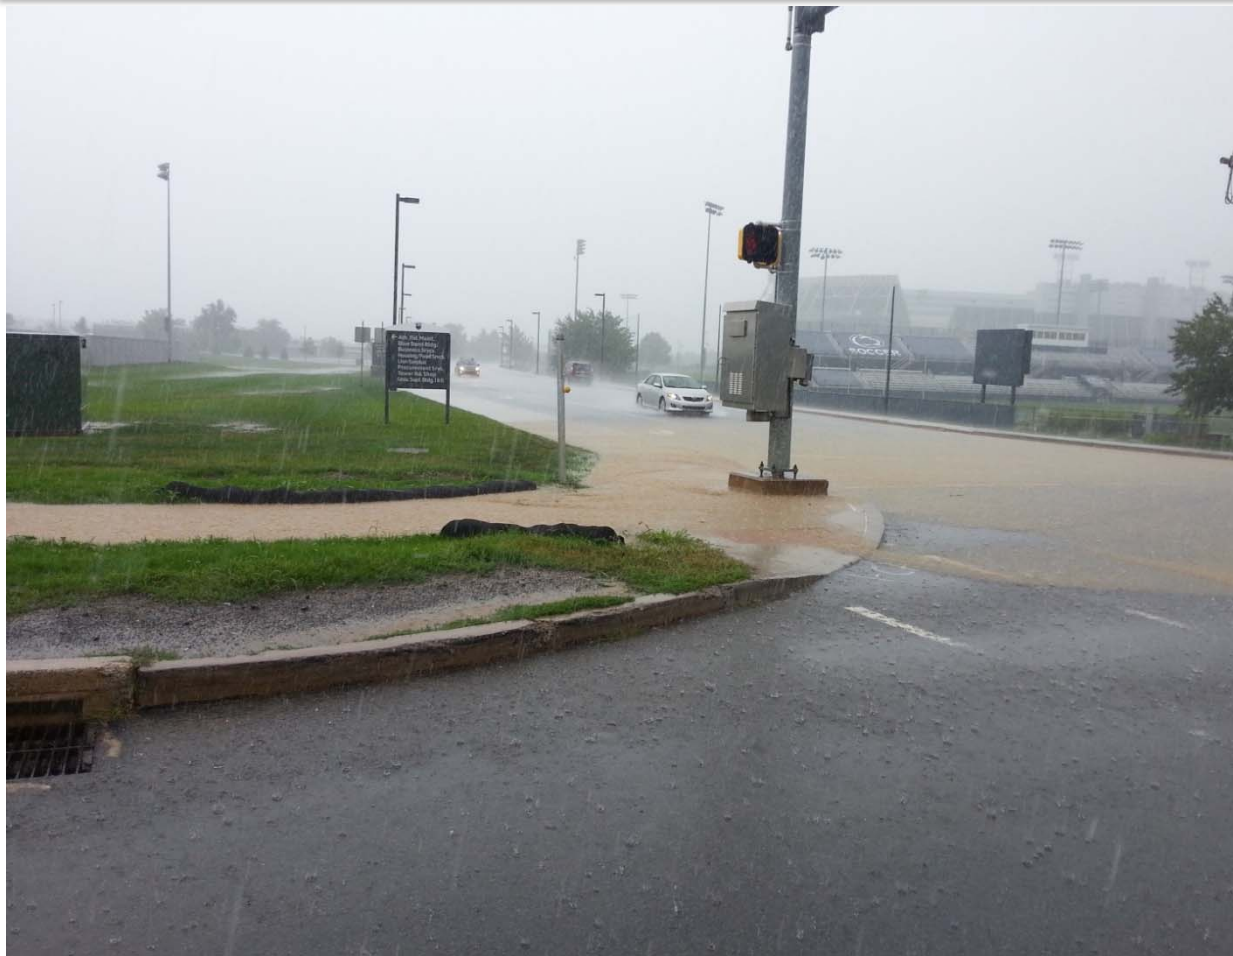
Figure 7.f. Flooding by Uncontrolled Drainage at the Intersection of Park Ave and University Dr

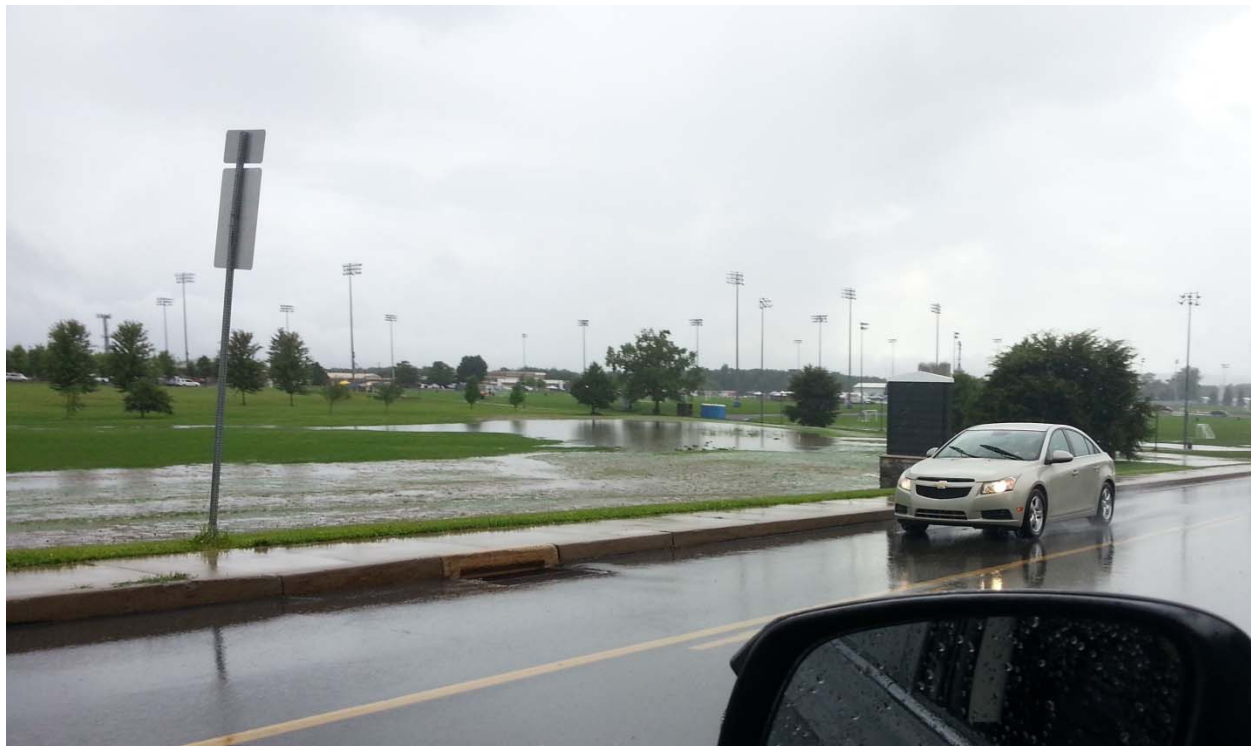
Figure 7.g. Flooding of Park Avenue from a New Stormwater Volume BMP Failure  
Section 7-7

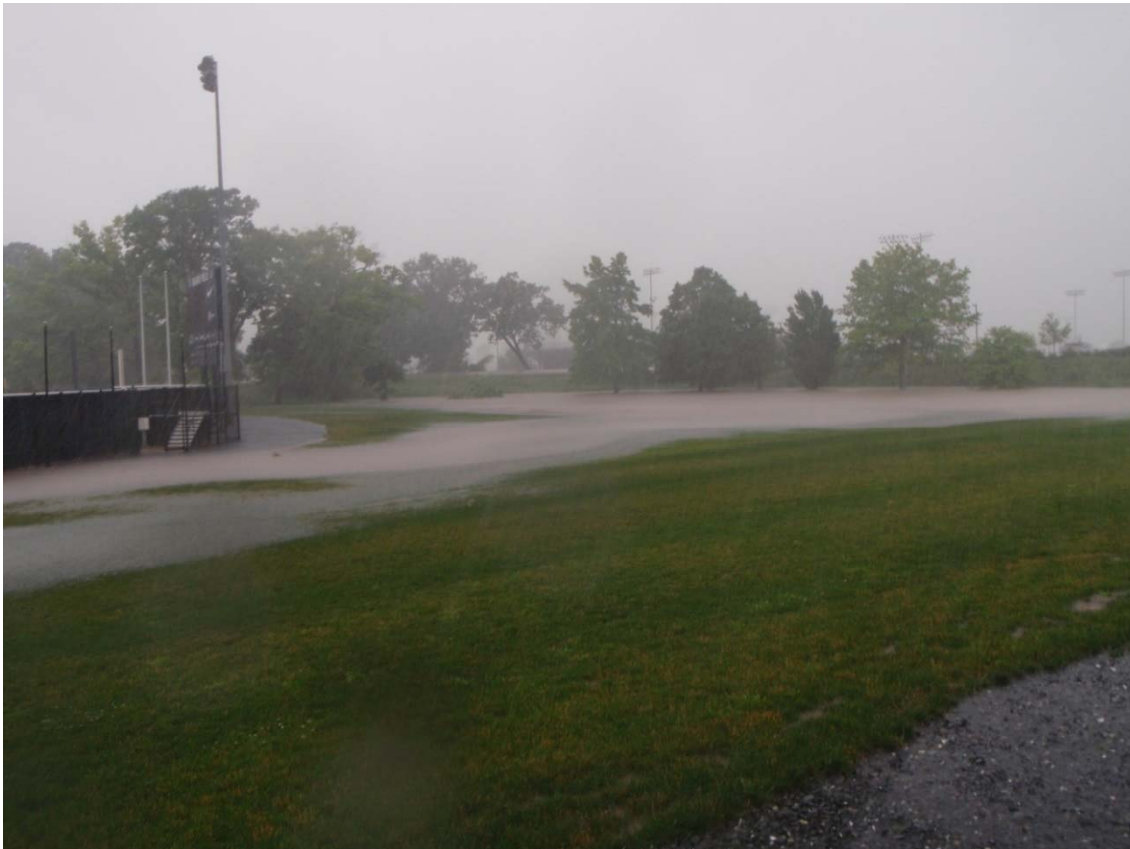
Figure 7.h. Ponding adjacent to the Softball Field  
Section 7-8

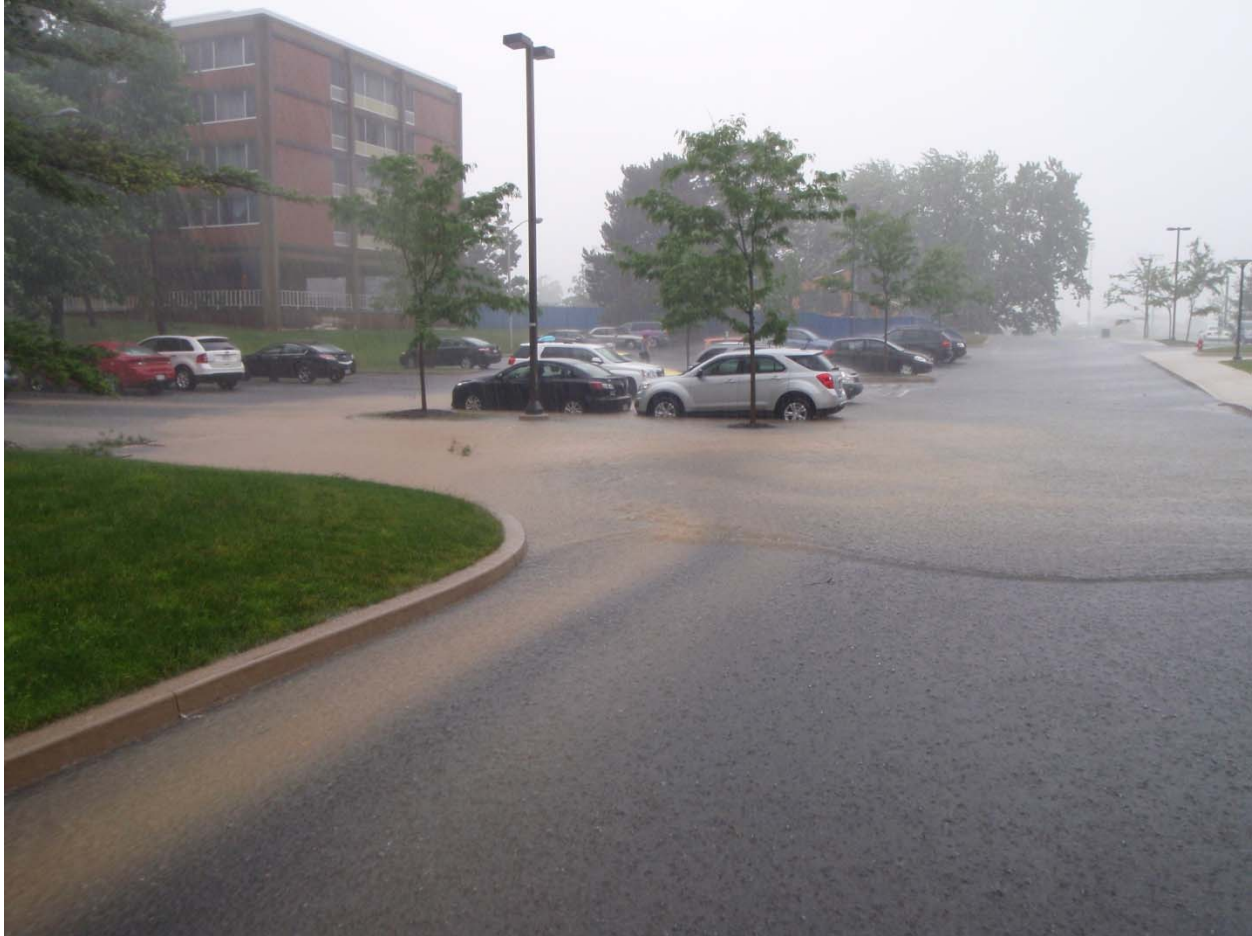
Figure 7.i Flooding of Parking Lot Between the Softball Facility and Snyder Hall

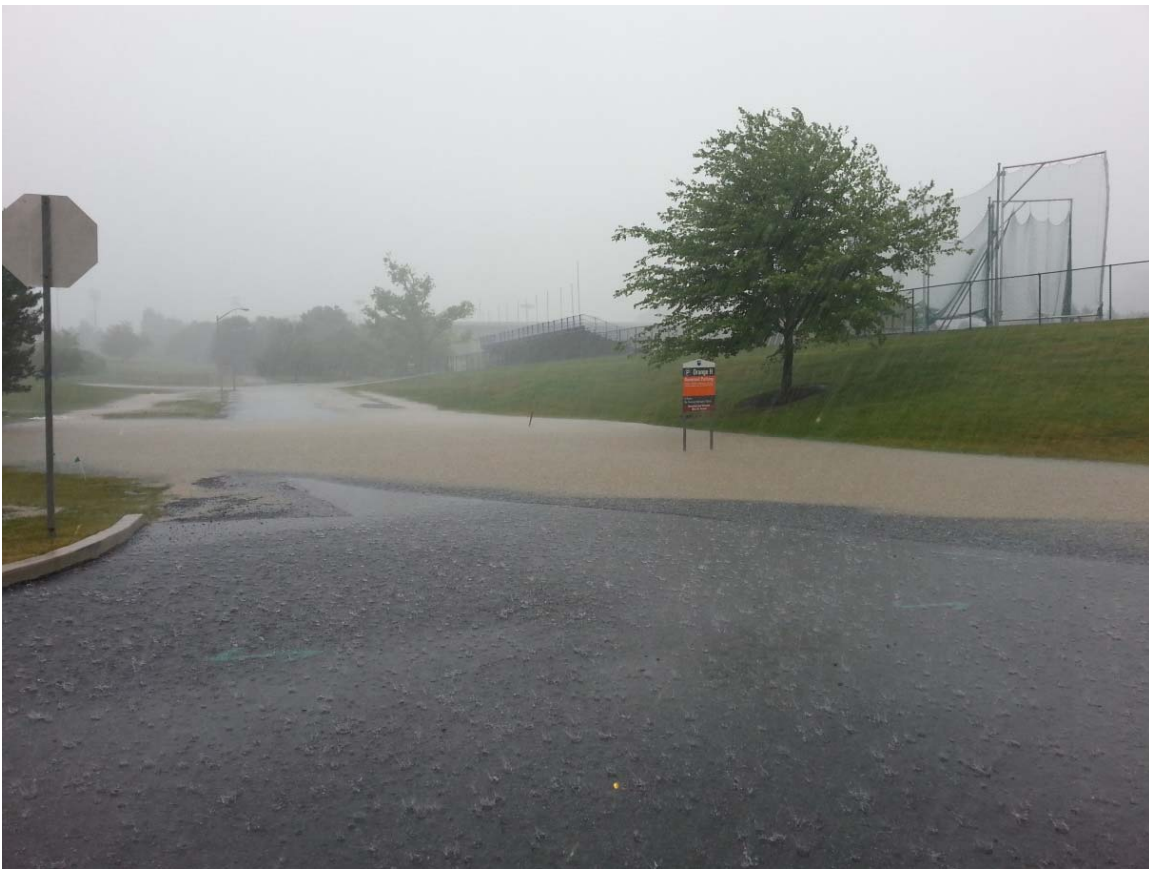
Figure 8.e. Flooding of Hastings Road during June 27, 2013 Event
