# Penn State

## University Park Campus

### Stormwater Guidance, Policies, and Master Plan

Latest Revision  
December 2016

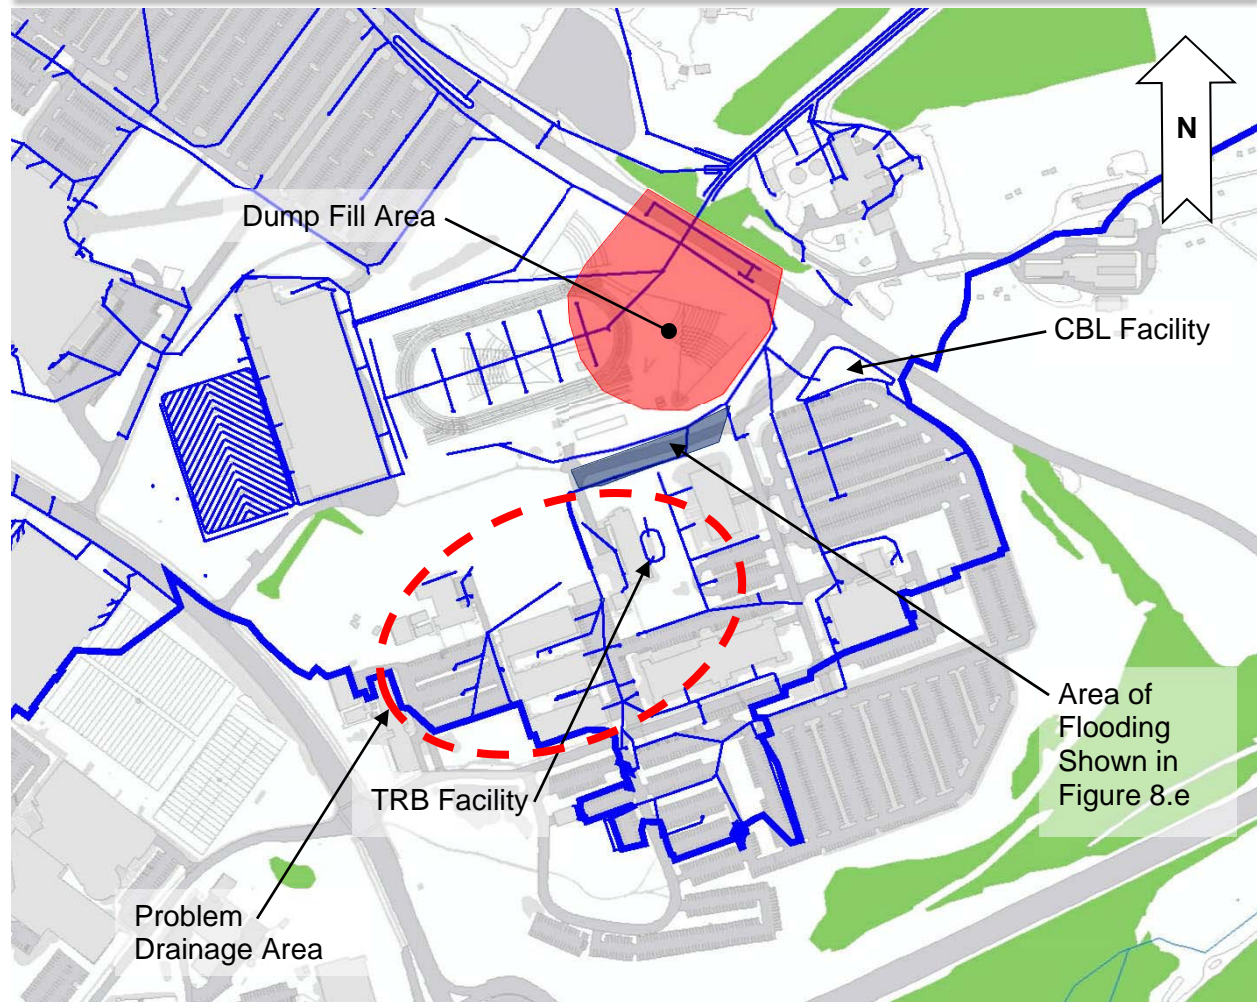
Figure 8.f. Problem Areas in the Bathgate Dam Drainage Basin
