Downtown San Rafael Precise Plan Historic Resources Inventory Summary Report

Downtown San Rafael Precise P	Plan
Historic Resources Inventor	y Summary Report
A companion document to the Downtown he San Rafael General Plan 2040 Environ	
Prepared by the City of San Rafael	
Vith assistance from Garavaglia Associa	ites and Opticos Design
Published December 2020	Cover Photo Credits: Matthew X Kiernan

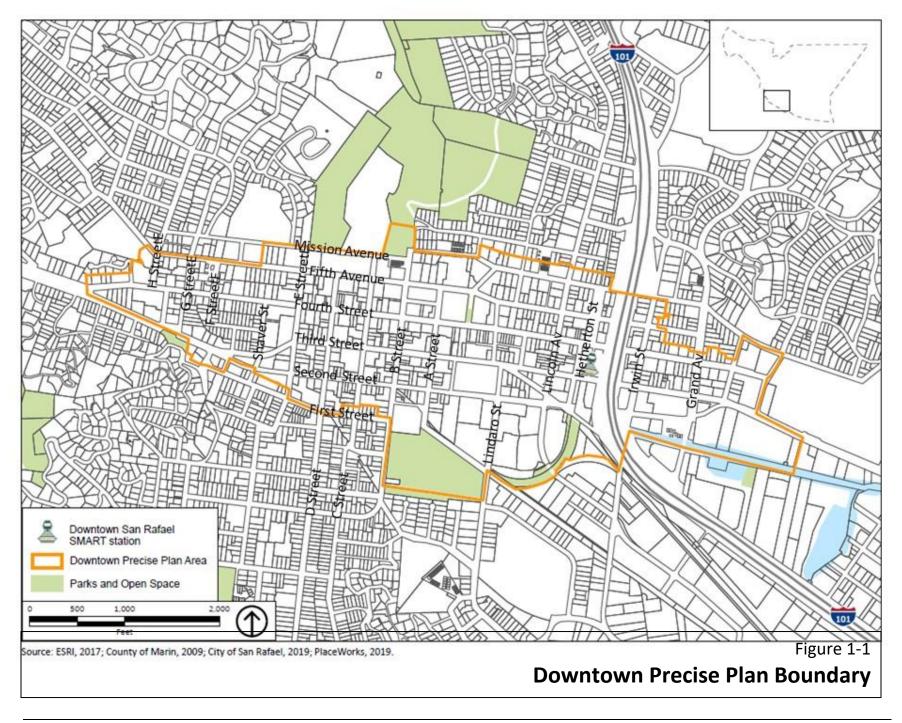
Figure 1-1 shows the Downtown Precise Plan Boundary. Figure 1-2 shows the areas that were excluded from the 2019-2020 field survey. Some of the excluded areas contain historic resources but are not expected to experience significant changes during the time horizon of the Precise Plan. Resources located in the excluded areas that were catalogued in 1977/1986 are listed in this report. However, there may be additional resources in these areas. In the event alterations are proposed in an excluded area, additional research may be needed to determine if the structure is a historic resource.

Properties that currently have landmark status were excluded from the survey, as they already have protected status. As noted in Chapter 1 and illustrated in Figure 1-2, several geographic areas were excluded from the survey due to limited resources and the fact that changes in these areas are unlikely in the next 20 years. In the event future projects are proposed in these areas, further evaluation of historic resources may be required.

¹ As noted in Chapter 3, a few small areas of Downtown were not surveyed (see Figure 1-2). Resources identified in the 1986 Survey are shown in these areas, but additional resources may be present in these areas. Projects in these areas may be subject to requirements to provide additional documentation on historic resources.

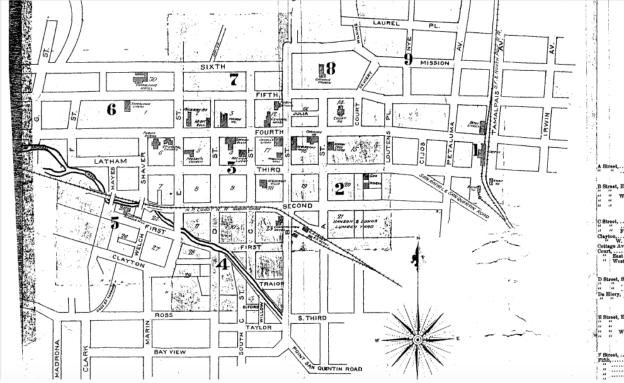
The NPC and SF&NP railroads are clearly marked in the 1877 Sanborn Fire Insurance Map. (Sanborn Map & Publishing Co., May 1877)

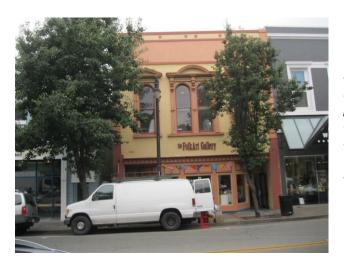
The oldest standing example of a commercial Italianate structure in San Rafael is at 1321 Fourth Street. Originally built in 1871 to house a business for local banker Upton Gordon, the building continued to be used for banking purposes through the early decades of the 20th century.³¹ The building has gone through several renovations but retains Italianate detailing in the pedimented arched windows and decorative quoins.

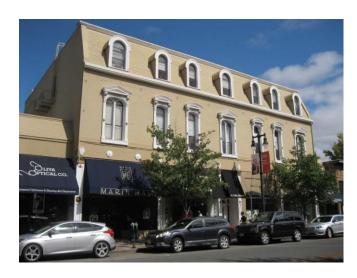
Originally known as the Mahon House, the building at 1330 Fourth Street first appears on the 1879 Sanborn Fire Insurance Map of San Rafael. The first floor of the building has continuously been occupied with commercial space, with apartments or hotel rooms on the second floor.³⁵

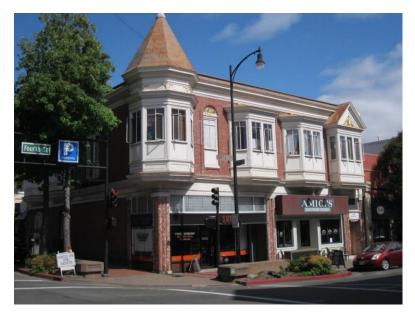
French-born tailor and local proprietor Louis Peter built 1240 Fourth Street to operate his dry goods business, opened in 1893. As a prominent commercial anchor on Fourth Street.

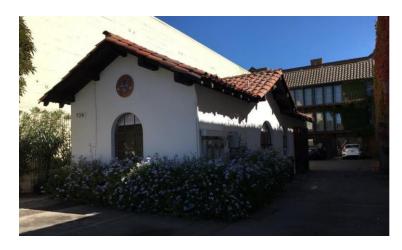
The station originally stood behind the Flatiron building at Second and B Street, but was moved to its current location at A Street in 1930 (720 [728] A Street).

While means of transportation were rapidly changing in the early 20th century, the need for rail stations persisted. The Spanish Colonial/Mission Revival "B Street Station" was constructed to replace an older structure in 1928. This era also saw the replacement of the 1890 railroad shed structure at Tamalpais Avenue with a Spanish Colonial/Mission Revival station in 1929. The station was designed by architect Frederick H. Meyer, who is credited with designing many "Mission Revival" stations throughout Marin County. The station has been significantly altered, but still stands in its original location.

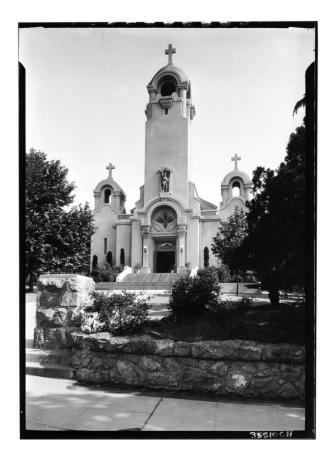
A principal example of Spanish Colonial Revival architecture in San Rafael is the Church of Saint Raphael / Mission San Rafael Arcángel. The buildings standing today were designed from research and findings by the Marin County Historical society to replicate the original Mission buildings as closely as possible. With financing from the Hearst Foundation, the structures were completed by 1949.⁵⁵ (California Historical Society Collection, 1860-1960, University of Southern California Digital Library)

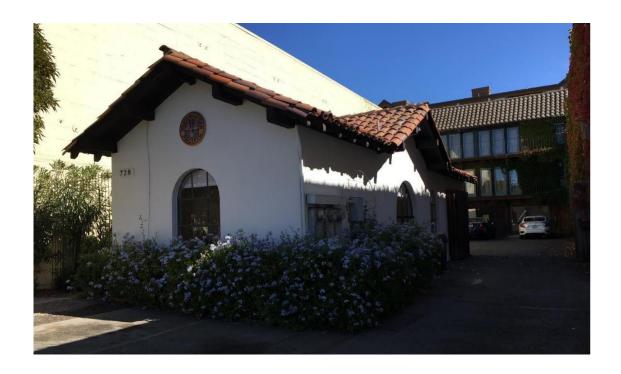
720 A Street		
Address/code	(728 A Street)	7N	Α
APN	013-012-05		
Building Name	Northwestern Pacific Railroad	d Station	
Year Built	1929 (https://annetkent.kont	ribune.com/articles/5656), c1960 moved
Original Use	Railroad station		
Architectural Style	Spanish Revival		
Architect/Builder			
Description	The diminutive one-story rectangular plan building is set back on its parcel in a neighborhood of taller buildings sited immediately adjacent to the sidewalk. It has a cross-gabled Tile roof with exposed purlins and rafter tails. Cladding is smooth plaster stucco. Large arched windows are fitted with multi-light steel sash. There is a decorative medallion with the railroad logo at the gable end.		
Integrity	Retains integrity despite being moved		
Significance	Individually eligible under A and C, also local contributor		
Notes	This is not the original Depot location, building appears to have been moved to site from original B St location when Safeway was developed early 1960s

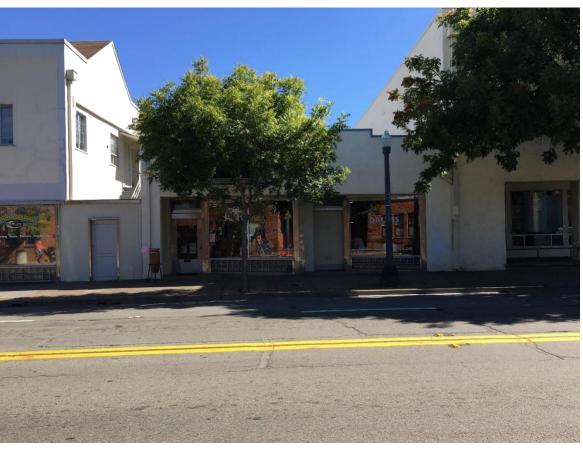
Address/code	740 A Street		В	
APN	013-012-20			
Building Name	A Drummer's Tradition (dru	m store)		
Year Built	1948			
Original Use	Retail			
Architectural	Midcentury Modern			
Style				
Architect/Builder				
Description	The one-story commercial building is rectangular in plan with its main façade immediately adjacent to the sidewalk. It has a simple stepped parapet and two storefronts with entrances left of display windows. Storefronts slant outward from recessed doors creating a zig-zag façade. The building has glass block bulkheads and metal window and door trim. Cladding is stucco. There is a small wood-clad volume at the rear of the main building with a shed roof.			
Integrity	Appears to retain integrity,	may have been altered 19	950s	
Significance	Potential local district contri		·	
	commercial resources is present, not individually eligible at any level			
Notes	Bulkhead and trim match the adjacent building to the north (742-744 A), probably both were remodeled in the 1950s as other details differ. Both buildings should probably be included or not included in potential district

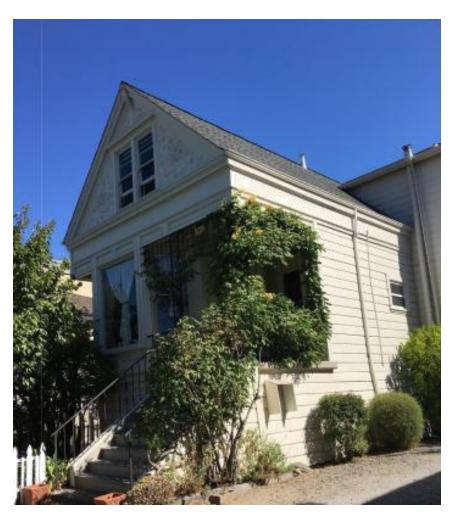
Address/code	808 A Street		В
APN	011-264-07		
Building Name			
Year Built	C1890 (Sanborn Maps)		
Original Use	Residence		
Architectural Style	Queen Anne Cottage		
Architect/Builder			
Description	The 1.5 story house has a roughly rectangular plan and a raised basement. It has a steeply pitched front-gabled roof. It is clad in drop wood siding and has a combination of double-hung wood sash and replacement windows. Decorative features include ornamental scrolls at the main façade gable end and a paneled frieze. Porch supports and balustrade are wrought iron.		
Integrity	Retains integrity despite replacement of some windows and original wood porch details		
Significance	Local district contributor, not individually eligible for architecture due to alterations		
Notes	_

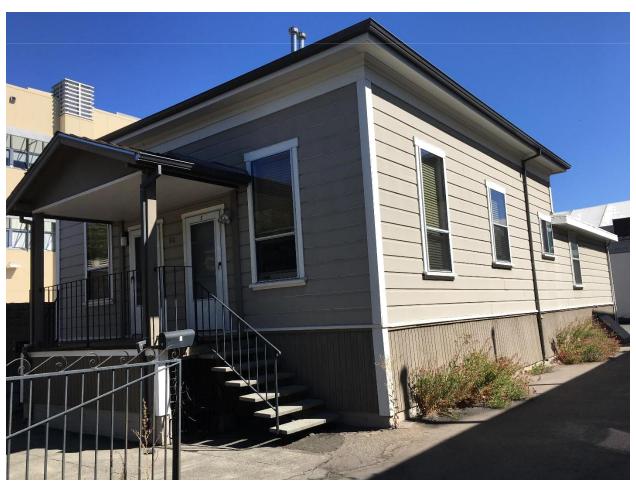
Address/code	812 A Street		E
APN	011-264-08		
Building Name			
Year Built	Before 1887 (Sanborn Maps)		
Original Use	Multi-family Residence		
Architectural Style	Folk Victorian Duplex		
Architect/Builder			
Description	The one story duplex has a rectangular plan and a slightly raised basement. Its front wing has a steeply pyramidal roof; the rear of the building has a lower shed roof. Front doors are side by side in the symmetrical main façade. The building is clad in drop wood siding with vertical groove plywood at the basement level and has vinyl replacement windows. A partial width projecting porch has a low pitch gabled roof, concrete steps with open risers, and a balustrade are wrought iron. The building lacks decorative features		
Integrity	Lacks integrity due to replacement of windows and original full-width porch, basement siding, and installation of inappropriate porch steps and balustrade

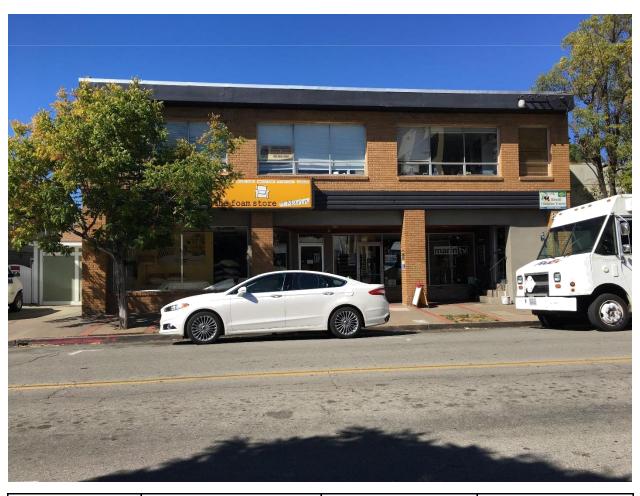
Address/code	813 A Street		В
APN	011-262-06		
Building Name	Foam Store		
Year Built	1951 (Sanborn Maps, aerials)		
Original Use	Commercial		
Architectural Style	Midcentury Modern		
Architect/Builder			
Description	The two story commercial building has a rectangular plan with storefronts on the ground floor and offices above. It has a flat roof with a heavy soffit on the upper floor. It is clad in brick with small areas of stucco. Upstairs windows are three-part steel casement. Decorative grooved moulding separates upper and lower stories. The storefront in the south third of the building is adjacent to the sidewalk, while the north end storefront and entrances are recessed behind heavy brick pillars and are fitted with contemporary replacement aluminum frame doors and windows.		
Integrity	Retains integrity despite storefront replacement.		
Significance	Potential local district contributor if a sufficient concentration of postwar

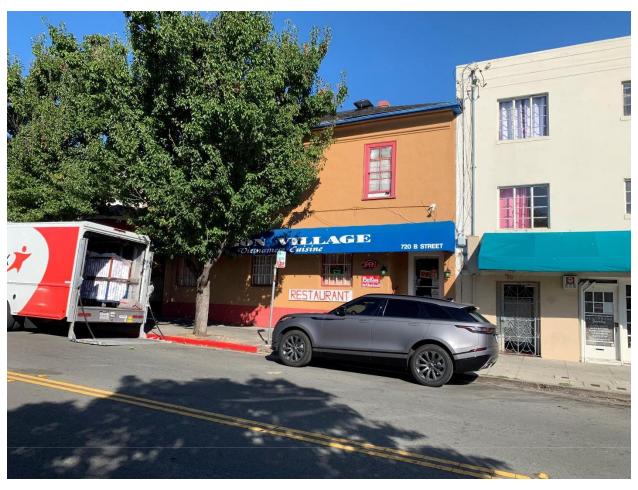
Address/code	720 B Street		С	
APN	013-011-02			
Building Name	Saigon Village Restaurant, His	storic San Rafael House res	staurant/saloon/lodging	
Year Built	Before 1887 (Sanborn Maps)			
Original Use	Saloon/restaurant with hotel	upstairs		
Architectural Style	American Foursquare			
Architect/Builder				
Description	The two story residential-style building has a triangular plan to conform to the railroad tracks to its northeast. It features a medium pitch hipped roof in front with a flat-roofed addition at the rear. Cladding is stucco, windows are a combination of double-hung wood sash and fixed multi-light. The entrance is fitted with a fully-glazed aluminum frame commercial-style door. There are commercial buildings immediately adjacent to its side elevations.			
Integrity	Current appearance probably c1905, door modern, requires more study			
Significance	Potential local district contributor as extant nineteenth century

restaurant/hotel. Not eligible	for its architecture.		
Notes

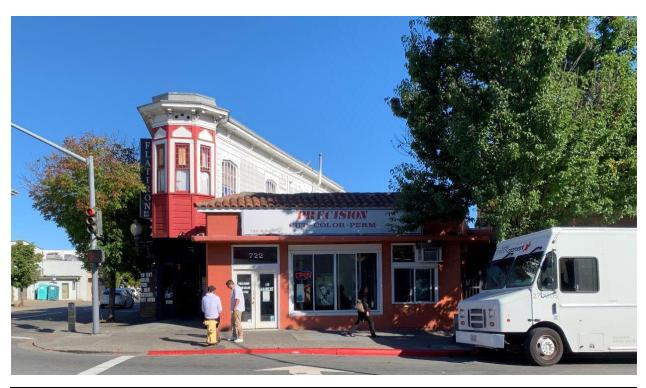
Address/code	724 B Street	7N	Α	
APN	013-011-05			
Building Name	Flatiron Building			
Year Built	1883			
Original Use	Saloon/residential			
Architectural Style	Queen Anne Commercial			
Architect/Builder				
Description	The two story commercial bu the ground floor and apartme elaborated with ornamental bu and has double-hung wood so highly decorative projecting be decorative spandrel panels all and doorways on the north efitted with wood-frame Frence	ents above. It has a flat room orackets and frieze. It is class windows. Its northwes pay above the main entran pove multi-light stained-gladevation feature pediment	of and cornice and in drop wood siding at corner features a ace which features ass windows. Windows and hoods. Entrances are	
Integrity	Retains integrity, only doors appear to have been altered			
Significance	Individually NRHP eligible under C and potentially A, also local contributor			
Notes	Designated as Local Landmark in 1982, decorative features may have been

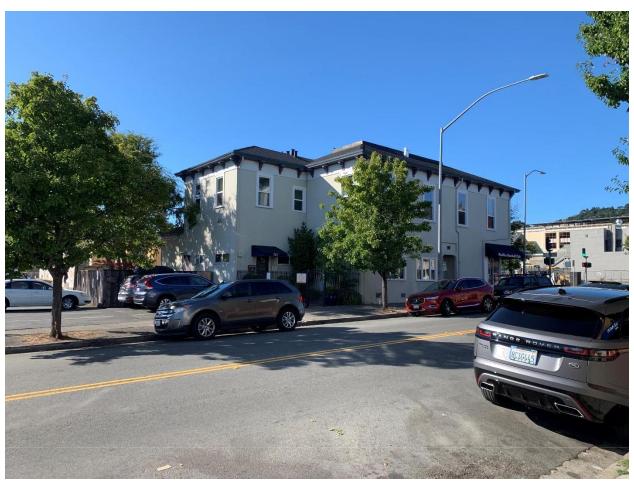
747 B Street (1201 Second		
Address/code	Street)	N/A	D
APN	013-011-056		
Building Name	Cosmopolitan Hotel		
Year Built	Before 1887 (Sanborn Maps)		
Original Use	Hotel		
Architectural Style			
Architect/Builder			
Description	The two story hotel building has an irregular plan with moderate pitch hipped roof and ornamental brackets at the cornice. Cladding is stucco and the building has vinyl replacement windows. There is a small wood frame storefront at its northwest corner. The balance of the lower north elevation lacks fenestration.		
Integrity	Does not appear to retain integrity, more study needed but stucco, windows, storefront, blank wall all appear to be alterations		
Significance	Unlikely to be eligible, lack of integrity		
Notes

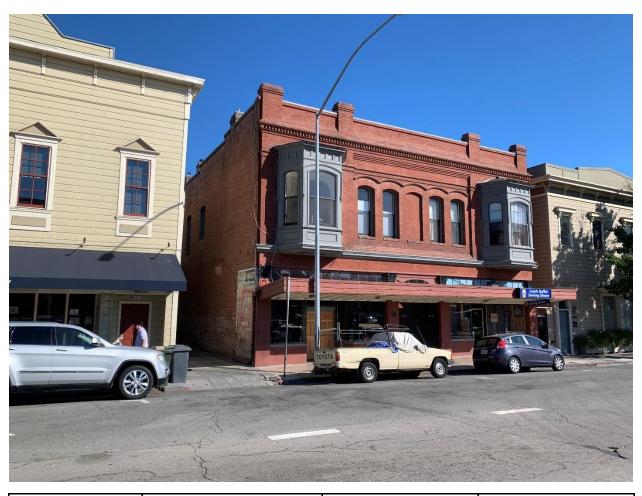
Address/code	810-814 B Street	3S	Α
APN	01011-262-14		
Building Name	World Wide Antiques/Victory	/ Grocery	
Year Built	Before 1894 (Sanborn Maps)		
Original Use	Retail storefront		
Architectural Style			
Architect/Builder			
Description	The two story commercial building has a rectangular plan with flat roof and parapet. Cladding is brick with ornamental features including dentil moulding, upper floor pilasters, and window hoods also executed in brick. Two projecting wood upstairs bays have decorative frieze and window hoods. Window openings are arched and fitted with wood sash. Ground floor pilasters have Corinthian capitals flanking multiple light transoms above storefronts. A metal awning projects from the façade just below the capitals. Bulkheads and pilasters have been stuccoed below the awning. Ground floor doors are residential-type paneled wood doors on the north and a contemporary aluminum frame glazed door on the south.

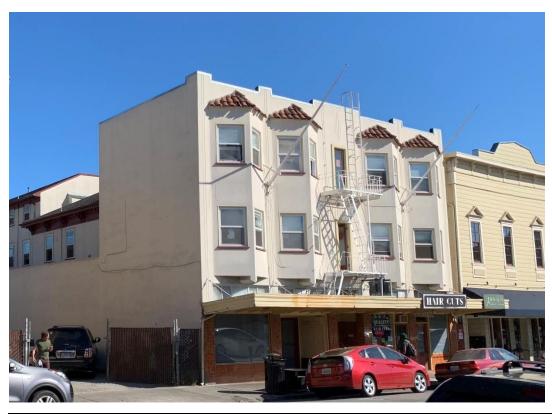
Address/code	826 B Street (830 B St) 5S2	С	
APN	01011-262-16		
Building Name	Albion House, Hotel Carmel		
Year Built	1887 Albion Hotel, 2 story, smaller footprint; 1894 Cypr	ess Villa Hotel,	
	expanded footprint; 1907/1924 unchanged; 1950 Hotel	Carmel current	
	footprint (Sanborn Maps) c1930 current façade (spread	sheet)	
Original Use	Retail storefront/hotel		
Architectural Style			
Architect/Builder			
Description	The three story building is rectangular in plan with a low the rear. Its main façade is immediately adjacent to the with a shaped parapet. Four slanted bays project from topped with a tile roof. Fenestration consists of vinyl re There is a fire escape with exits at the center of the faça below multiple-light transoms shades the ground floor are stuccoed while the ground floor is clad in tile. Store which is recessed, are fitted with partially glazed panels	sidewalk. The roof is flat the upper stories; each is placement windows. ade. A metal awning storefronts. Upper floors front entrances, one of ed wood doors.

Integrity	May retain integrity to c1930 façade, more research needed		
Significance	Potential local contributor, not individually eligible		
Notes

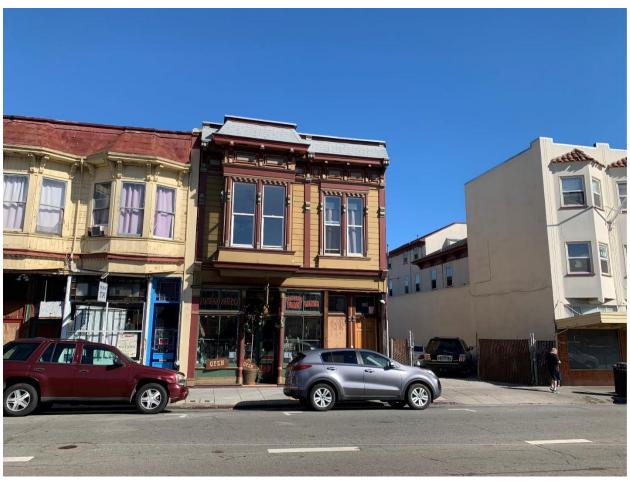
Address/code	834-840 B Street	3 S	Α
APN	01011-262-22		
Building Name	Players Guitars		
Year Built	1885 per DPR, c1895 (betwee	en 1894 and 1907 Sanborn	Maps)
Original Use	Retail storefront (shoe and bo	oot store)	
Architectural Style	Stick Eastlake		
Architect/Builder			
Description	The two story commercial building is rectangular in plan with a mansard roof. The façade is asymmetrical with has one projecting square bay on the upper floor. Cladding is drop siding. Tall vertical windows separated by stylized pilasters are fitted with vinyl replacement sash. Ornamental features include cornice with decorative brackets and elaborate paneled frieze as well as bird's eye moulding above windows. Rare original storefronts have multiple-light display windows and transoms. There is a set of original double wooden doors flanked by decorative round columns. Doors at the south end of the storefront have been replaced or boarded up.

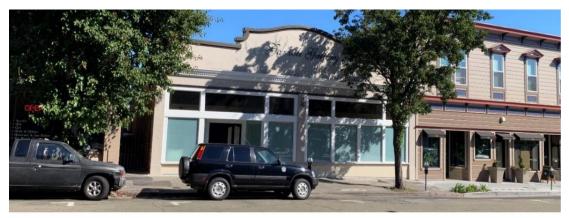
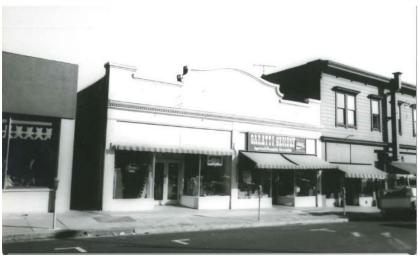
Address/code	926-930 B Street	7N	D	
APN	011-261-13			
Building Name	Garatti Grocery			
Year Built	1912 (spreadsheet)			
Original Use	Retail storefront grocery			
Architectural Style	Mission	Mission		
Architect/Builder				
Description	The one story commercial building is rectangular in plan with a decorative shaped parapet and entablature with dentil moulding above the storefront level. Replacement storefronts are divided by heavy wooden moulding. Cladding is stucco. The entrance is fitted with a paneled wooden door.			
Integrity	Lacks integrity, major alterations since 1970s survey (see above)			
Significance	not eligible, combination	of modest architecture and in	tegrity problems	
Notes			•

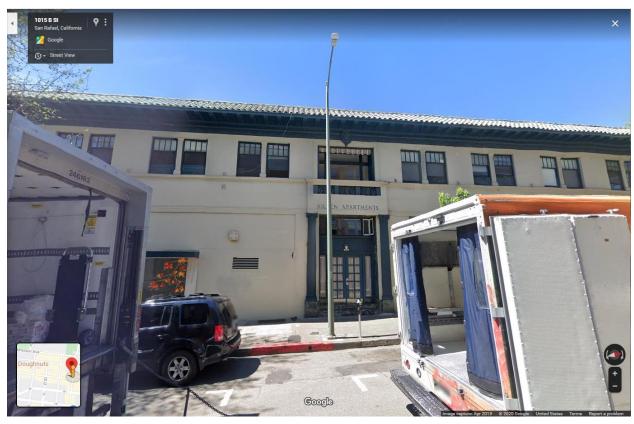
1009 B Street (1200-		
Address/code	1212 4 th)	5S2	Α
APN	011-212-05		
Building Name	Aileen Apartments		
Year Built	c1930? (architecture)		
Original Use	Retail storefront /apartment		
Architectural Style	Spanish Revival		
Architect/Builder			
Description	The two story commercial/aparmansard roof and cornice with cartouche, and floral frieze. The is stucco. Upper floor windows a separated by pilasters elaborated decorative plaster in floral patter flanked by Corinthian columns, doors with sidelights. Storefront somewhat altered	decorative rafter tails, do re are facades on B and are paired double-hunged with floral motifs. An erns. The ground floor a topped by a transom, a	entil moulding, Fourth streets. Cladding 4-over-1 wood sash upstairs balcony feature partment entrance is nd has double French
Integrity	Retains integrity despite storefront replacement		
Significance	Eligible as individual landmark and contributor

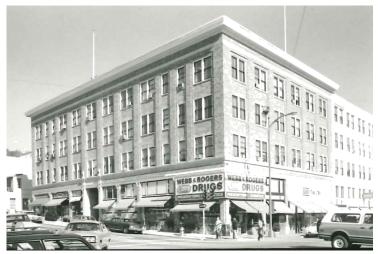
1010 B Street (1138-1146		
Address/code	Fourth)	1S	Α
APN	011-215-01		
Building Name	Albert Building		
Year Built	c1920 (DPR), 1930 (Patch Article)		
Original Use	Retail storefront /apartment		
Architectural Style	Chicago/Commercial		
Architect/Builder			
Description	The four story commercial/apartme and heavy decorative cornice. Ther brick with terra cotta decorative feare paired double-hung fitted with decorative plaster in floral patterns Corinthian pilasters elaborated with name. The door is deeply recessed door/sidelight/transom assemblage terra cotta capitals. Most have orig Contemporary awnings have been in	e are facades on B a atures and granite b replacement window . The ground floor a n decorative urns an and fitted with an o e. Storefronts are se inal fully glazed woo	nd Fourth streets. Cladding is ulkheads. Upper floor windows ws. An upstairs balcony feature partment entrance is flanked by d inscribed with the building riginal bronze parated by brick pilasters with od doors and transoms.

Integrity	Retains integrity despite window replacement and some storefront alterations		
Significance	Eligible as individual landmark and contributor		
Notes		·

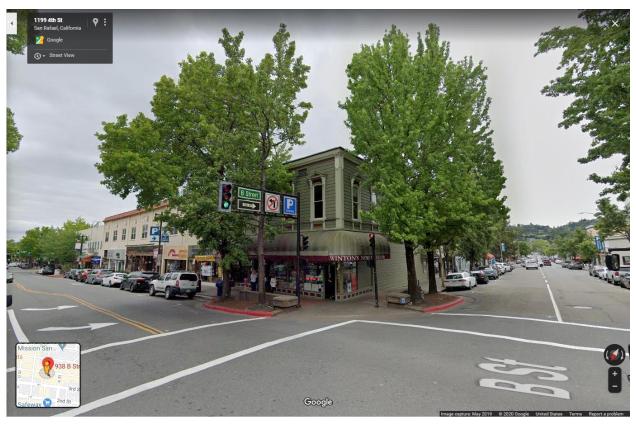
938 B Street (1143			
Address/code	Fourth St)	6X	B+	
APN	011-261-01			
Building Name	McDermott Building			
Year Built	Prior to 1887 (Sanborn Maps)			
Original Use	Retail storefront (grocery)/apa	artment		
Architectural Style	Italianate/Second Empire	Italianate/Second Empire		
Architect/Builder				
Description	The two story commercial/apartment building has a rectangular plan with a flat roof and minimal cornice. There are facades on B and Fourth streets. Cladding is drop wood siding. Upper floor windows are tall double-hung wood sash with decorative pedimented hoods elaborated with brackets and diamond shingles The ground floor storefronts have paneled frieze bulkheads.			
Integrity	Appears to retain integrity despite some storefront alterations, spreadsheet says cornice removed			
Significance	Eligible as contributor and possibly as individual landmark			
Notes

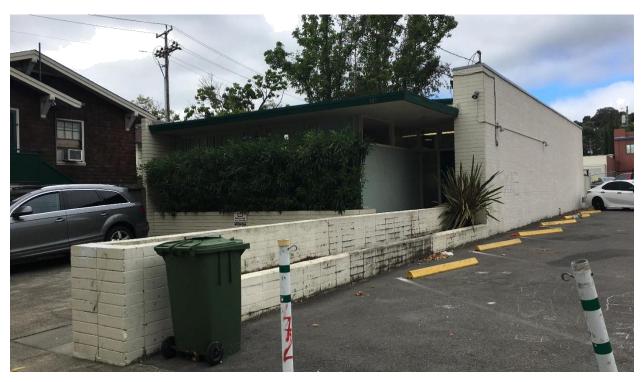
Address/code	707 C Street		A-
APN	012-073-11		
Building Name			
Year Built	1952 (spreadsheet)		
Original Use			
Architectural Style	Midcentury Modern		
Architect/Builder			
Description	The one story commercial building is recessed behind a parking area. It has a rectangular plan with a flat roof that projects over its deeply recessed entry, which is at the south end of its main (east) façade. The building is clad in brick with stucco accents and features clerestory windows on its main façade. There are built-in brick planters in front of the building and along the south property line.		
Integrity	Retains integrity, low visibility because of shrubbery		
Significance	Eligible as contributor and po architecture	ssibly as individual landma	ark for its Modern
Notes

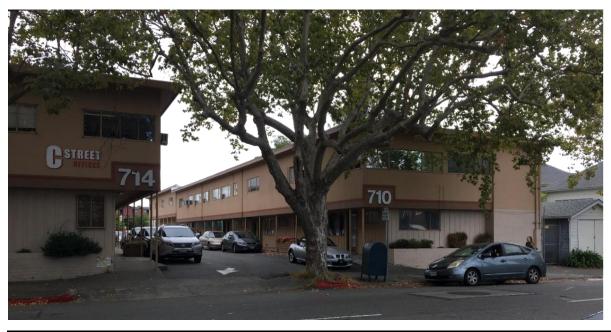
Address/code	710-714 C Street		E	
APN	012-075-17			
Building Name				
Year Built	1954 (spreadsheet)			
Original Use	Apartment			
Architectural Style	Midcentury Modern			
Architect/Builder				
Description	roofed buildings facing a cent ground floor and stucco abov overhanging second story on	The two story apartment building (now used for offices) has two rectangular-plan flat-roofed buildings facing a central courtyard. Cladding is board and batten on the ground floor and stucco above. Windows are narrow frame metal casement. The overhanging second story on the courtyard-facing elevations is supported by plain metal poles and forms a sort of loggia sheltering apartment entrances. There are brick		
Integrity	Retains integrity			
Significance	Not eligible individually or as district contributor			
Notes	Common example of inexpen	sive midcentury architectu	re

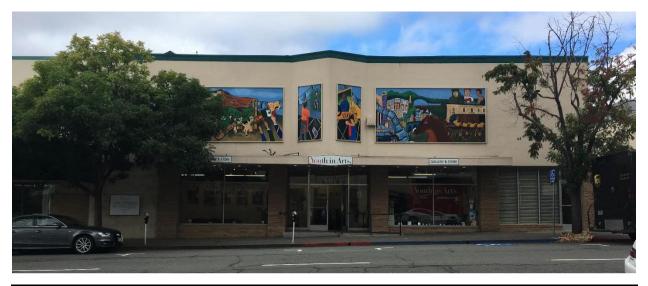
Address/code	917 C Street		E
APN	011-253-06		
Building Name	Youth in Arts		
Year Built	1880 (spreadsheet) /c1950		
Original Use			
Architectural Style			
Architect/Builder			
Description	The two story commercial bu disguised by a parapet on the is stuccoed and lacks fenestra on the main façade. The grouwindows and split-face rock of glazed aluminum frame doub rear elevations have steel sas	e main (east) façade. The mation. There is a projecting and floor has large aluminu columns and bulkheads. The doors with transom and hundows in vertical oper	nain façade upper story v-shaped bay centered m frame storefront e entrance has fully I sidelights. Sides and nings.
Integrity	Lacks integrity to 1880 constr		e of a 1950s building
Significance	Not eligible individually or as		
Notes	19 th century industrial origins of elevations. Partial c1950 faça not a good example of either of a midcentury commercial b	de remodel created an odd era. 917 C St (adjacent sou	dly hybrid building that is

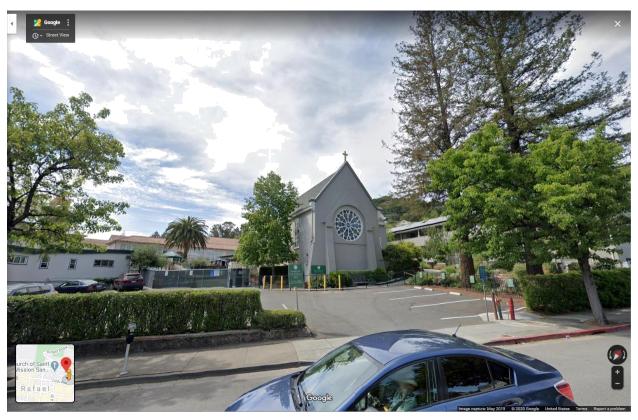
Address/code	1123 Court Street		D		
APN	011-213-18				
Building Name	St Paul's Episcopal Church				
Year Built	1927 (church website), 1920	(DIJ 1949, Sanborn Maps)			
Original Use	Religious				
Architectural Style	Gothic Revival / Classical Revi	ival			
Architect/Builder					
Description	The church sanctuary building is rectangular in plan with a steeply pitched gabled roof. It is connected to other church buildings to form a U-shaped compound building. The sanctuary has a rose window on the south elevation and pointed arch stained glass on the sides. It is clad in smooth stucco (may be reinforced concrete construction) with decorative buttresses. The main entrance is in a projecting volume near the east corner of the north elevation and features a pointed arch doorway under a pedimented gable.				
Integrity	unknown				
Significance	Unlikely to be eligible, requires more study, entrance apparently altered

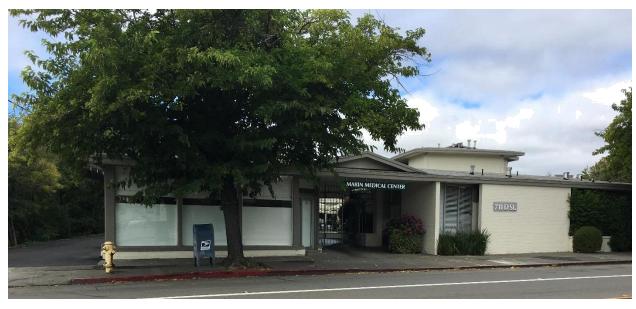
Address/code	711 D Street		С
APN	012-071-17		
Building Name	Marin Medical Center		
Year Built	Before 1952 (aerials)		
Original Use	Commercial		
Architectural Style	Mid-century Modern		
Architect/Builder			
Description	The commercial building is trapezoidal in plan with an interior courtyard and main facades on the east (D Street) and north (parking lot) elevations. The primary roof is flat with a low pitch gable over the courtyard entrance on D Street, which features large expanses of glass and brick cladding. The east façade has wood cladding and clerestory windows. A large second story addition on the east side of the building has low pitch roof and metal casement windows.		
Integrity	Research required to determine date of second story		
Significance	May be district contributor, not individually eligible		
Notes	Second story may have been added within the historic period but does not fit Modernist aesthetic of other building elements. May be important as an early example of auto-oriented commercial architecture

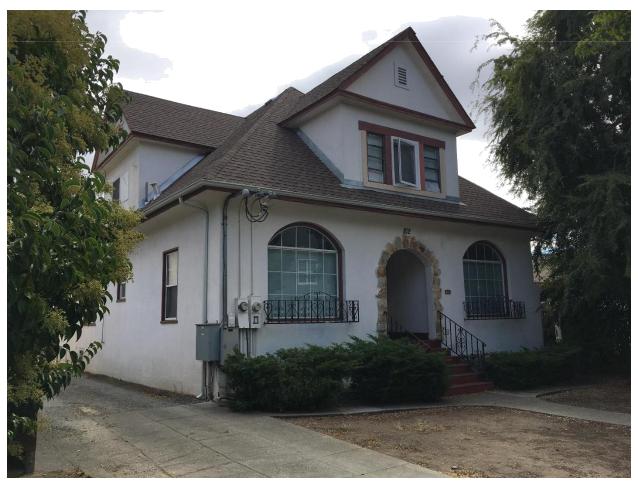
Address/code	812 D Street		Е
APN	011-254-22		
Building Name			
Year Built	1930s (spreadsheet) 1908-19	23 (Sanborn Maps) 1906 (ı	real estate ads)
Original Use	Residential		
Architectural Style	Hip roof cottage (Foursquare)		
Architect/Builder			
Description	The rectangular plan residence is 1.5 stories and exhibits a hybrid appearance with a pyramidal roof, large dormers, and double-hung dormer windows dating from the building's original construction the first decade of the twentieth century. Arched window and door openings, flagstone door surround, and stucco cladding appear to date from a later addition.		
Integrity	Lacks integrity due to stucco, arched windows, etc.		
Significance	Not eligible individually or as contributor		
Notes

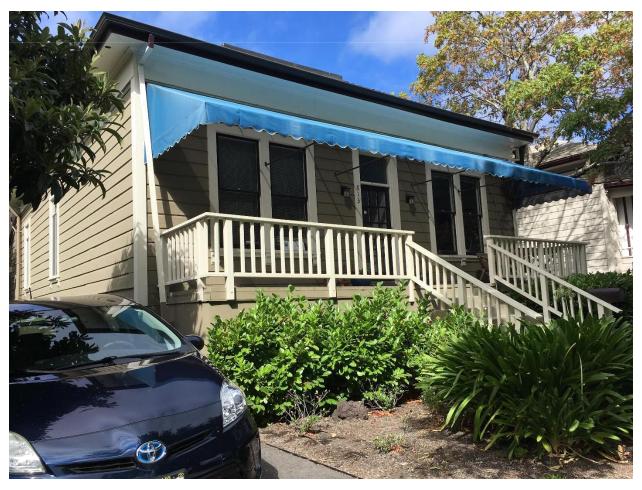
Address/code	813 D Street		С
APN	011-252-06		
Building Name			
Year Built	1882 (spreadsheet)		
Original Use	Residential		
Architectural Style	Folk Victorian		
Architect/Builder			
Description	The rectangular plan resident cornice with boxed eaves and awning, likely a replacement Windows are double hung we floor sits above a raised base steps.	I full-width porch with sim for an original porch roof, ood sash and cladding is di	ple balustrade. A canvas shelters the porch. rop siding. The ground
Integrity	More research required, porc may be additional alterations		en removed and there
Significance	Potentially eligible as contrib	utor	
Notes	Good example of a folk house	if integrity is present

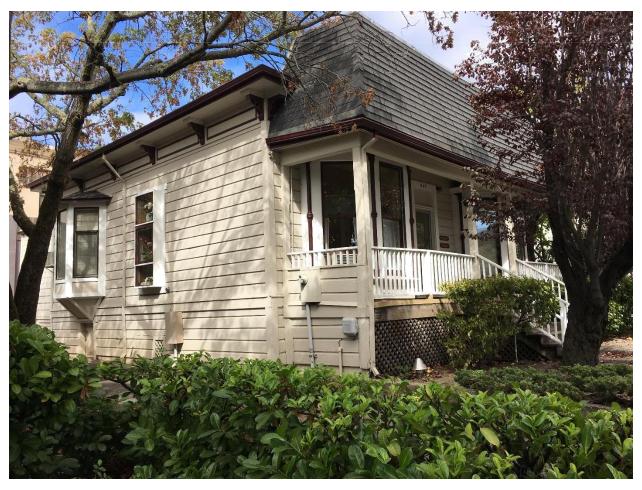
Address/code	817 D Street		С
APN	011-252-05		
Building Name			
Year Built	1884 (spreadsheet)		
Original Use	Residential		
Architectural Style	Folk Victorian		
Architect/Builder			
Description	The rectangular plan resident with boxed eaves, ornamenta has a replacement balustrade double hung wood sash with Cladding is drop siding. The gaccessed via a wide set of wo basement level is clad in lattice.	al brackets, and paneled from and an unusual mansard a projecting bay on the maround floor sits above a rangeled steps. The front of the control of the properties of the ground of the	ieze. Its full-width porch roof. Windows are ain (east) façade. ised basement and is
Integrity	More research required, porc	ch appears altered, porch r	oof may not be original
Significance	Potentially eligible as contrib	utor	
Notes	Good example of a folk house	e, appears related to 813 D	next door

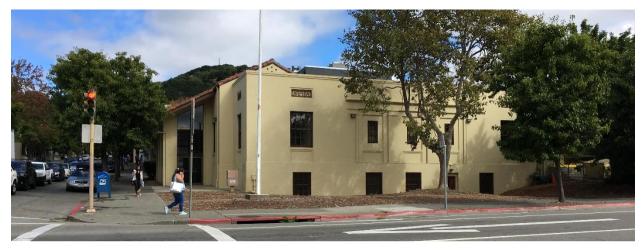
Address/code	910 D Street		E
APN	011-253-09		
Building Name	San Rafael Post Office		
Year Built	1936		
Original Use	Post office		
Architectural Style			
Architect/Builder			
Description			
Integrity	Lacks integrity		
Significance	Not eligible		
Notes	City should contact USPS, Tetra Tech looked at it in 2013 and recommended it		
	lacked integrity due to Moder	rnist addition

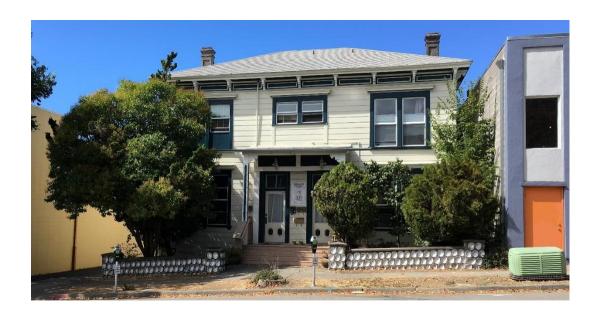
Address/code	809-11 E Street		С
APN	011-246-08		
Building Name			
Year Built	1885 (spreadsheet)		
Original Use	Residence (duplex)		
Architectural Style	Italianate		
Architect/Builder			
Description	The rectangular plan resident decorative brick chimneys proornamental brackets, and parand square supports elaborat different types have been fitt been altered. Cladding drop swith octagonal panels topped wooden steps. A low concrete abalone shells.	oject. It has a cornice with neled frieze. Its partial-wid ed by scrolled brackets. Red into window openings, iding. Side-by-side original with transoms are accesse wall enclosing the prope	boxed eaves, Ith porch has a shed roof eplacement windows of some of which have I partially glazed doors sed via a wide set of orty is adorned with
Integrity	Appears to retain sufficient in needed.	tegrity for district contrib	utor status, more study
Significance	Good example of Italianate/v Contributor	ernacular duplex, potentia	ally eligible as district

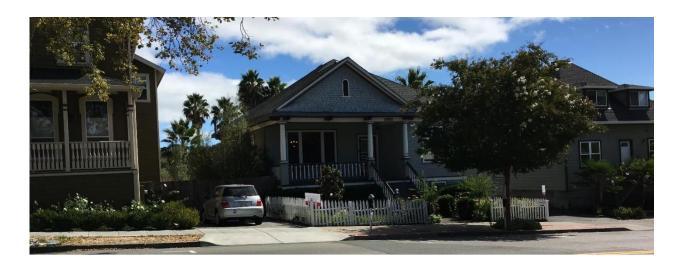
Address/code	810 E Street		Α
APN	011-252-14		
Building Name			
Year Built	1910 (spreadsheet)		
Original Use	Residence		
Architectural Style	Hipped roof cottage		
Architect/Builder			
Description	The rectangular plan residence is single story with a hipped roof from with a large gable over the partial-width porch. The gable end has a louvered vent in an arched opening and is clad in shingles. Boxed eaves have decorative shaped rafter tails. Porch supports are Tuscan columns a top a balustrade of narrowly spaced turned balusters. The front door is fitted with a paneled partially glazed wood door and accessed via a set of wooden steps. Windows are double-hung wood with at least one decorative cottage window on the main (east) façade. The main floor sits atop a raised basement		
Integrity	Retains integrity despite possible replacement of balustrade.		
Significance	Excellent example of vernacular hipped roof cottage, eligible landmark and contributor

Notes	Transitional Victorian/craftsn	nan features

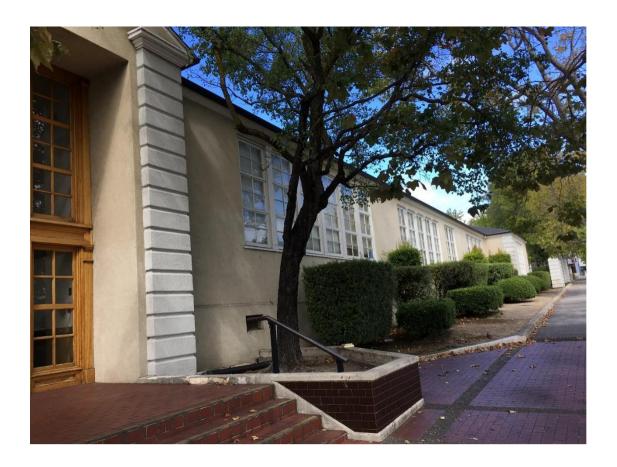
Address/code	901 E Street		С
APN	011-245-27		
Building Name	E Street Grammar School		
Year Built	1932-1946 (aerials)		
Original Use	School		
Architectural Style	Classical/Mediterranean Revi	val	
Architect/Builder			
Description	The single story building is roughly rectangular in plan with a hipped roof main volume and a smaller gable roof volume at the south. Large windows are fitted with multiple light windows. The main entrance on E Street has an assemblage of wood multiple light doors, sidelights and transoms. There are decorative quoins flanking the entrance. Cladding is spray-on stucco. There is a basement at the south end of the building.		
Integrity	May retain integrity despite modern stucco, more research needed.		
Significance Notes	Good example of a 1930s sch lacks the distinction of an arc	· ·	ble as a contributor,

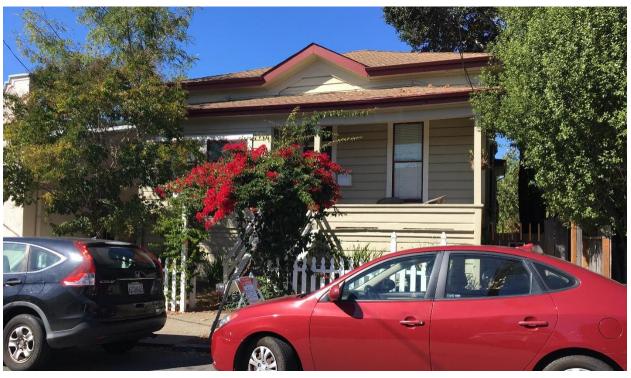
Address/code	105 F Street		E
APN	011-194-06		
Building Name			
Year Built	1893 (spreadsheet)		
Original Use	Residence		
Architectural Style	Folk Victorian		
Architect/ Builder			
Description	The single story house is roughly rectangular in plan with a gable on hip roof and full width porch under its own hipped roof. It is clad in drop siding and has tall window openings fitted with replacement windows. The south end of the porch has been enclosed.		
Integrity	Lacks integrity, odd roof form may be alteration, enclosed porch		
Significance	Not eligible		
Notes

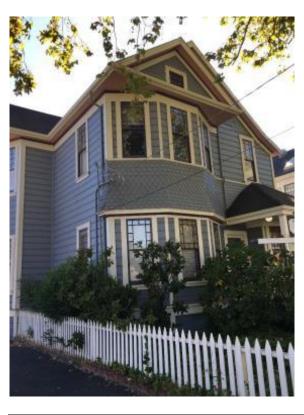
Address/code	633 Fifth Ave		Α
APN	014-084-02		
Building Name			
Year Built	1898 (spreadsheet)		
Original Use	Residence		
Architectural Style	Queen Anne		
Architect/Builder			
Description	The two story house is rough projecting two-story bays at topped with pedimented gab siding. Primary cladding is droupper and lower window bay openings. The main entrance with a partially glazed panele porch with hipped roof and toporch has been filled in and hoor.	the main (north) and west les with multiple light wind op wood siding, with fished is. Multiple light windows a is roughly centered in the d wood door. It is sheltered urned posts. A small area a	elevations. They are dows and fishscale tale shingles separating are fitted into tall north façade and fitted to by a partial-width at the west end of the
Integrity	Retains integrity despite porc	ch alterations	
Significance	Eligible as district contributor and individual landmark

Notes	Pair with adjacent house at 6	37 Fifth

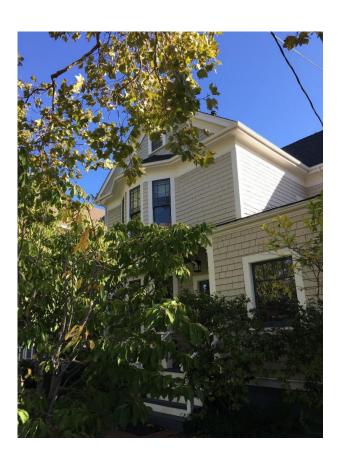
Address/code	637 Fifth Ave		Α
APN	014084-13		
Building Name			
Year Built	1954 (spreadsheet) c1895 pla	usible	
Original Use	Residence		
Architectural Style	Queen Anne		
Architect/Builder			
Description	The two story house is roughly rectangular in plan with a gable roof. There are projecting two-story bays at the main (north) and east elevations. They are topped with pedimented gables with multiple light windows and fishscale siding. Primary cladding is drop wood siding, with fishscale shingles separating upper and lower window bays. Multiple light windows are fitted into tall openings. The main entrance is roughly centered in the north façade and fitted with a glazed wood door. It is sheltered by an integral porch with hipped roof and turned posts. There is an exterior staircase at the rear leading to upper floor entrance		
Integrity	Retains integrity despite porc	h alterations	
Significance	Eligible as district contributor and individual landmark

Notes	Pair with adjacent house at 6	33 Fifth

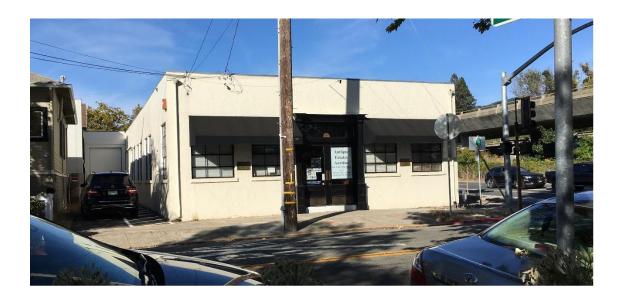
Address/code	634 Fifth Ave		E
APN	014081-08		
Building Name			
Year Built	1948 (spreadsheet)		
Original Use	Commercial		
Architectural Style	Utilitarian		
Architect/Builder			
Description	The single story commercial building is rectangular in plan with a flat roof. Windows are steel multiple light casement. The centered entrance has double partially glazed wood doors topped with a transom and flanked by wood pilasters. East and north elevations lack fenestration		
Integrity	Retains integrity		
Significance	Not eligible a landmark or contributor		
Notes

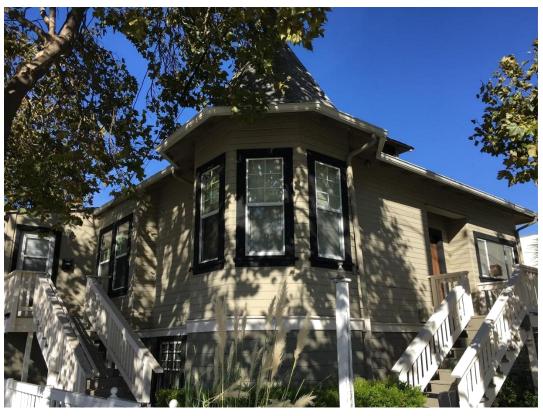
Address/code	638 Fifth Ave		E
APN	014-081-09		
Building Name			
Year Built	1910 (spreadsheet)		
Original Use	Commercial		
Architectural Style	Hipped Roof Cottage with Queen Anne details		
Architect/Builder			
Description	The single story residential building is rectangular in plan with a hipped roof and hipped dormers. There is a bay with hexagonal roof at its southeast corner. The main floor is raised over a basement with a set of wooden steps from the side. Windows are various shapes and materials of replacement windows.		
Integrity	Lacks integrity, windows, porch, other alterations		
Significance	Not eligible as a landmark or contributor due to lack of integrity		
Notes

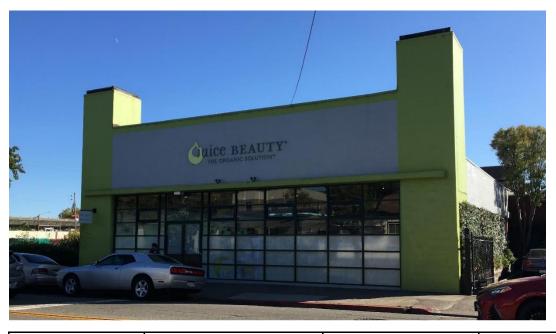
Address/code	709 Fifth Ave		E
APN	011-227-02		
Building Name			
Year Built	1941 (spreadsheet)		
Original Use	Supermarket		
Architectural Style	Utilitarian		
Architect/Builder			
Description	The single story commercial building is rectangular in plan with a gabled roof hidden by a parapet. Windows are steel multiple light casement. The main (north) façade is occupied by large divided storefront windows and flanked by square pillars. Main façade cladding is stucco, the balance of the building is board form concrete. The off center entrance has double glazed doors.		
Integrity	Lacks integrity		
Significance	Not eligible as landmark or contributor due to lack of significance and integrity		
Notes

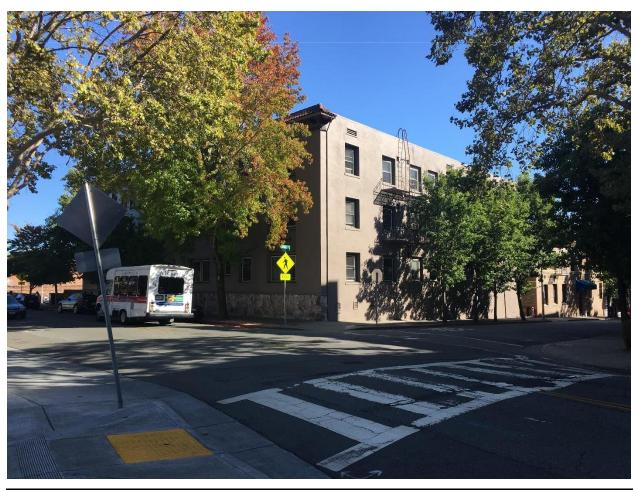
Address/code	845 Fifth Ave		D
APN	011-224-01		
Building Name			
Year Built	1920 (spreadsheet)		
Original Use	Multi-family residential		
Architectural Style	Mediterranean Revival		
Architect/Builder			
Description	The three story apartment but hipped tile parapet with decors is a floral frieze below the conbuilding is clad in stucco with entrance. The recessed door decorative fanlights. Fenestra windows. There is a fire escale	prative cornice featuring shall refer to the cornice and decorative swags decorative stone wainsco is wood frame and fully glastion is vertical openings we con the main (north) factors	naped rafter tails. There son spandrel panels. The ting and arched main azed with sidelights and with replacement ade.
Integrity	Apparently lacks integrity, re research needed	placement windows and w	rainscoting, more
Significance	Not likely to be eligible as lan and lack of integrity	dmark or contributor due	to marginal significance

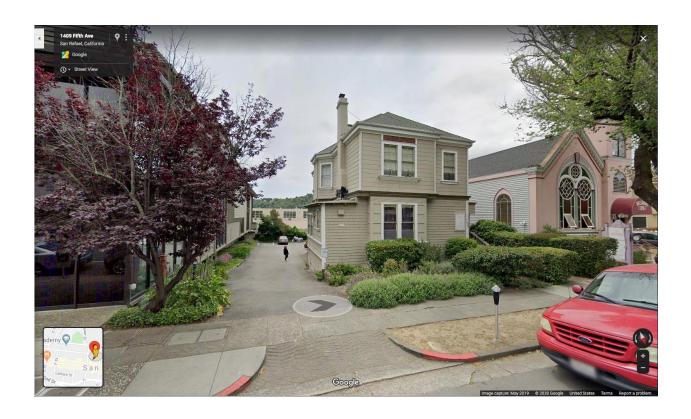
Address/code	1409 Fifth Ave		Е
APN	011-204-18		
Building Name			
Year Built	1888/1949 (spreadsheet)		
Original Use	Multi-family residential		
Architectural Style			
Architect/Builder			
Description	The two story house is roughly rectangular in plan with a hipped roof. It is clad in shingles and drop siding wood siding. Double hung wood sash windows and some decorative elements reveal nineteenth century origin of building, but its original style and form are unknown. Converted to 5 apartments 1949.		
Integrity	Lacks integrity, specific altera historic residential style	tions unknown but not a g	ood example of any
Significance	Not eligible as landmark or co	ontributor due to lack of in	tegrity
Notes

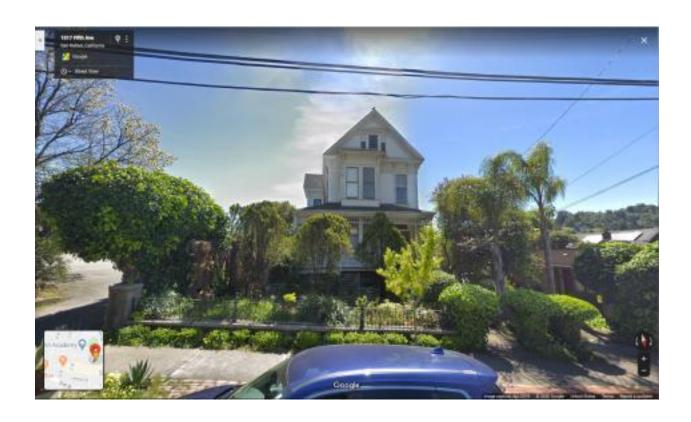
Address/code	1517 Fifth Ave	7N	Α
APN	011-202-04		
Building Name			
Year Built	1890/1920 (spreadsheet)		
Original Use	Residential		
Architectural Style	Queen Anne		
Architect/Builder			
Description	The 2.5 story raised basemer gabled roof. It is clad in narro Windows are double hung w projecting from the main (no light wood windows. Orname assemblage with diminutive with scrolled bracket and detention the porch, and projecting seconds.	ow clapboard and wide ho ood sash. A full-width por orth) façade and its east er ental details include decor shed roof on the pedimen corative frieze, turned pos	rizontal wood siding. ch has a hipped roof nd is enclosed in multiple- ative window ted front gable, cornice ts and elaborate trim on
Integrity	Retains integrity		
Significance	Eligible as landmark and contributor		
Notes

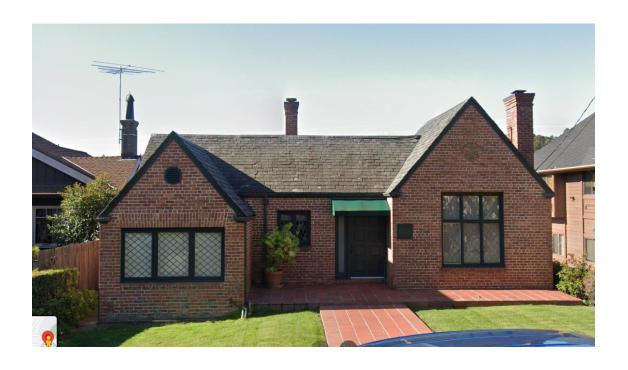
Address/code	1539 Fifth Ave		B+
APN	011-196-05		
Building Name			
Year Built	1935 (spreadsheet)		
Original Use	Residential		
Architectural Style	Tudor		
Architect/Builder			
Description	The single story raised basem pitched cross-gabled roof. It is two decorative brick chimney entrance is fitted with a wide	s constructed of brick with s. Windows feature leade	n a slate roof and has
Integrity	Retains integrity		
Significance	Eligible as contributor, poten	tially eligible as landmark	
Notes

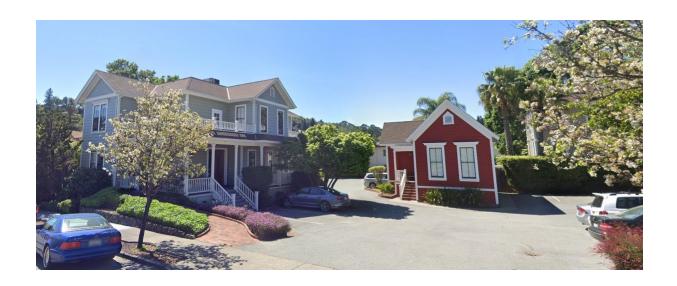
Address/code	1623-1627 Fifth Ave 7N B
APN	011-320-01 -02 -03 -04
Building Name	
Year Built	ND
Original Use	Residential
Architectural Style	Shingle, Folk Victorian
Architect/Builder	
Description	Multiple buildings, difficult to decipher Address/code /age etc.
Integrity	Retain integrity
Significance	Buildings remain eligible as district contributors
Notes

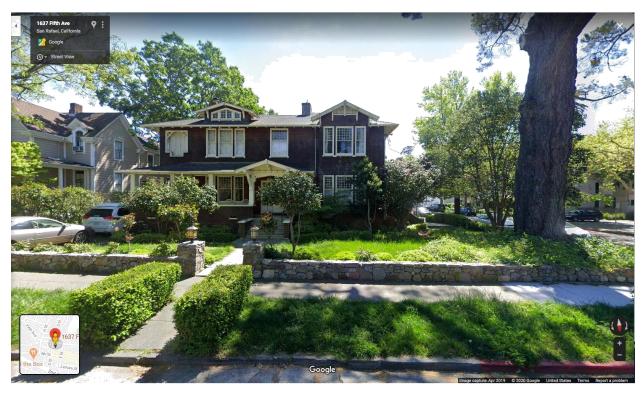
Address/code	1637 Fifth Ave	35	Α
APN	011-194-01		
Building Name			
Year Built	1913/1990 (spreadsheet)		
Original Use	Residential		
Architectural Style	Craftsman		
Architect/Builder			
Description	gabled dormers. The house width porch has its own hip ornament includes gable-en	is clad in natural oped roof and solid nd vents, shaped kolumns, and multi	th hipped roof and large decorative wood shingles. A projecting partial diparapet. Lavish craftsman-style knee braces, arched porch ple-light cottage windows. The
Integrity	Retains integrity		
Significance	Excellent example of Crafts contributor	man architecture.	Eligible individually and as district
Notes

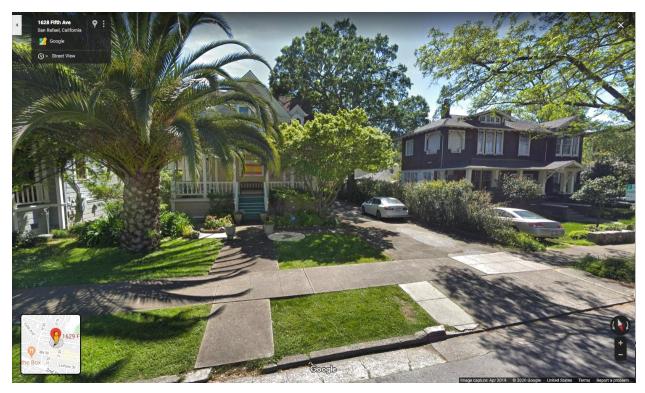
Address/code	1629 Fifth Ave	7N	Α
APN	011-194-02		
Building Name	Thomas Morris House		
Year Built	1878 (spreadsheet)		
Original Use	Residential		
Architectural Style			
Architect/Builder	Queen Anne Cottage		
Description	The 1.5 story house is roughly rectangular in plan with steeply pitched cross-gabled roof and decorative gabled dormers. The house is clad in natural wood shingles. A full-width porch has its own hipped roof. The building is obscured by vegetation on available images and details are unclear.		
Integrity	Appears to retain integrity, field photography needed		
Significance	Eligible individually and as di	strict contributor if field vi	sit reveals integrity
Notes

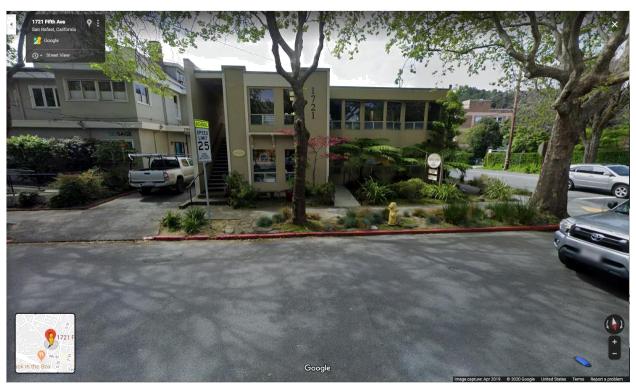
Address/code	1721 Fifth Ave		E
APN	011-192-01		
Building Name			
Year Built	1939 (spreadsheet)		
Original Use			
Architectural Style			
Architect/Builder	Midcentury Modern		
Description	The two story commercial but house is clad in natural wood ribbon bands of windows, ot fixed squares smaller rectang zigzag with a staircase to the	I shingles. Its street facades her elevations lack fenestra gular jalousies below. The r	s are dominated by ation. Windows are large main (north) façade is
Integrity	Does not retain integrity to 1	939.	
Significance	Not eligible as a contributor of	or landmark due to lack of	significance/integrity
Notes	Does not display integrity to	1939, is a common exampl	e of a c1960 building
