Downtown San Rafael Precise Plan Historic Resources Inventory Summary Report

Downtown San Rafael Precise P	Plan
Historic Resources Inventor	y Summary Report
A companion document to the Downtown he San Rafael General Plan 2040 Environ	
Prepared by the City of San Rafael	
Vith assistance from Garavaglia Associa	ites and Opticos Design
Published December 2020	Cover Photo Credits: Matthew X Kiernan

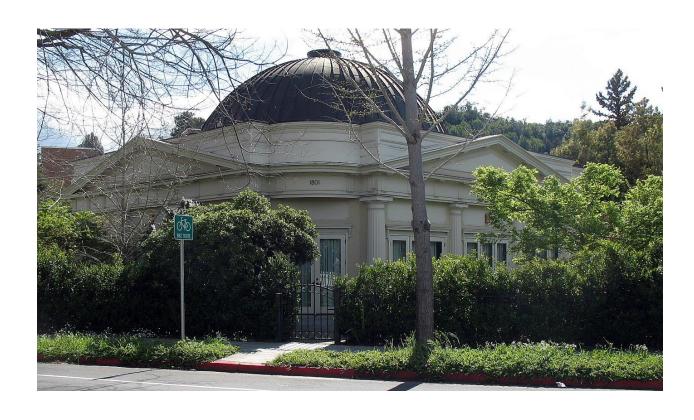
Address/code	1800 (1801) Fifth Ave	15	Α
APN	010-291-16		
Building Name	San Rafael Improvement Club)	
Year Built	1915/1916 (NRHP)		
Original Use	Panama-Pacific Exhibition Bu	ilding/local clubhouse	
Architectural Style	Classical Revival		
Architect/Builder	William B. Faville		
Description	The single story building has a roughly square plan and flat/domed roof.		
	Cladding is smooth plaster stucco or concrete. Classical revival ornament		
	includes fluted plasters, cornice and frieze, and formal pediments. The building		
	is obscured by vegetation on available images and details are unclear.		
	Appears to retain integrity, dome was added after 1983, field photography		
Integrity	needed		
Significance	eligible as landmark and contr	ibutor	
Notes	Listed on the NRHP 1984

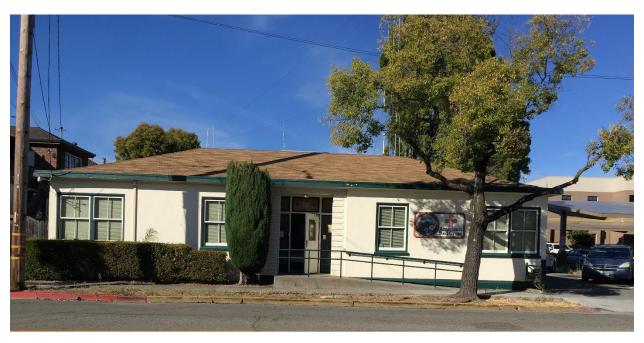
Address/code	712 Fifth Ave		Е
APN	011-226-06		
Building Name			
Year Built	1940/1970/1994 (spreadshee	et)	
Original Use			
Architectural Style	Minimal Traditional		
Architect/Builder			
Description	The single story building has a T-shaped plan and low pitch hipped roof. It is clad in stucco with brick quoins around the recessed entry. The partially glazed metal replacement door has sidelights and transom and is accessed via an accessible ramp. Windows are double hung two over two wood sash.		
Integrity	Appears to retain integrity de	spite replacement door ar	nd ramp addition.
Significance	Lacks architectural significand	ce, not eligible as landmark	c or contributor
Notes

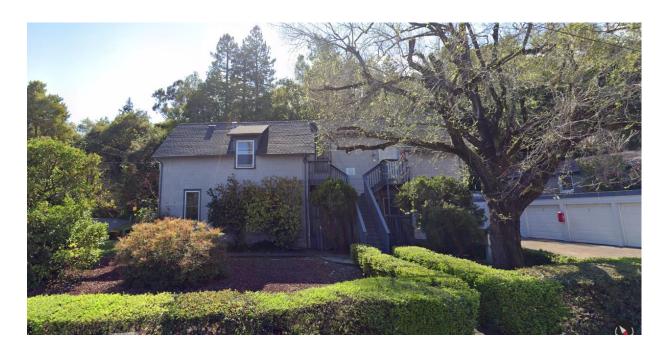
455 First St /1621 Second		
Address/code	St		E
APN	012-054-02		
Building Name			
Year Built	1950 (spreadsheet), appears to b	e c1900 house convert	ted to multi-unit
Original Use	residential		
Architectural Style			
Architect/Builder			
Description	The single story building has a roughly rectangular plan and steeply pitched gabled roof with shed dormers. It is clad cement shingle and has replacement windows in vertical openings. The north elevation has been remodeled into apartments with an exterior staircase to the second floor		
Integrity	Lacks integrity		
Significance	Not eligible as landmark or contributor		
Notes		<u> </u>

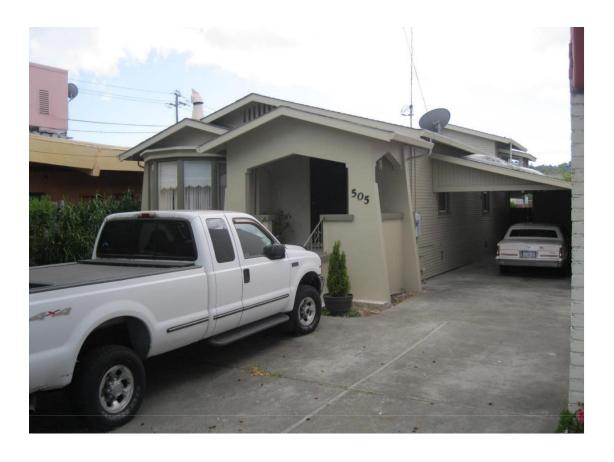
Address/Code	505 Fourth Street		E
APN	014-123-09		
Building Name	Residence		
Year Built	1924/1930 (spreadsheet),		
Original Use	residential		
Architectural Style	Craftsman		
Architect/Builder			
Description	The single story house has a roughly rectangular plan and medium pitched multi-gabled roof with shed dormers. It is wood clapboard with stucco on the main (north) façade. There is a projecting partial-width porch with battered supports and shaped opening adjacent to a projecting window bay. A shed roof carport projects from the west side of the house.		
Integrity	Lacks integrity, replacement windows, carport, probably stucco over original wood, large neighboring building affects setting		
Significance	Not eligible as landmark or integrity	contributor due to margina	al significance and lack of
Notes

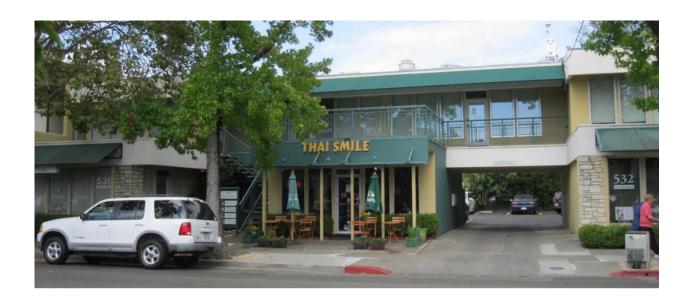
Address/code	532 Fourth Street		E		
APN	014-086-26				
Building Name					
Year Built	1965 (spreadsheet),				
Original Use					
Architectural Style	Midcentury Modern				
Architect/Builder					
Description	The two story storefront commercial building is rectangular in plan with flat roof, ground floor retail, and second floor office space. The two storefronts are separated by a driveway that leads under the second floor to the rear parking lot. Cladding is stucco with manufactured stone on the east storefront. Fixed windows are vertical with aluminum frames and doors are fully glazed aluminum frame.				
Integrity	Probably lacks integrity, stone facing, upstairs balustrade, windows appear to be replacements				
Significance	Not eligible as landmark or cointegrity	ontributor due to marginal	significance and lack of		
Notes

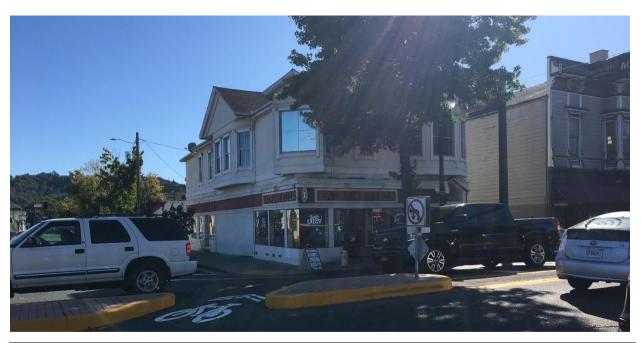
Address/code	705 Fourth Street		Е
APN	011-275-03		
Building Name			
Year Built	1898/1991/2008 (spreadshee	et)	
Original Use			
Architectural Style	Queen Anne		
Architect/Builder			
Description	The two story house is roughly rectangular in plan with a gable on hip roof and projecting bays at the north, east, and corner. It is clad in stucco and upper floor windows have been replaced. East and north elevations have been converted to storefront on the ground floor.		
Integrity	Lacks integrity, roof form and decorative window casings are only remnants of original		
Significance	Not eligible as landmark or contributor due to lack of integrity		
Notes		·

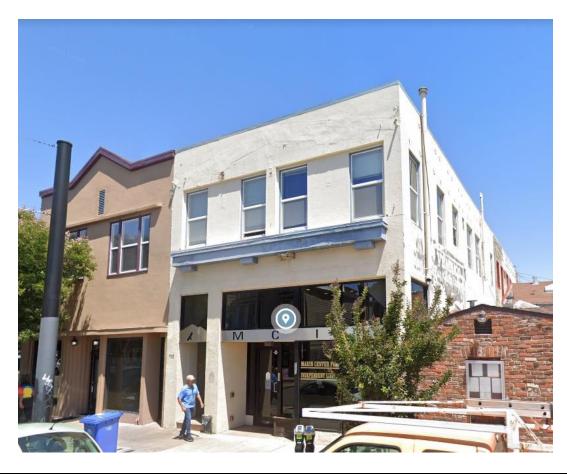
Address/code	710 Fourth Street		E
APN	011-227-04		
Building Name	Marin Center for Independent	Living	
Year Built	1950s? (spreadsheet), c1930	(aerials)	
Original Use	residential		
Architectural Style	Minimal Traditional/Commer	cial	
Architect/Builder			
Description	Historic aerials suggest that the southwest portion of the building with cross-gabled roof was originally a small house constructed about 1930. Additions were constructed over the decades, resulting in a hybrid building with multiple roof forms and both horizontal and vertical window shapes. Brick cladding is unlikely to be original		
Integrity	Lacks integrity to 1930		
Significance	Not eligible as landmark or contributor, not a recognizable example of a historic		
	style		
Notes

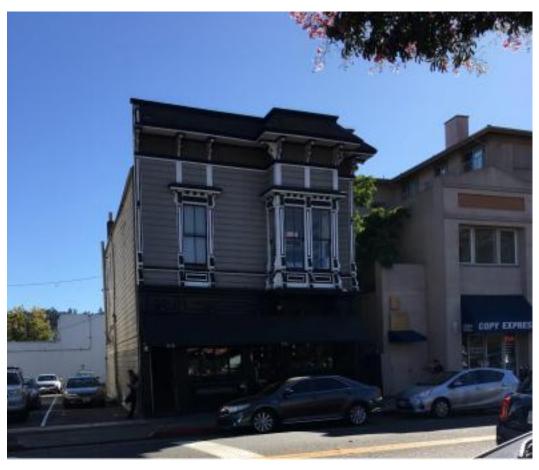
Address/code	709-711 Fourth Street	7N	Α
APN	011-275-02		
Building Name			
Year Built	1898 (spreadsheet)		
Original Use	Storefront/residential		
Architectural Style	Italianate		
Architect/Builder			
Description	The two story building is rectafloor residential. Its mansard Upper floor windows are tall elaborated with decorative he Cladding is drop siding. A decupper floor. An original partiamain (north) façade leads to a storefront entrance are contest.	roof has a cornice with elatwo over two double hung boods and casings. There is orative frieze separates th ally glazed wood panel doo a staircase to the second f	aborate shaped brackets. g wood sash and a projecting square bay. le storefront from the or at the east end of the
Integrity	Retains integrity despite mod	ernization of storefront	
Significance	Excellent example of Italianat landmark and contributor.	e commercial/residential	architecture, eligible as

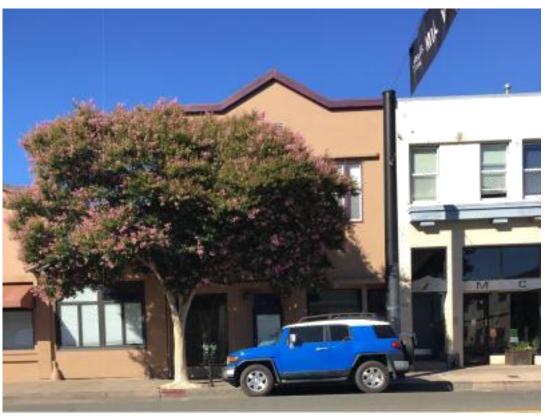
Address/code	716 Fourth Street		E
APN	011-227-05		
Building Name			
Year Built	1908/1949/1983 (spreadshee	et)	
Original Use	Storefront/residential		
Architectural Style			
Architect/Builder			
Description	The two story building is rectangular in plan with ground floor retail and upper floor residential or offices. It is clad in stucco and has a pointed parapet. Tall original window openings on the upper floor are fitted with replacement windows. The ground floor has storefront windows and a rounded streamline modern entrance and awning.		
Integrity	Lacks integrity		
Significance	Hybrid architecture from various eras, not a good example of any historic style, not eligible		
Notes

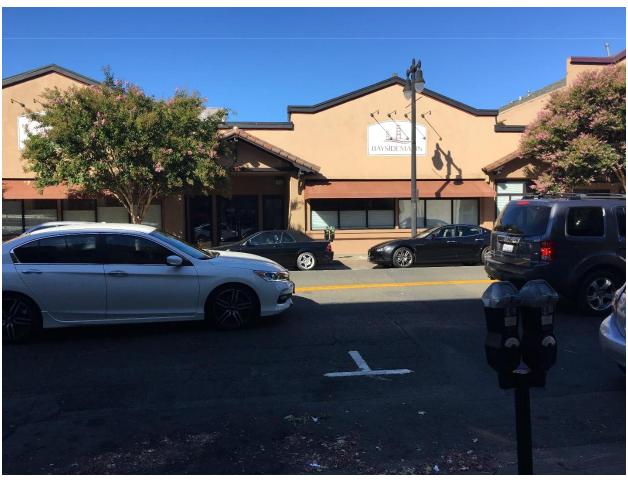
Address/code	718-24 Fourth Street		E
APN	011-227-06		
Building Name	Bayside Marin		
Year Built	1918 (spreadsheet)		
Original Use	Storefront		
Architectural Style			
Architect/Builder			
Description	The large single story building is rectangular in plan with a tall shaped parapet and divided storefront windows. The projecting entrance has a gabled roof with plastic tile and shaped knee braces. The building is clad in stucco.		
Integrity	Lacks integrity		
Significance	Not a good example of any hi	storic style, not eligible	
Notes		·

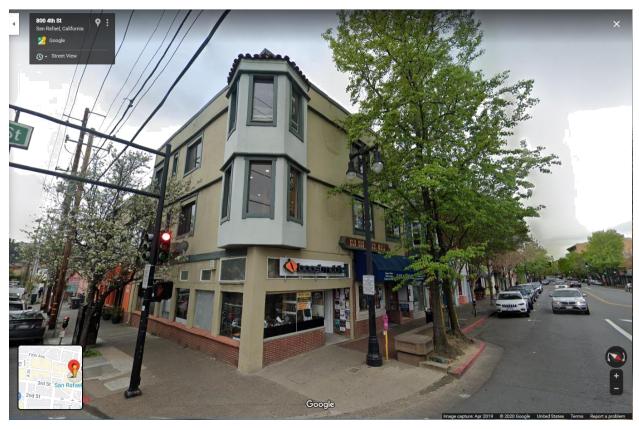
Address/code	801-805 Fourth Street	5S2	E
APN	011-273-06		
Building Name	Old San Rafael Mall		
Year Built	1878 (spreadsheet)		
Original Use	Storefront		
Architectural Style			
Architect/Builder			
Description	The three story corner comm Fourth St and Lincoln Ave fact stucco with Roman brick bulk window openings altered. A p is the only recognizable element	ades with apartments about the second and third second second and third second	ve. The building is clad in en replaced and most d floor bay at the corner
Integrity	Lacks integrity		
Significance	Not a good example of any hi	storic style, not eligible	
Notes

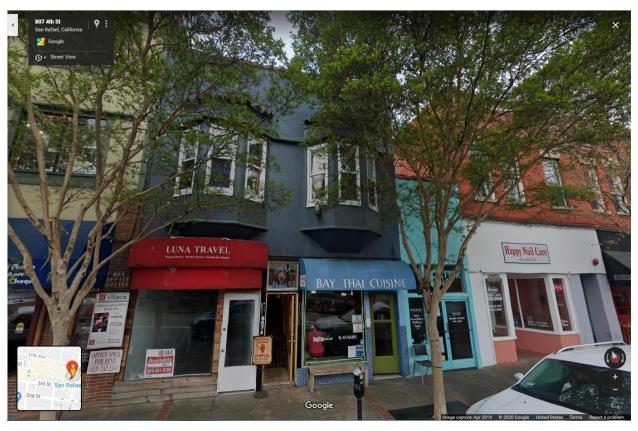
Address/code	807 Fourth Street		E
APN	011-273-05		
Building Name			
Year Built	1903 (spreadsheet)		
Original Use	Storefront		
Architectural Style			
Architect/Builder			
Description	The two story commercial building is rectangular in plan with gabled roof concealed by parapet and storefronts on ground floor with apartments above. The building is clad in stucco. Tall windows in upper floor bays are fitted with metal windows. Bays are topped with tile roofs A projecting second and third floor bay at the corner is the only recognizable element of the building's nineteenth century origins.		
Integrity	Lacks integrity		
Significance	Not a good example of any hi	storic style, not eligible	
Notes

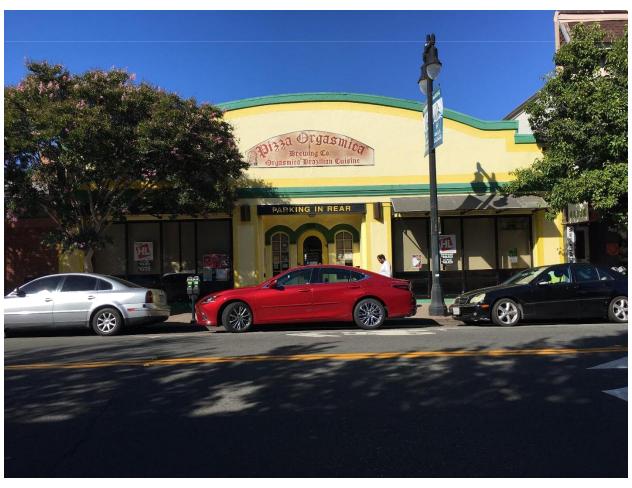
Address/code	812 Fourth Street	5S2	В
APN	011-224-11		
Building Name	Redhill Imports		
Year Built	1920/1950/1971 (spreadsh	neet)	
Original Use	Commercial		
Architectural Style	Mission		
Architect/Builder			
Description	The one story storefront commercial building is rectangular in plan with arched roof and shaped parapet. Its recessed main entrance has an arched door flanked by arched multiple light wood windows. Divided storefront windows are contemporary.		
Integrity	Appears to retain integrity, more research needed		
Significance	Good if modest example of Mission commercial architecture, not a landmark, potentially a district contributor		
Notes	Adjacent building to the east (806) apparent district contributor does not appear on any spreadsheet tab is not in exclusion area

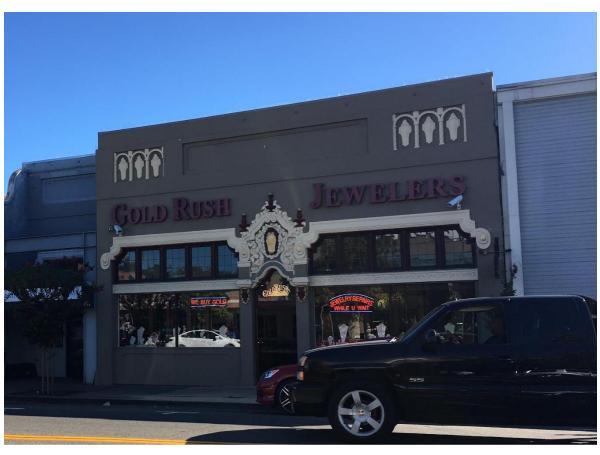
Address/code	827-831 Fourth Street	35	Α	
APN	011-273-02			
Building Name	Rafael Florist/Gold Rush Jewe	elers		
Year Built	Before 1924 (Sanborn Maps)			
Original Use	Commercial (auto showroom)		
Architectural Style	Mission			
Architect/Builder				
Description	The one story storefront commercial building is rectangular in plan with gabled roof concealed by a parapet. The building is stucco with terracotta ornament including cartouche and arch motif at parapet corners. Storefront windows are topped by floral frieze and large multiple light transoms with decorative turned posts and scrolled moulding. The partially glazed wood door is topped by a transom and set in an elaborately shaped arch. A cartouche with ornate floral and candle motifs tops the door. 827 Fourth originally had a vehicle door leading to a repair area behind the showroom and retains scrolled moulding and parapet that matches the primary building.

Integrity	Retains integrity			
Significance	Excellent example of Mission architecture, eligible as landmark and district contributor			
Notes

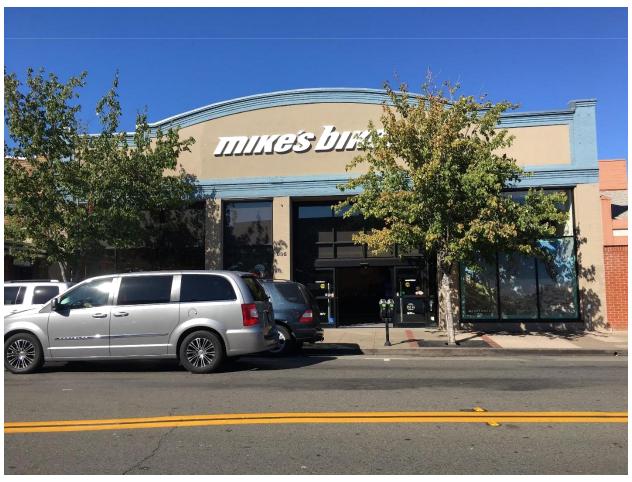
Address/code	836 Fourth Street		В
APN	011-224-13		
Building Name			
Year Built	1924 (spreadsheet, Sanborns)	
Original Use	Commercial, auto showroom	1	
Architectural Style	Mission		
Architect/Builder			
Description	The single story commercial building is rectangular in plan with a gabled roof hidden by a shaped parapet. The main (south) façade is occupied by large contemporary storefront windows and centered entrance. Cladding is brick with stuccoed areas. Decorative corbelling is also executed in brick.		
Integrity	Retains integrity		
Significance	Good simple example of Miss	ion architecture, potential	district contributor
Notes	Similar to 831 Fifth but better	example of the style

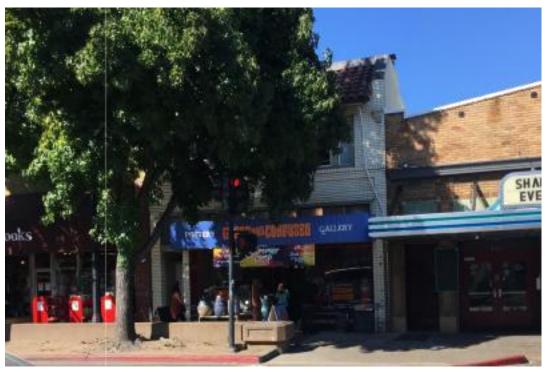
Address/code	846 Fourth Street		В
APN	011-224-14		
Building Name			
Year Built	1908-1924 (Sanborn Maps)		
Original Use	Storefront Commercial		
Architectural Style			
Architect/Builder			
Description	The two story commercial but parapet and decorative tiled (south) façade is occupied by centered entrance. Cladding Decorative frieze separating a Tripartate upstairs windows a entrance is flanked by slanted panel door. There are divided to the upstairs is fitted with a	shed roof with shaped raft large contemporary store is glazed brick with decora ground and second stories are fitted with replacemen d storefronts and fitted with I light transoms above the	ter tails. The main front windows and itive tile bulkhead. is also executed in brick. its. The recessed th a fully glazed wood
Integrity	Retains integrity		
Significance	Good example early twentiet contributor	h century commercial stor	refront, potential district

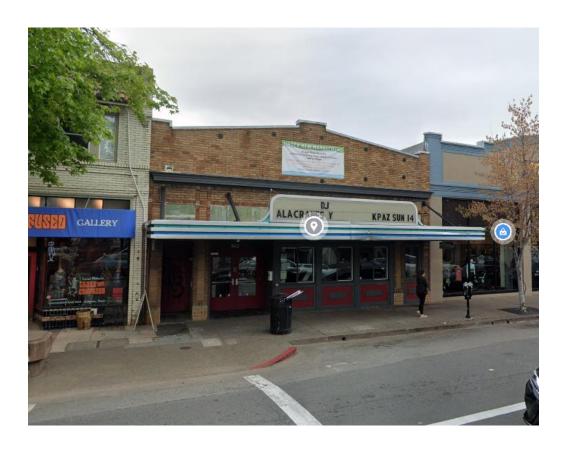
Address/code	842 Fourth Street		В
APN	011-224-14		
Building Name			
Year Built	1929 (spreadsheet)		
Original Use	Commercial		
Architectural Style	Mission		
Architect/Builder			
Description	The single story commercial is stepped parapet. The main (so a paneled bulkhead and two small marquee projects from above the awning appear to be between transoms and paraparticulated in contrasting cold	outh) façade is occupied bentrances at its west end. It the façade above the store have been partially covered to the building is clad in be	y small windows above A metal awning with a efront level. Transoms d. There is a cornice orick with columns
Integrity	Retains integrity, probable all	terations to storefront leve	el are sympathetic
Significance	Good example of Mission arc	hitecture, potential distric	t contributor
Notes	Same parcel as 842 Fourth

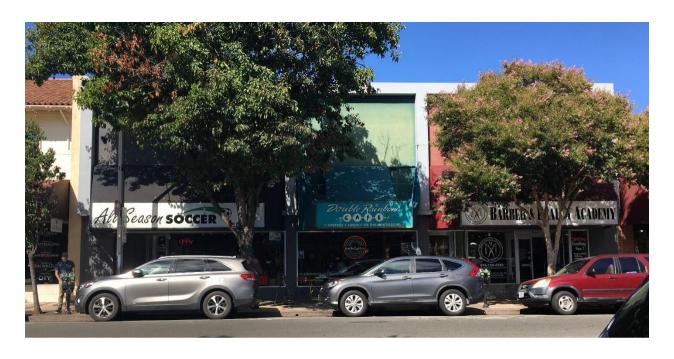
Address/code	866 Fourth Street	5S2	E
APN	011-224-20		
Building Name			
Year Built	1953 (spreadsheet)		
Original Use	Commercial		
Architectural Style			
Architect/Builder			
Description	The single story commercial building is rectangular in plan with arched roof and flat parapet. Three storefront bays are divided by concrete beams. The building is clad in stucco. Storefront windows and doors are contemporary.		
Integrity	Integrity unknown		
Significance	Not eligible, not a good example of any historic architectural style		
Notes

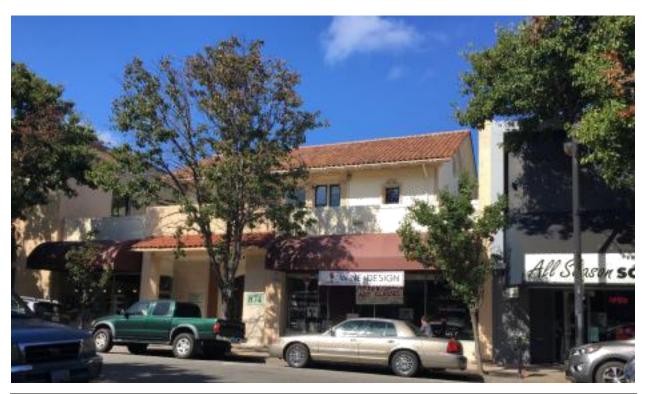
Address/code	874 Fourth Street		E	
APN	011-224-17			
Building Name	Marin Municipal Water Depa	rtment		
Year Built	1903 (spreadsheet)			
Original Use	Water Department			
Architectural Style	Spanish Revival			
Architect/Builder				
Description	The municipal/commercial building has a two story 1903 municipal building set back on the lot with a single story storefront addition adjacent to the sidewalk. The original building has a side-gabled roof and stucco cladding with highly decorative terra cotta ornament. The storefront is also stucco and has a shed tile roof at the center entrance, but it is contemporary in character.			
Integrity	Lacks Integrity, intrusive main façade addition 1951-1964.			
Significance	Architecturally significant original building ineligible, lack of integrity			
Notes

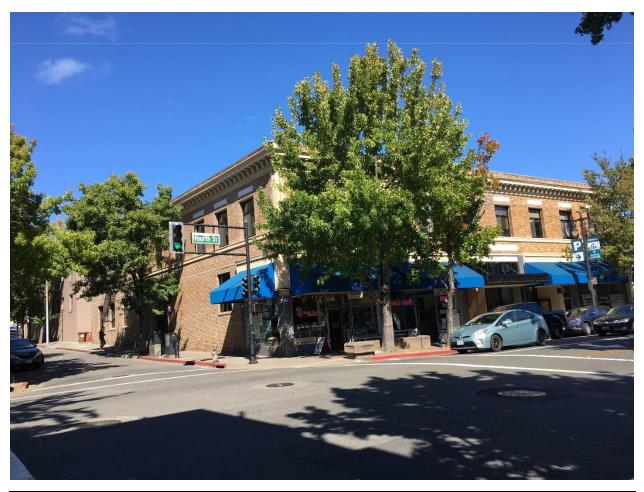
Address/code	882-884 Fourth Street (1010 Lootens)	7N	В	
APN	011-224-18			
Building Name	Masonic Building			
Year Built	1910 (spreadsheet)			
Original Use	Lodge/Storefront Commercial			
Architectural Style	Classical Revival			
Architect/Builder				
Description	The lodge/commercial building is two st roof. The building is clad in brick and has heavy cornice features decorative brack decorative moulding separating upper a have been replaced, and original transorentrance on Fourth Street leading to the	s facades on Fo ets and dentil n nd lower floors ms are covered	urth and Lootens. The noulding, there is also . Storefronts and doors	
Integrity	Retains sufficient integrity for listing as district contributor despite replacement windows and storefronts.			
Significance	Eligible as district contributor, lacks inte	grity for landma	ark status	
Notes			·

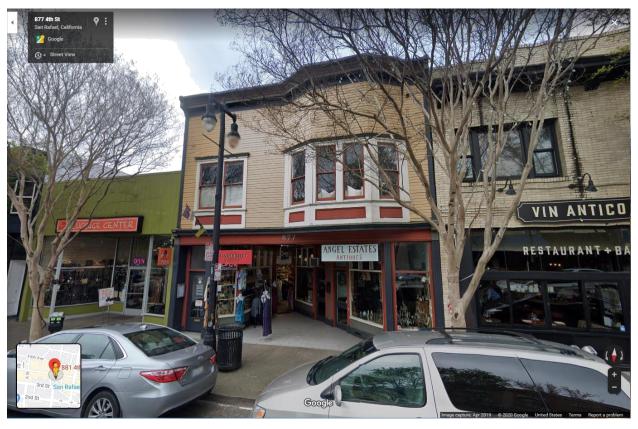
Address/code	881-883 Fourth Street	7N	Α
APN	011-271-03		
Building Name			
Year Built	1905 (DPR)		
Original Use	Storefront Commercial		
Architectural Style			
Architect/Builder			
Description	The commercial building is tw stepped parapet. The building ground floor. The cornice feat Projecting upstairs bays have storefronts are contemporary	g is clad in narrow wood si tures decorative rafter tail tripartite replacement wi	iding with stucco at the ls and dentil moulding.
Integrity	Retains integrity		
Significance	Eligible as district contributor and landmark		
Notes	881 Fourth right frame, adjac be contributor but was elimin condition assessment	•

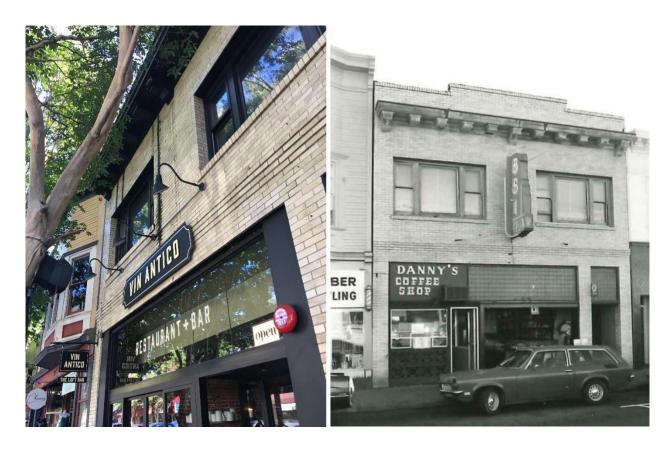
Address/code	885-887 Fourth Street		Α
APN	011-271-02		
Building Name			
Year Built	1910/1975 (spreadsheet)		
Original Use	Storefront Commercial		
Architectural Style			
Architect/Builder			
Description	The commercial building is two story and rectangular in plan with a flat roof. It has a stepped parapet and heavy wood cornice with decorative rafter tails. Tripartite upstairs windows have been fitted with fairly sympathetic replacement windows. The building is clad in brick with mouldings and windows sills also executed in brick. Original obscure transom has been retained above the door to the upstairs. Replacement storefront and doors are sympathetic.		
Integrity	Retains integrity despite replacement window and storefront, appearance similar to 1970s photo		
Significance	Eligible as landmark and contributor		
Notes			_

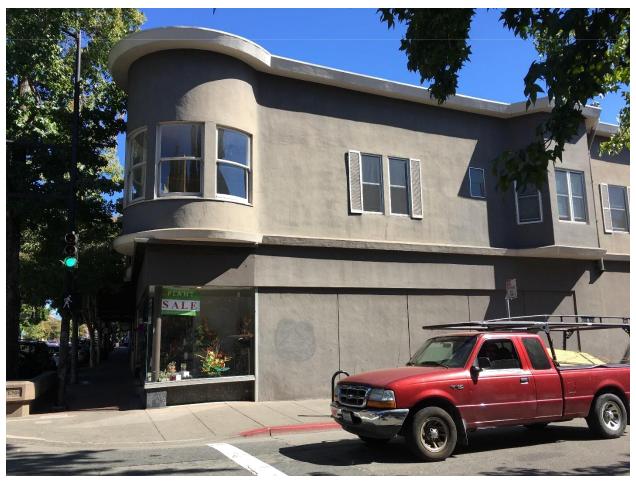
Address/code	889-891 Fourth Street		Е
APN	011-271-01		
Building Name			
Year Built	1908/1956 (spreadsheet)		
Original Use	Storefront Commercial		
Architectural Style			
Architect/Builder			
Description	The commercial building is two story and rectangular in plan with a flat roof and heavy plain cornice. There is a rounded upper bay at the corner and a slanted bay on Lootens. Cladding is stucco. Some upper windows have been replaced and some are double hung wood sash. Terrazzo flooring and storefront configuration suggest it was installed in 1956		
Integrity	Lacks integrity	•	·
Significance	Not a good example of any hi	storic building type, not el	igible for listing
Notes

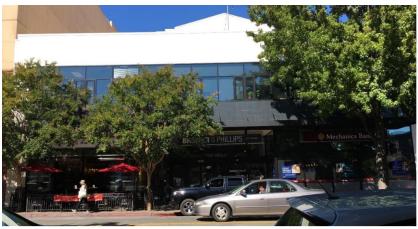
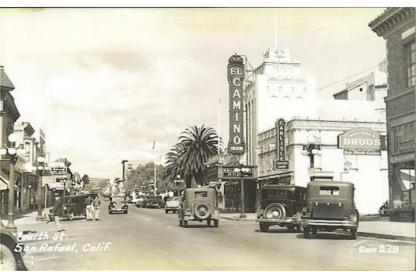
Address/code	900 Fourth Street		E
APN	011-222-05		
Building Name	El Camino Theatre		
Year Built	1925-30 (Sanborns/aerials)		
Original Use	Cinema		
Architectural Style	Art Deco?		
Architect/Builder			
Description	The large commercial buildin roof. It is clad in stucco with on on Fourth Street. Some remn and rear but building is missi defining elements	continuous windows along ants of Art Deco details ca	upper and ground floors n be discerned at sides
Integrity	Lacks integrity, does not conv	vey significance	
Significance	Not eligible because of lack of integrity		
Notes

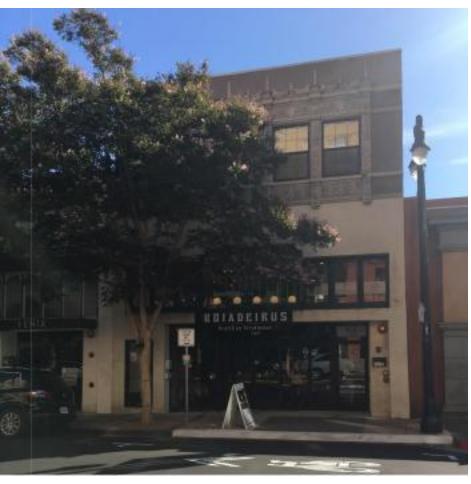
Address/code	925 Fourth Street		В
APN	011-263-07		
Building Name			
Year Built	1928 (spreadsheet)		
Original Use	Storefront Commercial		
Architectural Style			
Architect/Builder			
Description	The commercial building is twis clad in stucco and has orna upstairs windows, which are balconet at the mezzanine lettransom divided by diminutiv	te terracotta decorative so fitted with vinyl replacemovel has a shaped opening a	urrounds on vertical ent sash. A decorative and is flanked by
Integrity	Retains sufficient integrity to	qualify as district contribu	itor but not as landmark
Significance	Good example of 1920s com	mercial architecture, eligib	le as district contributor
Notes

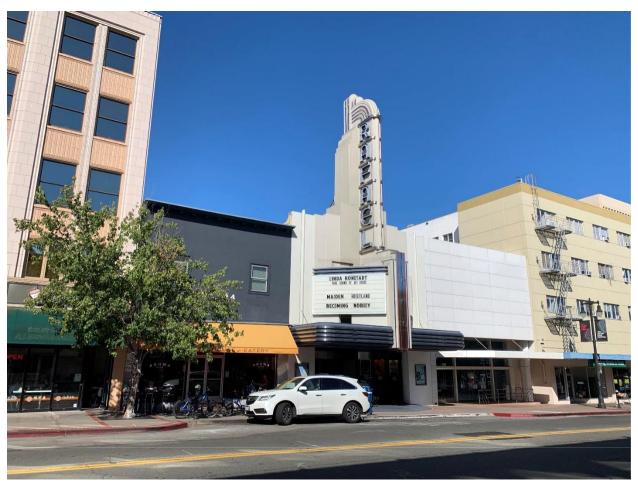
Address/code	1118 Fourth Street	3S	Α	
APN	011-215-04			
Building Name	Orpheus/Rafael Theatre			
Year Built	1920/1938 (spreadsheet/Cine	ema Treasures)		
Original Use	Cinema			
Architectural Style	Streamline Moderne			
Architect/Builder				
Description	The small theater building occupies a single parcel. Its façade is dominated by a tall pylon marquee with neon letters spelling "Rafael" and the curved horizontal motif that characterizes Streamline Moderne architecture. The building's parapet is stepped up to the pylon sign. There is a marquee with streamline neon atop a curved awning with the same motif. The original entrance and ticket booth have been removed and replaced with a recessed contemporary entrance. Original terrazzo sidewalks have been preserved.			
Integrity	Retains integrity despite entrance replacement			
Significance	Good example of 1930s cinema architecture, eligible as landmark and district contributor

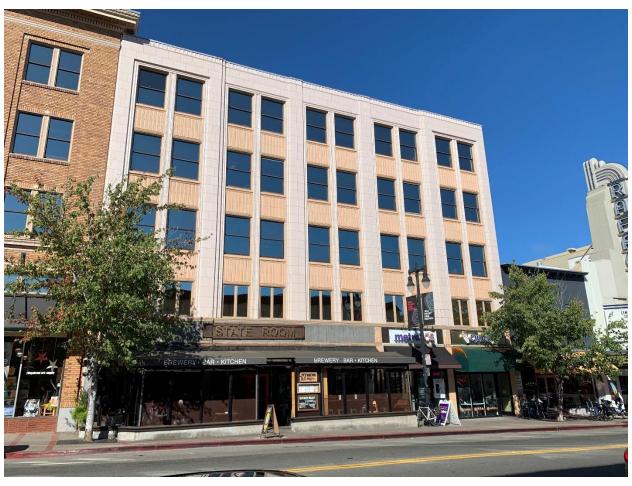
Address/code	1122-1132 Fourth St		E			
APN	011-215-02	011-215-02				
Building Name						
Year Built	1916 (spreadsheet)					
Original Use	Storefront Commercial/apart	ments				
Architectural Style	Art Deco					
Architect/Builder						
Description	The five story building is recta windows are paired and have replacement windows and ho restrained pilasters that refer decoration at the cornice. Pai There are pilasters with styliz elements of the ground floor projecting storefront	been fitted with a combination of the prize	nation of hung are separated by e, as does the minimalist grooved moulding. he storefront level; other			
Integrity	Lacks integrity, windows, projecting storefront					
Significance	Not eligible for listing					
Notes	Closely related to Albert build NOT INCLUDED IN GROUP OF OF PHOTO SET	9	•

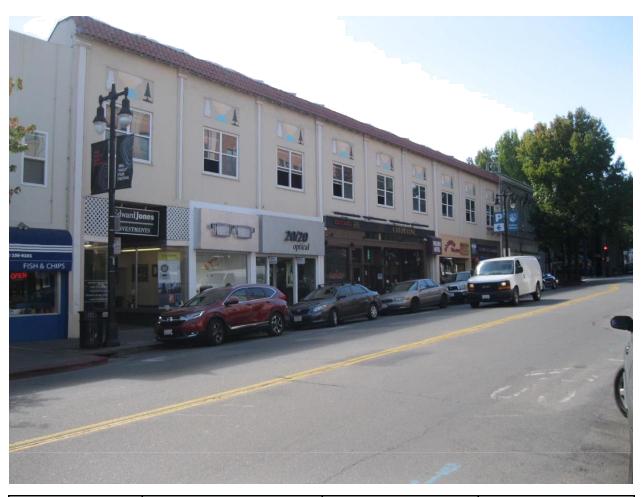
Address/code	1125-1139 Fourth St		C		
APN	011-261-31				
Building Name					
Year Built	1892/1893/1920 (spreadshee	et)			
Original Use	Storefront Commercial/apart	ments			
Architectural Style					
Architect/Builder					
Description	The two story building is rectangular in plan with a flat roof and parapet with decorative tiled shed roof. It is clad in stucco with nine bays divided by stylized pilasters. Upper floor windows are paired and have been fitted with vinyl replacement windows. There is a decorative frieze with building/sunrise/tree motif above each window. Historic storefronts at the center of the building have wooden doors and divided transoms. Storefronts at either end are contemporary				
Integrity	Probably retains integrity despite window/storefront replacement, more research needed				
Significance	Appears eligible as landmark and district contributor, unusually detailed frieze				
Notes		·	·

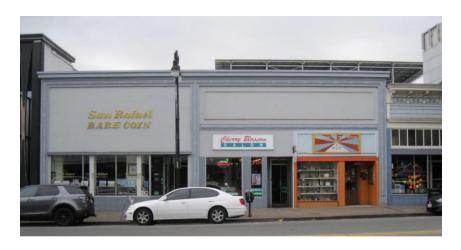
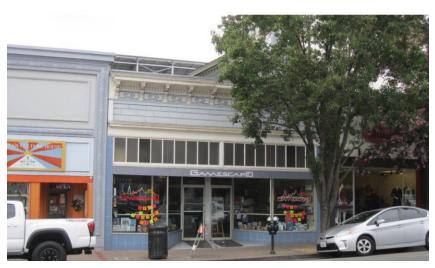
Address/code	1219-1223 Fourth St		E	
	1225 Fourth St	5S2	Α	
APN	011-255-28			
Building Name	Grosjean & Co.			
Year Built	Prior to 1887 (Sanborns)			
Original Use	Storefront Commercial			
Architectural Style				
Architect/Builder				
Description	The parcel has three single-story rectangular plan storefront commercial buildings. The two buildings at the east are clad in stucco and have terracotta ornament with large ceramic tile at the bulkhead. 1225 Fourth Street at the west end of the parcel has a wooden cornice elaborated with ornate brackets, paneled frieze, dentil moulding and decorative pediment above Wood siding on the upper façade is rusticated and there are divided light transoms above the storefront. Storefront is contemporary			
Integrity	East end does not retain integrity (upper photo). West end retains integrity (lower photo).			
Significance	eligible as landmark and district contributor, unusual example of nineteenth century wood commercial facade

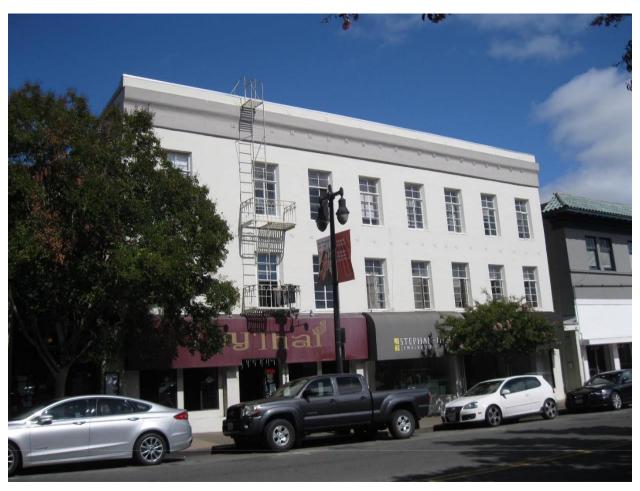
Address/code	1222-1230 Fourth Street	5S2	E	
APN	011-212-06			
Building Name	Central Hotel			
Year Built	1864 (spreadsheet)			
Original Use	Hotel			
Architectural Style				
Architect/Builder				
Description	The three story rectangular plan storefront commercial building has a flat roof with simple cornice. It is clad in smooth plaster stucco with steel casement windows. Storefronts are contemporary.			
Integrity	Lacks integrity, building doe	s not resemble historic Cer	ntral Hotel	
Significance	Not eligible as landmark or district contributor, nothing is left of the Central			
	Hotel building and its c1930 current appearance is undistinguished.			
Notes

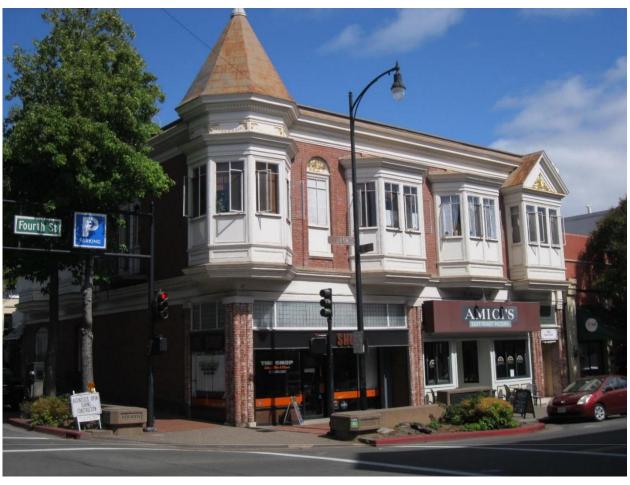
Address/code	1242-1244 Fourth Street		A	
-				
APN	011-212-14			
Building Name	Peter Building			
Year Built	1893 (spreadsheet)			
Original Use	Commercial			
Architectural Style				
Architect/Builder				
Description	The two story rectangular pla with decorative cornice and p is brick with projecting bays of wood. Window openings are replacements. Window bays paneled frieze, and one is top arched window near the west transom. Storefronts are sepa originally to have been plaste Storefronts are contemporary	peaked roof on projecting on both C and Fourth Street vertical and fitted with unhave their own cornices we ped with an ornamental put end of the south façade arated by round brick pilasted and are topped with or the south factorials are topped with the core and are topped with the core are topped with the core and are topped with the core are to the core are to the core are to the core are topped with the core are to the core are the core are to the core are the core	corner bay. The building et facades executed in sympathetic eith dentil moulding and bediment. A single has a decorative blind esters which appear

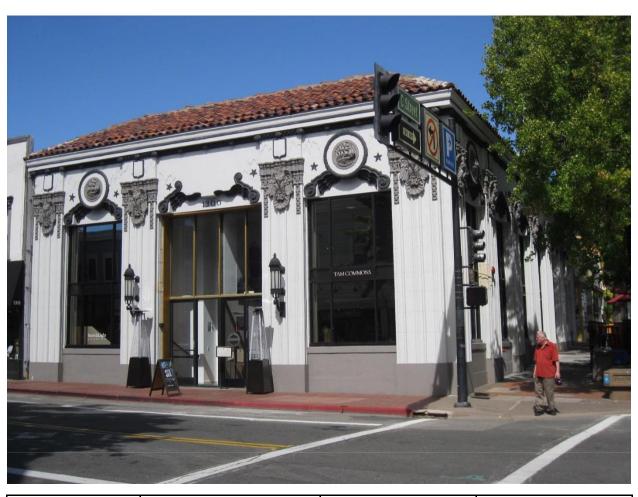
Address/code	1300 Fourth Street	3S	Α		
APN	011-205-08				
Building Name	Bank of Italy				
Year Built	1928 (spreadsheet)				
Original Use	Bank				
Architectural Style	Art Deco/Spanish Revival				
Architect/Builder					
Description	The tall single story building is rectangular in plan with a hipped tile roof. Its large window bays are separated by heavy stylized fluted pilasters topped with ornate capitals featuring an eagle motif. Shaped window openings have elaborately scrolled moulding. The main (Fourth Street) façade has medallions with the Bank of Italy's sailing ship emblem. The carved Bank of Italy name over the main entrance has been removed. Original sconces flank the main entrance. Windows and doors are contemporary.				
Integrity	Retains integrity despite window replacement				
Significance	Unique example of a bank building, eligible as landmark and contributor				
Notes

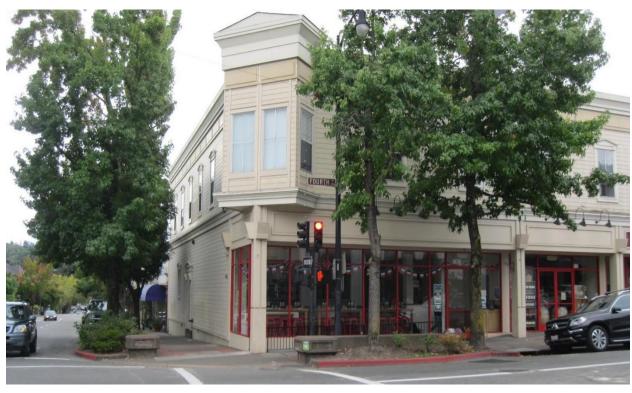
Address/code	1301 Fourth Street	5S2	E
APN	011-253-10		
Building Name	Hayes		
Year Built	1987 (spreadsheet)		
Original Use			
Architectural Style			
Architect/Builder			
Description	·		nth century building. Architecture n but is not a replica of a historic
Integrity	Not historic		
Significance	Not historic		
Notes

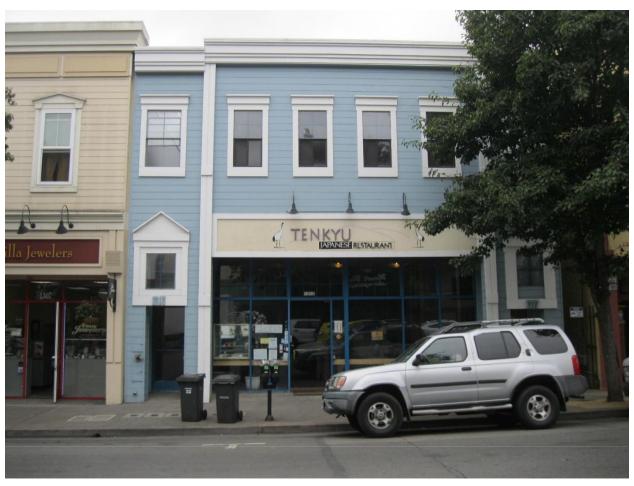
1313-1317 Fourth				
Address/code	Street	7N	E		
APN	011-253-04				
Building Name	Hayes				
Year Built	1987 (spreadsheet)				
Original Use					
Architectural Style					
Architect/Builder					
Description	Adjacent to 1301 Fourth St. Per spreadsheet 1987 replacement of nineteenth century building. Architecture displays nods to historic period building design but is not a replica of a historic building				
Integrity	Not historic				
Significance	Not historic				
Notes

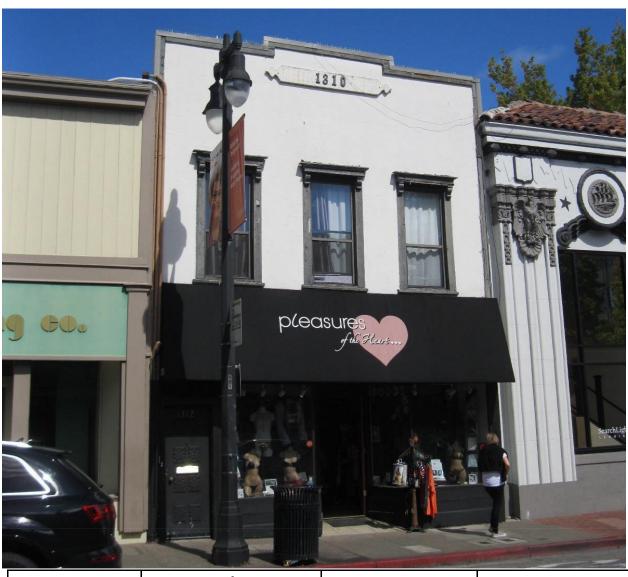
Address/code	1310 Fourth Street	7N	E
APN	011-205-09		
Building Name			
Year Built	before 1894 (Sanborns)		
Original Use	Commercial		
Architectural Style			
Architect/Builder			
Description	The single story building is rectangular in plan with a gabled roof hidden by a stepped parapet. Tall upper floor windows are fitted with replacement windows and have decorative crowns. The building is clad in stucco. The storefront and entrance are contemporary.		
Integrity	Lacks integrity, window replacement, stucco, storefront		
Significance	Not eligible, modest example lacking integrity		
Notes

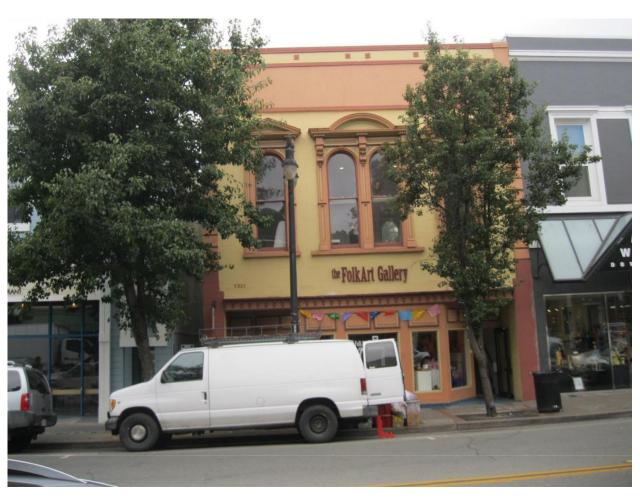
Address/code	1321 Fourth Street	7N	В
APN	011-253-03		
Building Name			
Year Built	c1871 (DPR)		
Original Use	Commercial		
Architectural Style	Italianate		
Architect/Builder			
Description	The two story building is rectangular in plan with a flat roof. Tall upper floor windows are fitted with double hung wood sash and feature highly decorative surrounds and crowns. The building is clad in rusticated smooth plaster stucco with decorative quoins at the corners. The contemporary storefront has a paneled frieze and is sympathetically designed.		
Integrity	Retains sufficient integrity for district despite loss of original cornice		
Significance	Eligible as district contribute	or, lacks integrity required	for landmark status
Notes

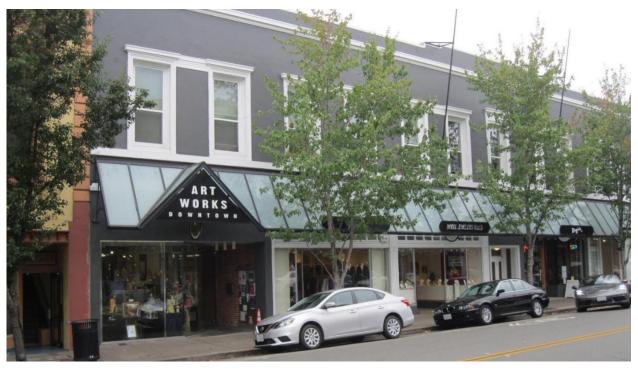
1327-1337 Fourth		
Address/code	Street		D
APN	011-253-02		
Building Name	Gordon's Opera House		
Year Built	1989 (spreadsheet) but archi	tecture reveals a historic p	eriod building
Original Use			
Architectural Style			
Architect/Builder			
Description	The two story building is rectangular in plan with a flat roof and stepped parapet. Tall upper floor windows are fitted with vinyl replacement windows decorative surrounds and crowns. The building is clad in stucco and has minimal decorative features. Most storefront fabric is contemporary although two have original transoms under awning.		
Integrity	Lacks integrity		
Significance	May be historically significant but in its current form it is not a good example of a historic architectural style.		
Notes

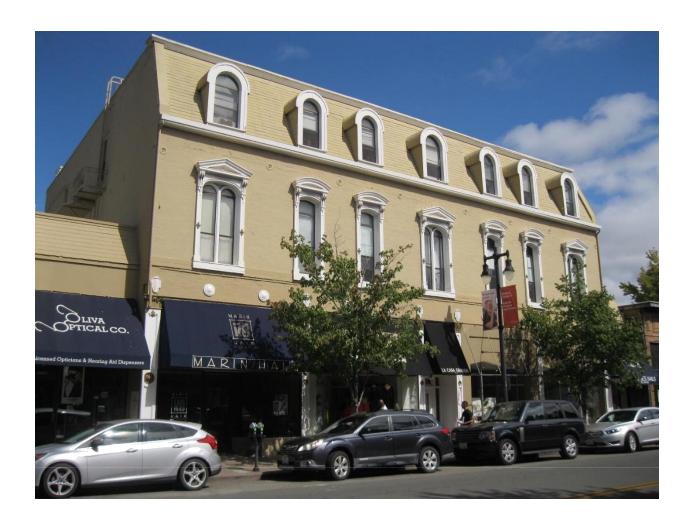
Address/code	1322-1328 Fourth St	3\$	Α	
APN	011-205-11			
Building Name	Mahon House, Butchart Build	ding		
Year Built	1869 (spreadsheet)			
Original Use	Storefront/Hotel			
Architectural Style	Second Empire			
Architect/Builder				
Description	The two story building is rectangular in plan with a mansard roof and arched roof dormers. Tall upper floor windows are fitted with vinyl replacement windows and have highly decorative surrounds and crowns. The building is brick. Storefront bays are separated by pilasters with Corinthian capitals. The centered entry to the second floor is fitted with fully glazed wood door, transom, and sidelights. Most storefront fabric is contemporary.			
Integrity	Retains integrity despite window and storefront replacement.			
Significance	Eligible as landmark and district contributor			
Notes

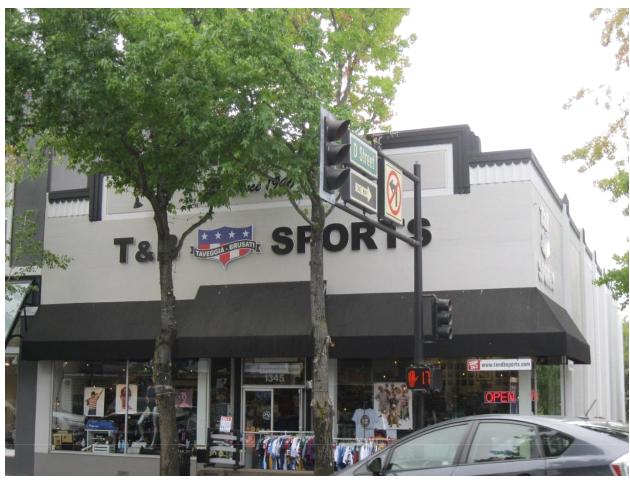
Address/code	1345 Fourth Street		В
APN	011-253-01		
Building Name			
Year Built	1930 (spreadsheet)		
Original Use	Storefront		
Architectural Style	Art Deco		
Architect/Builder			
Description	The single story building is rectangular in plan with a flat roof and stepped parapet. The building is clad in stucco. Fluted columns and cornice exhibit typical Art Deco style. Storefront and door are contemporary		
Integrity	Retains integrity despite store	efront replacement.	
Significance	Eligible as district contributor, not sufficiently distinguished for landmark status		
Notes

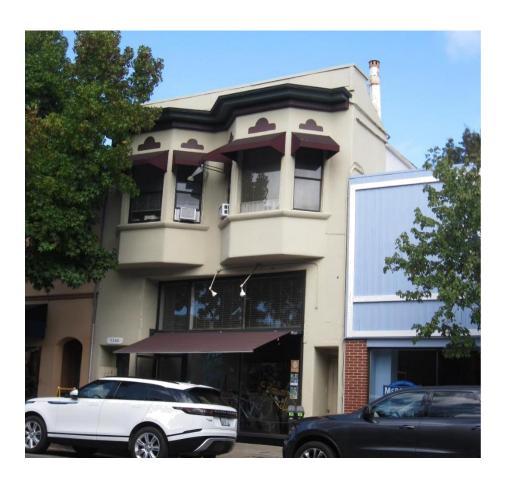
Address/code	1344-46 Fourth Street		E
APN	011-205-13		
Building Name			
Year Built	1904/1967 (spreadsheet)		
Original Use	Storefront		
Architectural Style	Art Deco		
Architect/Builder			
Description	The single story building is red Projecting upstairs window be stucco. Fluted columns and co door are contemporary	ays are topped by a cornic	e. The building is clad in
Integrity	lacks integrity		
Significance	Not Eligible, lack of significant	ce/integrity	
Notes		·

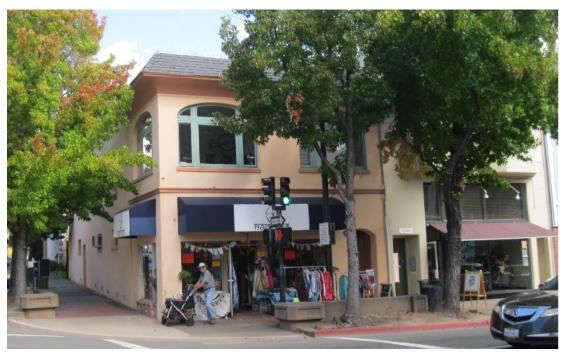
1350 Fourth St (1040		
Address/code	D St)		D
APN	011-205-14		
Building Name			
Year Built	1903 (spreadsheet)		
Original Use	Storefront		
Architectural Style	Mission		
Architect/Builder			
Description	The two story building is rectangular in plan with a flat roof with decorative hipped roof at the south end of the building. Upper floor windows have divided lights in arched openings. The building is clad in stucco. Storefront and door are contemporary		
Integrity	Lacks integrity, roof appears to have lost tile and decorative features, bulkhead altered		
Significance	Appears ineligible, lack of significance/integrity		
Notes

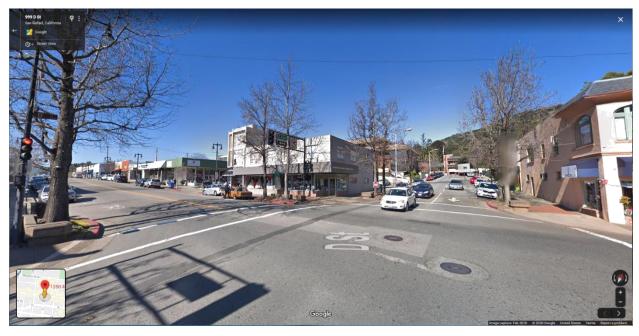
Address/code	1400 Fourth Street		E
APN	011-204-08		
Building Name			
Year Built	1958 (spreadsheet)		
Original Use	Storefront		
Architectural Style	Midcentury Utilitarian		
Architect/Builder			
Description	The two story building is rectangular in plan with a flat roof. The building is constructed of concrete masonry units and lacks decorative features. Upper floor windows are square steel casement. Aluminum frame doors and storefronts appear original. A heavy soffit/awning has been installed above the storefronts.		
Integrity			
Significance	Undistinguished midcentury building, Not Eligible, lack of significance		
Notes	This was subsequently droppe consideration. It provides a b 1414		-

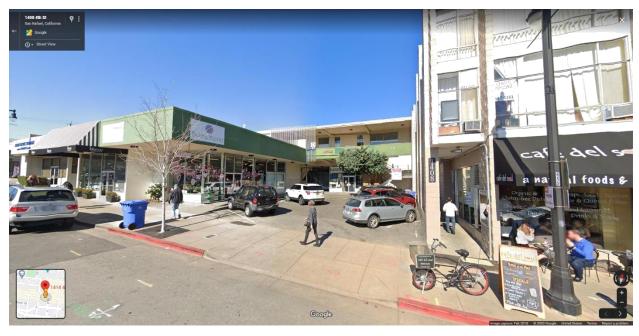
Address/code	1414 Fourth Street		E	
APN	011-204-17			
Building Name				
Year Built	1958 (spreadsheet)			
Original Use	Storefront/office			
Architectural Style	Midcentury Modern			
Architect/Builder				
Description	street and a two story volume is constructed of concrete ma floor windows are rectangula	The building is L-shaped in plan in plan with a single story volume near the street and a two story volume recessed behind a parking lot. It has flat roof and is constructed of concrete masonry units. It lacks decorative features. Upper floor windows are rectangular. Aluminum frame doors and storefronts appear original. A heavy soffit/awning has been installed above one of the storefronts.		
Integrity		·		
Significance	Undistinguished midcentury building, Not Eligible, lack of significance			
Notes	1408 Fourth not included, bet	ter example of modernism	than 1400 or 1414

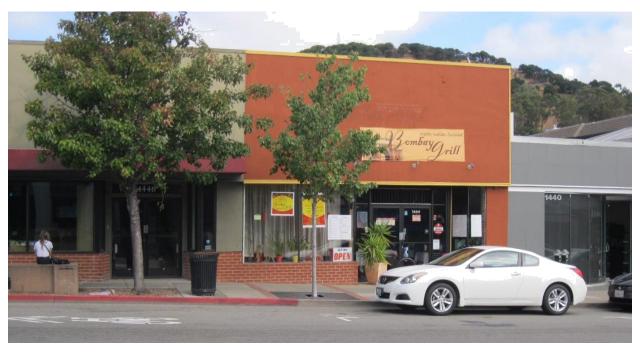
1444- 1446 Fourth				
Address/code	Street		E		
APN	011-204-15				
Building Name					
Year Built	1915/1965 (spreadsheet)				
Original Use	Storefront				
Architectural Style					
Architect/Builder					
Description	Two adjacent storefront buildings on the parcel are nearly identical in form, style and plan. They feature tall parapets, stucco cladding, brick bulkheads, and contemporary storefronts. They exhibit the typical plan and form of an early twentieth century storefront building but no architectural details associated with that era. Nor are they good examples of midcentury architecture.				
Integrity					
Significance	Undistinguished buildings not eligible as landmarks or contributors.				
Notes

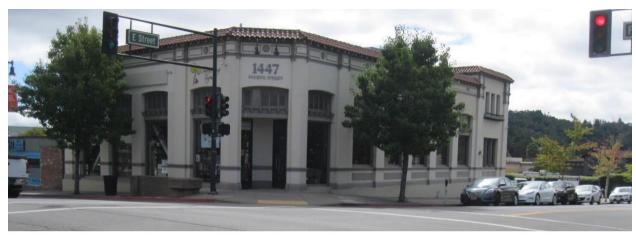
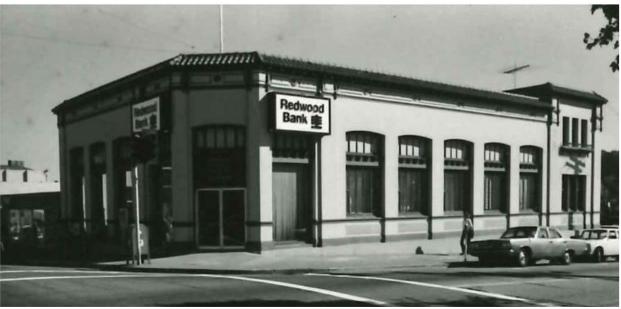
Address/code	1447 Fourth Street	7N	Α
APN	011-251-01		•
Building Name			
Year Built	c1916 (DPR)		
Original Use			
Architectural Style	Spanish Revival		
Architect/Builder			
Description	The tall single story building is rectangular in plan with a mansard tile roof and exposed rafter tails. It is clad in stucco with terracotta ornament including paneled frieze with floral motif and turned posts. Storefront bays are separated by wide pilasters with granite bases. Their tall rectangular windows are topped with arched transoms with wood frame divided lights and decorative brackets. Two recessed entrances have been created at the original corner entrance.		
Integrity	Retains integrity (see 1970s photo above)		
Significance	Excellent example of Spanish Revival Commercial architecture, eligible as		
	landmark and contributor.		
Notes

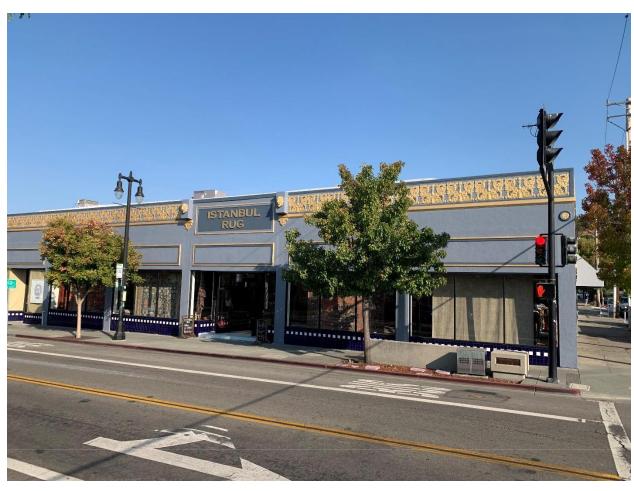
Address/code	1504-1512 Fourth St		В
APN	011-202-14		
Building Name			
Year Built	1929 (spreadsheet)		
Original Use			
Architectural Style	Art Deco/Spanish Revival		
Architect/Builder			
Description	The large single story building is rectangular in plan with flat roof. It is clad in stucco with terracotta ornament including ornate floral frieze and lions' heads flanking the main entrance. Storefront bays are separated by minimalist pilasters with granite bases. Original transoms have been covered. Bulkhead is tile, and storefronts are contemporary.		
Integrity	Retains sufficient integrity for district contributor status because of well- preserved ornate frieze		
Significance	eligible as contributor, lacks i	ntegrity required for landr	mark
Notes
