Downtown San Rafael Precise Plan Historic Resources Inventory Summary Report

Downtown San Rafael Precise P	Plan
Historic Resources Inventor	y Summary Report
A companion document to the Downtown he San Rafael General Plan 2040 Environ	
Prepared by the City of San Rafael	
Vith assistance from Garavaglia Associa	ites and Opticos Design
Published December 2020	Cover Photo Credits: Matthew X Kiernan

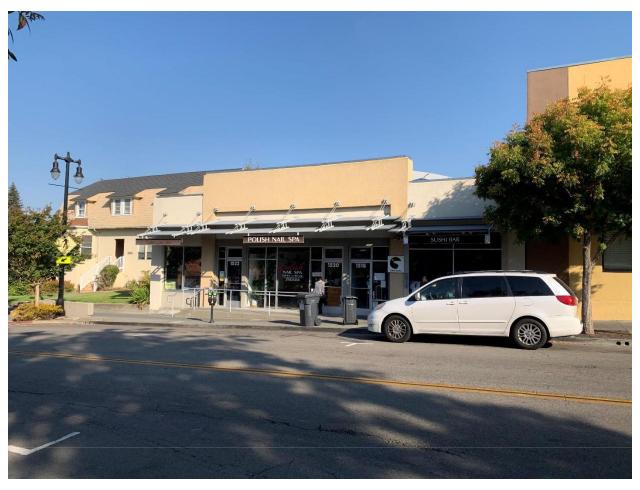
1508-1522 Fourth		
Address/code	Street		E
APN	011-202-11		
Building Name			
Year Built	1928 (spreadsheet)		
Original Use			
Architectural Style			
Architect/Builder			
Description	The single story storefront commercial building is rectangular in plan with stepped parapet. It is clad in stucco and has aluminum frame storefronts and glazed doors. It exhibits no characteristics of historic architecture		
Integrity			
Significance	Not eligible as contributor or landmark		
Notes

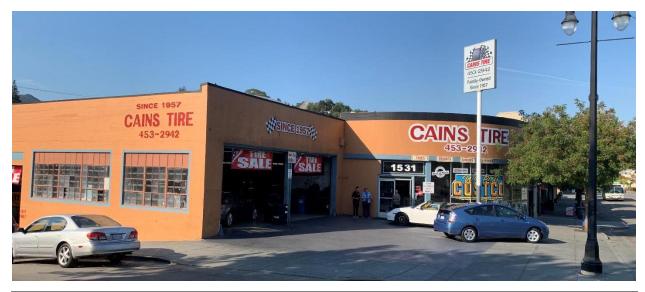
Address/code	1531 Fourth Street		B+
APN	011-242-11		
Building Name			
Year Built	1931 (spreadsheet)		
Original Use			
Architectural Style			
Architect/Builder			
Description	The single story auto-oriented rounded volume projecting from has industrial sash windows copenings at the north and easis almost completely glazed, with the main building.	om its main (north) facade in its east elevation. There st of the rectangular volum	e. It is clad in stucco and are three large vehicle ne. The rounded volume
Integrity	Retains integrity		
Significance	Eligible as contributor and po oriented building	ssibly landmark, good exa	mple of early auto-
Notes

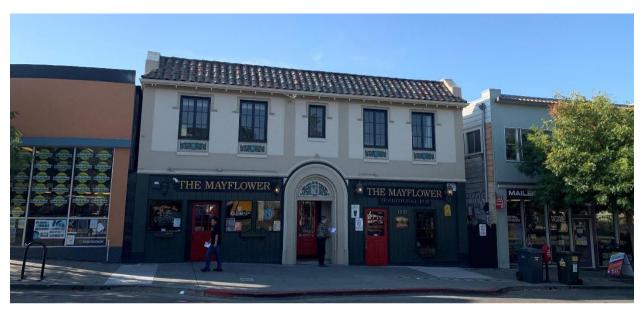
Address/code	1533 Fourth Street		В
APN	011-242-10		
Building Name			
Year Built	1925 (spreadsheet)		
Original Use			
Architectural Style	Spanish Revival		
Architect/Builder			
Description	The two story commercial building is rectangular in plan with decorative shed roof at the main (north) façade. The building is clad in stucco and has terracotta ornament with floral and shield motif. Upper story windows are fitted with multiple light wood sash and topped with ornamental hoods. The central entrance had a large arched surround with Romanesque moulding. Vertical wood cladding and small windows have replaced what were likely originally storefronts.		
Integrity	Retains integrity despite storefront alterations, highly decorative features have been retained.		
Significance	Eligible as contributor and possibly landmark, good example of Spanish/Mediterranean architecture		
Notes

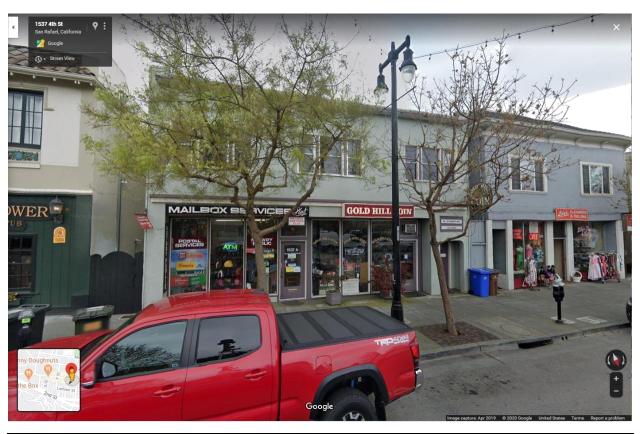
Address/code	1539 Fourth Street		E
APN	011-242-09		
Building Name			
Year Built	1923/1961 (spreadsheet) pro	bably older (drop siding w	ith historic advertising
	side elevation		
Original Use			
Architectural Style	Spanish Revival		
Architect/Builder			
Description	The two story commercial building is rectangular in plan with decorative shed roof at the main (north) façade. The building is clad in stucco tripartite upper story windows fitted with vinyl sash. Storefronts are contemporary.		
	story windows fitted with vin	yi sasii. Storeironts are coi	петгрогагу.
Integrity			
Significance	Lacks architectural significance, not eligible		
Notes

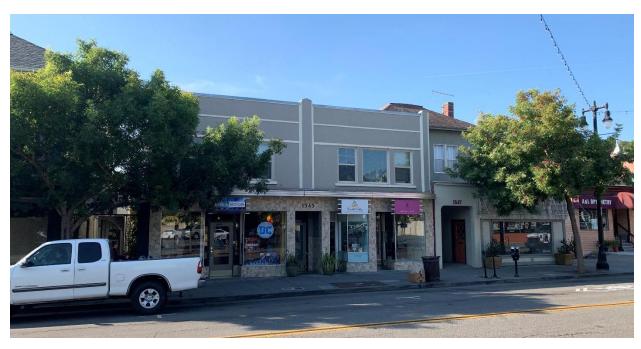
Address/code	1545 Fourth Street		E
APN	011-242-07		
Building Name			
Year Built	1947 (spreadsheet)		
Original Use			
Architectural Style	Streamline Moderne		
Architect/Builder			
Description	The two story commercial building is rectangular in plan with flat roof. The building is clad in stucco tripartite upper story windows fitted with vinyl sash. Simple grooved columns adorn the corners and center of the building. There is a grooved metal awning over the storefront. Storefronts are contemporary with stone tile.		
Integrity	Lacks integrity, windows, stone tile		
Significance	Not eligible as landmark or co	ontributor	
Notes

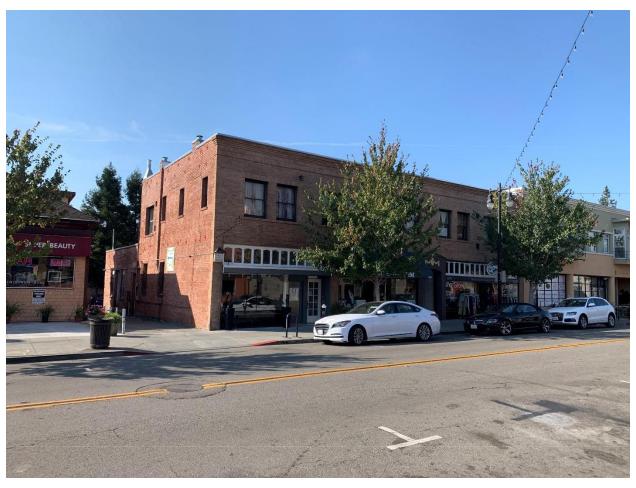
Address/code	1553-1555 Fourth St	7N	В
APN	011-242-04		
Building Name			
Year Built	1926 (spreadsheet)		
Original Use			
Architectural Style			
Architect/Builder			
Description	cladding and cornice. Upper A slightly projecting entrance stucco, with terracotta carto	story windows has a gabled i uche and swag	gular in plan with flat roof and brick fitted with double hung wood sash. oof form with arched opening. It is . Decorative transoms are multiple theads and contemporary doors.
Integrity	Retains integrity		
Significance	eligible as contributor, lacks	significance red	quired for landmark status
Notes

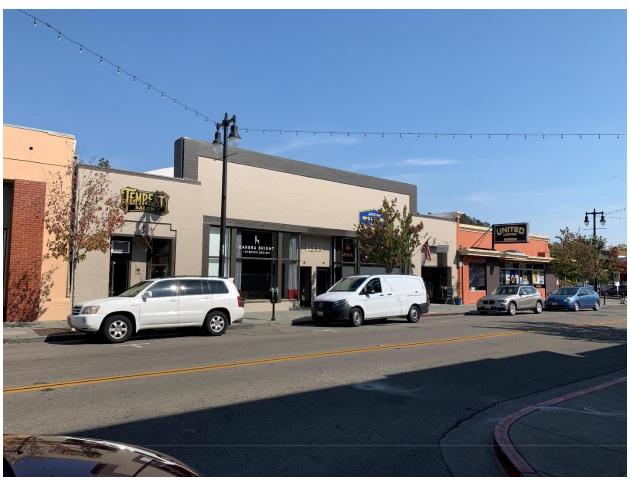
Address/code	1560 Fourth Street		E
APN	011-196-11		
Building Name			
Year Built	1938 (spreadsheet)		
Original Use			
Architectural Style			
Architect/Builder			
Description	The single story commercial building is rectangular in plan with flat roof and stepped parapet. It clad is stucco, with shaped doorways at its east and west ends. Flush storefronts have multiple lights divided by heavy wood frames and doors at the center of the building		
Integrity			
Significance	Not eligible, lacks architectur	al significance	
Notes		·

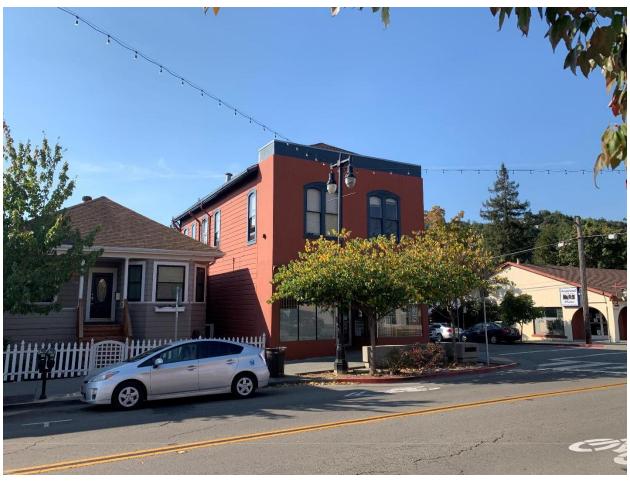
Address/code	1569 Fourth Street		E
APN	011-242-01		
Building Name			
Year Built	1928 (spreadsheet), apparen	t nineteenth century build	ing.
Original Use			
Architectural Style			
Architect/Builder			
Description	The two story commercial-residential building is rectangular in plan with hipped roof and parapet. It clad is stucco, with drop wood siding at rear and side elevations. Double hung wood windows with arched tops and decorative surrounds and roof form indicate the building's probable origin as an Italianate house. Storefronts are contemporary.		
Integrity	Lacks integrity, stucco, parapet, storefronts		
Significance	Not eligible, lacks integrity		
Notes

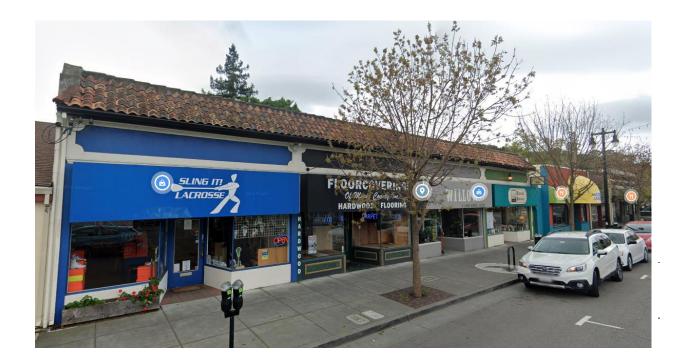
Address/code	1605-1611 Fourth St
APN	011-241-32
Building Name	
Year Built	1927 (spreadsheet)
Original Use	
Architectural Style	Spanish Revival
Architect/Builder	
Description	The single story storefront building is irregular in plan with flat roof and decorative tiled shed roof on the main (north) facade. It clad is stucco, with drop wood siding at rear and side elevations. There is a simple paneled frieze above the four storefront bays. Large awnings cover the transom area. Slanted storefronts have original tile bulkheads (some of which have been painted) and fully glazed wood doors.
Integrity	Retains integrity
Significance	Simple but good example of Spanish Revival commercial architecture, eligible as district contributor, probably not distinguished enough for landmark status
Notes

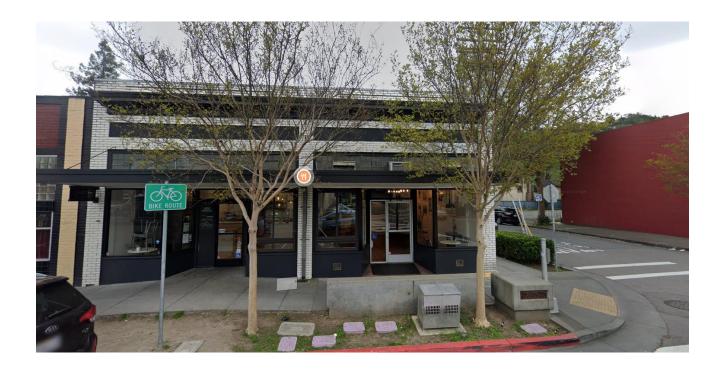
Address/code	1617 Fourth Street		В
APN	011-241-01		
Building Name			
Year Built	1920 (spreadsheet)		
Original Use			
Architectural Style	Spanish Revival		
Architect/Builder			
Description	The single story storefront but parapet with decorative corn glazed brick, which is plastered have small square panes with sidewalk below transoms. Slaglazed aluminum replacement	ice on the main (north) faced at rear and side elevation obscured glass. A heavy anted storefronts have orig	cade. The building is ons. Original transoms awnings projects over the
Integrity	Retains integrity despite door replacement		
Significance	Simple but good example of o	commercial architecture, e	eligible as district
	contributor, probably not dist	tinguished enough for land	dmark status
Notes

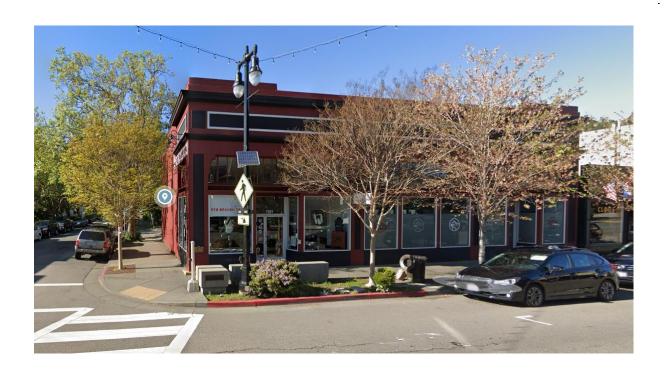
Address/code	1701 Fourth Street		С
APN	011-232-03		
Building Name			
Year Built	1925 (spreadsheet)		
Original Use			
Architectural Style			
Architect/Builder			
Description	The single story storefront bu stepped parapet with decora- stucco. There is a simple pand openings and divided lights. T	tive cornice on the main (reled frieze above the trans	north) facade. It clad is soms, which have shaped
Integrity	May retain integrity, more stu	udy needed, stucco may n	ot be original
Significance	Possibly eligible as district constatus	ntributor, not distinguishe	d enough for landmark
Notes		<u> </u>	·

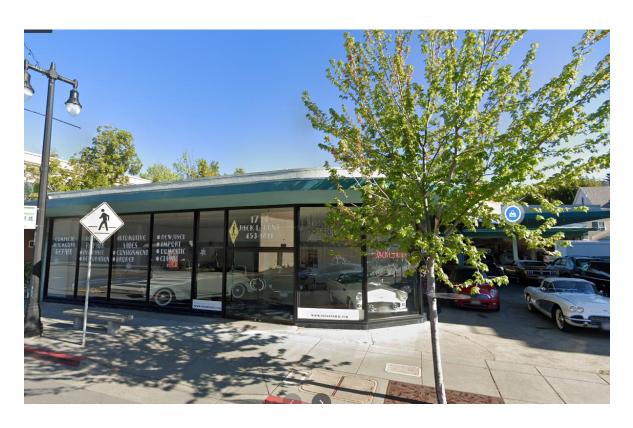
Address/code	1714 Fourth Street		С
APN	011-192-08		
Building Name			
Year Built	1951 (spreadsheet)		
Original Use	Service station		
Architectural Style	Midcentury Modern		
Architect/Builder			
Description	The single story storefront bu with flat roof and projecting phas a curved corner is fully glarounded at the corner, projecthe porte cochere has flat rooshaped wing at the rear (north	porte cochere at the east. azed on the south and east ts below the parapet. A self and industrial sash wind	The front (south) end t. A heavy awning, also econd story adjacent to ows. There is an L-
Integrity	May retain integrity, more stu	ıdy needed, glass not origi	inal
Significance	Possibly eligible as district cor	ntributor, not distinguishe	d enough for landmark
	status		
Notes

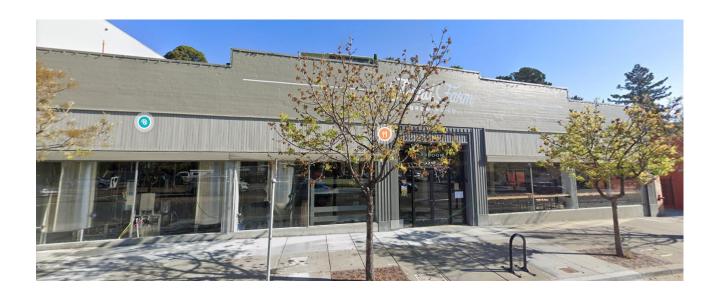
Address/code	1848 Fourth Street		В
APN	010-291-35		
Building Name			
Year Built	1947 (spreadsheet)		
Original Use	Commercial		
Architectural Style	Streamline Moderne/Stripped	d Classicism	
Architect/Builder			
Description	The single story storefront bu stepped parapet. It is constru door surround featuring styliz are covered with metal panel contemporary	cted of board form concre red fluted columns and de	ete with a decorative ntil moulding. Transoms
Integrity	Retains integrity despite store	efront and door replaceme	ent
Significance	eligible as district contributor distinguished enough for land	• • • • • • • • • • • • • • • • • • • •	classical detailing, not
Notes

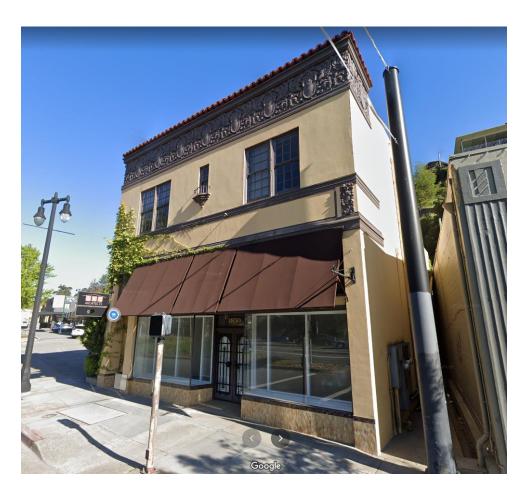
Address/code	1850-1852 Fourth St	7N	Α
APN	010-291-57		
Building Name			
Year Built	1922 (spreadsheet)		
Original Use	Commercial		
Architectural Style	Art Deco/Spanish Revival		
Architect/Builder			
Description	The two story storefront build tile parapet. It is clad in stucco frieze at the cornice, diminuti detailing between stories. Pai hung multiple light wood sash glazed wood doors are at the and bulkheads are contempor	o with terracotta ornamer ve balconet at the center red upper story windows n. Transoms are also multi center and west end of th	nt including an elaborate of the upper façade, and are fitted with double ple light wood. Original
Integrity	Retains integrity despite store	efront replacement	
Significance	eligible as district contributor	and landmark	
Notes

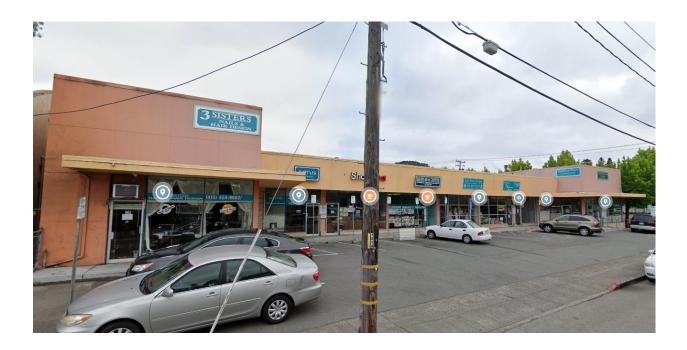
Address/code	963-977 Grand Av		D
APN	014-123-10		
Building Name			
Year Built	1956		
Original Use			
Architectural Style			
Architect/Builder			
Description	The one-story building has a full building is an early example of the building. There is a slit-fact ends of the long recessed volstucco. Large storefronts line end have higher roofs than the storefront windows. Heavy so are canted.	of a strip shopping center was rock bulkhead, as well a sume. Elsewhere, the build the main façade. The projue rest of the building and	with parking in front of as vertical strips at both ling is clad in smooth jecting volumes at either flat awnings above the
Integrity	Appears to retain integrity		
Significance	Lacks architectural distinction	, not eligible as landmark	or contributor
Notes		·

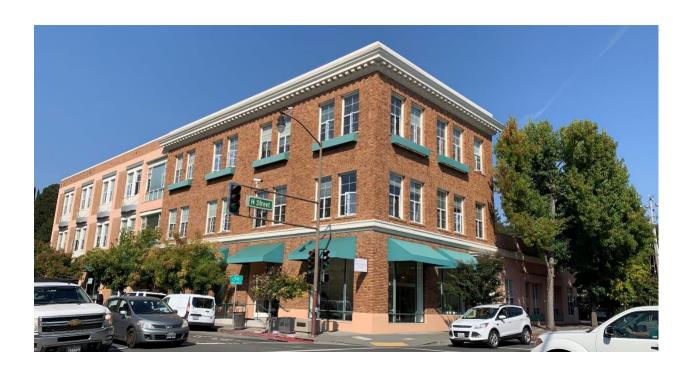
1 H Street		
Address/code	1820 4th		D
APN	010-291-69		
Building Name			
Year Built	c1950		
Original Use			
Architectural Style			
Architect/Builder			
Description	The parcel encompasses three adjoining buildings with three façades that face onto streets and a parking lot alongside the back. It has a flat roof. The three-story portion, which forms a roughly T-shaped layout, is clad in a combination of brick and smooth stucco, with dentil molding at the roof and molding between the first and second stories. Windows on the main first floor, the main façade of which runs along an entire block, are large storefronts and have cloth awnings. There are railings outside of some of the third-floor windows. On either side of the building are one-story additions, both of which are entirely clad in smooth stucco.		
Integrity	Nineteenth century building at corner lacks integrity		
Significance	Not significant at any level

Notes	Current footprint dates from the early 1950s, original building at corner and midcentury additions have all been altered

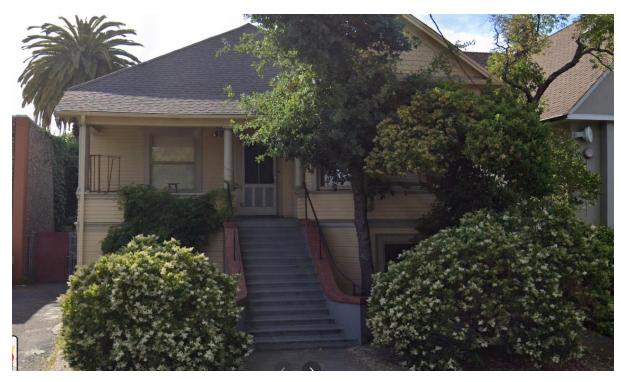
Address/code	1011 Irwin Street		В
APN	014-085-10		
Building Name			
Year Built	1907		
Original Use	Residential		
Architectural Style			
Architect/Builder			
Description	The two-story building has a on the main façade and one so volume with a second-floor beartial-width projecting porcioecorative shingles at gable 6	side. Under the gable on th ay window; next to the vo n. The building is clad in a v	e front is a projecting lume is the second-floor
Integrity	Retains Integrity		
Significance	Good example of hipped roof	cottage, eligible as contrib	outor
Notes

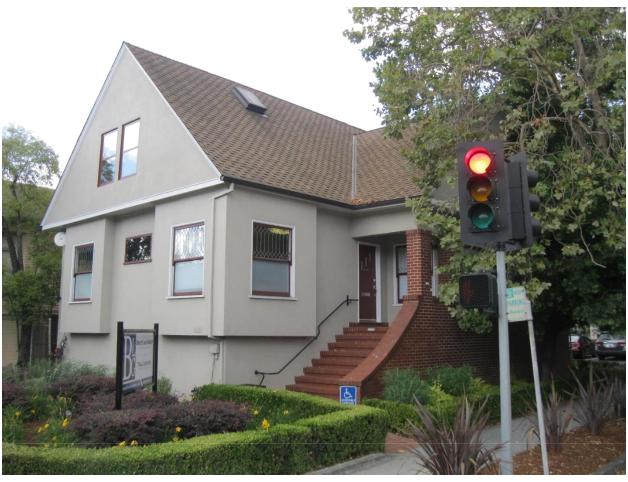
Address/code	1015 Irwin Street		E
APN	014-085-11		
Building Name			
Year Built	c1900		
Original Use	Residence		
Architectural Style			
Architect/Builder			
Description	The one-and-a-half story building has a rectangular plan and cross-gabled roof. It has a raised elevation and a small integral entry porch accessed via brick steps. The main façade is also clad in brick on the first floor, and the rest of the building is clad in smooth stucco. A side elevation has a staircase to access rear entrances on both floors.		
Integrity	Appears to lack integrity, stucco, brick		
Significance	Not eligible at any level, lacks integrity		
Notes

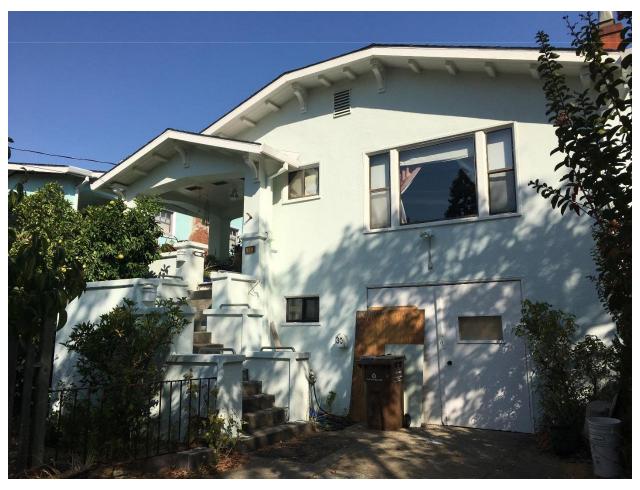
Address/code	30 Latham Street		В	
APN	011-242-22			
Building Name				
Year Built	1928			
Original Use	Residential			
Architectural Style				
Architect/Builder				
Description	The two-story house has a ro is sheltered under a partial-w gable. The entrance faces into first floor opposite the porch stucco.	idth integral porch with its the side of the building.	s own, slightly projecting There is a garage on the	
Integrity	Retains integrity			
Significance	Good example of craftsman a	Good example of craftsman architecture, district contributor		
Notes

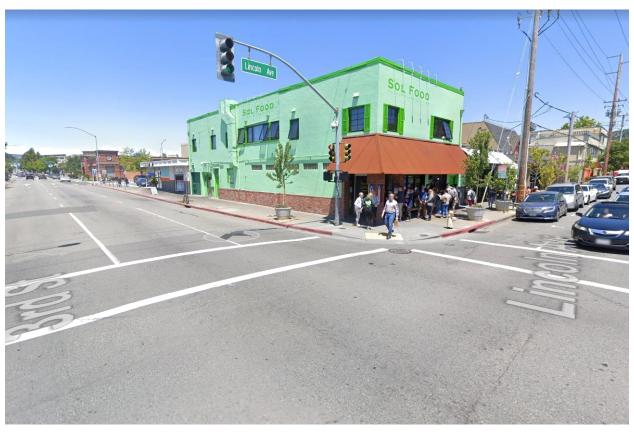
Address	901 Lincoln Avenue		E
APN	011-273-12		
Building Name			
Year Built	c1920		
Original Use			
Architectural Style			
Architect/Builder			
Description	The two-story building has a fentrance in the corner and floof one façade. Windows on the floor also features a corrugation the façade with windows. The at the bottom; otherwise, the	oor-to-ceiling windows alo ne second floor have wood ed metal awning with a wi e other street-facing façad	ng most of the first story len shutters. The first de brick support above e has a low strip of brick
Integrity	Appears to lack integrity, no	visible 1920s fabric	
Significance	Not eligible		
Notes

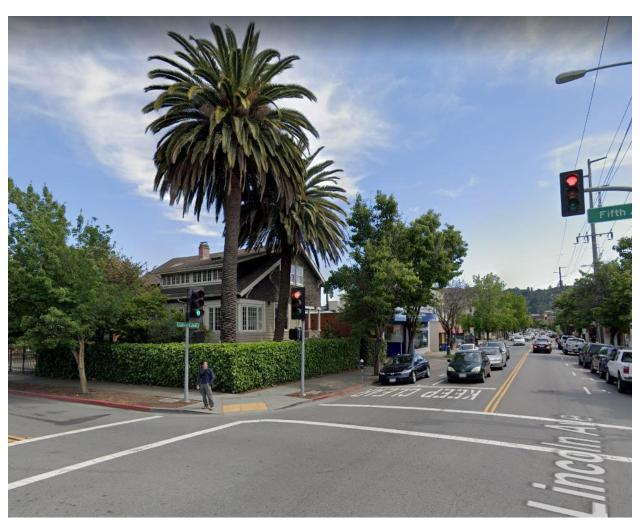
Address	1016 Lincoln Avenue	7N	С
APN	011-227-01		
Building Name			
Year Built	c1889-1891		
Original Use			
Architectural Style			
Architect/Builder			
Description	The one-and-a-half story buil roof. It is surrounded by a hig and a partial-width integral p façade of the corner building siding and the second floor is	gh, vine-covered fence. It I orch. There is a long dorm . The first floor is clad in w	nas a raised foundation ner window on the side
Integrity	Appears to retain integrity, n	nore study needed	
Significance	Potential district contributor	not individually eligible a	t any level
Notes

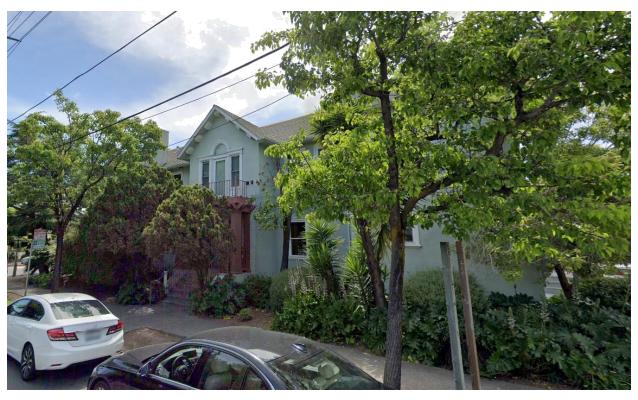
Address	1103 Lincoln Avenue		D
APN	011-225-04		
Building Name			
Year Built	c1900		
Original Use			
Architectural Style			
Architect/Builder			
Description	The two-story building has a mansard roof. There are three The central volume has a gab entrance accessed by concret flanking it are hipped. The bu	e small projecting volumes led roof, a second-floor ba e steps on the first floor.	s on the main façade. Alcony, and a recessed The two volumes
Integrity	Integrity appears impaired	·	
Significance	Probably Not eligible		
Notes

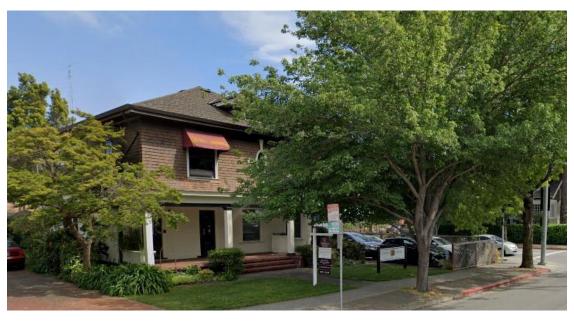
Address	1104 Lincoln Avenue	7N	В	
APN	011-226-07			
Building Name	San Rafael House			
Year Built	1906			
Original Use				
Architectural Style	American Foursquare	American Foursquare		
Architect/Builder				
Description	The two-story building has a roughly square plan and a hipped composition shingle roof. There is a full-width integral porch with wide brick steps on the main façade and a dormer window in the center. There are cloth awnings on the windows. The first floor is clad in narrow horizontal board siding and the second floor is clad in shingle.			
Integrity	Retains Integrity			
Significance	Potential district contributor, not individually eligible at any level			
Notes

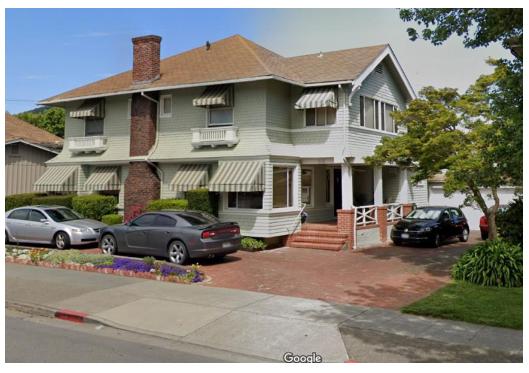
Address	1110 Lincoln Avenue	5S2	В
APN	011-226-08		
Building Name			
Year Built	1907		
Original Use			
Architectural Style	Craftsman		
Architect/Builder			
Description	The two-story building has a composition shingle roof. The the main façade, running alourick steps, with a brick floor supports. The main entrance double hung wood sash wind chimney at the center. The woulding is clad in in shingle.	ere is a deep one-story into ng part of a side façade. It and brick around the bott faces into the side of the lows have been replaced.	egral porch at one end of is accessed by a set of coms of the porch building. Some original There is a large brick
Integrity	Retains sufficient Integrity fo	r district contributor despi	te window replacement
Significance	Eligible as district contributor	r	
Notes

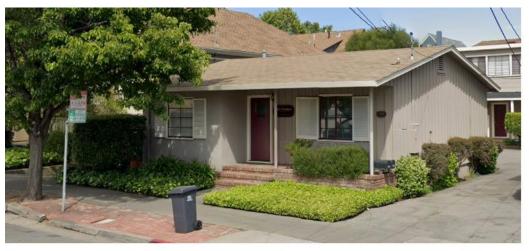
Address	1116 Lincoln Avenue		E
APN	011-226-13		
Building Name			
Year Built	1953		
Original Use	Residential		
Architectural Style			
Architect/Builder			
Description	The one-story building has a roughly square plan and gabled roof. The entrance is centered on the main façade at one end of a partial-width integral porch with a brick floor, steps, and planter. Windows are eight-light with large wooden shutters. The building is clad in board-and-batten.		
Integrity	Integrity appears impaired		
Significance	Not eligible, lacks significance	2.	
Notes		·

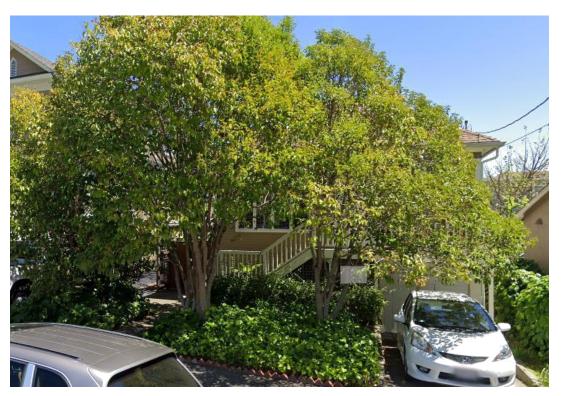
Address	1118 Lincoln Ave		С
APN	011-226-10		
Building Name			
Year Built	c1903		
Original Use	Residential		
Architectural Style			
Architect/Builder			
Description	The two-story building has a plan. The second-floor main or runs along the length of the runderneath the staircase on and wide horizontal board side.	entrance is accessed by a s main façade. There is a me the first floor. The building	ide-facing staircase that tal roll-up garage door
Integrity	Integrity appears impaired; v	isibility limited more study	needed
Significance	May be eligible as district cor	ntributor	
Notes

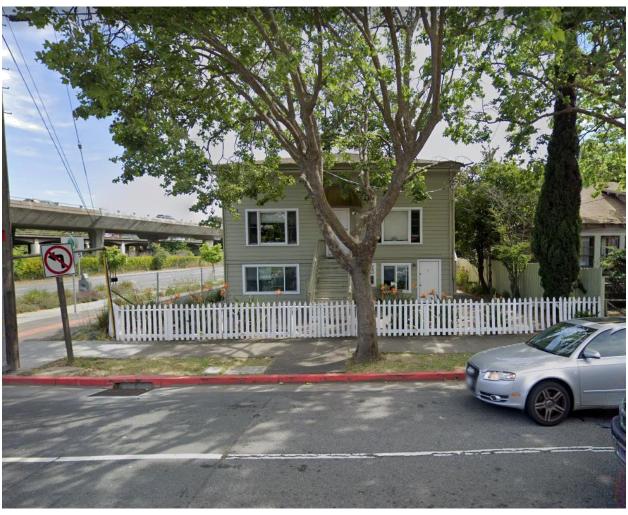
Address	633 Mission Avenue		E
APN	014-081-02		
Building Name			
Year Built	Pre-1894		
Original Use	Residential		
Architectural Style			
Architect/Builder			
Description	The two-story building has a rectangular plan and low-pitch hipped composition shingle roof. There are multiple entrances on the main façade, one on the first floor and one on the second floor, accessed by a wooden staircase and sheltered under an awning. The building is clad in horizontal board siding.		
Integrity	Appears to lack integrity		
Significance	Not eligible		
Notes

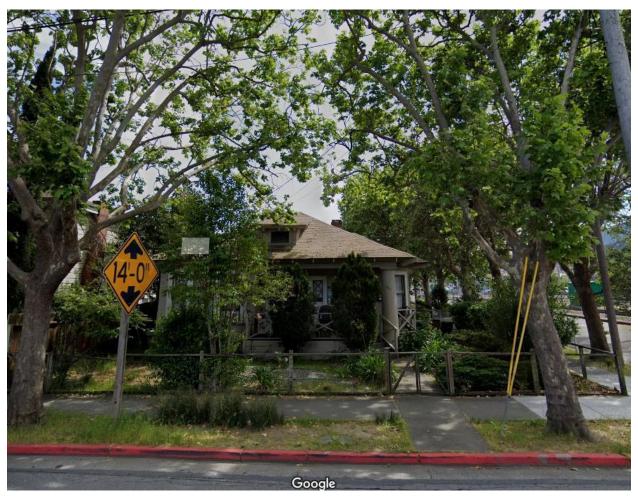
Address	637 Mission Avenue		(likely B)
APN	011-081-01		
Building Name			
Year Built	1904		
Original Use	Residential		
Architectural Style	Craftsman		
Architect/Builder			
Description	The one-story building has a roughly rectangular plan and hipped composition shingle roof with exposed rafter tails. There is a shed dormer on the main façade as well as a partial-width integral porch with one massive column. The building has large, wide double-hung wood sash windows and is clad in a combination of narrow and wide horizontal board siding.		
Integrity	Appears to retain integrity		
Significance	Excellent small example of cr contributor and individual lar	•	ntial local district
Notes

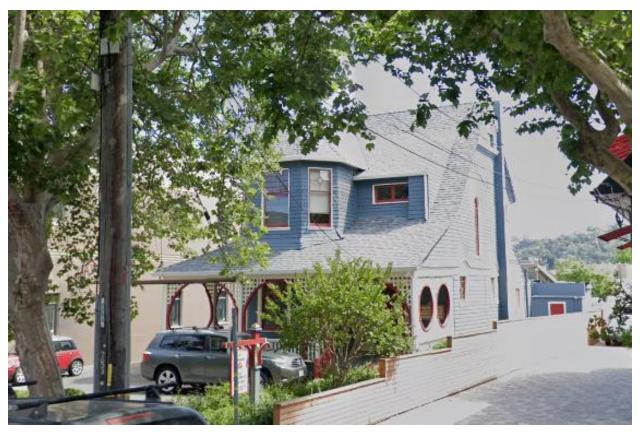
Address	705 Mission Avenue	7N	Α
APN	011-226-03		
Building Name			
Year Built	c1900		
Original Use	Residential		
Architectural Style	Shingle		
Architect/Builder			
Description	The one-and-a-half-story building has a roughly rectangular plan. It has a hip-on-dual-pitched-gable roof. It has a full-width integral porch with rounded openings on all sides. Double hung wood sash windows have various decorative configurations. It is clad in shingle, with several decorative strips of straight-lined fishscale on the second-floor projecting volume.		
Integrity	Appears to retain integrity		
Significance	Good example of rare style, Eligible as landmark and district contributor		
Notes

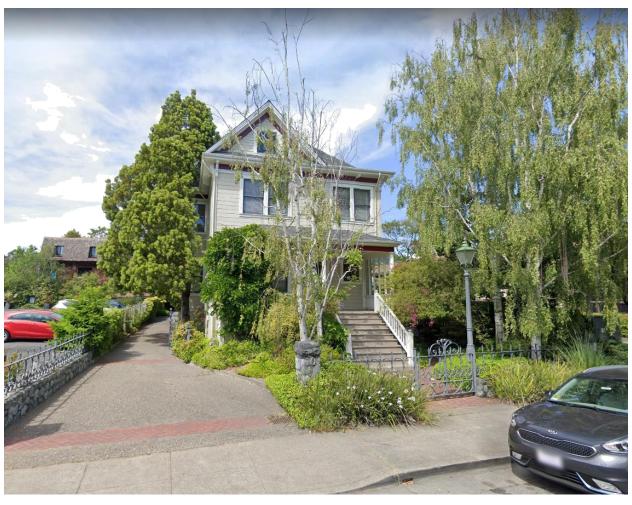
Address	710 Mission Avenue		Α
APN	011-186-10		
Building Name			
Year Built	c1900		
Original Use	Residential		
Architectural Style	Queen Anne		
Architect/Builder			
Description	The two-and-a-half story buil with decorative brackets at the raised elevation and a full-wid center that is screened on the The building is clad in horizor fishscale on the attic-floor gamany of them in pairs.	ne cornice and a roughly ro dth one-story projecting fr e sides. The entrance is ce atal board siding, with a co	ectangular plan. It has a cont porch with at the ntered and recessed.
Integrity	Appears to retain integrity	·	
Significance	Eligible as individual landmar	k and district contributor	<u> </u>
Notes

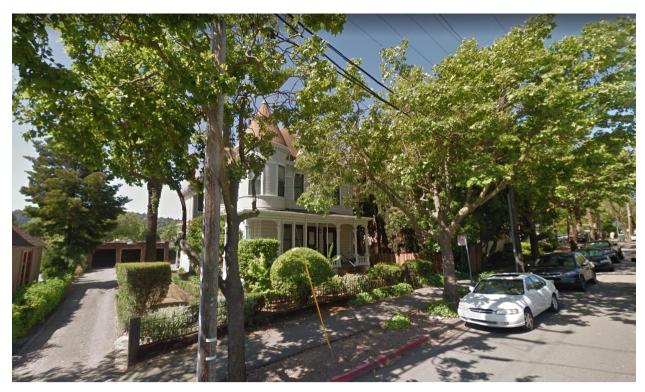
823-25 Mission		
Address	Avenue	3S	Α
APN	011-223-02		
Building Name			
Year Built	Pre-1887		
Original Use	Residential		
Architectural Style	Queen Anne		
Architect/Builder			
Description	The two-story building has a roughly rectangular plan and a gable-on-hip composition shingle roof with a round, pointed tower in one front corner. There is a projecting full-width porch on the first floor that extends wider than the house at one side. The building is clad in horizontal wood siding. Queen Anne decorative features include brackets at the tower cornice, ornate window casings, and square porch columns with capital and scrolled brackets.		
Integrity	retains integrity		
Significance	Excellent example of high style Queen Anne architecture, landmark and contributor		
Notes

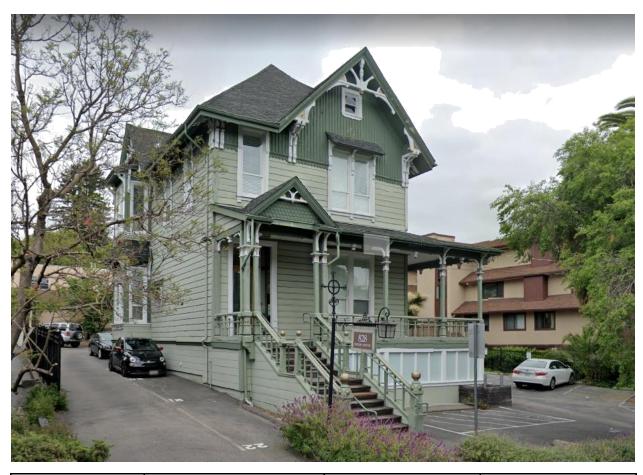
Address	828 Mission Avenue		Α	
APN	011-184-10	011-184-10		
Building Name				
Year Built	Pre-1887			
Original Use	Residential			
Architectural Style	Stick			
Architect/Builder				
Description	The two-story building has a reside. The gable-on-hip composite brackets at the corners and government with the first small gable on the one-story entrance. The building, sited front, and a set of stairs lead in horizontal board siding with	sition shingle roof feature able trusses. There is a pro t floor of the main façade projecting porch roof abou on a slope, has a raised for directly to the main entrai	es decorative triangular ojecting full-width and a side façade, with a ve the corner main undation toward the nce. The building is clad	
Integrity	retains integrity			
Significance	Eligible as landmark and cont	ributor		
Notes

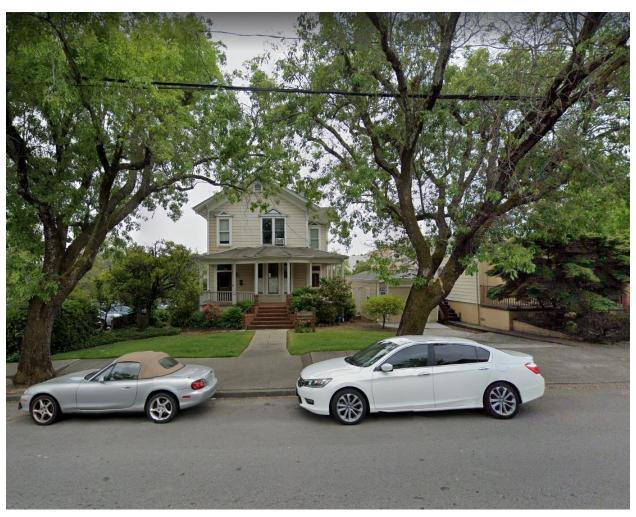
Address	907 Mission Avenue	7N	A-
APN	011-221-03		•
Building Name			
Year Built	c1900		
Original Use	Residential		
Architectural Style	Folk Victorian		
Architect/Builder			
Description	composition shingle roof feat corners. There is a projecting the main façade and side, with accessed by a set of brick steam wood sash windows, and the pediments. The building is cl	tures decorations of the tentrances and the entrances and the buildings on the second of the building with the tentrances on the second of the building with the tentrances of the second of the tentrances of the tentrances of the second of the tentrances of tentrances of the tentrances of the tentrances of tentr	rigular plan. The cross-gabled we triangular knee braces at the aparound porch on the first floor of a teither end and a bay window. It is ag has tall, narrow double-hung and floor feature decorative wood all board siding. There is a small matching cladding and a low-pitch rage door.

Integrity	Appears to retain integrity		
Significance	Eligible as landmark and con	tributor	
Notes

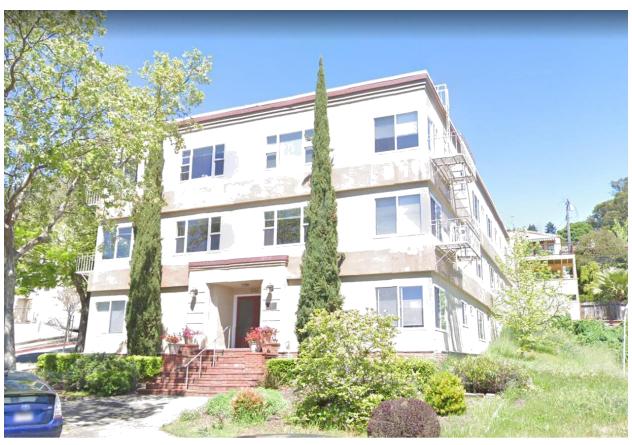
Address	1012 Mission Ave		E
APN	011-174-11		
Building Name			
Year Built	1949		
Original Use	Residential		
Architectural Style	Streamline Moderne		
Architect/Builder			
Description	The three-story building has center and a flat roof. There Located on a slope, the build front entrance is accessed by façade. Windows are fitted w	is a large parking lot to one ing is only two stories at the a set of brick steps at the	e side of the building. The back. The recessed center of the main
Integrity	Appears to lack integrity		
Significance	Unlikely to be significant		
Notes

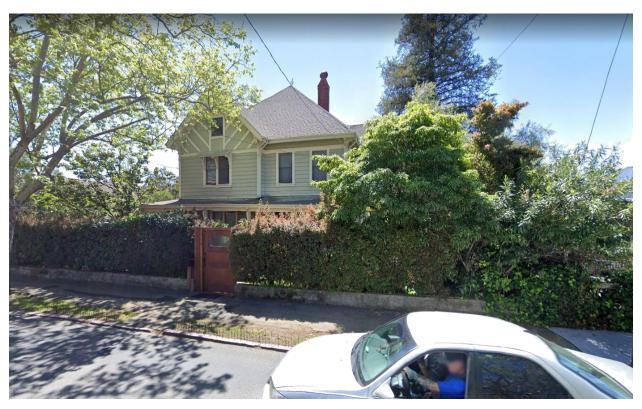
Address	1135 Mission Av	(lik	ely B)
APN	011-213-04		
Building Name	DeCourtieux House	DeCourtieux House	
Year Built	1893		
Original Use	Residential		
Architectural Style	Stick		
Architect/Builder			
Description	The two-and-a-half-story building has a roughly rectangular plan and combination cross-gabled and hipped roof. While the first floor is mostly obscured behind a tall hedge, the building appears to have a full-width integral porch with a slightly projecting roof on the main façade. There is a variety of cladding, including horizontal channel board siding and half-timbering on the gable faces.		
Integrity	Appears to retain integrity		
Significance	Potential local district contribu	itor, not individually eligible	
Notes

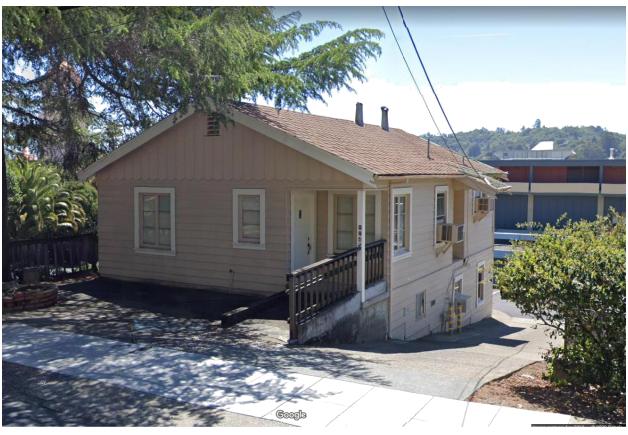
Address	1145 Mission Av	(likely E)
APN	011-186-11	•
Building Name		
Year Built	1937 (spreadsheet)	
Original Use	Residential	
Architectural Style	Minimal Traditional	
Architect/Builder		
Description	The one-story building has a rectangular plan and gabled composition shingle roof with exposed rafter tails. Sited on ground that slopes downward from the front, the building has a second, lower floor at the back. There is a small, partial-width integral porch, and a ramp with a wooden railing on one side leads up to it. The main entrance faces into the side of the building from the porch. The building is clad in a variety of wood board siding, both vertical and horizontal.	
Integrity	Integrity appears impaired; ramp has been added	
Significance	Not eligible, architecture not significant	
Notes

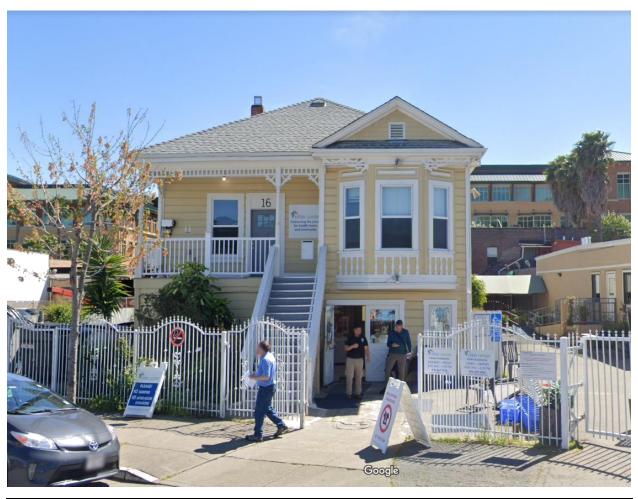
Address	16 Ritter Street	(likely E)
APN	011-272-04	
Building Name		
Year Built	1911 (spreadsheet)	
Original Use	Residential	
Architectural Style	Queen Anne Cottage	
Architect/Builder		
Description	The two-story building has a rectangular plan and a gable-on-hip composition shingle roof. There are two entrances on the main façade: a set of double doors on the first floor, and an entrance sheltered by a partial-width integral porch on the second floor. There is a bay window above the first-floor entrance. The building is clad in horizontal drop siding. The building has vinyl windows, a replacement door, replacement porch balustrade, and may have been raised.	
Integrity	Integrity appears impaired; windows replaced, door altered	
Significance	Not eligible, lacks integrity	
Notes

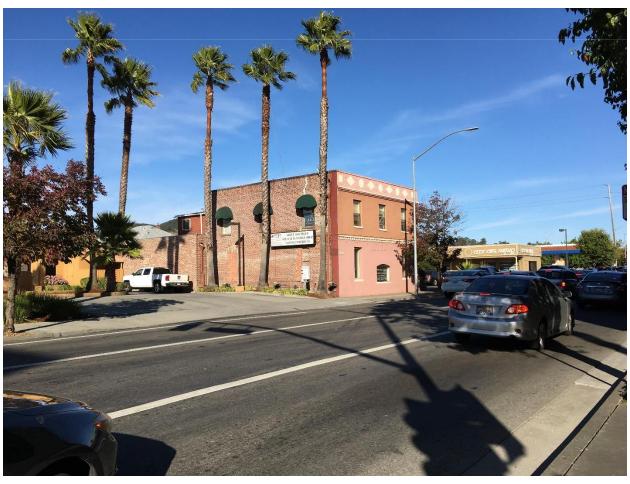
Address	826 Second Street	(likely E)
APN	011-272-10	·
Building Name		
Year Built		
Original Use		
Architectural Style		
Architect/Builder		
Description	front with a one-story porticled in brick, with stucco or molding above the first floor roof of the two-story volum. Windows are varied and febuilding, as does a door into	and roughly rectangular plan. It is two stories at the on and a lower one-story addition at the back. It is a the main façade and addition. There is dentiled or on the main façade. There is brick trim around the ne as well as brick sills on the second-floor windows. The attraction of the lower volume. There are also two garage doors is ilding, and the addition has an entrance as well.
Integrity	Lacks Integrity	
Significance	Not eligible, nineteenth cer	ntury commercial heavily altered on main facade
Notes

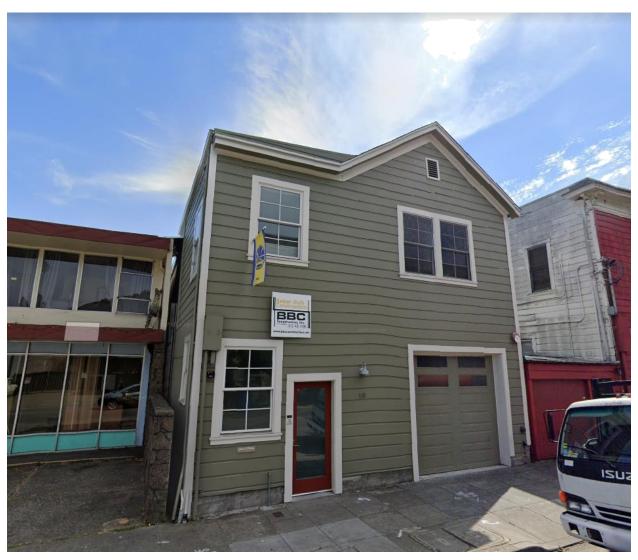
Address	1115 Second Street	7N	E	
APN	013-011-06	-		
Building Name	Mackey Frames			
Year Built	1875 (spreadsheet)			
Original Use	Residential	Residential		
Architectural Style				
Architect/Builder				
Description	The two-story building has a combination shed and gabled roof and a rectangular plan. It is clad in horizontal drop siding. There is a glazed door and a metal roll-up garage door on the main façade. Windows are hung vinyl sash			
Integrity	Appears to lack integrity	·		
Significance	Not eligible, lack of significa	nce and integrity		
Notes

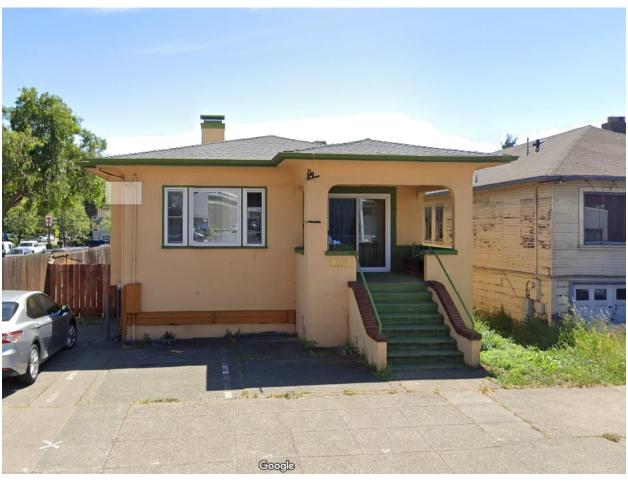
Address	1209 Second Street		E
APN	12-075-05		
Building Name			
Year Built	1924 (spreadsheet)		
Original Use	Residential		
Architectural Style	Craftsman		
Architect/Builder			
Description	The one-story building has a rincludes a projecting partial-viroof. There are two doors acceptass door that faces the streethat faces to the side. The burnear the bottom on the side faces to	vidth porch. It has a hipped essed via the raised porch et, and one partially glazed ilding is clad in stucco with	d composition shingle : one sliding double I single wooden door
Integrity	Appears to lack integrity, rep	acement windows, sliding	glass door
Significance	Not eligible, lacks significance	and integrity	
Notes

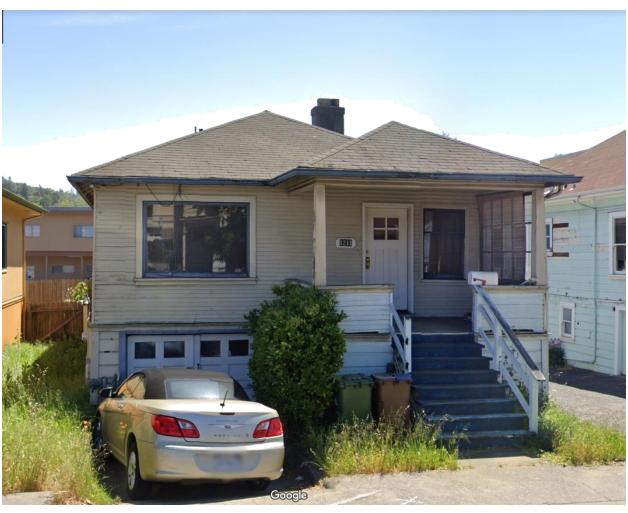
Address	1211 Second Street		С
APN	012-075-04		
Building Name			
Year Built	1920 (spreadsheet)		
Original Use	Residential		
Architectural Style	Hipped roof cottage		
Architect/Builder			
Description	The two-story building has ar width porch screened on one main entrance is on the secon siding in a variety of widths. Taçade.	side. It has a hipped comp nd floor. The building is cla	position shingle roof The d in a horizontal board
Integrity	Appears to retain integrity, m	ore study needed, conditi	on poor
Significance	Potential local district contrib	outor, not eligible as landm	ark
Notes

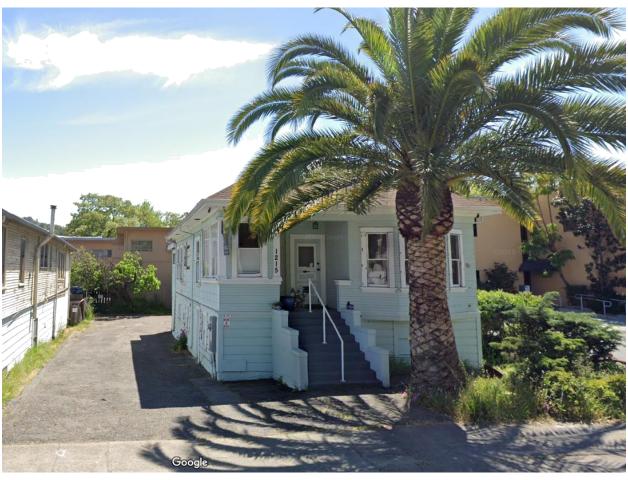
Address	1215 Second Street		В
APN	012-075-03		
Building Name			
Year Built	1916 (spreadsheet)		
Original Use	Residential		
Architectural Style	Hipped roof cottage		
Architect/Builder			
Description	The two-story building has re roof and has a parking lot bel sheltered under a partial-wid The building is clad in multipl double hung wood sash and partial building buildin	nind it. The second-story method it. The second-story method it. The second-story method it. The second it. The	nain entrance is ay window on one side. rd siding. It has original
Integrity	Retains Integrity		
Significance	Potential local district contrib	outor, not individually eligil	ole at any level
Notes

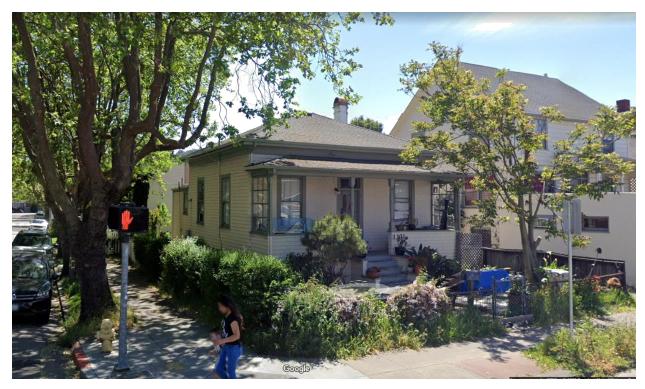
Address	1301 Second Street		B+
APN	012-073-07		
Building Name			
Year Built	1907 (spreadsheet)		
Original Use	Residential		
Architectural Style	Hipped roof cottage		
Architect/Builder			
Description	The one-story building has a a composition shingle hipped than the main roof. The main sheltered under a full-width decorative turned posts. The double hung wood sash and	roof. A volume at the real entrance is centered on torojecting porch, screened building is clad in wood sh	r of the building is lower he main façade and I on both sides with ningle. It has original
Integrity	Appears to retain integrity		
Significance	Contributor and potentially la roof cottage with excellent in		d example of hipped
Notes

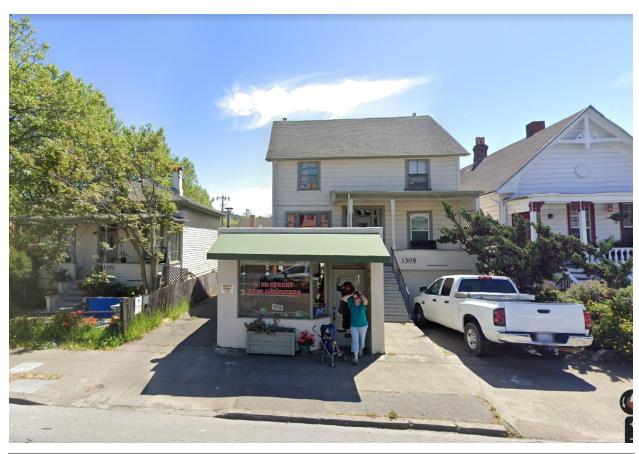
Address	1305 Second Street		E	
APN	012-073-06			
Building Name				
Year Built	1887 (spreadsheet)			
Original Use	Residential			
Architectural Style	Folk Victorian			
Architect/Builder				
Description	The original building has a rouprojects forward on the main with a gabled composition sh partial-width projecting porchannel board siding. On the The addition is one story; it risecond floor, running next to supports, which is abbreviate original volume's main entrarplate glass window on its main	façade. The original voluningle roof. The main entran with a flat roof. The volufirst floor is a vertical boarses to about halfway up the front staircase, under d to make space for it, and noe. The addition has its over	ne is three stories tall nce is sheltered under a me is clad in horizontal od wooden garage door. ne original volume's one of the porch d up to one side of the wn entrance and large	
Integrity	lacks integrity due to additior	<u> </u>

Significance	Not eligible, lacks integrity			
Notes

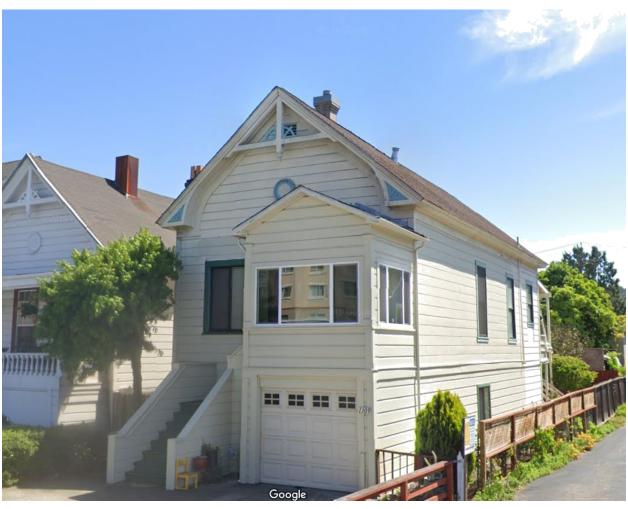
Address	1309 Second Street		E
APN	012-073-04		
Building Name			
Year Built	1900 (spreadsheet)		
Original Use	Residential		
Architectural Style	Victorian		
Architect/Builder			
Description	The long rectangular building roof with decorative gable br sheltered under a partial-wid from the side and above the horizontal board siding.	acket details. The second-s th projecting gabled porch	story entrance is , accessed by a staircase
Integrity	Lacks Integrity, replacement	windows and porch	
Significance	Not eligible, lack of integrity		
Notes

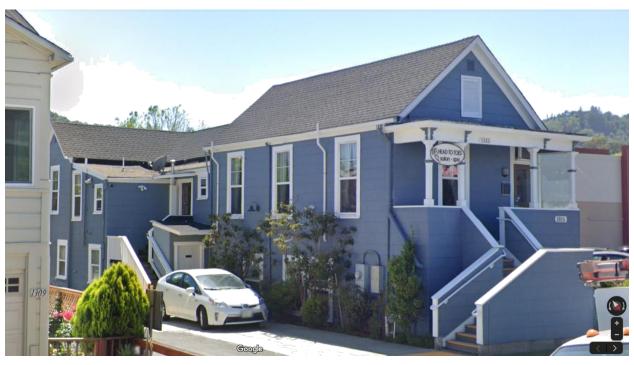
Address	1315 Second Street	E	
APN	012-073-03		
Building Name			
Year Built	c1900 (spreadsheet)		
Original Use	Residential		
Architectural Style	Folk Victorian		
Architect/Builder			
Description	The long, L-shaped two-story building has a gabled composition shingle roof. It is clad in horizontal board siding. The building has a second-floor entrance, sheltered under a projecting full-width porch accessed by a staircase on the main façade.		
Integrity	Lacks Integrity impaired, repl	acement windows, raised	
Significance	Ineligible, lack of integrity	<u> </u>	
Notes

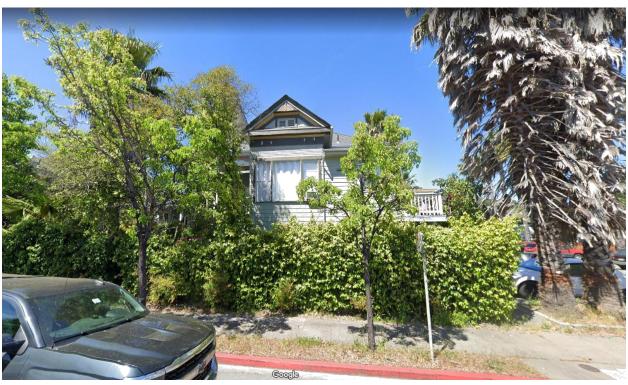
Address	1416-1420 Second St	7N	E
APN	011-252-11		·
Building Name			
Year Built	1895 (spreadsheet)		
Original Use	Residential		
Architectural Style	Queen Anne		
Architect/Builder			
Description	is a parking lot to one side of deck are located near the ba parking lot rather than the fa	nere is considera the building, ar ck of the buildin gade facing the	s located behind a high wall able vegetation on the parcel. There and the second-story entrance and ag on the façade that faces the street. The building has a gabled oom in one corner with a pointed
Integrity	Lacks Integrity, replacement	windows and st	airs/deck
Significance	Not eligible, lacks integrity		
Notes
