Downtown San Rafael Precise Plan Historic Resources Inventory Summary Report

Downtown San Rafael Precise P	Plan
Historic Resources Inventor	y Summary Report
A companion document to the Downtown he San Rafael General Plan 2040 Environ	
Prepared by the City of San Rafael	
Vith assistance from Garavaglia Associa	ites and Opticos Design
Published December 2020	Cover Photo Credits: Matthew X Kiernan

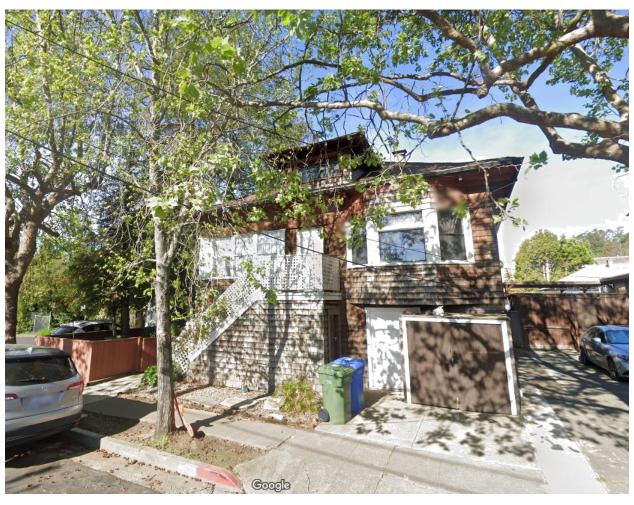
Address	3 Stevens Place		С
APN	014-011-15		
Building Name			
Year Built	1913 (spreadsheet)		
Original Use	Residential		
Architectural Style			
Architect/Builder			
Description	The two-story rectangular bu overhanging eaves. It is clad i the main façade, including a sade-facing entrance that op varied, and there is a dormer	n wood shingle. There are second-story entrance acc pens into the base of the s	multiple entrances on essed by a staircase and
Integrity	Integrity impaired, replacemental study needed	ent doors and windows, po	orch enclosed, more
Significance	Potential district contributor	if integrity is retained	
Notes

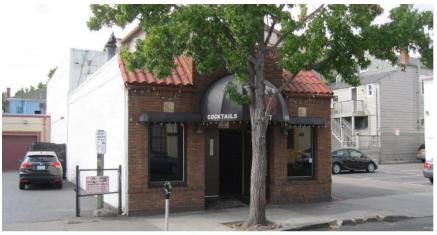
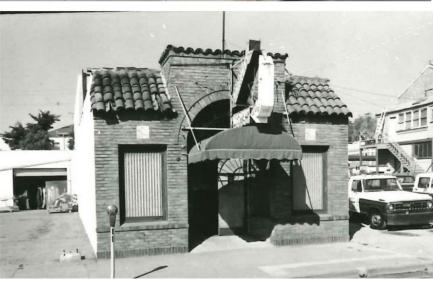
Address	927 Tamalpais Av	3S	В
APN	011-275-04		
Building Name	Barrel House		
Year Built	c1925 (spreadsheet)		
Original Use			
Architectural Style			
Architect/Builder			
Description	The narrow rectangular building is one story at the front and two stories toward the back. It has a flat roof and is clad in brick with some vertical board siding on the second story. The brick is unpainted on the main façade. The main façade also features a slanted tile roof on either side of the partial-width parapet that		
	shelters the arched main ensmall storefront windows.	trance. There are large dec	orative tiles over the
Integrity	Retains integrity, see 1970s	photo above	
Significance	Eligible as district contributor, lacks significance for landmark status		
Notes

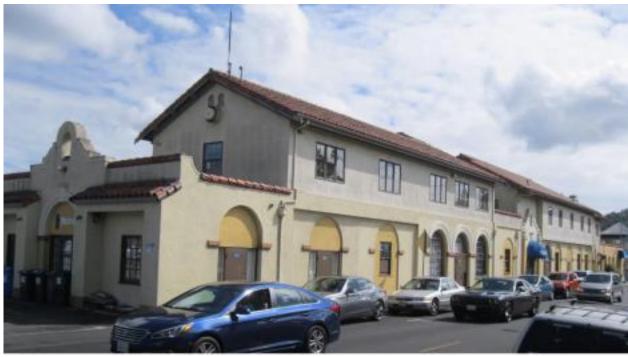
Address	930 Tamalpais Av	3S	E
APN	011-277-01		
Building Name	Northwest Pacific Railroad De	epot	
Year Built	c1929 (spreadsheet)		
Original Use	Railroad Depot		
Architectural Style	Spanish?		
Architect/Builder			
Description	The two-story linear building runs along the railroad tracks next to Tamalpais Avenue. It is clad in smooth stucco and has a gabled tile roof. Windows are varied, but all have multiple small lights; most are wide vertical eight-over-eight light windows. A series of arches in shallow relief along the main façade have windows or doors in them. There are a number of entrances on the main façade, but the main entrance is located under a cloth awning and large decorative arch.		
Integrity	Appears to retain integrity, more study needed, 2 nd story addition		
Significance	Likely significant, currently be nomination	eing separately evaluated f	or individual NRHP
Notes

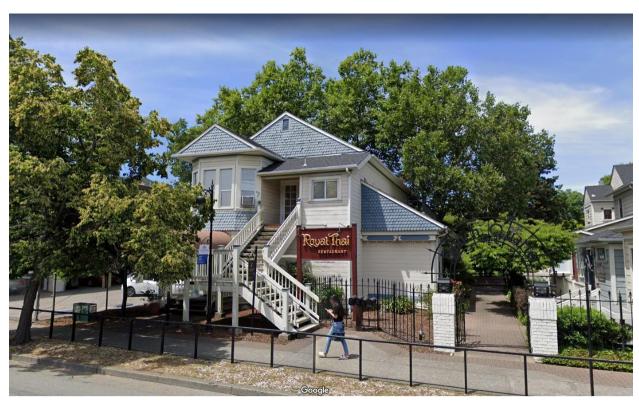
Address	610 Third Street		E
APN	014-122-14		
Building Name	French Quarter		
Year Built	[spreadsheet gives implausib	le date of 1970]	
Original Use	Residential		
Architectural Style	Queen Anne		
Architect/Builder			
Description	The two-story rectangular building has a gabled composition shingle roof. There are two entrances located on the main façade. An entrance on the first floor under a bay window is sheltered by a cloth awning. The other entrance, located on the second floor, is accessed by a wooden staircase and sheltered under a partial-width integral porch. The building is clad in a combination of horizontal board and fishscale shingle siding. Appears to have been raised, shed roof addition		
Integrity	Integrity impaired by windows, staircase, enclosed porch, shed addition		
Significance	Not eligible, lacks integrity		
Notes

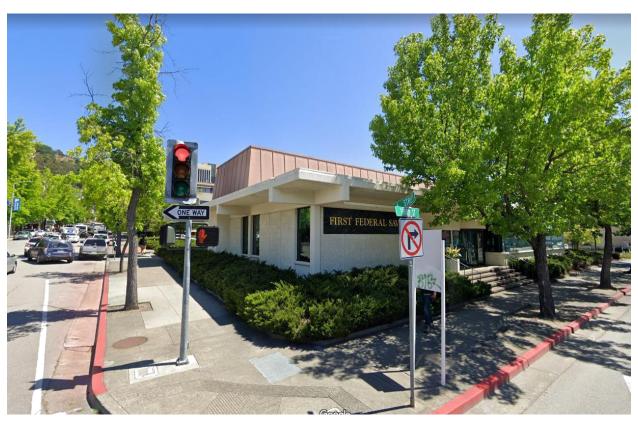
Address	1030 Third Street		Α
APN	011-263-21		
Building Name	First Federal Savings and Loai	า	
Year Built	1963 (spreadsheet)		
Original Use	Commercial		
Architectural Style	Modern		
Architect/Builder	John Carl Warnecke (DIJ 11/23/1962)		
Description	The one-story rectangular bu other two sides by a driveway roof with wide eaves and a perough stucco, which are interlong horizontal stretches of warevolving door accessed by a other entrances.	y and parking lot. The build enthouse with slanted side spersed with tall vertical w vindow on multiple façade	ding has a flat concrete es. It is clad in panels of vindows. There are also . The main entrance is a
Integrity	Appears to retain integrity, further study needed		
Significance	Probable eligible as landmark, designed by John Carl Warmecke		
Notes

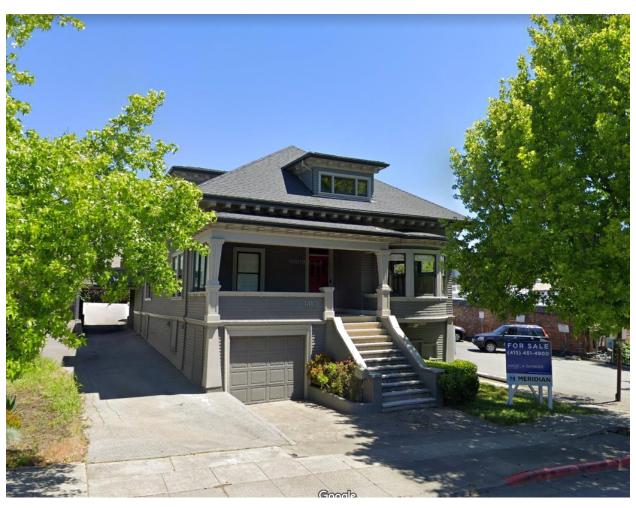
Address	1410 Third Street		Α
APN	011-251-09		
Building Name			
Year Built	1916 (spreadsheet)		
Original Use	Residential		
Architectural Style	Foursquare/Craftsman		
Architect/Builder			
Description	The two-story rectangular bu hipped dormers on three faça under a deep partial-width in Eaves around the roof as wel all feature decorative bracket original double hung wood sa columns are highly decorative	edes. The second-story ma tegral porch; next to it is a las the porch, the bay win is. The building is clad in cl ish windows and partially	nin entrance is sheltered a rounded bay window. Indow, and the dormers appoard siding and has
Integrity	retains integrity		
Significance	Eligible as landmark and distr	ict contributor	
Notes

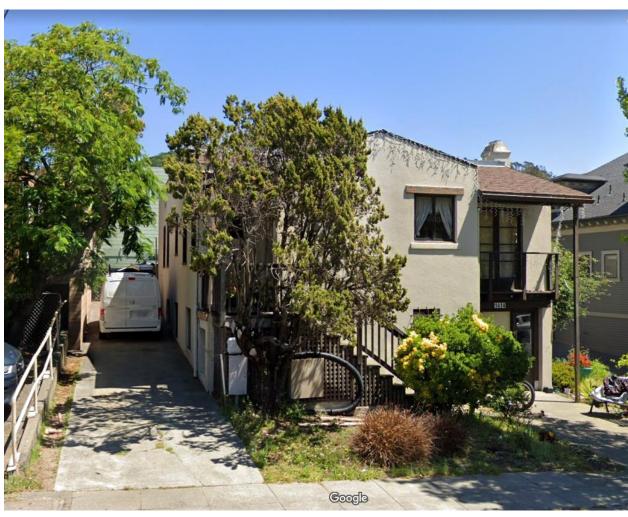
Address	1414 Third Street		E
APN	011-251-11		
Building Name			
Year Built	1930 (spreadsheet)		
Original Use	Residential		
Architectural Style			
Architect/Builder			
Description	The two-story rectangular-plan building has a cross gable near the main façade, but most of the roof is flat. The building is clad in stucco with varied fenestration. The main façade features a ground-floor entrance as well as a second-floor entrance accessed by a wooden staircase.		
Integrity	Appears to lack integrity		
Significance	Not likely to be significant		
Notes

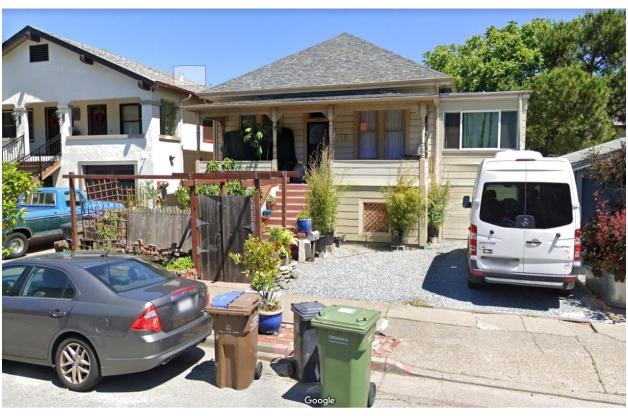
Address	1532 Third Street		В
APN	011-243-11		
Building Name			
Year Built	1900 (spreadsheet)		
Original Use	Residential		
Architectural Style	Hipped Roof Cottage		
Architect/Builder			
Description	The building is one story with a hipped composition shingle façade, accessed by a center posts and scrolled brackets. roofed addition to one side.	e roof and a projecting full- ed set of steps. The porch h It is clad in horizontal board	width porch on the main has decorative turned disiding. There is a flat-
Integrity	Retains Integrity despite side	addition	
Significance	Eligible as district contributo	r, not a landmark	
Notes

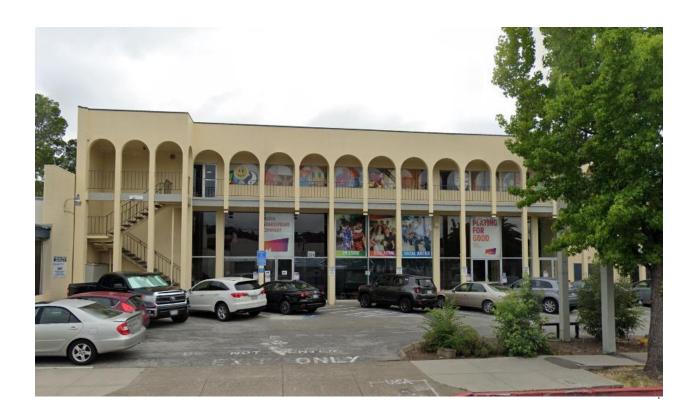
Address	514 Fourth Street		E
APN	014-086-15		
Building Name			
Year Built			
Original Use	Commercial		
Architectural Style	New Formalism		
Architect/Builder			
Description	The two-story rectangular-plate parking lot. The double-height aluminum frame storefronts of forward slightly at one corner along the second floor; both the projecting roof with an arcad	t first floor features multipon the main façade. An ext on the main façade, and a of the main façade, and a the staircase and hallway a	ole entrances and large terior staircase projects an exterior hallway runs are sheltered under a
Integrity	Retains integrity		
Significance	Not eligible, not a significant	example of the style	
Notes

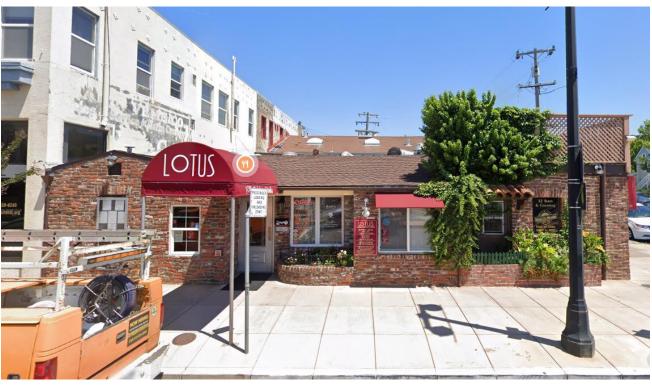
Address	704 Fourth Street		E
APN	011-227-10		
Building Name	Lotus Restaurant		
Year Built			
Original Use	Commercial		
Architectural Style	Mid-century		
Architect/Builder			
Description	The rectangular-plan building is located on a corner lot. The roof type is unclear, but there is a front gable located to the side of the main entrance. The roof is composition shingle and there is a tile awning over one window, a cloth awning over another window, and a projecting cloth awning over the main entrance. The building is clad in brick and the main façade features built-in brick planters. Windows are a variety of shapes and sizes.		
Integrity	Integrity appears impaired		
Significance	Not likely to be significant		
Notes

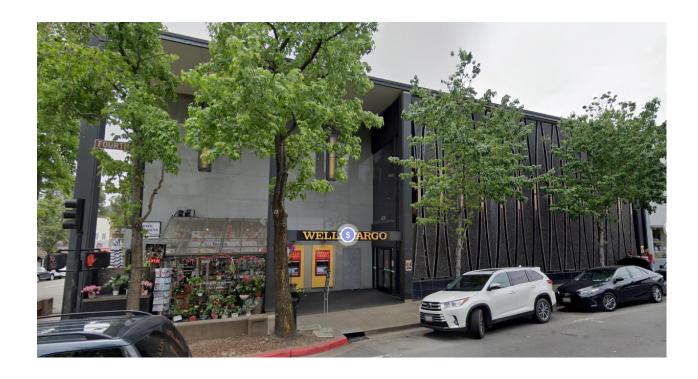
Address	1203 Fourth Street		C
APN	011-255-23		
Building Name	Wells Fargo		
Year Built			
Original Use	Commercial		
Architectural Style	Midcentury Modern		
Architect/Builder			-
Description	The rectangular-plan building clad in two kinds of tile and for walls with decorative cutouts integral full-height awning at under its own lower awning.	eatures large windows scre . The main entrance is loca	eened by pebbledash ated to the side of an
Integrity	Appears to retain integrity, m	ore study needed	
Significance	Appears eligible as landmark	and contributor

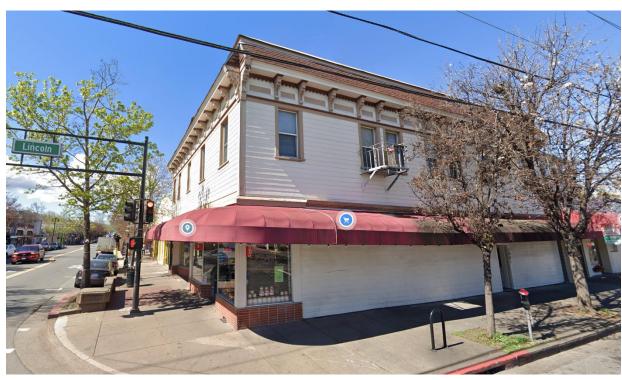
Address	1001 Lincoln Avenue		В
APN	011-224-10		
Building Name			
Year Built			
Original Use	Commercial		
Architectural Style			
Architect/Builder			
Description	The two-story building has a side composition shingle gable corner lot by a slanted parape. The main façade contains two plate-glass windows, with bribetween the windows. On the clad in horizontal board siding	es, hidden on both the street supported by decorative of first-floor storefronts corock bulkheads and narrow we second floor and other face.	eet-facing sides of the molding and brackets. Insisting primarily of large vertical board siding açades, the building is
Integrity	Appears to retain integrity de	spite window replacemen	ts
Significance	Eligible as district contributor	, lacks integrity required for	or landmark
Notes

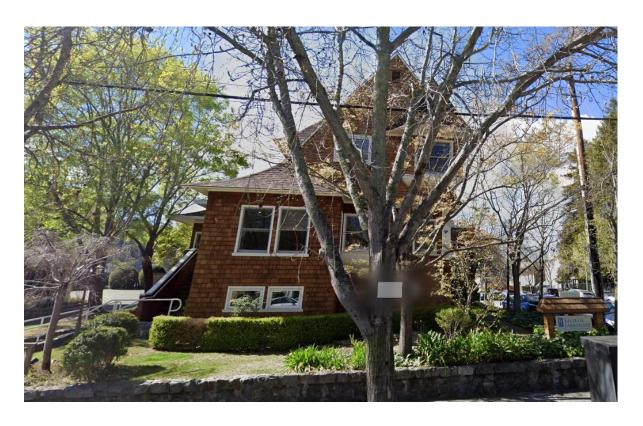
Address	1099 E Street		В
APN	011-202-06		
Building Name	Schlosser-Cole Residence		
Year Built			
Original Use	Residential		
Architectural Style			
Architect/Builder			
Description	The three-story building has a composition shingle gable-on integral porch on the main fa building. The building has wid small tower with a pointed ro	-hip roof. It is clad in wood çade and several other en de double-hung wood sash	d shingle. There is an trances around the windows. There is a
Integrity	Appears to retain integrity		
Significance	Potential district contributor,	not individually eligible at	any level
Notes	Registered local landmark		·

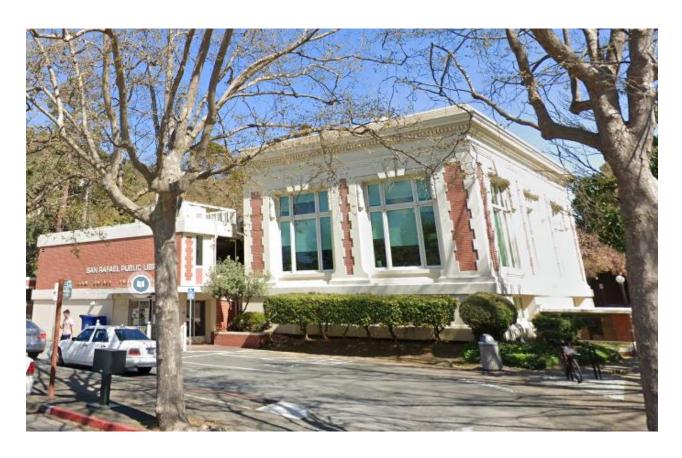
Address	1100 E Street	35	Α
APN	011-203-01		
Building Name	San Rafael Public Library		
Year Built			
Original Use	Library		
Architectural Style			
Architect/Builder			
Description	The large T-shaped building of surrounded by landscaping a The building is composed of taller older volume is clad in volume features a number of quoins flanking the windows the windows. The newer volubrick. On its main façade, the a corner; the upper half of the subtle dentil molding in a more façade is clad almost entirely alternate with brick-and-studies.	nd parking lots as well as multiple volumes of differ brick and stucco and has decorative details, includes well as at the corners, ame is longer and shorter automatic sliding glass defaçade is clad in brick, are subdued echo of the orin brick. On the volume's co patterns that mimic the	streets on three sides. rent sizes and eras. The large windows. This ding dentil molding, and large keystones on . It is clad in stucco and oor entrance is located in and the lower features older volume. The rear s other façades, windows he older volume's quoins.

Integrity	60s addition in notably differ		c and both the addition
	and original building look to		
Significance	Eligible as landmark and cont	ributor	
Notes

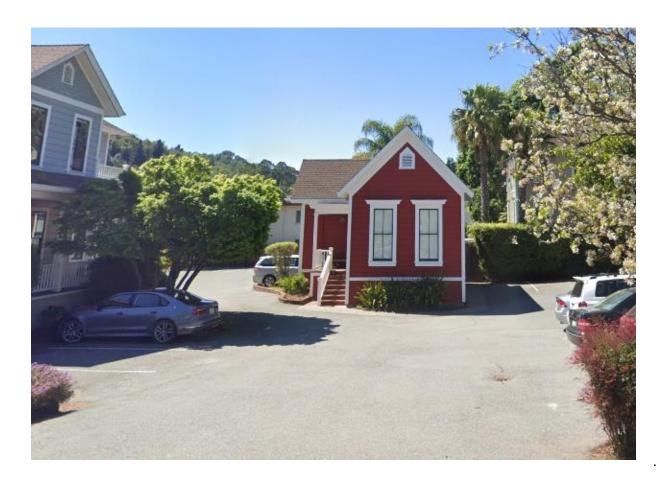
Address	1623 5 th Avenue, Building C	7N	В
APN	011-320-03	1710	
Building Name			
Year Built			
Original Use	Residential		
Architectural Style	Victorian		
Architect/Builder			
Description	The small one-story L-shape buildings and is set back from shingle roof. It is clad in hori on the gable faces. A small in entrance, which opens into two-over-two light double-h	m the street. It has a cross- zontal channel board sidin ntegral porch on the main the side of the projecting v	gabled composition g with fishscale shingle façade leads to the main
Integrity	Appears to retain integrity		
Significance	Potential local district contri	butor, not individually elig	ible at any level
Notes
