# Inspection Report

**Property Address:**  
3618 Groveland Ave  
Mt. Pleasant SC 29466

<b>Date:</b> 5/15/2013	<b>Time:</b> 08:45 AM	<b>Report ID:</b> Sample Report
<b>Property:</b> 3618 Groveland Ave Mt. Pleasant SC 29466	<b>Customer:</b> Mrs. Carla Blackburn	<b>Real Estate Professional:</b>

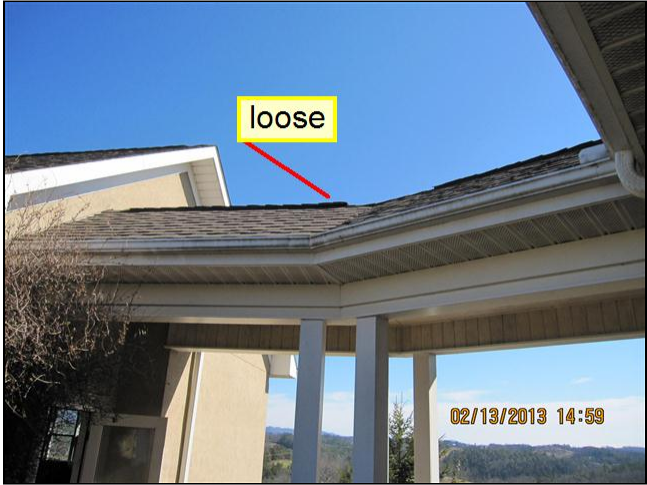
1.2 Item 1(Picture)

Ridge vent loose at end above breezeway and needs to be fastened. Nail head used to fasten should be sealed with sealant.

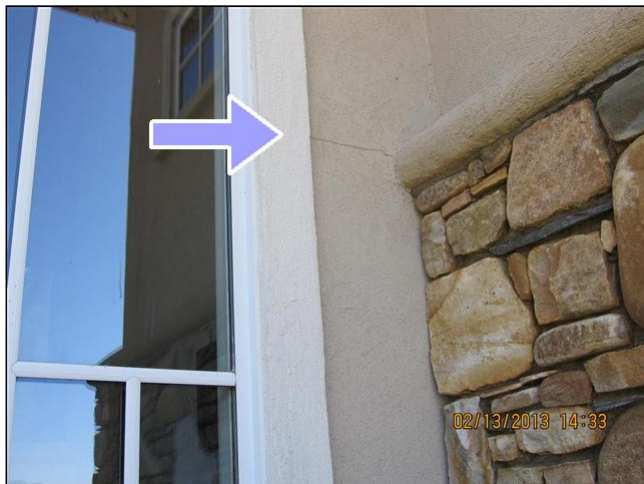
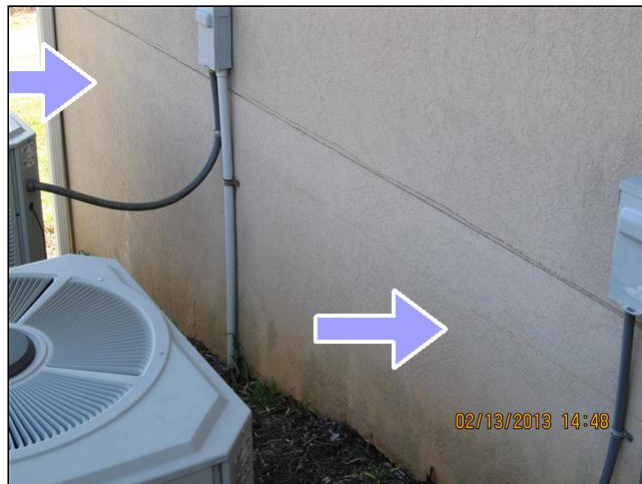
2.0 Item 2(Picture)

(1) Some hairline cracks in areas around home. These appear to be typical.

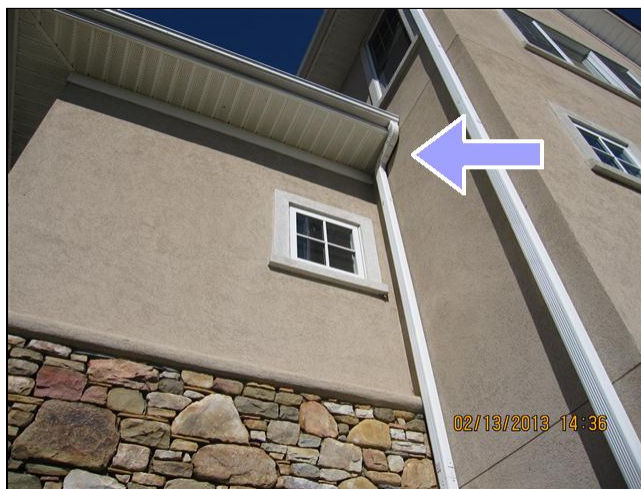
2.0 Item 3(Picture)

(2) Bird nest is wedged between downspout elbow and home should be removed and inspect further as animals can damage and allow water to get inside wall.

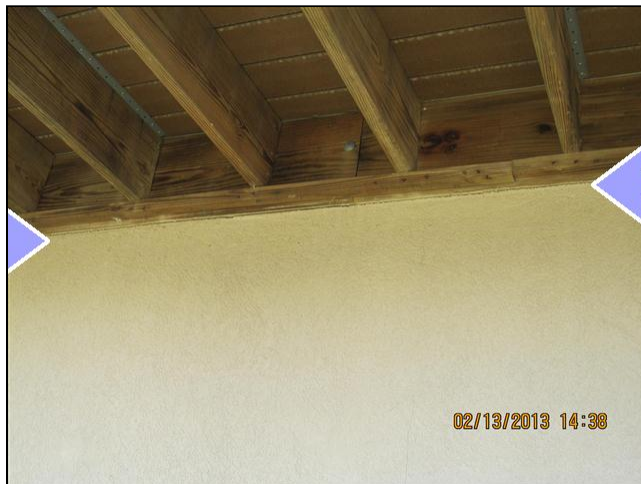
2.0 Item 4(Picture)

(3) A common seam where stucco and ledger meet under deck. I recommend silicone caulking to seal.

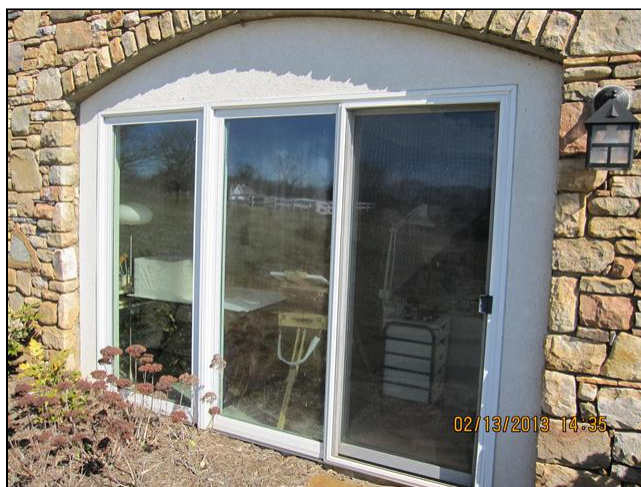
2.1 Item 1(Picture)

Glass panel doors/window at right side (facing front) cloudy or seal is broken. Glass panes that have lost their seal (cloudy) can usually be replaced without replacing the entire unit. A qualified contractor should inspect and repair as needed.

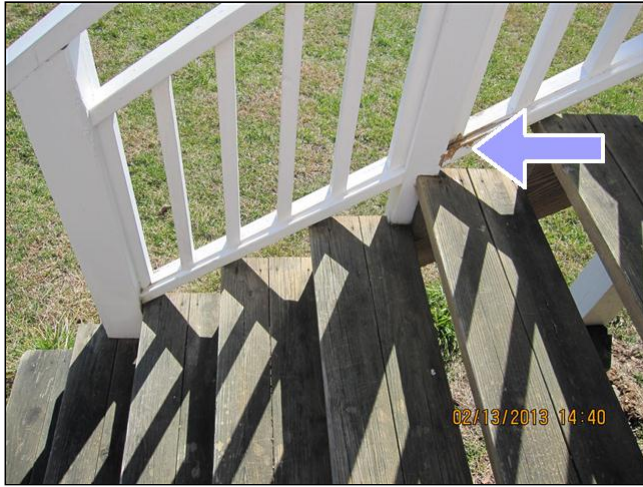
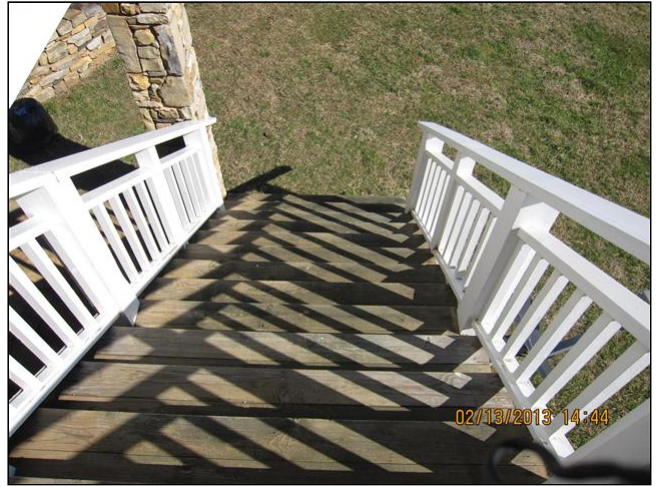
2.3 Item 2(Picture)

Bottom rail is soft or deteriorated in one area and other areas weathered. Needs prep and paint. Deck stairs need algae removed with a cleaner and seal with a non skid weather sealant.

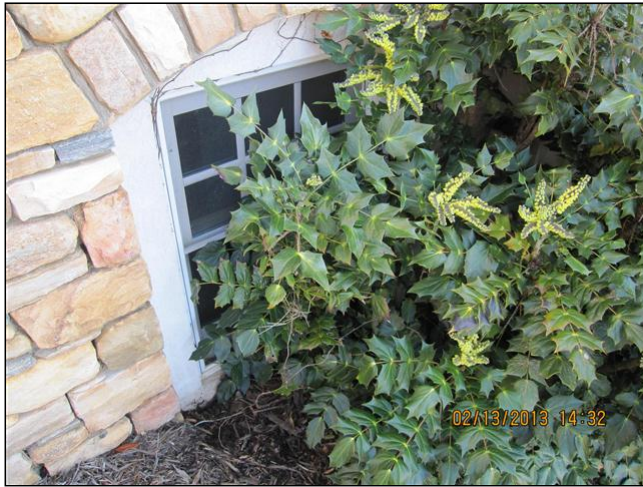
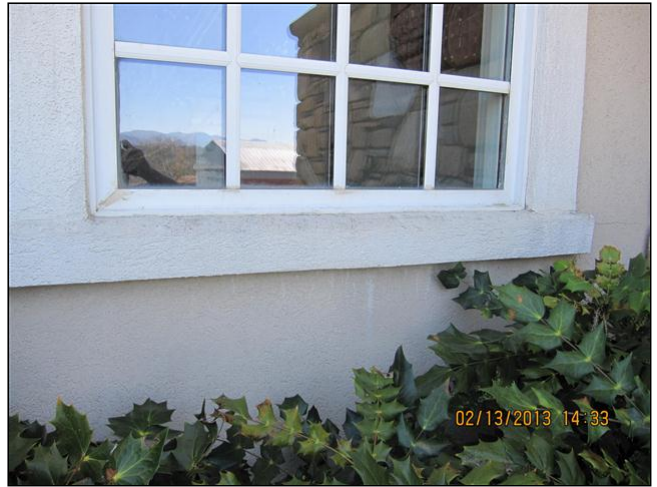
2.4 Item 2(Picture)

Thorny bushes or vegetation obstructing access and should be relocated to allow clearance from siding of home

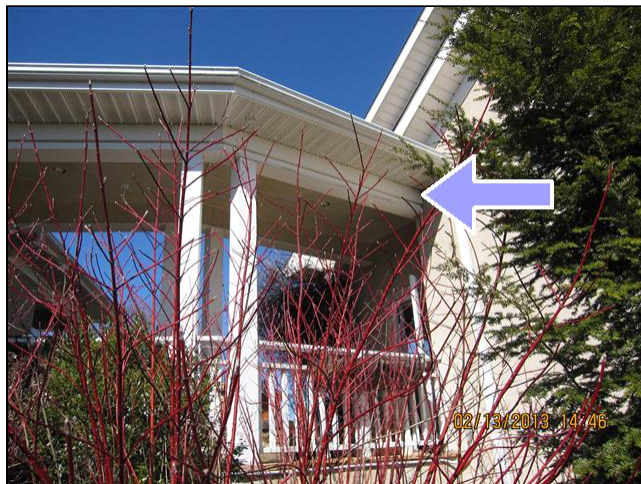
2.5 Item 1(Picture)

Some areas need prep and paint along breezeway at top fascia trim (cosmetic).

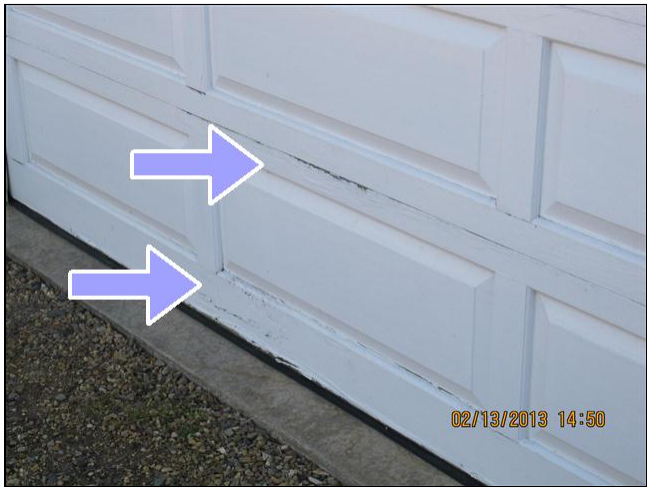
3.3 Item 1(Picture)

Weathered needs prep and paint at Garage door.

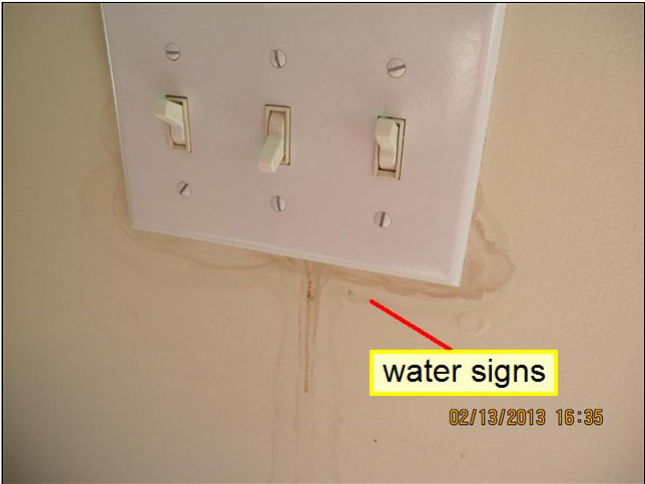
4.1 Item 2(Picture) wall switch Lower level

Wall switch at lower level shows evidence of water getting in from outside? There is a light fixture in relation to this wall switch and perhaps water is getting in there? i recommend further investigation to determine location and correct.

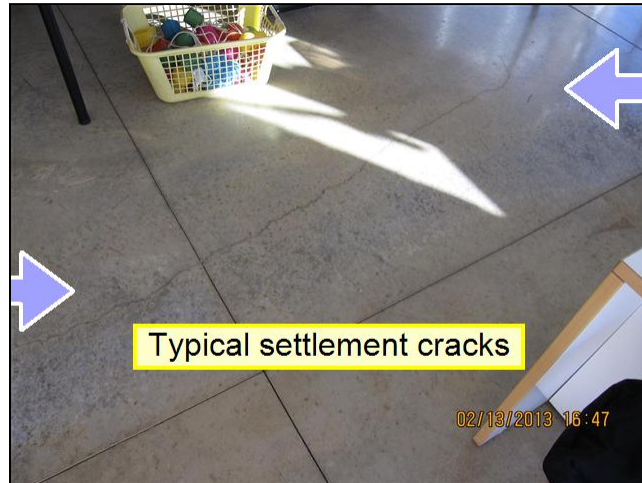
4.2 Item 1(Picture)

Lower level concrete has typical settlement cracks. We did not remove area rug or inspect underneath it.

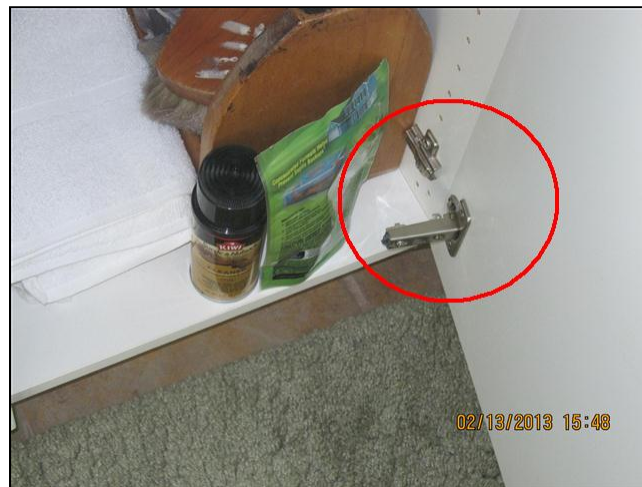
4.4 Item 1(Picture)

Hinge needs repair/replace at sink base in master bath.

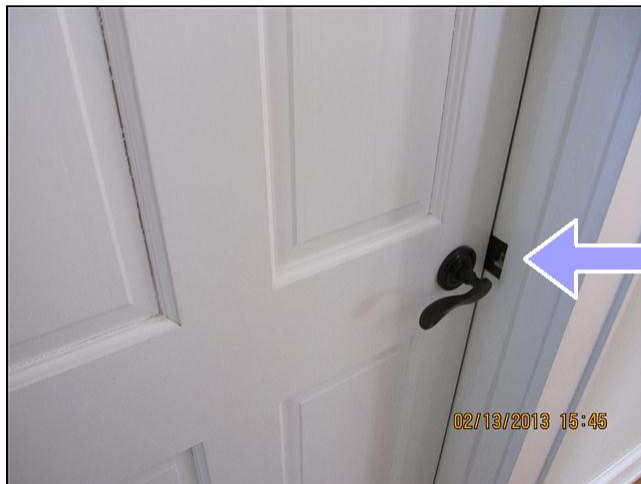
4.5 Item 1(Picture)

Master bedroom closet door (His) will not latch easily, needs adjustment

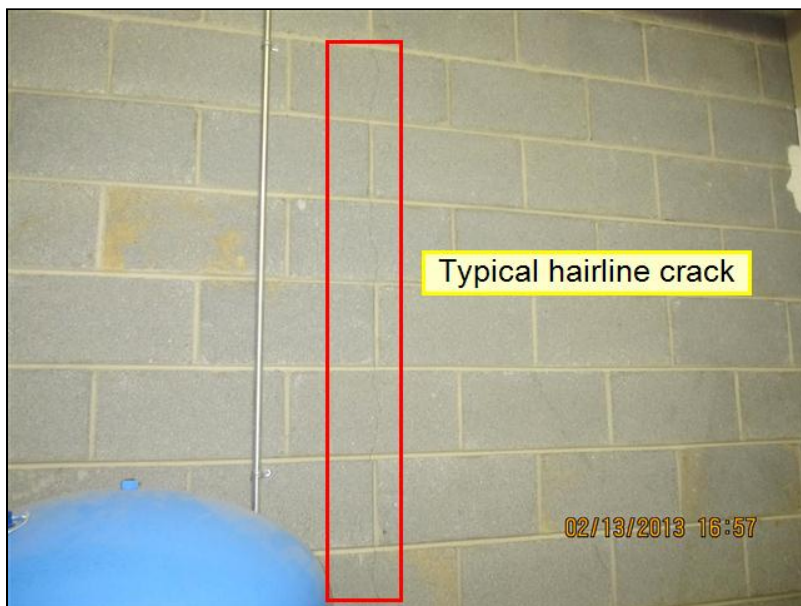
5.1 Item 1(Picture)

Hairline cracks in wall (typical).

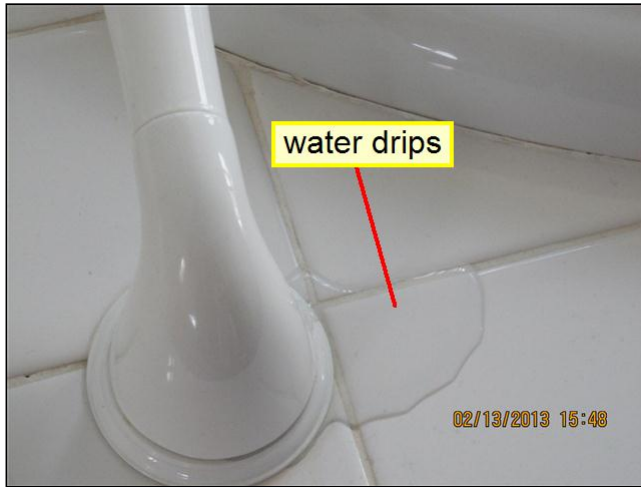
6.1 Item 1(Picture)

(1) Water drips from control knob on Jacuzzi brand tub. Also the lever to switch from spout to shower head works but feels weak when moved/turned and I am not sure if it is standard or loose? Recommend a plumber to inspect and repair as needed.

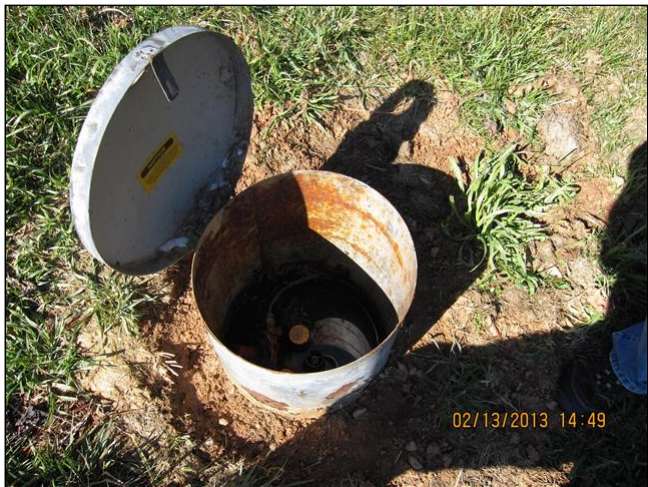
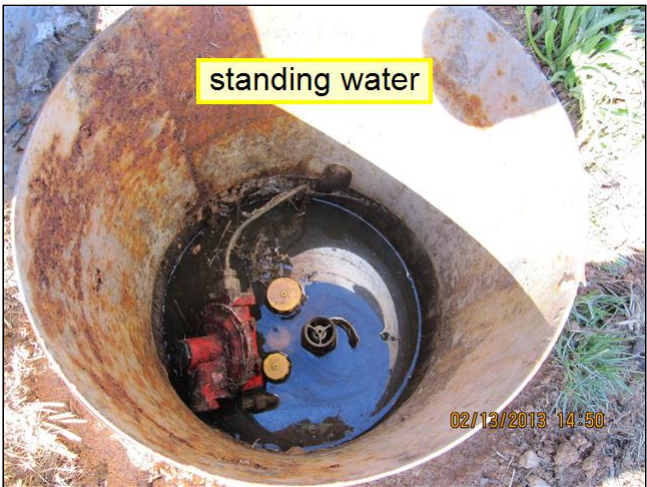
6.4 Item 2(Picture) propane tank valves

(1) Standing water should be removed and prevented from occurring at propane valves and meter access.

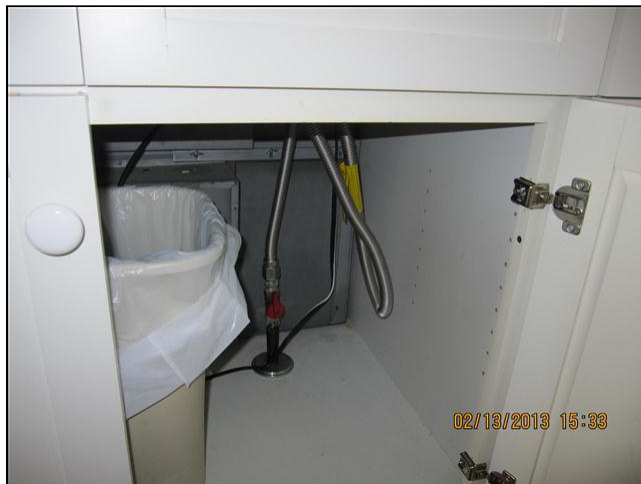
6.4 Item 3(Picture)

(2) Gas odor detected under range in kitchen and also upon entering into Equipment room downstairs where LP gas water heater is located. Note, there is a fresh air pipe connecting the equipment room to the outside air. Some energy pros may suggest that a mechanical fan would be more energy efficient than the passive vent installed.
