Survey and Research Report On The Sherrill-Robbins House

A Brief History of the Sherrill-Robbins House

Architectural Descriptions

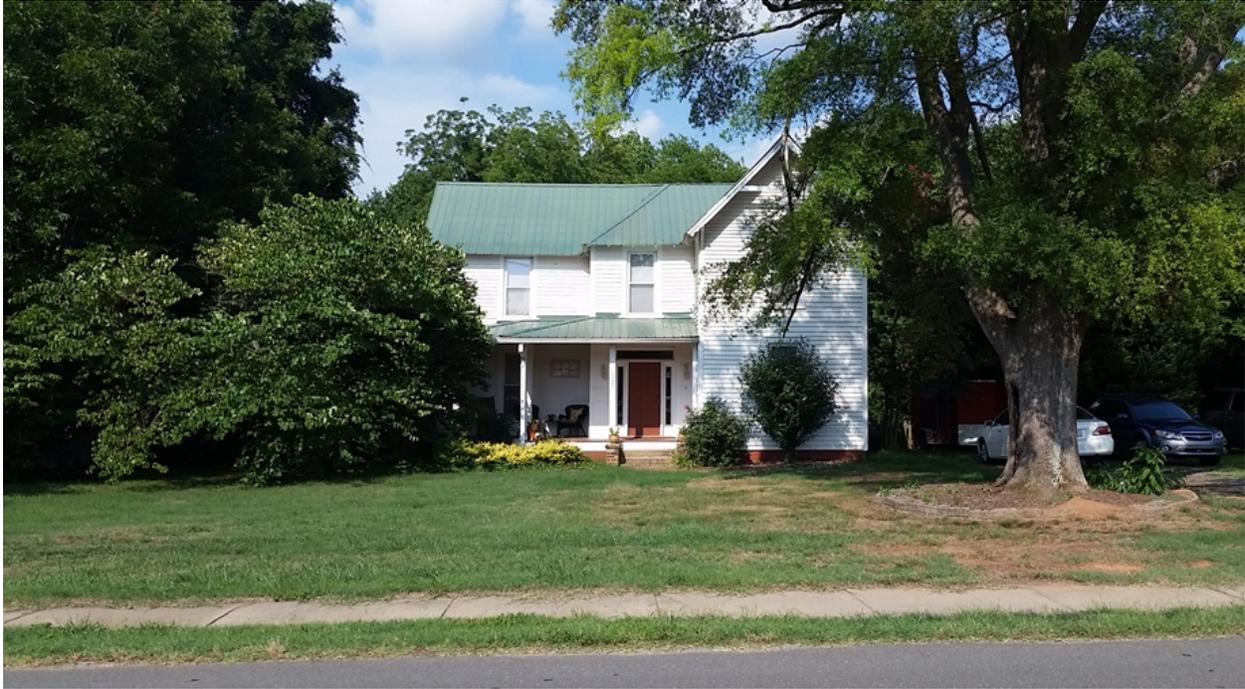
The Sherrill-Robbins House is located at 19726 Zion Avenue, in Cornelius, NC. The two-story, frame, crossed-gabled house faces west on a large lot and is setback approximately seventy feet from the street. Zion Avenue is quiet, narrow, and unlined. In front of the Sherrill-Robbins House, Zion Avenue runs parallel to the north-south line of the Norfolk-Southern Railway. The street is approximately 30 feet to the east of the rail line. A concrete sidewalk runs along the east side of the street, separated from the street by a grassy strip. The approximately 1 acre lot features large trees and shrubs around the house and dense woods toward the rear of the lot. The lot slopes gradually to the rear.

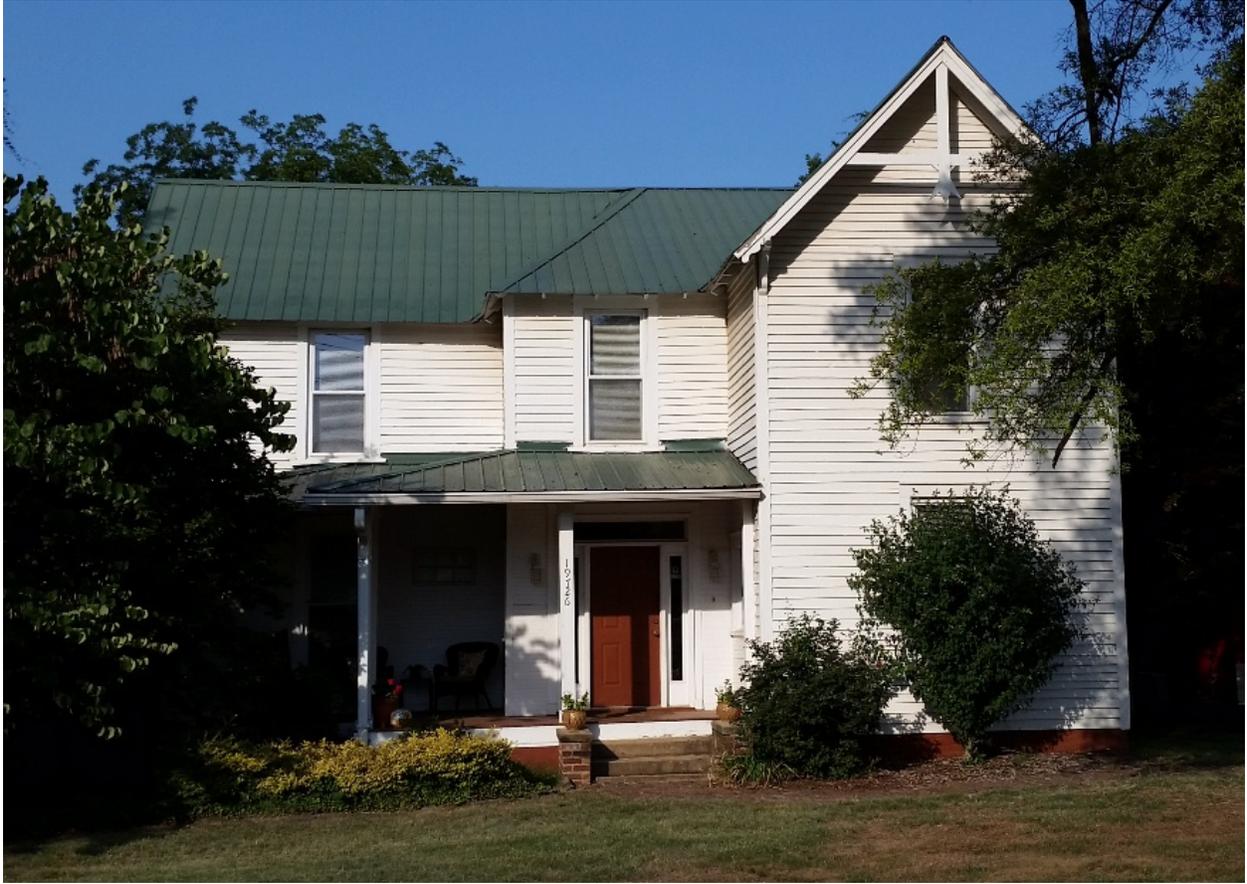
At the core of this cross-gabled plan house is a two-story, single-pile, side-gabled principal section, which is essentially the I-house form. Projecting forward from the southern side of the principal section is a one-bay-wide gabled wing. Between the gabled wing and the principal section is a shallow, hipped-roof projecting bay that accommodates a large hall and stairwell. This floor plan not only accommodates generous interior space, but it also presents an asymmetrical façade, which is a key element of the Queen Ann style. Other Queen Ann style elements include crossed trim in the gables, and the use of diamond-light sash windows. The Sherrill-Robbins House could be considered an example of Folk Victorian architecture or a restrained example of the Queen Ann style.

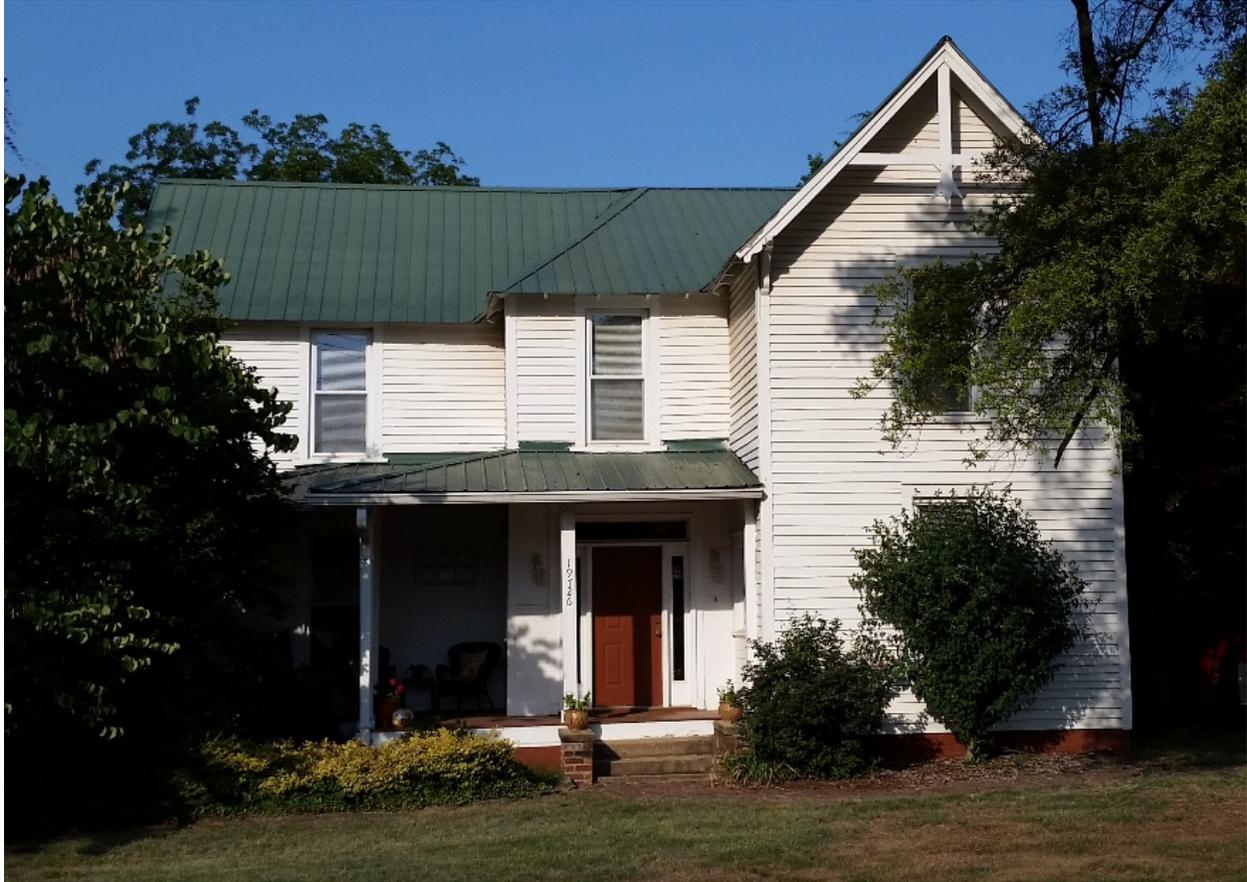
The façade of the Sherrill House can be divided into three bays. The façade is dominated by the two story front-projecting wing and a hipped-roof porch that wraps around the shallow center bay. The two-story wing is set close to the south elevation and rests on brick piers infilled with brick curtain walls. The wing, and the majority of the exterior, are covered with simple weatherboards that terminate in simple corner boards. A single two-light replacement window is centered in the wing on both the first and second story. The replacement windows are set in the original window frames. The original window frames feature moulded cap trim. The siding continues entirely over the gable. The gable features a decorative cross-design truss with a star-shaped pendant, and rake boards that terminate with curved scroll-work and rests on triangular brackets with applied curved trim. The gabled roof is steeply pitched and covered with green metal roofing panels. The exposed underside of the roof deck is covered with beaded board.

The porch extends from the north elevation of the gabled projecting wing, wraps around the center hipped bay and across most of the northern bay of the principal side-gabled section of the house. The porch is covered with green metal roofing panels and is supported by simple box-construction posts and pilasters with simple caps and bases. The exterior walls sheltered by the porch are covered with beaded boards. The porch floor is narrow tongue-and-groove boards, and the ceiling is beaded boards. The porch rests on brick piers, infilled with brick curtain walls. The porch shelters a wide original door opening in the center bay. The opening has retained the original trim, including starter blocks and a moulded cap. A replacement door frame with sidelights and a transom has been installed in the opening. The porch also shelters two fixed

diamond-light windows. One is located in the north elevation of the projecting wing, and one is located in the north elevation of the shallow projecting center bay. The stained glass is not original. A single window that pierces the northern bay of the principal section is also sheltered by the porch. Like the windows in the front wing, a replacement window has been installed in the original window opening. On the second story, the center projecting bay and the northern bay each contain a single window like those in the projecting wing. The roof overhang features exposed rafter tails.

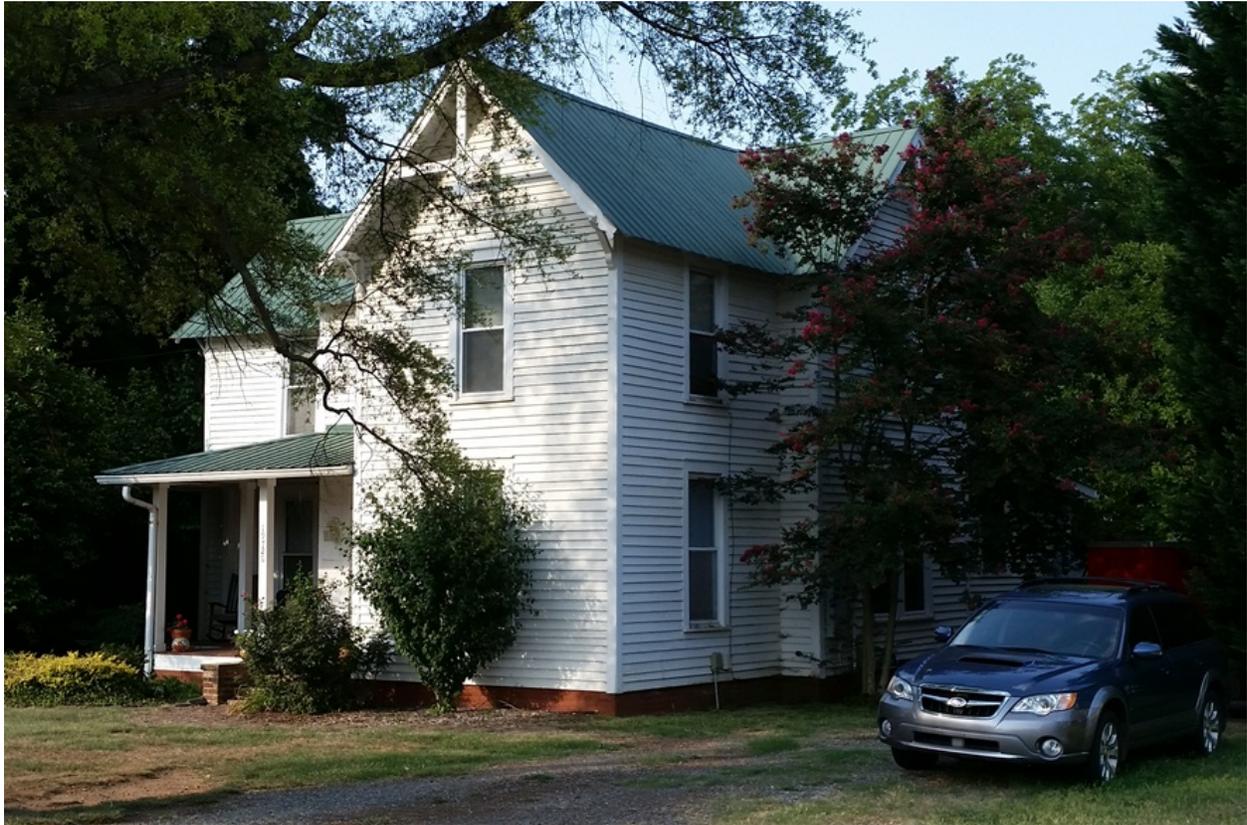
The original portion of the south elevation is two bays wide. The projecting wing is one bay wide and features a single replacement window set in the original window frame on the first and second stories. Under the wing the original brick piers are exposed and infilled with brick.

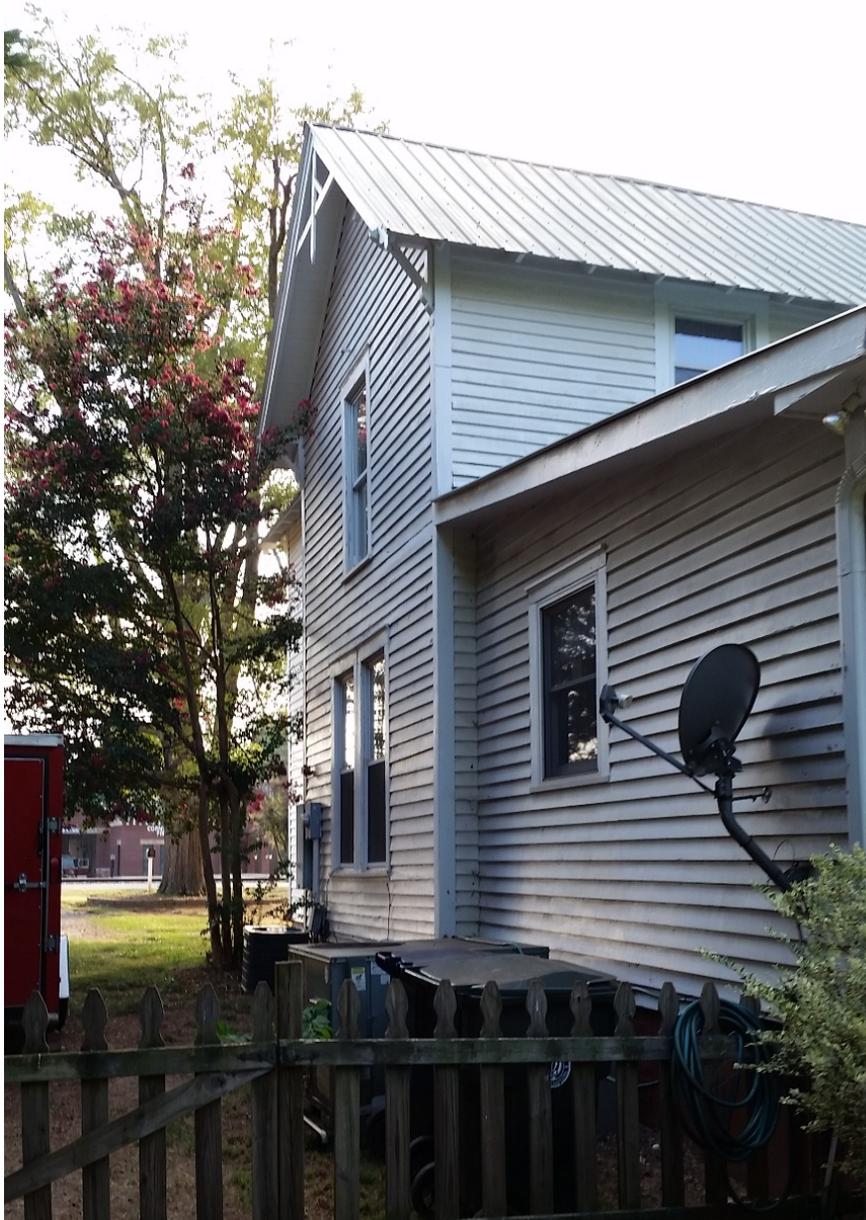
Windows are centered on the gabled section, with paired windows piercing the first story and a single window on the second story. The gable features a decorative truss with a simple pointed pendant. The truss originally featured two angled braces, one of which is missing. As on the front elevation, decoratively sawn rake boards rest on triangular brackets with applied curved trim. The gabled roof is steeply pitched, and the exposed underside of the roof deck is covered with beaded board. The original brick piers are exposed and infilled with brick and masonry block. A shed-roof kitchen addition projects from the rear of the house and likely incorporates an original rear porch. A brick pier is visible near the middle of the foundation, but beyond the brick pier, the addition's foundation is entirely block construction. The south elevation of the addition is pierced by a single replacement window.

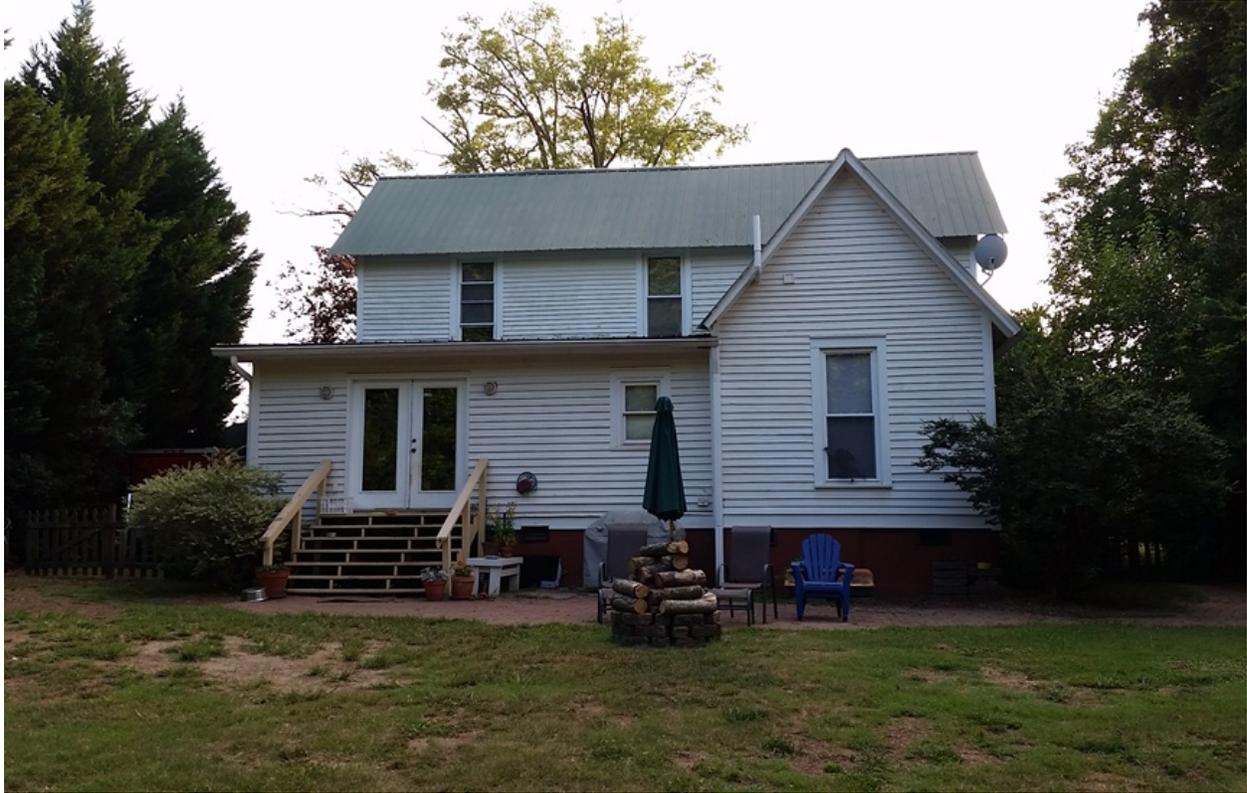
The rear of the house is dominated by the kitchen addition and an original one-story gabled wing that projects from the northern portion of the rear elevation. The kitchen addition is pierced by modern, glazed double doors, and a small replacement window set high in the wall. On the rear, the foundation of the kitchen addition is block construction. The gabled wing rests on brick piers infilled with a brick curtain wall. Centered in the wing is a single replacement window set in the original window frame. The steep gable lacks the decorative trusses and brackets found in the other gables. On the rear, a portion of the second story of the principal section of the house is exposed. Two replacement windows set in original window openings pierce the second story.

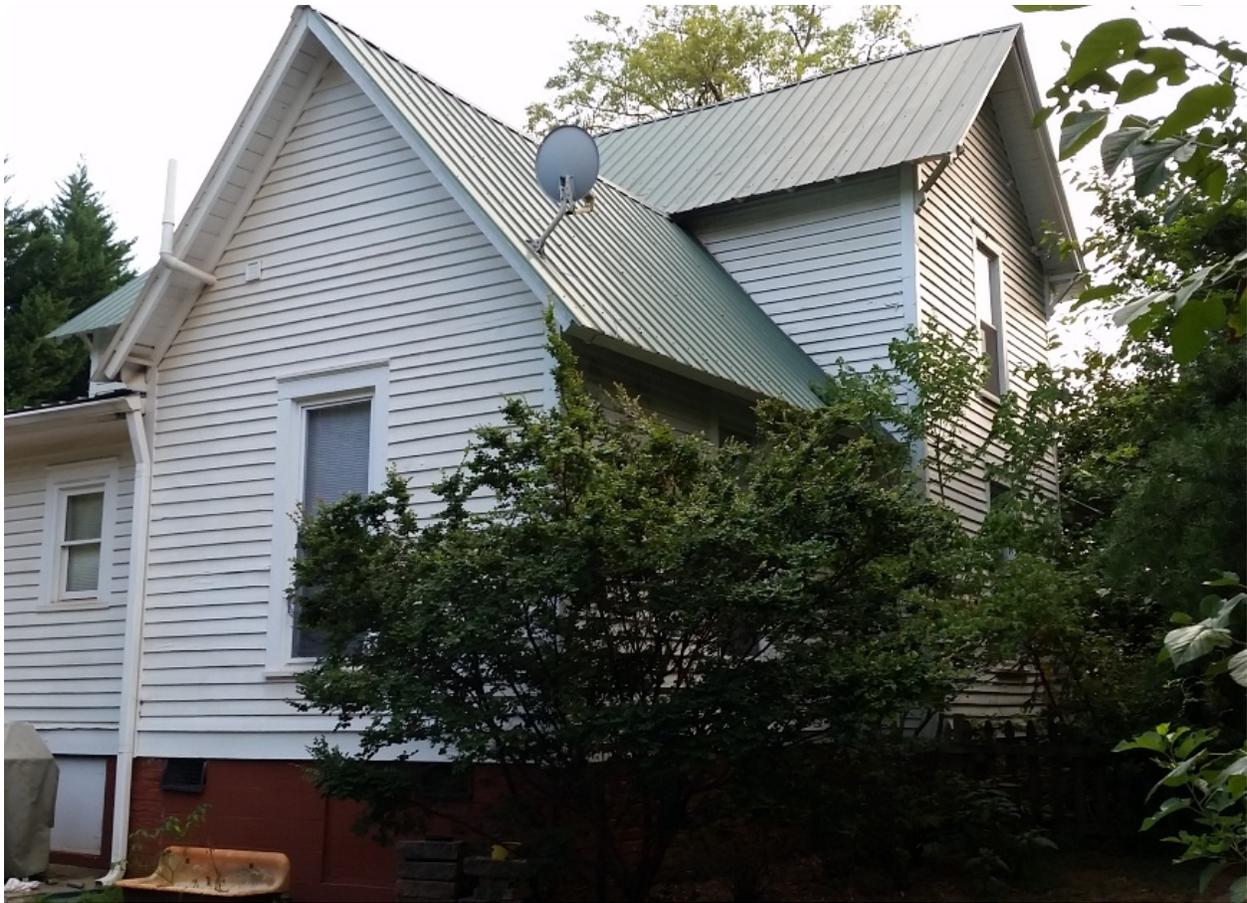
The north elevation is dominated by the two-story gabled wall of the house's principal section. A single two-light replacement window is centered in the wing on both the first and second story. The gable features brackets supporting the rake boards but lacks the decorative trusses found on the front and south elevations. To the rear of the two-story gable is the north elevation of the one-story rear wing, which is pierced by a single two-light replacement window, set in an original window opening. The foundation on the north elevation consists of brick piers infilled with brick curtain walls. Two internal chimneys have been partially demolished to a point below the roof.

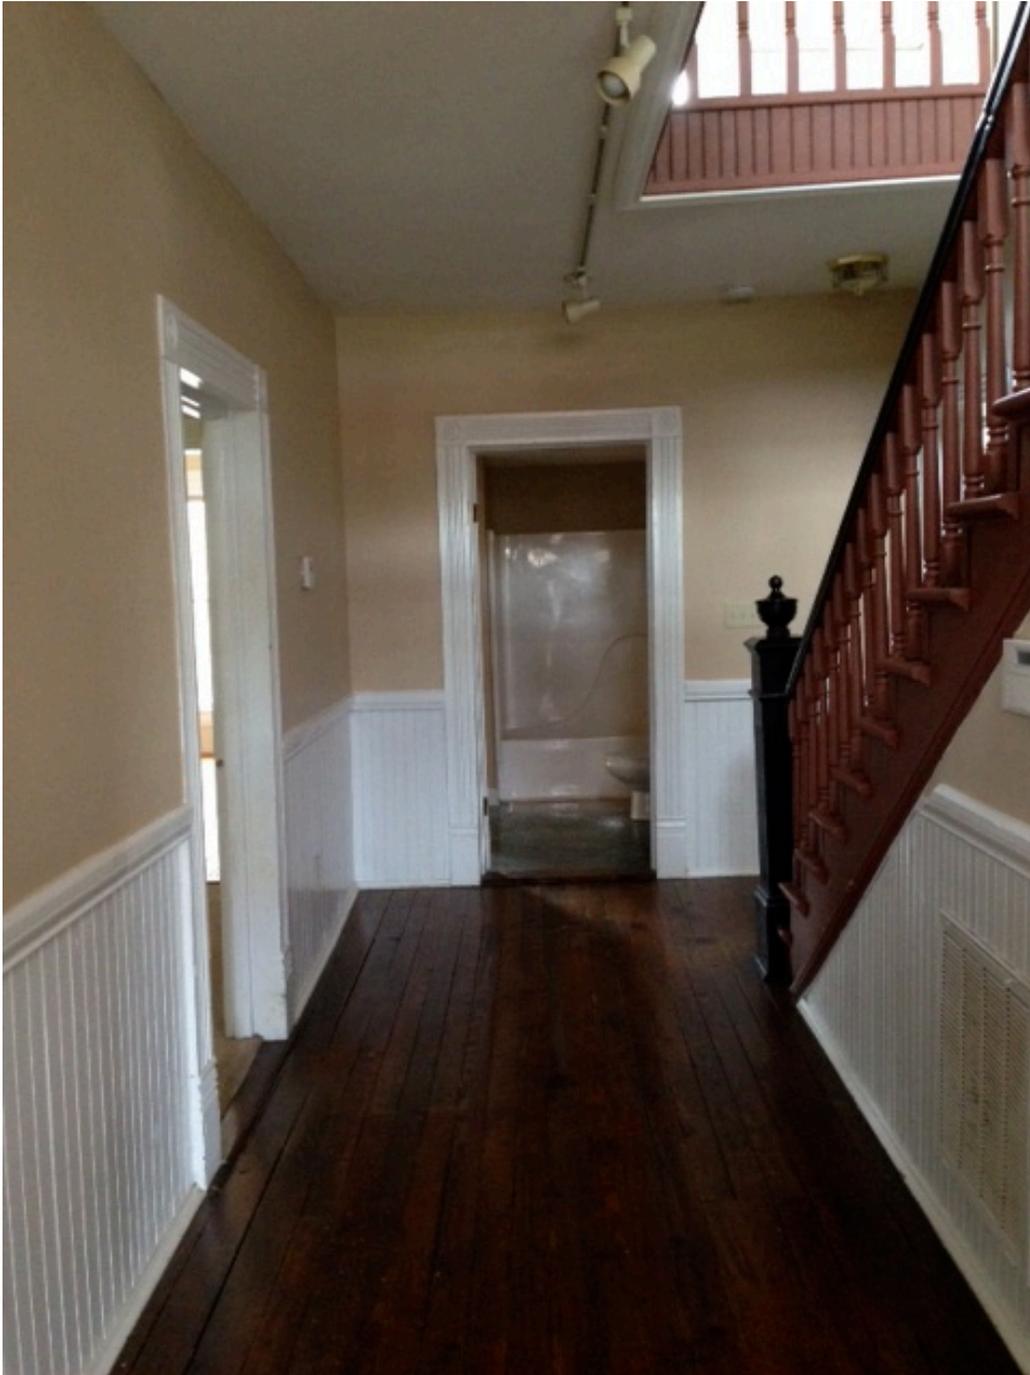
Interior

The high degree of integrity exhibited by the exterior of the Sherrill-Robbins House is also found in the interior of the house. With the exception of the bathroom and the kitchen, which likely occupy space that once included a rear porch, the interior is remarkably intact.

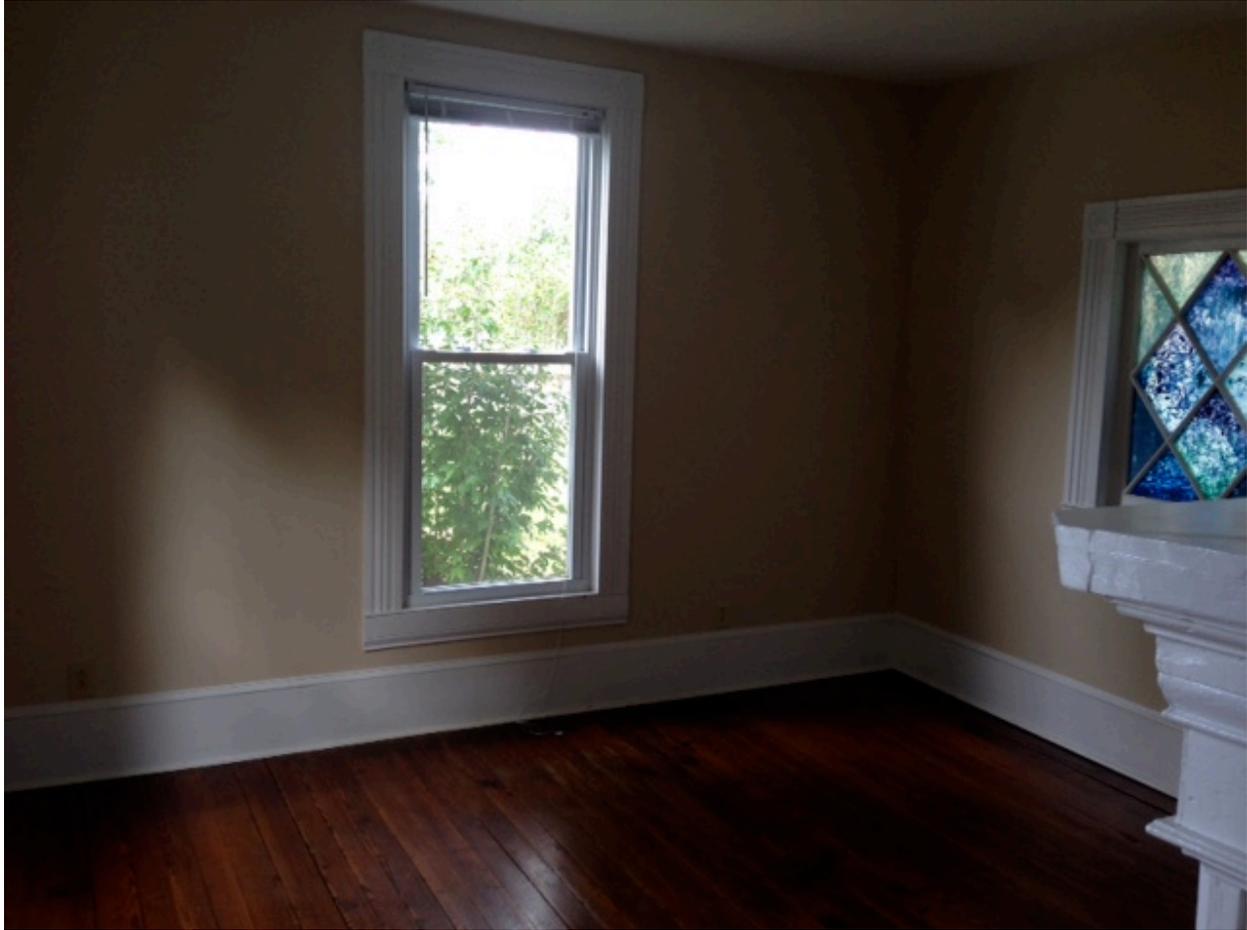
South Front Room

The interior is composed of central hallways on the first and second stories, connected by a staircase. The hallway on each story opens onto three primary rooms. These rooms on each story have nearly identical floor plans. All of the rooms are approximately the same size, and it is difficult to tell precisely the original function of the rooms on the first story. It is likely that they included a parlor on the south side and a dining room on the north side. The three rooms on the second floor were bedrooms. Each of the rooms features the original pine flooring. The majority of the flooring is approximately 4 inches wide, but 5 inch flooring is also installed. The flooring is bordered by a tall baseboard topped with a moulded cap. It appears that the original plaster walls have been replaced with wallboard. While most of the windows have been replaced, the original interior window trim has been preserved. The stool trim features a moulded lower edge. The jam and head trim is fluted and meet at square rosette blocks. A five-panel door is used throughout the house. The same fluted trim and rosettes are used around the doors, with the jam trim resting on moulded starter blocks. The walls are topped with narrow moulded trim. Ceilings are beaded board. All of the primary rooms feature a fireplace. Each fireplace mantel is different, and appears to have been constructed on-site. On the southern side of the house there are back-to-back fireplace on each story serving the four southern rooms and sharing a single internal chimney. Each room originally featured a closet with a shorter five-panel door. On the southern side of the house the closets flank the masonry mass of the chimney.

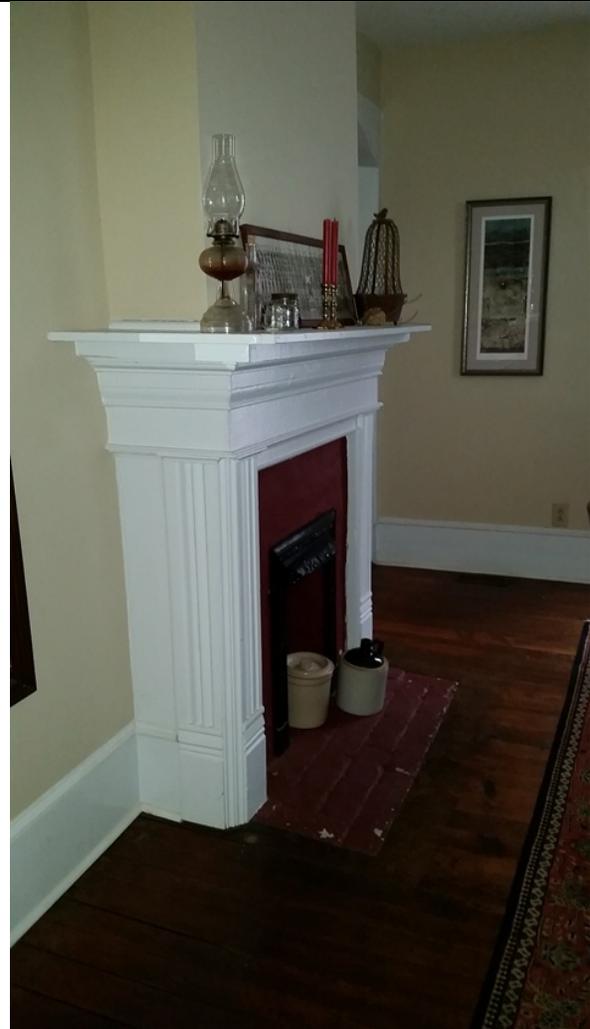
Front room, south side

On the first floor the closet from the front room has been removed to form a passageway between the rooms on the south side. The rearmost primary room on the first story features beaded-board wainscoting, with a substantial moulded cap rail, and a simple quarter-round base moulding.

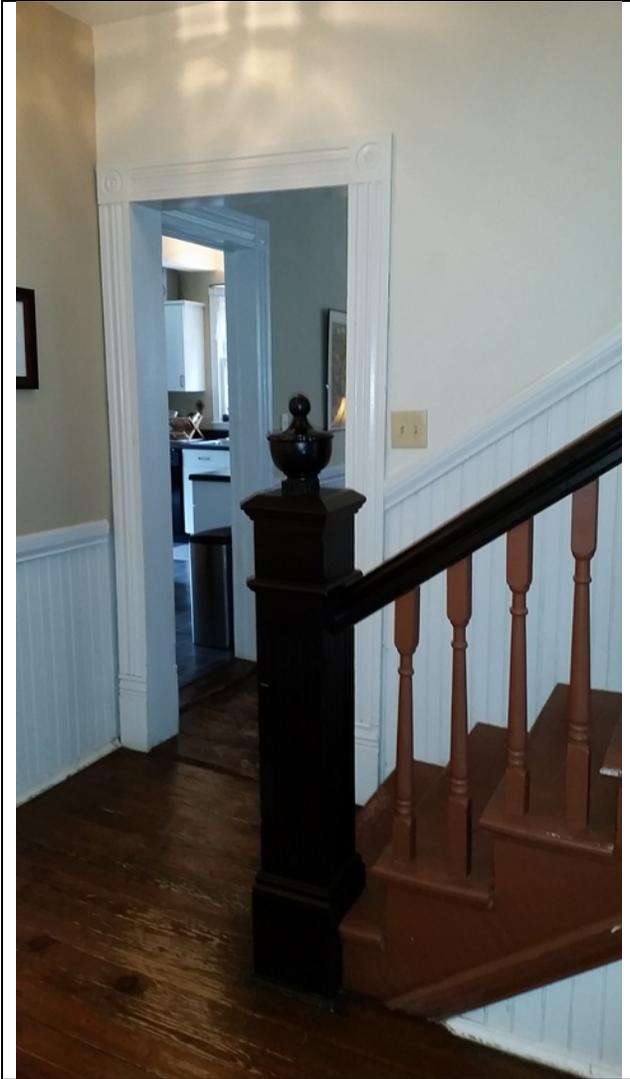
First story hall, newel post

The wainscoting continues in the hallway on both stories. The staircase features a substantial newel post with a turned urn-shaped finial, turned balusters, pine steps and risers, and a moulded handrail. On the second story the newel posts are smaller, with chamfered caps.

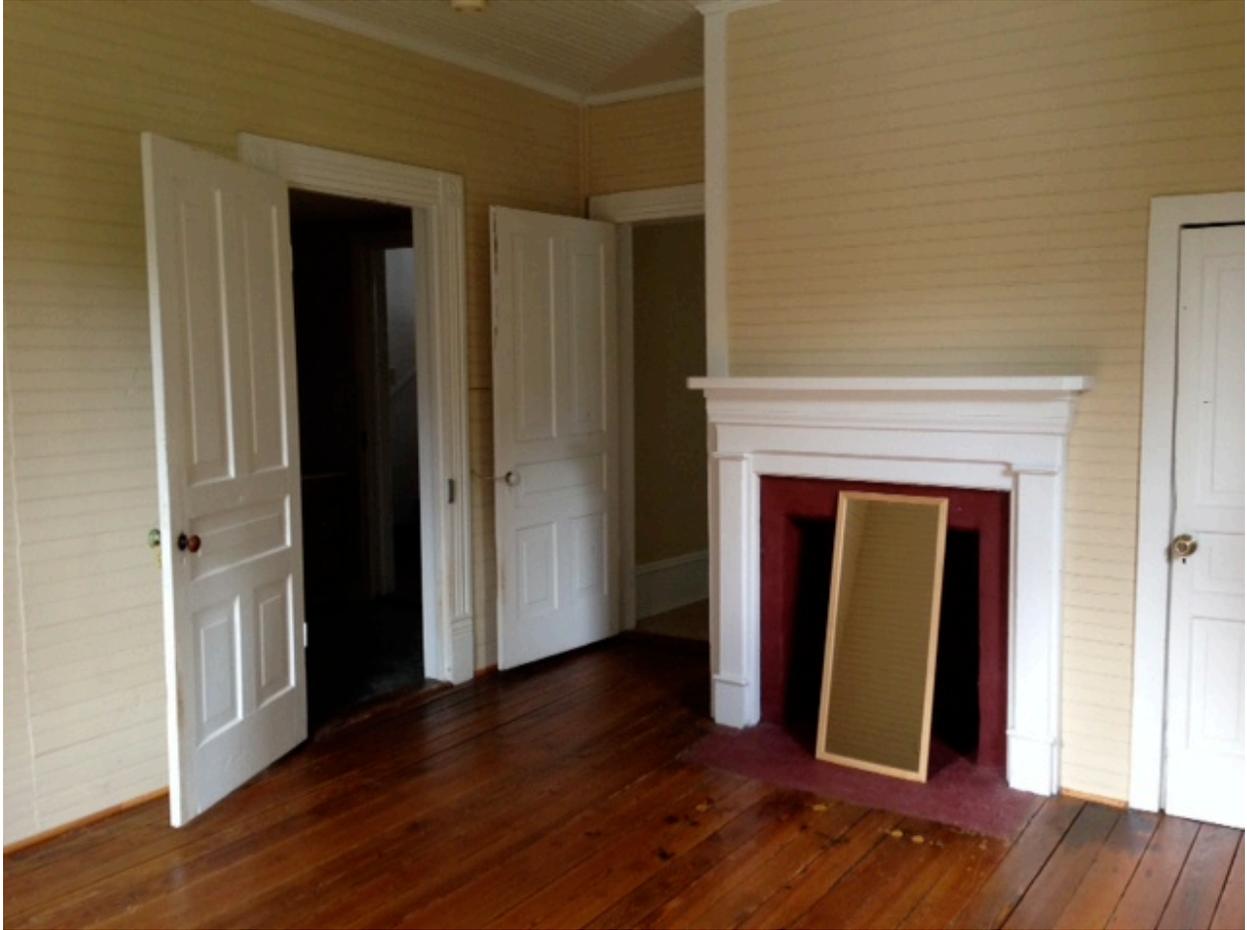
Former kitchen

The former kitchen is located in the one-story rear el. It shares a chimney with the primary rooms on the north side of the house. The kitchen features a fireplace and the same trim found in the rest of the house. Walls and ceiling are covered with beaded board.

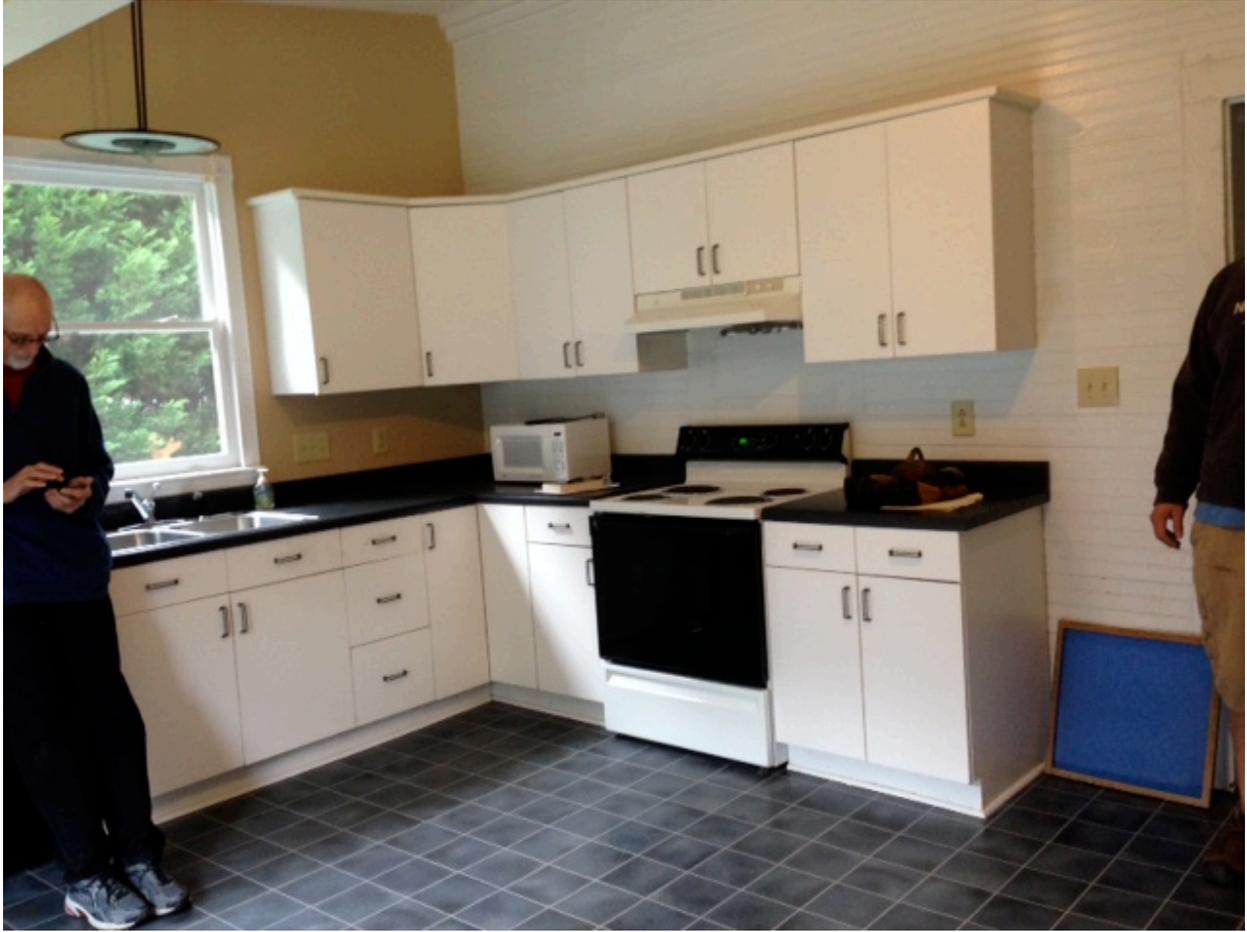
Current kitchen built in former porch space

Originally a rear porch ran from the kitchen to the southern edge of the house. The space was enclosed and expanded and now houses a bathroom adjacent to the former kitchen and a new kitchen at southern end of the space.
