## ASSEMBLY INSTRUCTION SHEET

# EXPLORER/BRONCO II ATLAS 4SP. SHIFTER

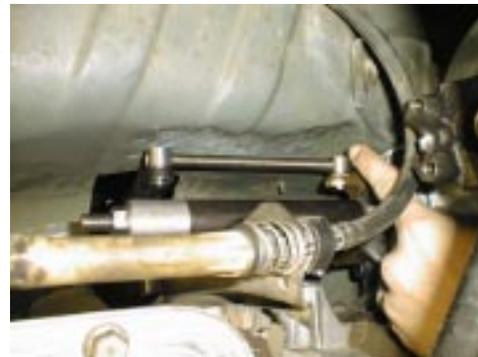
Floorboard clearance for the shifter linkage is required.

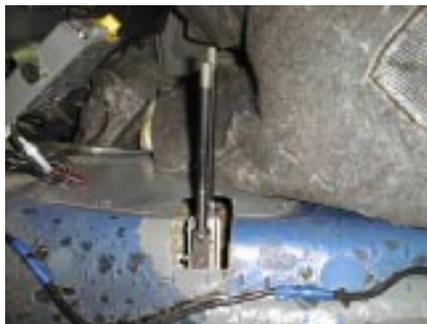
A new hole must be cut into your floorboard to fit the new handle assembly.

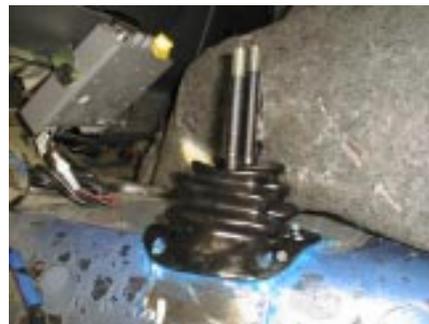
The Atlas boot and handle assembly installed. The carpet must be modified to fit over the shifter assembly.

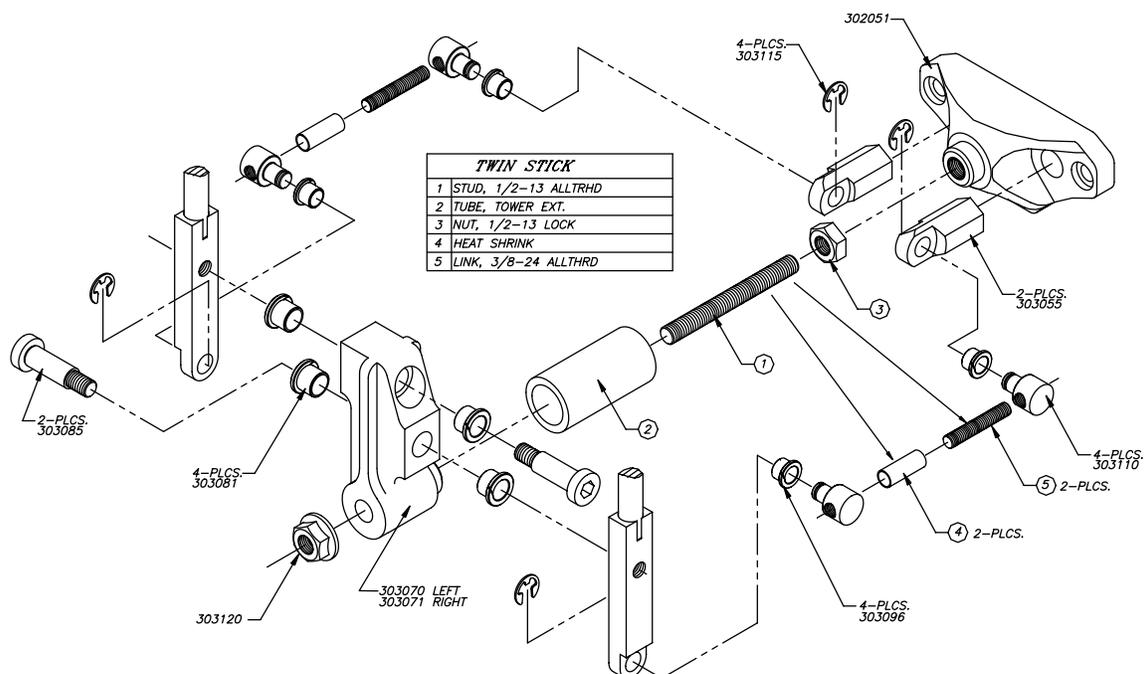
1. Install the shifter base to the face of the Atlas using the three S.H.C.S. 3/8"-16 x 1". These bolts have a sealant patch that will prevent leakage on the threads. This should be done before the Atlas is installed into the vehicle.

2. Install 1/2"-13 all-thread and jam nut to the shifter base.
3. Slide the shifter tower along the all-thread stud until the shifter arms are at the center of your stock floor cutout.

4. Measure between the tower and the base to obtain the correct extension tube length.
5. Remove the tower and install the extension tube.
6. Assemble the shift handles to the shift tower.

7. Install the shift tower assembly to the extension tube using the lock nut on 1/2"-13 all-thread to secure.
8. Install the brass shift rod ends to the Atlas shift rods. Teflon tape should be used on the threaded portion of the shift rod.

9. With the Atlas in neutral and the shift handles parallel with the shift tower, measure the distance for the linkage rods.
10. Connect the shift buttons and heat shrink tubing to the 3/8"-24 all-thread at the distance measured. Make sure that the all-thread is flush with the outside edge of the shift button. Cut all-thread if necessary.

11. Assemble the linkage rods to the shift handle and brass portion of the shift rod and verify the shift handles are parallel to the tower.
12. Install the e-clips to retain the buttons to the mating parts.

13. Make sure the brass shift rod ends are not too tight. They should be finger tight.
14. Modify the floorboard if necessary.
15. Install the rubber boot and boot ring to the floorboard. (Note: On some twin stick configurations, the boot ring may need to be cut in order to fit around the Atlas twin sticks).

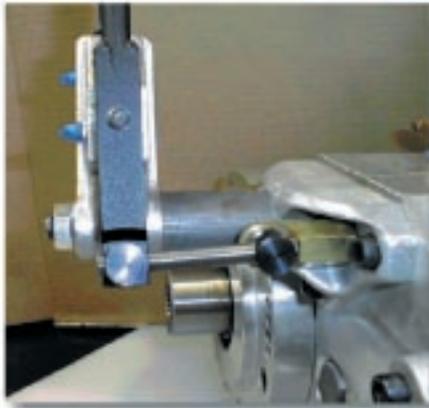
Atlas shifter problem check list: When installing the twin stick shifters, there are a few key areas that must be addressed. One of the most common difficulties we hear is that "my unit isn't shifting fully into one of the gear ratios". Incorrect adjustment of the shift handles to the linkage rods is normally the cause. With both shift rods in neutral, the linkage rod (connected to the shift handles) must be parallel with the aluminum shift tower. Refer to the photo left.
