STRUCINSPECT
Infrastructure Lifecycle Hub

How Inspections gain Efficiency using AI

Palfinger Structural Inspection GmbH

Vienna, 24.11.2023

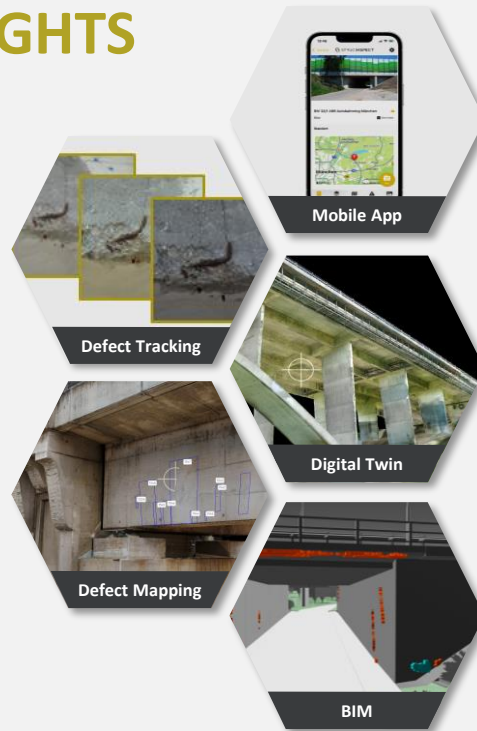
Automated Defect Tracking

AI digitizes and links defect images with previous documentations

Defect Mapping

Documented defects are precisely mapped and clearly displayed on the 3D model

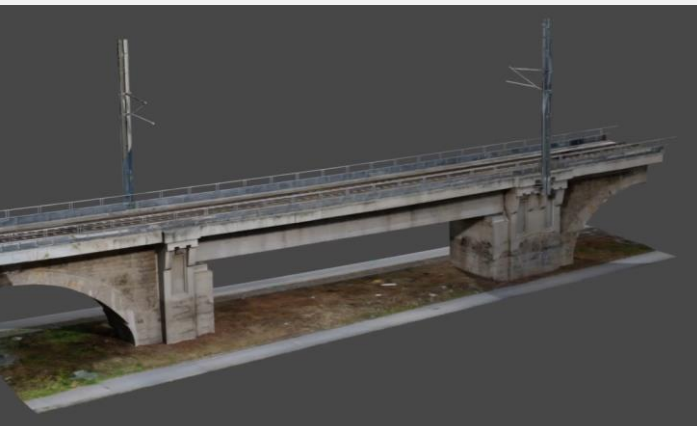
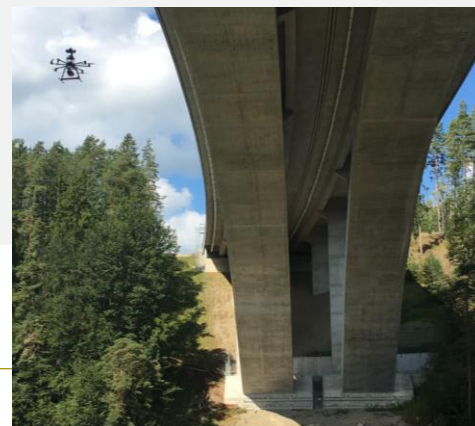
AI-assisted inspection workflow

Less clicks for documentation on-site – **40%**

Automated defect mapping on 3D model

No defect location drawings – **60 to 90%**

Automated defect tracking

up to 50% savings in follow-up inspections – **50%**

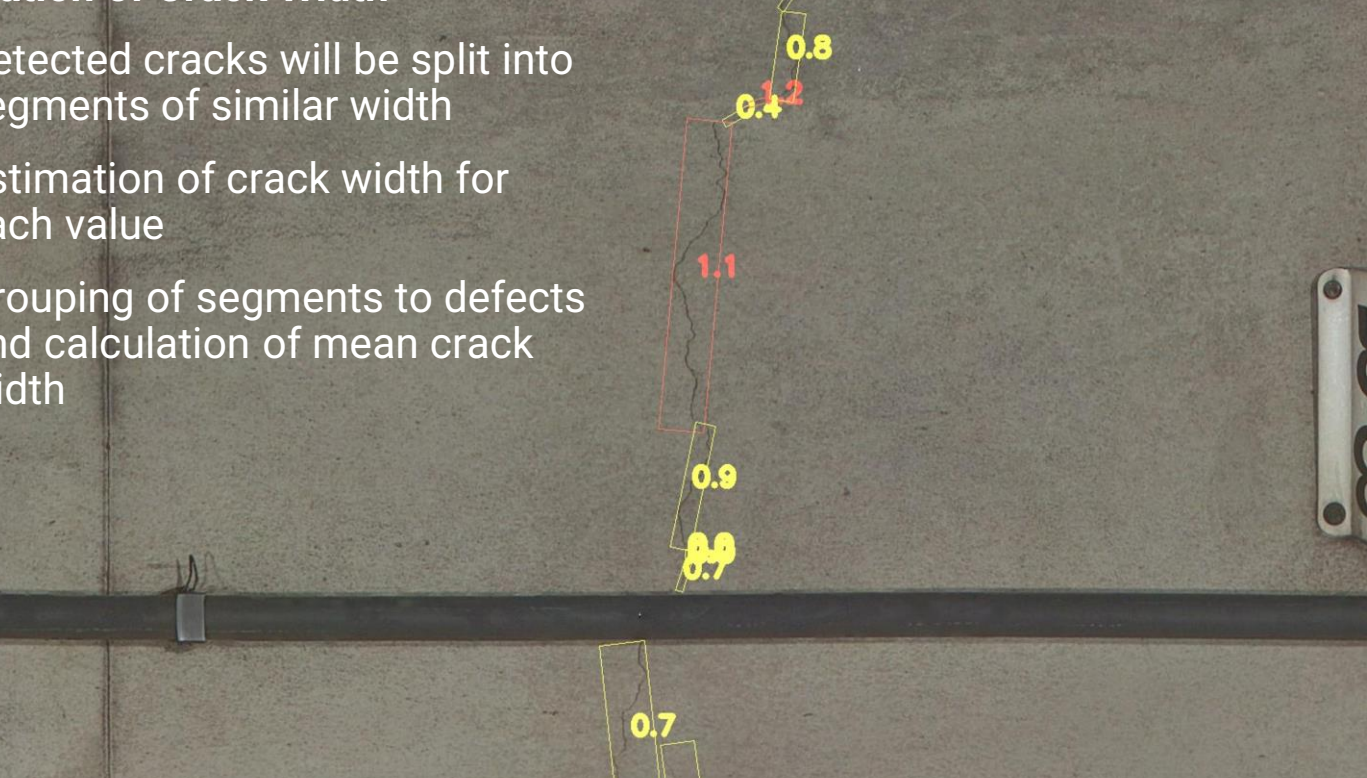
Estimation of Crack Width

1. Detected cracks will be split into segments of similar width
2. Estimation of crack width for each value
3. Grouping of segments to defects and calculation of mean crack width

The image shows a vertical crack on a concrete wall. The crack is segmented into several parts, each labeled with a yellow number indicating its width. The segments are labeled 0.8, 0.8, 0.4, 1.1, 0.9, 0.9, 0.7, 0.7, 0.7, and 0.4. A horizontal black line is drawn across the wall, and a small metal bracket is attached to it on the left. On the right, a white sign with black text is visible, showing 'ARAR' and '0.89.8'.

1. Detected cracks will be split into segments of similar width
2. Estimation of crack width for each value
3. Grouping of segments to defects and calculation of mean crack width

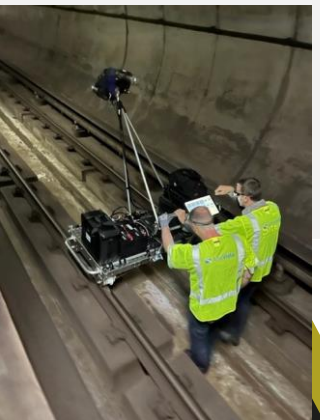
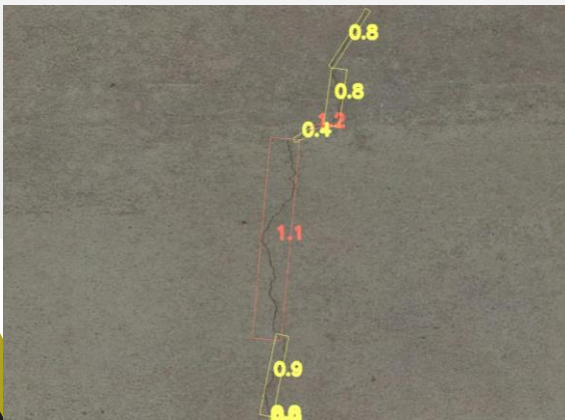
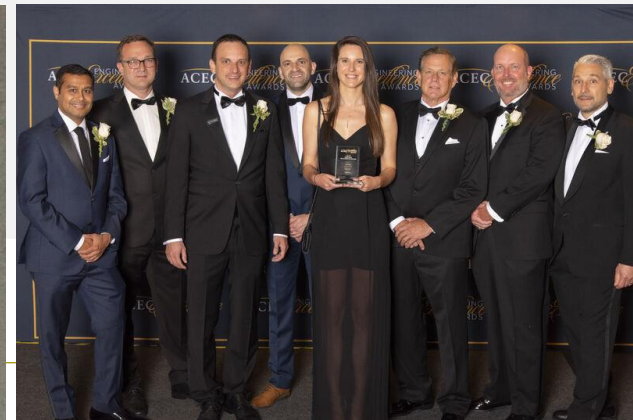
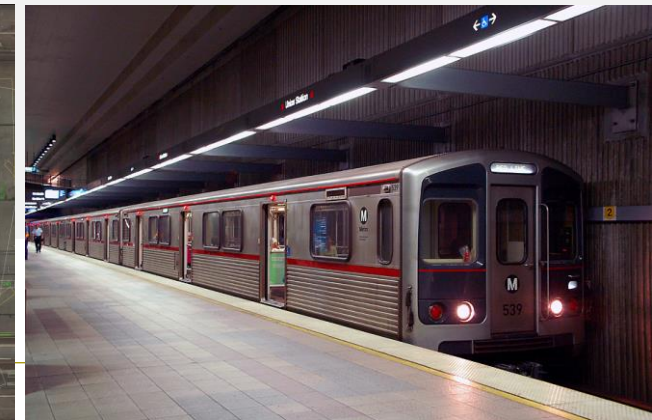
TUNNELS – Los Angeles Metro

Efficient **data capturing** process on-site

► Closing time of tunnel significantly reduced – **90%**

Less labor-intensive and time-consuming work due **AI-assisted inspection** workflows

► Total savings in own inspection resources – **80%**

Detailed determination of **Health Index** due to precise detection and analysis of defects

► up to 30% potential savings in maintenance costs – **30%**
