**Long Lasting** Repairs / Rebuilds

## ... vessels of all types ...

## REPAIRS . PROTECTION . REBUILDS

# Types of REPAIR and/or PROTECTION Applications for Truly Long-Lasting Performance

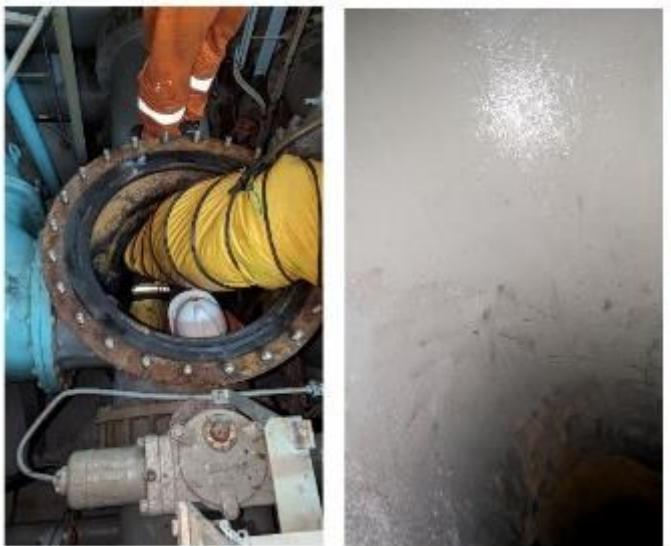
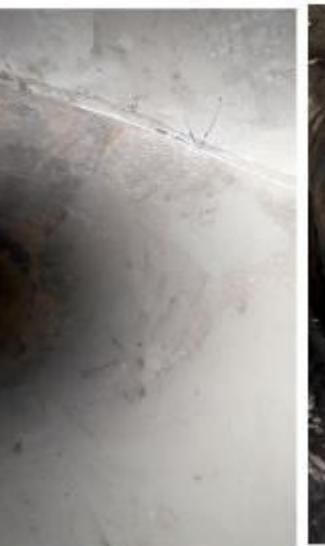
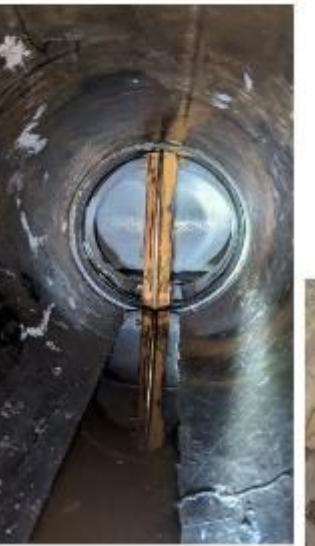
# Sea Chest Protection

**After 10 months of operation  
in Brazilian waters**

**Before  
ENECON  
– Other  
Brand  
Blue**

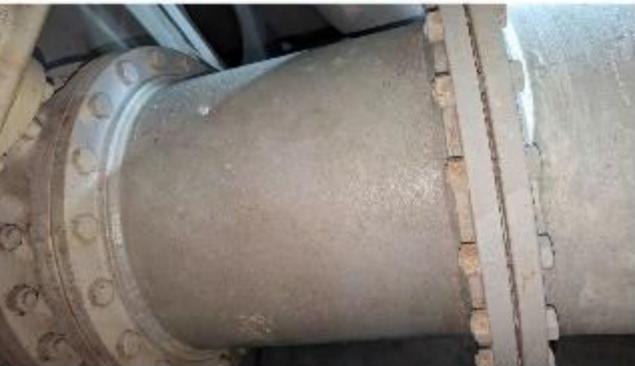
BALLAST PIPE IN E/R STRENGTHENING USING ENECON PUTTY (Ceramalloy CP+AC)

INITIAL CONDITION

COMPLETED APPLYING PUTTY EVENLY ON THE ENTIRE PIPE SECTION

THICKNESS MEASUREMENT READINGS OF BALLAST SEA CHEST PIPING IN E/R

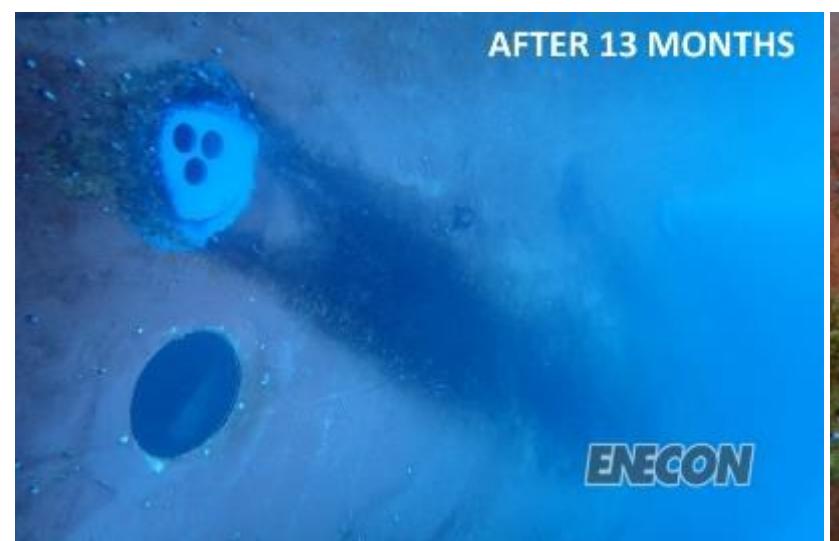
AFTER 13 MONTHS

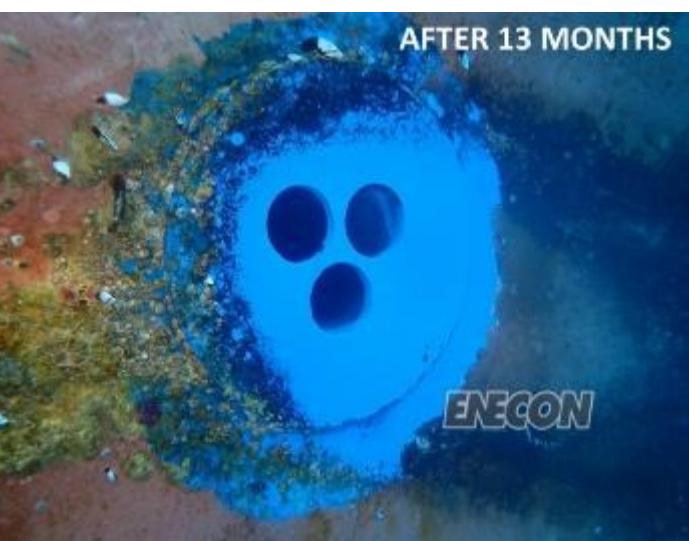
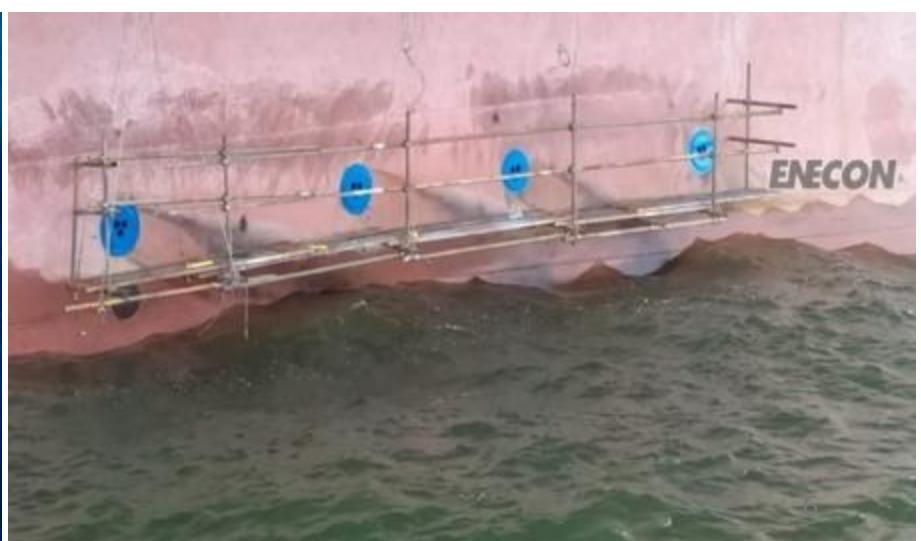
AFTER 13 MONTHS

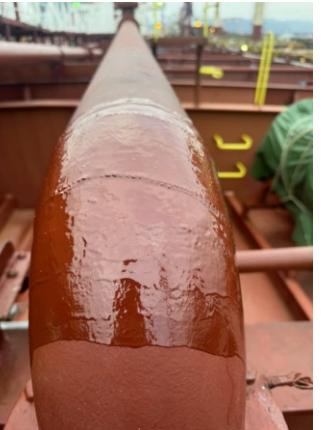
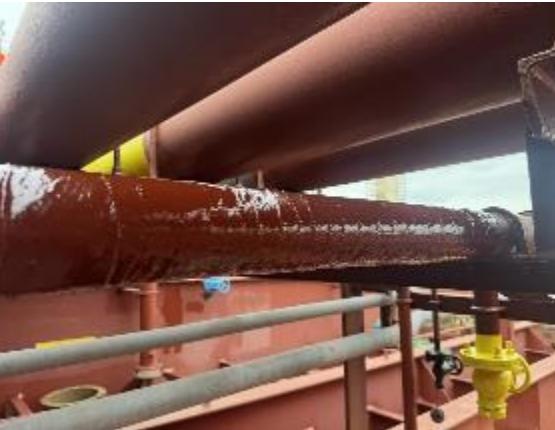
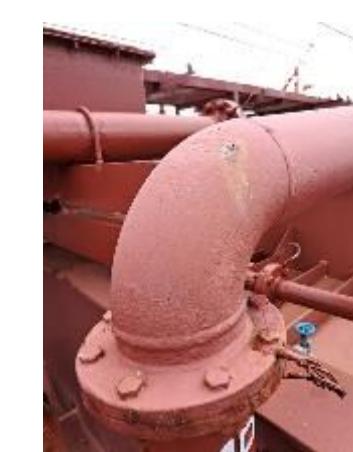
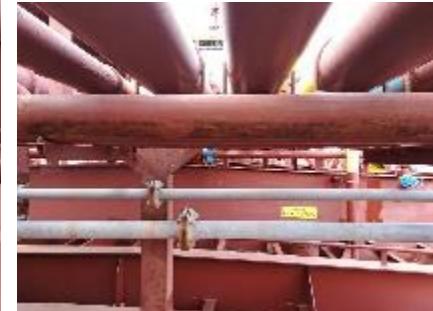
# FRAMO Pipes Repaired with DuraWrap

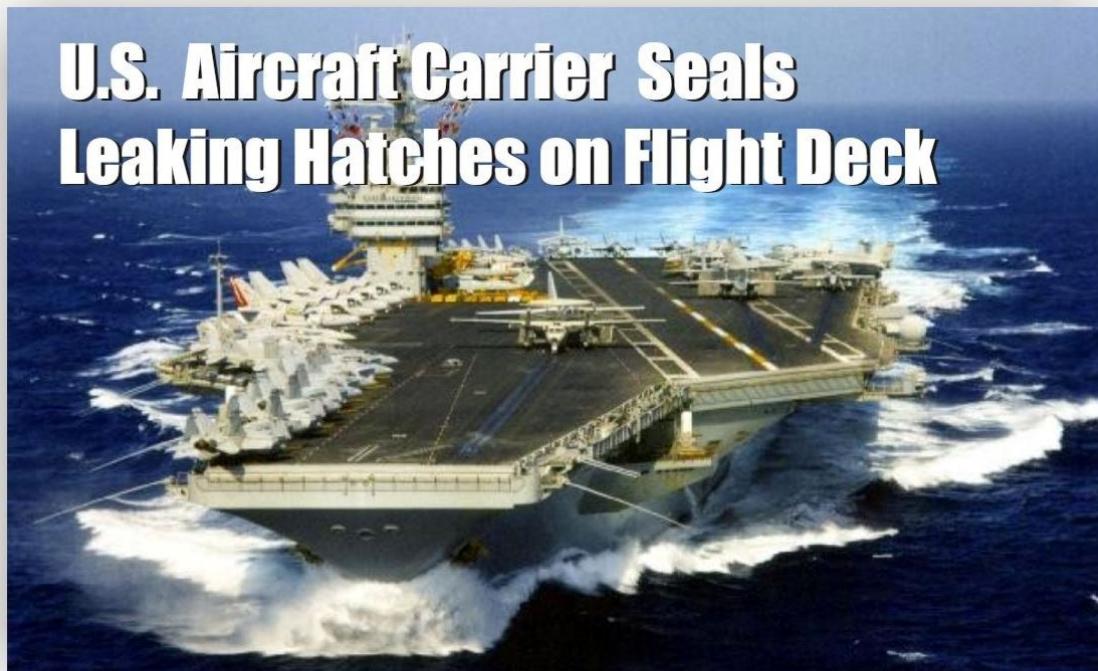
## U.S. Aircraft Carrier Seals Leaking Hatches on Flight Deck

The Auxiliary Electric Start Systems (AESS) lockers on an aircraft carrier provide the ability to "jump start" a fighter plane if required. The hatches are flush with the carrier deck and are designed to keep water and other contaminants from getting into these lockers – potentially compromising the operation of the electrical systems.

What often happens, however, is the gasket retainer corrodes due to constant immersion in saltwater, fuel, hydraulic fluid, etc. As a result, the hatches leak and the AEES lockers can fill with water. This is not a good thing.

A conventional welding repair is time-consuming and sometimes damages the hatches. The ship's engineers decided to utilize a

more "high-tech" approach. The damaged areas were repaired with **DurAlloy** then sanded smooth to the desired shape and dimension. Two coats of **CeramAlloy CL+ [AC]** were then applied over the entire seal area to provide long-term corrosion protection to these hatches.

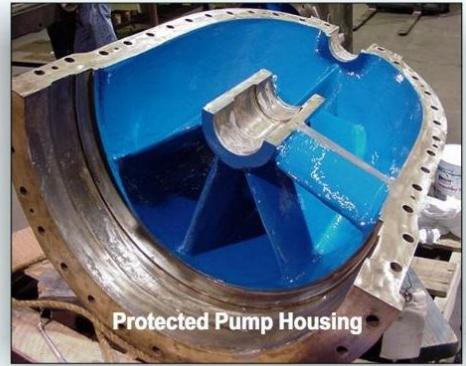
Protected Pump Housing

U.S. Navy Salvages Main Salt Water Circulating Pump on an Amphibious Assault Ship with CeramAlloy

ENECON Hampton Road's Pier Side Rapid Availability Team (P.R.A.T) were recently called in to solve a severe erosion/corrosion issue on the main sea water circulating pump that feeds the main steam condenser on an LHD vessel. This class of ships carries helicopters, Harriers (vertical take-off jets), LCAC's (Landing Craft - Air Cushion hover crafts) as well as about 2,000 Marines and all their equipment. It is a key component of the U.S. Navy's amphibious assault arsenal.

A direct replacement

for this 13 year old bronze/monel pump was not available and a redesigned pump would have required extensive re-piping and would have cost the Navy over \$250,000.

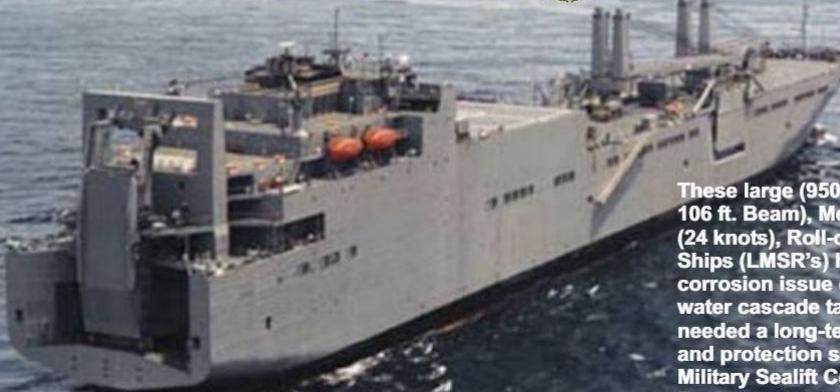
## Military Sealift Command Transport Ships Turn to CeramAlloy to Solve Critical Corrosion and Erosion Issues

These large (950 ft. Length, 106 ft. Beam), Medium-Speed (24 knots), Roll-on/Roll-off Ships (LMSR's) had a serious corrosion issue on their gray water cascade tanks. They needed a long-term repair and protection solution. The Military Sealift Command Engineers turned to ENECON for help.

There are a total of 5 ships in this class. Each \$55,000+ project required thorough grit blasting of the cascade tanks followed by a standard CeramAlloy CL + AC installation.

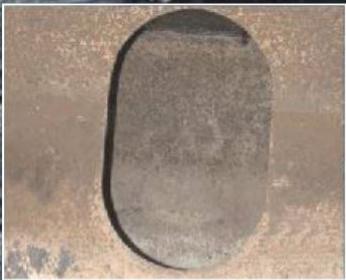
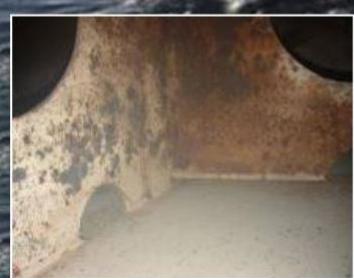
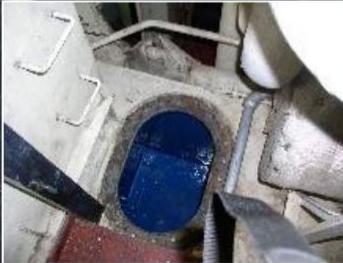
## U.S. Navy Saves \$37,000 On Emergency Heat Exchanger Repairs

The engineers on this Navy Frigate recently discovered that one of the bleed air heat exchangers was suffering from such severe erosion/corrosion damage that the unit was not cooling sufficiently.

After the unit was grit-blasted, a 3 coat system of CeramAlloy CL+ was applied as illustrated in these photos. This entire project cost the Navy less than \$5,000.

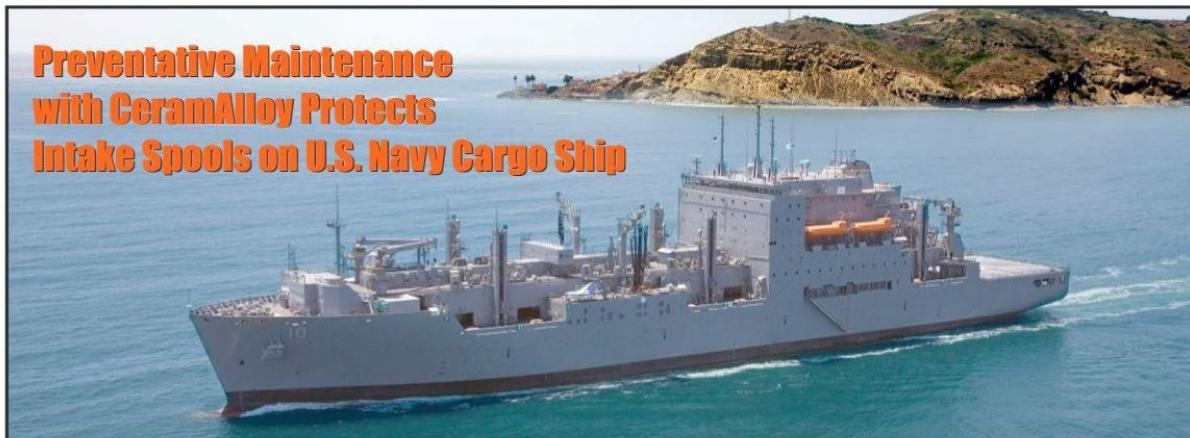
## Preventative Maintenance with CeramAlloy Protects Intake Spools on U.S. Navy Cargo Ship

In order to extend the service life of new intake spools and transition lines being installed on a cargo ship, the Navy chose to proactively protect them with CeramAlloy CL+AC.

After grit-blasting to a 4 mil profile, 2 coats of CeramAlloy CL+AC

were applied to some 15 spool pieces and transition lines that carry sea water to the engine for cooling.

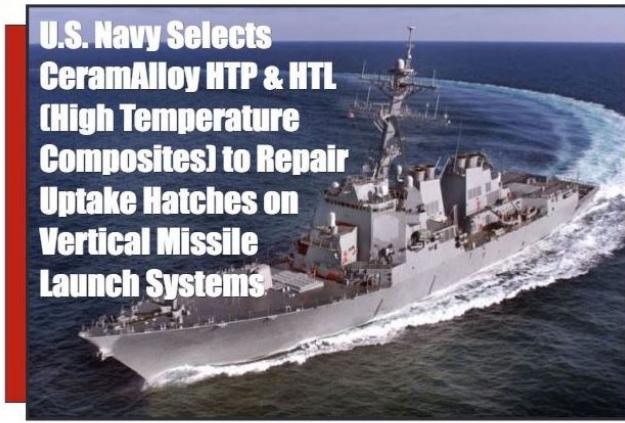
## U.S. Navy Selects CeramAlloy HTP & HTL (High Temperature Composites) to Repair Uptake Hatches on Vertical Missile Launch Systems

The U.S. Navy was in need of a solution to stop corrosion on their VLS (vertical launch system) uptake hatches on destroyer and cruiser class ships

Missiles are launched through open uptake hatches, usually located on the deck of a ship. The extreme high temperatures (400°F+), oxidized spent rocket fuel and environmental conditions of salt water

were causing premature coating failure of the hatches.

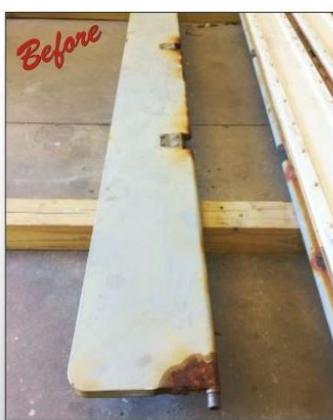
Repairs made with CeramAlloy HTP

ENECON's high temperature resistant repair and rebuilding composite, CeramAlloy HTP, was used to repair and rebuild the severely eroded areas of each hatch. The HTP was then machined to maintain the required tolerances.

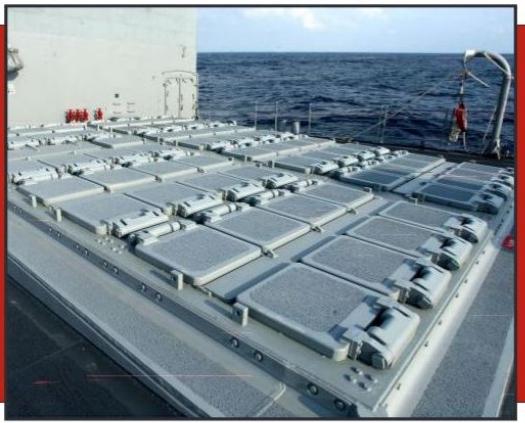
Then two coats of CeramAlloy HTL were applied to resurface and protect the entire area.

Completed hatch doors!

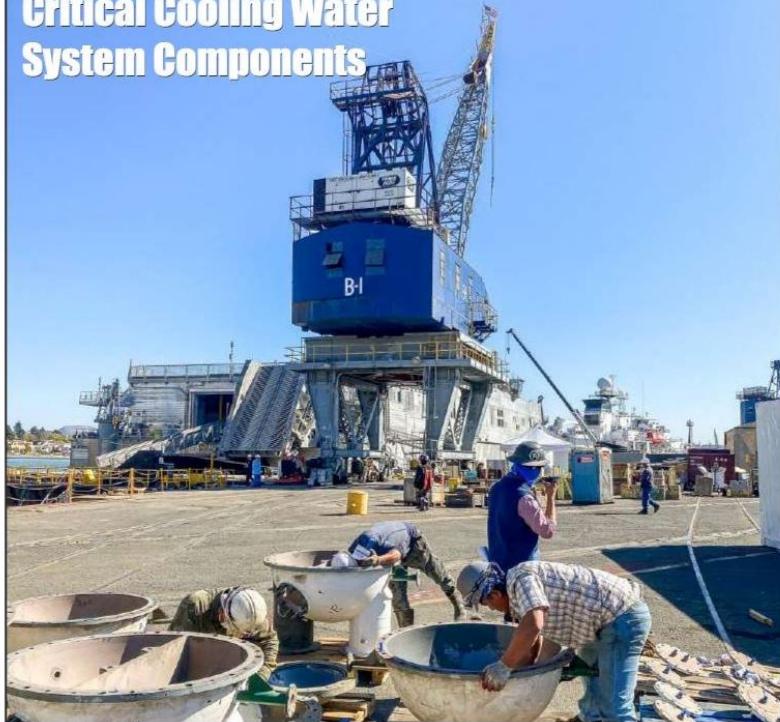
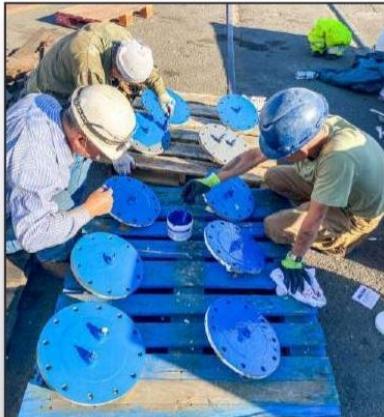
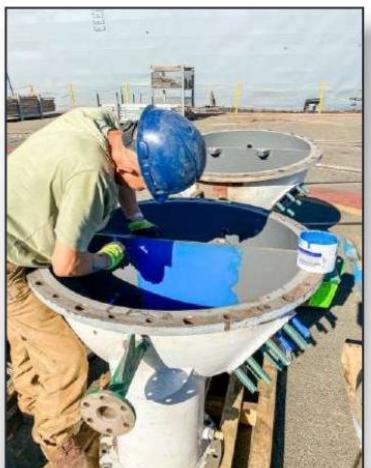
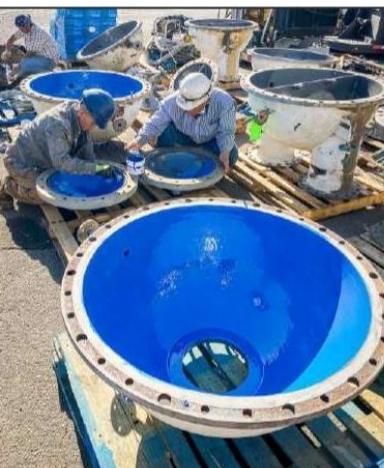
## U.S. Navy Selects CeramAlloy To Protect Critical Cooling Water System Components

When it comes to superior protection of its most critical components, the U.S. Navy routinely turns to ENECON and specifies *METALCLAD CeramAlloy CL+AC* to repair and protect its fluid flow components from erosion & corrosion damage from sea water.

After each cooling water system component was carefully grit blasted to a 3 mil profile, and inspected, ENECON NorCal then coordinated the application of two coats of *CeramAlloy CL+AC*, first coat gray and second coat blue.

These components are now protected better than new and ready to be re-installed on the vessel.

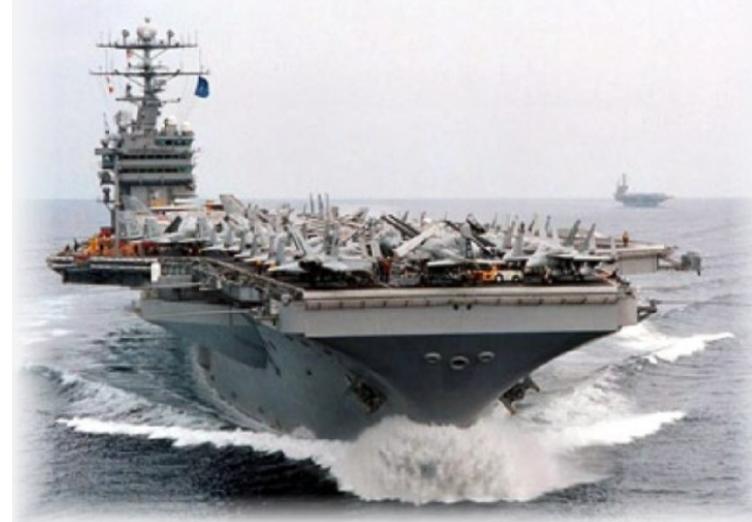
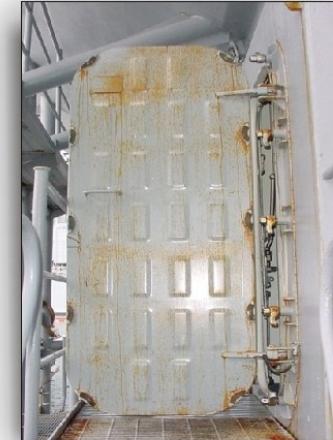
Powder coated doors after a few months at sea.
