Proceedings of Associated Schools of Construction 62nd Annual International Conference

## **Challenges and Insights from Remote Construction Administration in a Developing African Country: The Case of Malawi**

**Kyle Larson, Ph.D., P.E., and Dalton Rizzo**

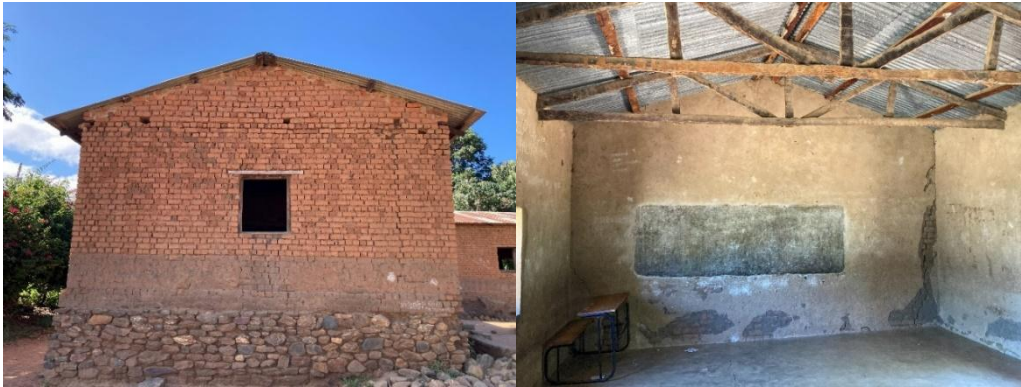
**Figure 1.** Deteriorated exterior and interior condition of the 1940s school building

In 2021, the village of Ifumbo (a remote region of northern Malawi, Africa, near the Tanzanian border) applied to EWB-USA for assistance to address severely degraded primary school facilities that had left nearly 700 children learning in deteriorated structures. The original school structures (two of them), built in 1947 with fired clay brick walls and metal roofing, remain in use today and are shown in Figure 1. Compounding the issue, all three current school buildings, including a block constructed in 2012 for grades 7 and 8, lack critical basic components such as functional doors, window shutters, electricity, and paint due to persistent funding barriers. Furthermore, two of the buildings lack serviceable desks for students, forcing them to sit on the ground. These existing buildings do not provide enough space, so classes are often taught outside, weather permitting, in

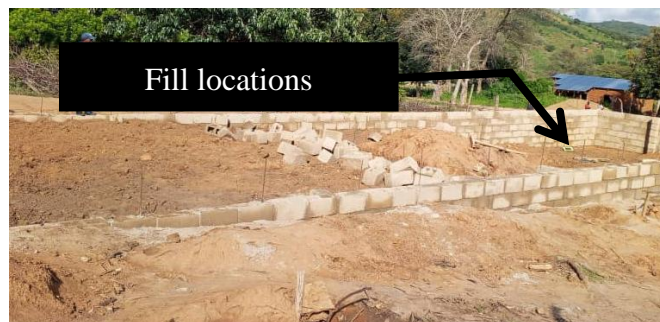
**Figure 3.** Locations where fill was needed

Ultimately, enforcing the construction documents was the project's most significant hurdle. The contractor repeatedly claimed compliance with local Malawian building standards, but EWB-KSU could neither locate supporting documentation nor reconcile these claims with the actual construction. This non-conformance led to specific, high-risk technical failures, particularly in the substructure. The design required a berm to direct water runoff around the foundation, which the contractor omitted, risking negative long-term effects on the footings. More critically, the contractor's decision to use unverified infill on the low side (right side in Figure 3) inadvertently created a non-uniform and excessive lateral soil pressure load on the foundation stem walls. These deviations, combined with unverified compaction techniques, significantly increase the risk of differential settlement of the concrete slab and potential cracking of the foundation walls, posing a serious threat of structural failure if the surrounding soil is not properly placed and maintained. The original design called for the high side of the site to be completely cut down with no fill on the low side.

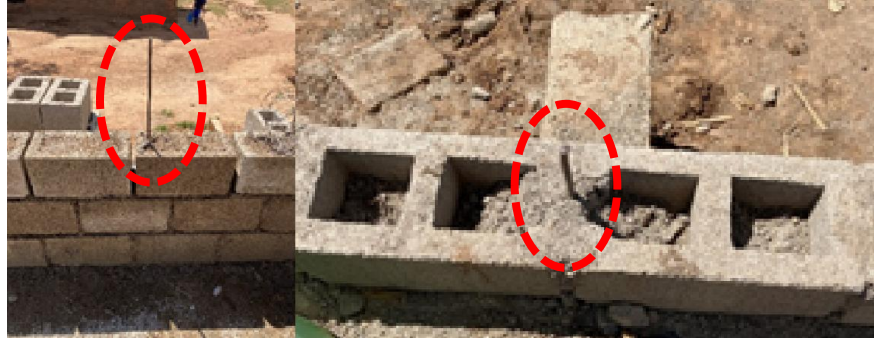
**Figure 4.** Examples of improperly placed vertical rebar

The superstructure exhibited the same non-conformance issues as the substructure. The contractor failed to follow proper placement techniques for reinforcing steel (rebar). As illustrated in Figure 4, rebar was often improperly installed between the CMU blocks rather than within the core of the masonry, a critical error observed at multiple locations.

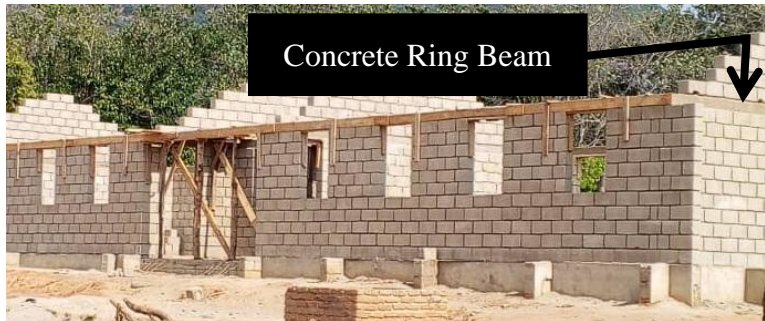
**Figure 5.** Concrete ring beam depth is not 300 mm, but rather 200 mm

A key requirement of the Malawian building codes, supported by the 'Safer Building Construction Guidelines', is a concrete ring beam near the roof line to ensure the structure maintains a 'box-like shape.' Although the construction documents specified a depth of 300 mm, which would be 50% taller than the CMU's, photographic evidence (Figure 5) shows the contractor constructed the beam at a depth of only 200 mm (the same depth as the CMU blocks). When questioned, the contractor insisted that 200 mm was the standard depth.
