Memorandum

Re: Distribution Line Upgrades – Section 248 Natural Resources
Assessment Supplement; Revised Wetlands Assessment

Murphy Road Energy Storage System Project | Bennington, Vermont

Murphy Road Energy Storage Project Distribution Line Upgrades – Representative Wetland Photographs

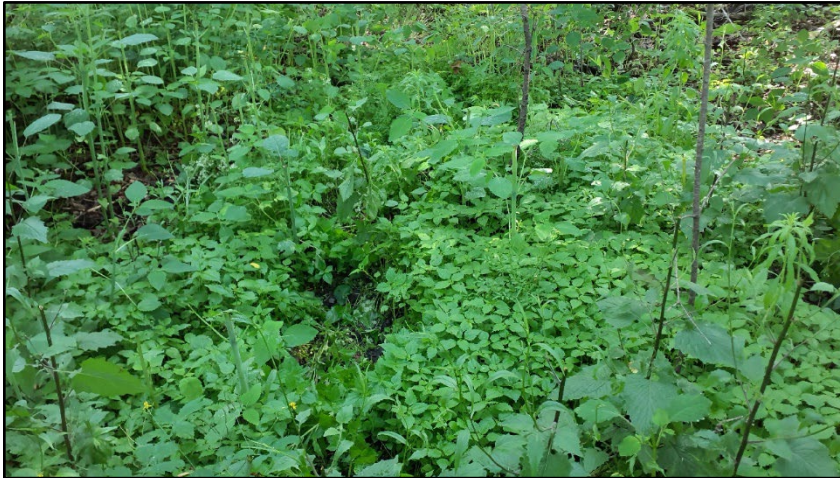
NO. 1 / 6.20.2025

A representative photograph of a small depression proposed Class III Wetland 2025-100, adjacent to existing GMP ROW and VT Route 67A.

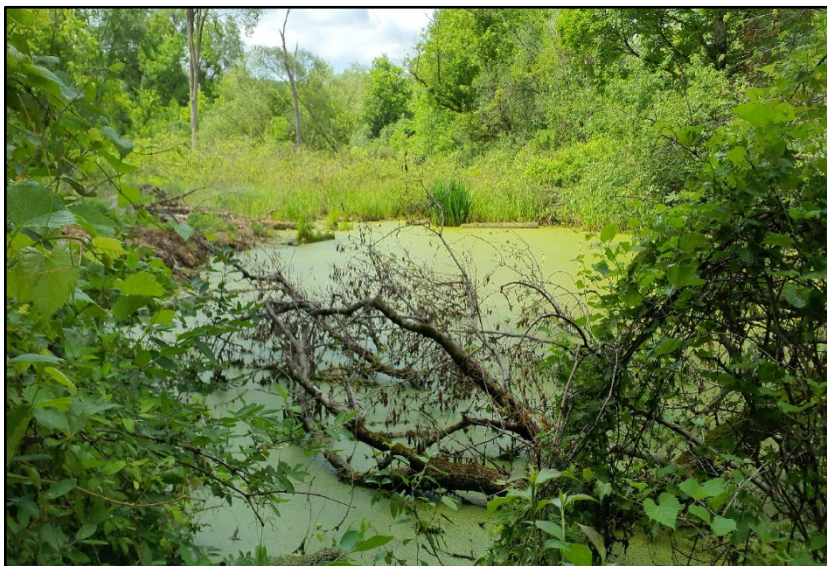
NO. 2 / 6.20.2025

A representative photograph of Palustrine Forested (PFO) Categorical Class II Wetland 2025-1, upstream of the Paper Mill Village Bridge and GMP utility ROW.

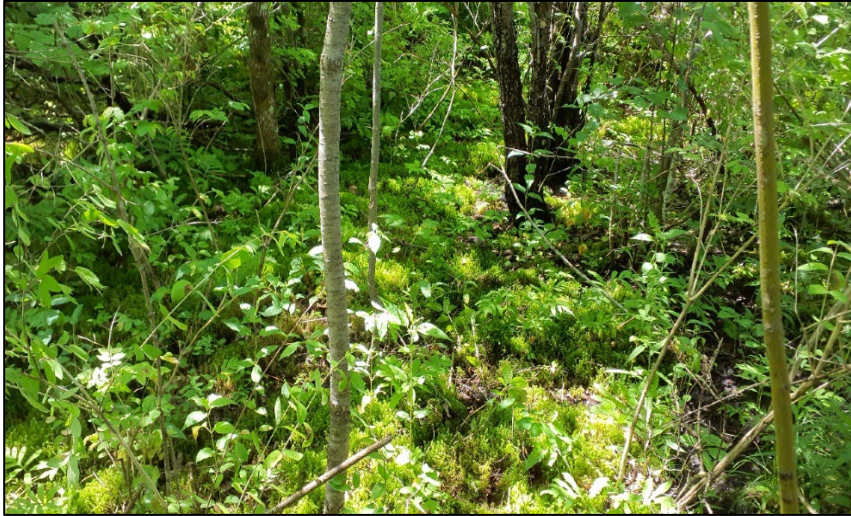
NO. 4 / 6.20.2025

A representative photograph of Palustrine Emergent Wetland (PEM) Categorical Class II Wetland 2025-4. View looking north toward existing utility pole number 858106 and Murphy Road

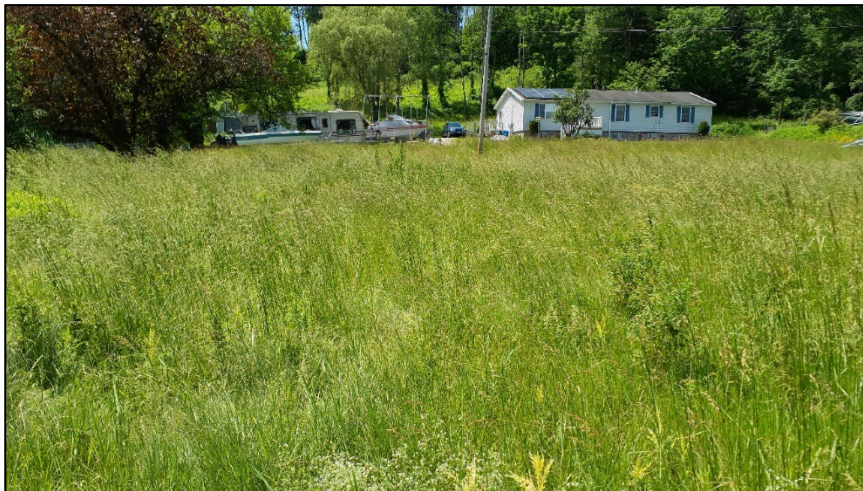
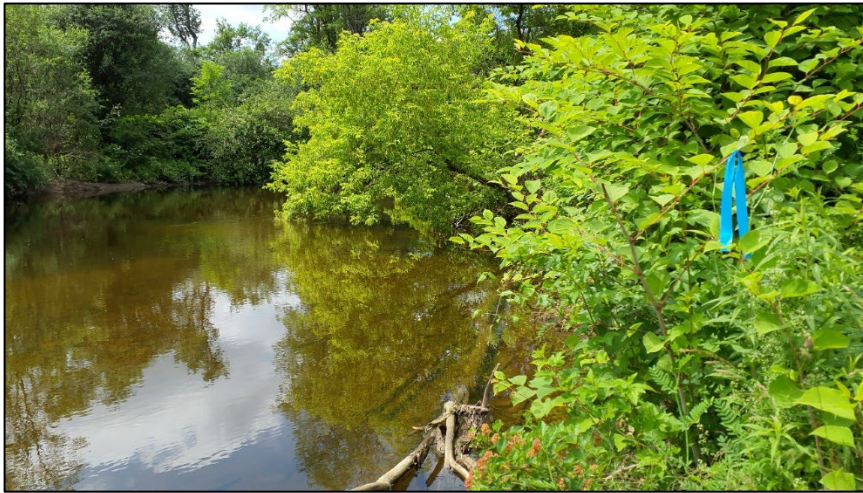
NO. 5 / 6.20.2025

A representative photograph of the Walloomsac River in the Study Area, photograph taken approximately 15 feet south of the covered Paper Mill Village Bridge near Murphy Road and VT Route 67A intersection.
