Preliminary Site Investigation with Limited Sampling

Middle Head Oval Amenities Building

Mosman Municipal Council, C/O Archer Office Pty Ltd

Reference: 754-SYDEN349808-R01- Rev1-PSI-Middle Head Oval

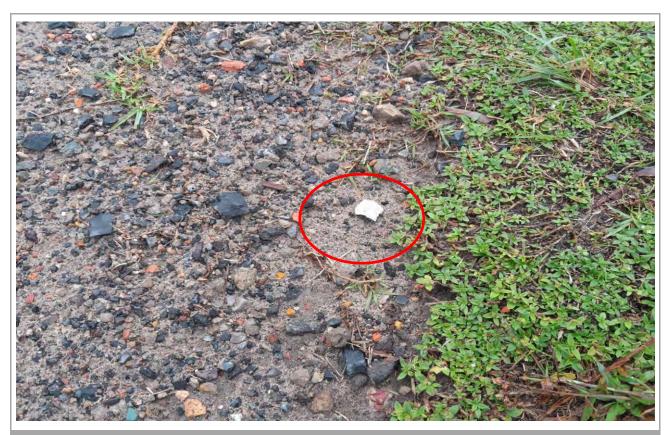
Photograph 1. Representative photograph of the subject material within the subject area, prior to removal, as observed on 03/05/2024.

Photograph 2. Representative photograph of the subject area, following removal, as observed on 03/05/2024

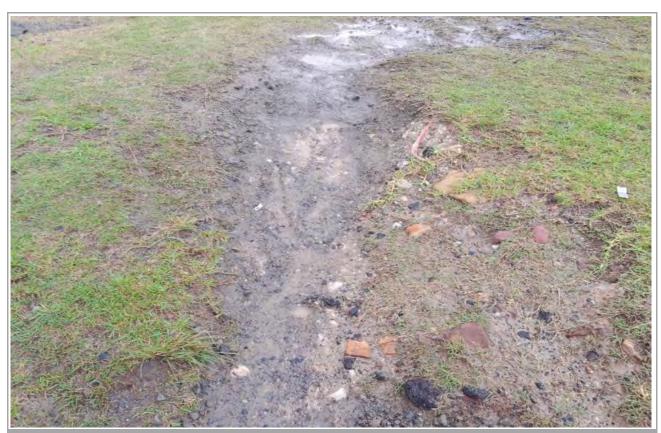
Photograph 3. Representative photograph of the subject area, following removal, as observed on 03/05/2024.

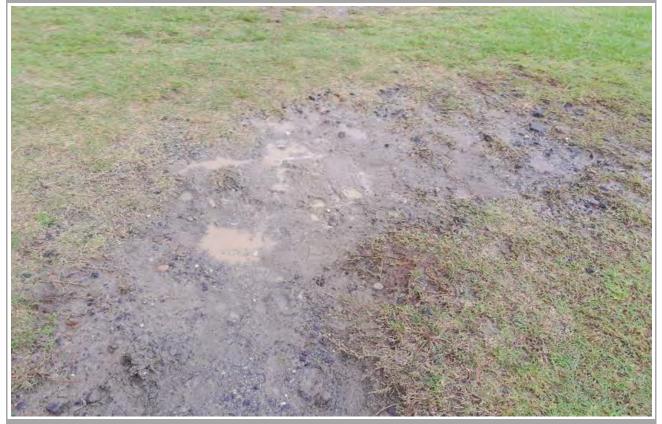
Photograph 4. Representative photograph of the subject area, following removal, as observed on 03/05/2024.
