SECOND FLOOR PLAN / Demolition wall details

Hulhumale Hospital

SIX STORY
2nd Floor Demolition

3RD FLOOR PLAN / Demolition wall details

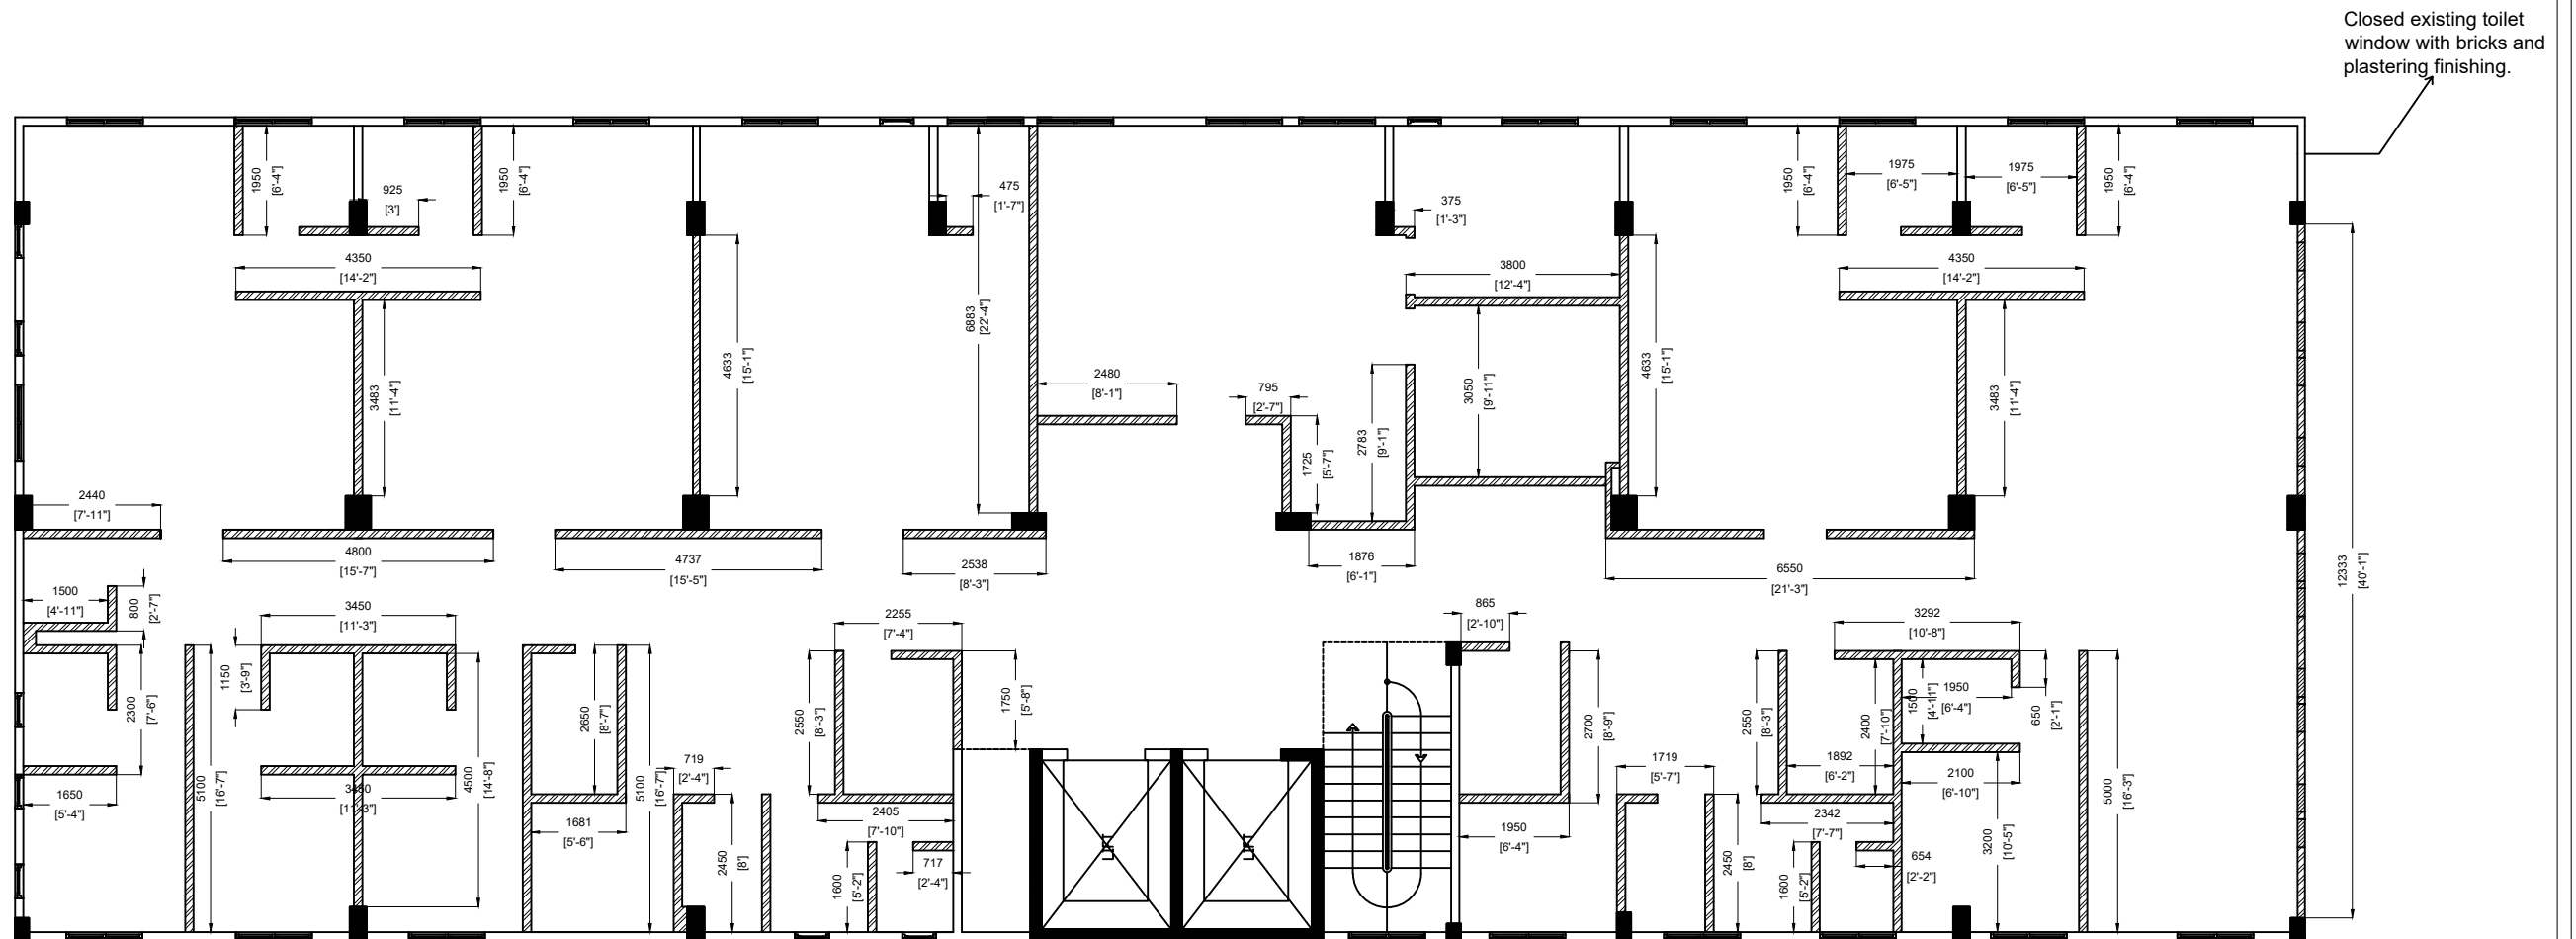
Closed existing toilet window with bricks and plastering finishing.

Window voids (Demolish window area below sill down to floor slab and above lintel beam up to main beam level.)

Fully Demolishing Wall

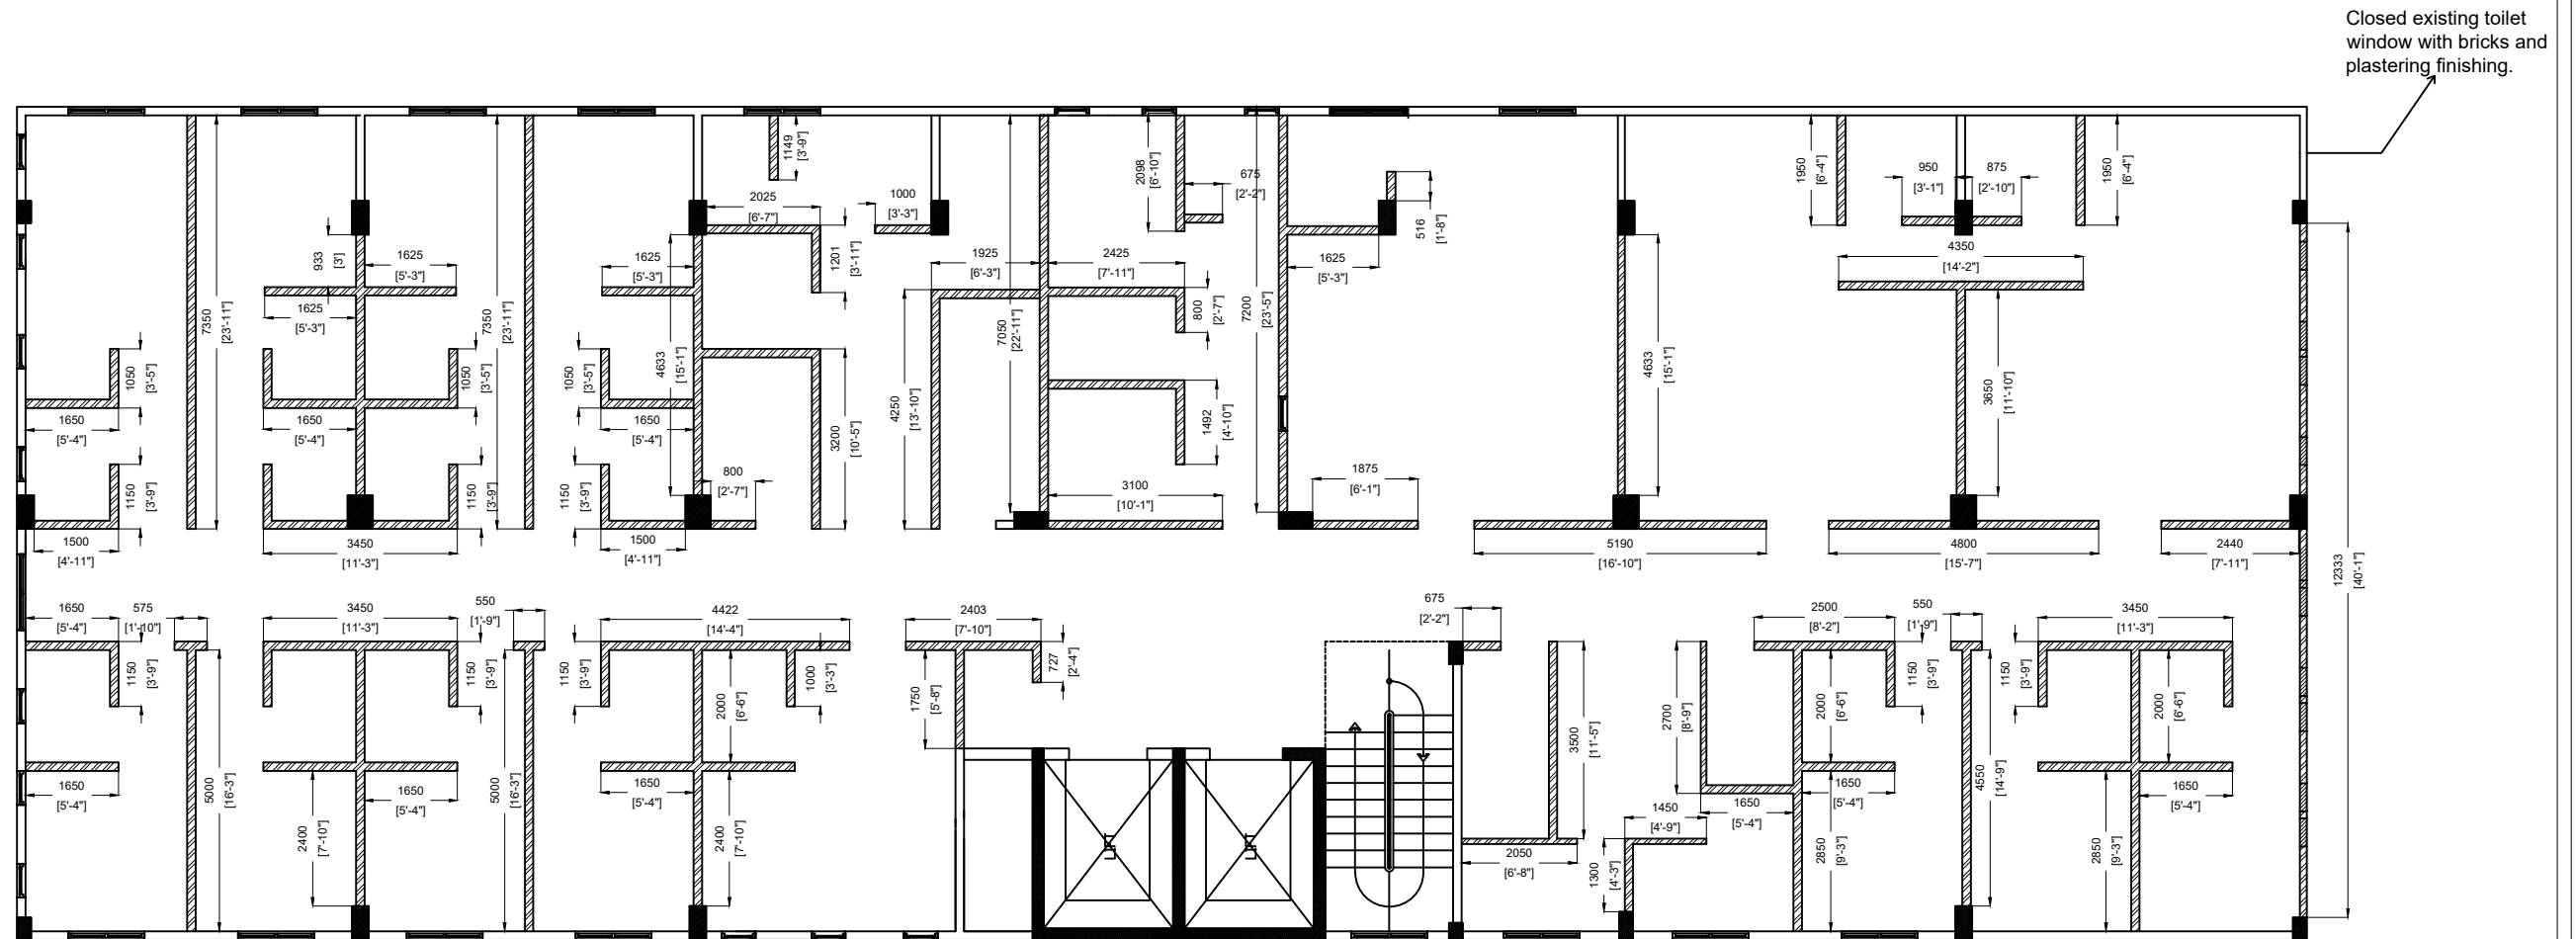
Closed existing toilet window with bricks and plastering finishing.

Window voids (Demolish window area below sill down to floor slab and above lintel beam up to main beam level.)

Fully Demolition Wall

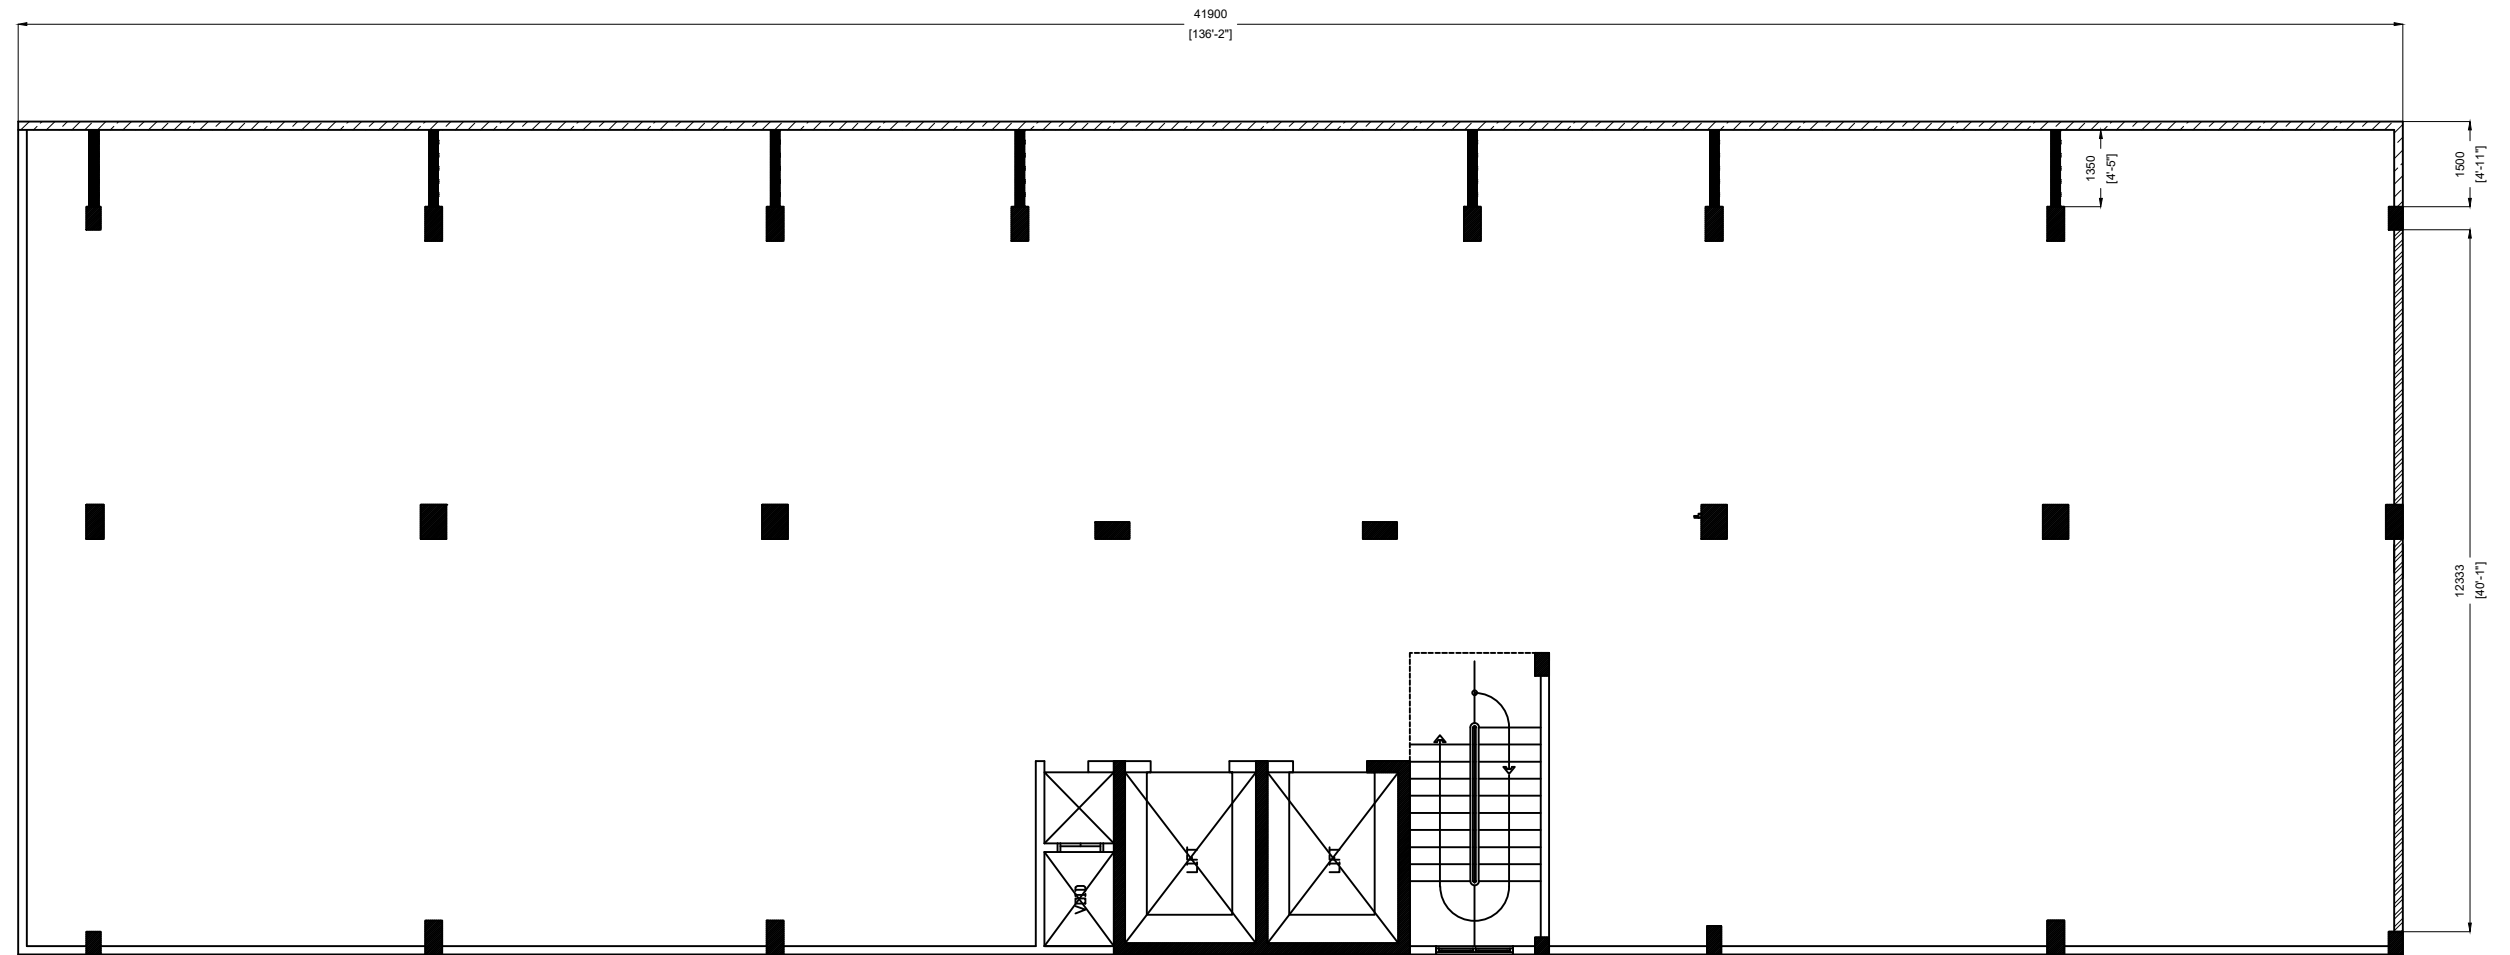
5th FLOOR PLAN / Demolition wall details

Demolish Mention Area and make new walls
-

Fully Demolishing Wall
-

New Masonry and Plated Walls
