Rotokauri Strategic Infrastructure Designation - Preliminary Site Investigation (Contamination)

Prepared for Hamilton City Council
Prepared by Beca Limited

24 April 2024

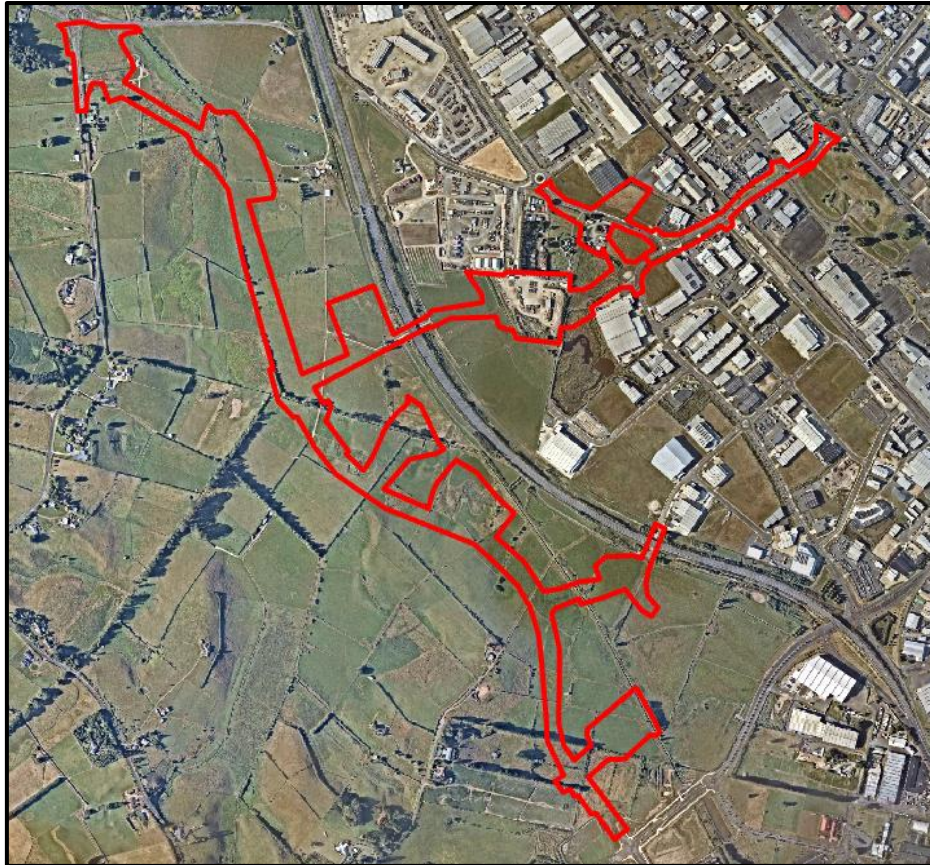
Figure 3: The alignment (red) (Base image source: Nearmap 2024).

The alignment is in Rotokauri, a committed residential greenfield growth cell in Hamilton. The alignment is approximately 5.8km in total length and is located within a predominantly 'greenfield catchment'. The alignment is identified in **Figure 3** below.

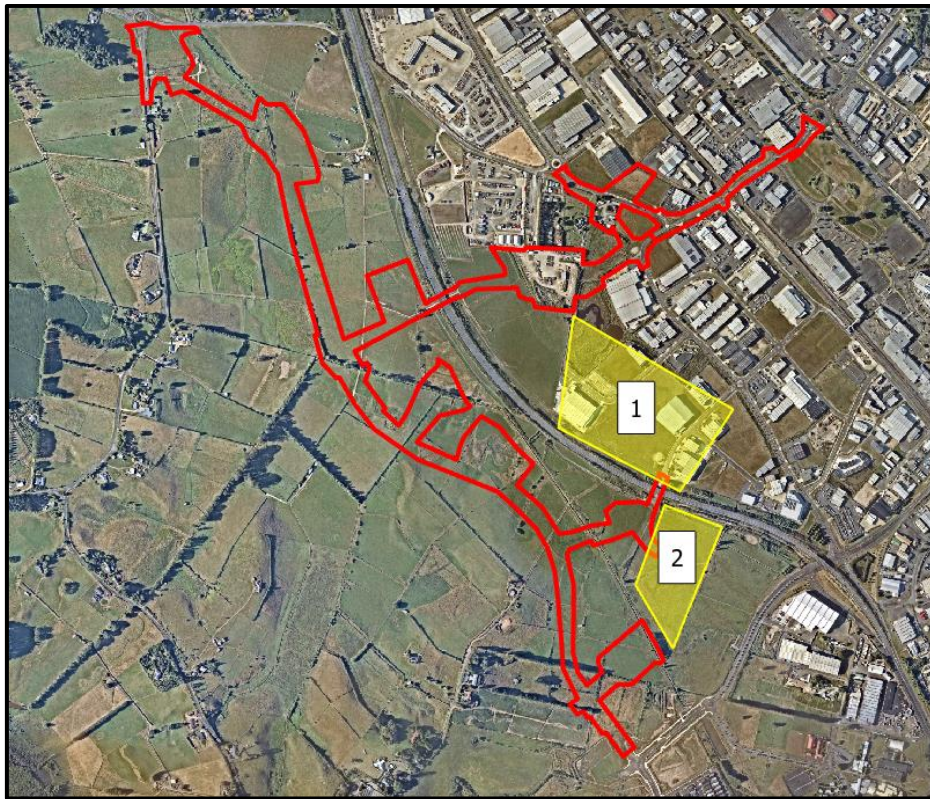
Figure 5: Location of Geotechnical reports as per Section 2.7 above (Base image source: Nearmap 2024).

of the Piako (Hinuera Formation) and Walton Sub-Groups, with the latter outcropping and forming the low-lying hills in the western part of the site. Observations from shallow piezometers showed groundwater levels at approximately 4.2m below ground level.

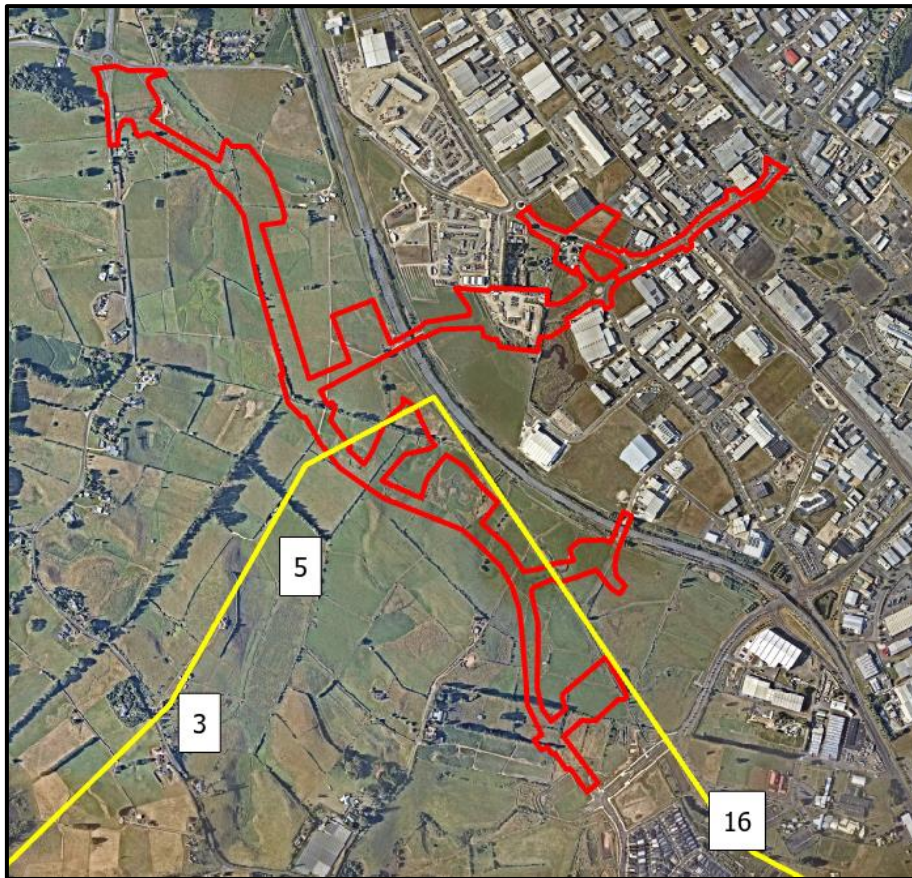
Figure 6 – Greenway (yellow) and Rotokauri arterial (red) alignments. (Base image source: Nearmap 2024).

- Within the road reserve along Exelby Road, approximately seven sheets of cladding with potential ACM were noted (Site 3 in **Figure 6** below). Other small stockpiles of refuse material appeared to have also been disposed of these included a trampoline net and metal poles and two full household rubbish bags. The Rotokauri Greenway Designation did not intersect this area and no soil disturbance activities were proposed therefore the NESCS was not considered applicable in this area.

All activities identified within the Beca Greenway report are located more than 200m from the alignment that is the subject of this PSI.

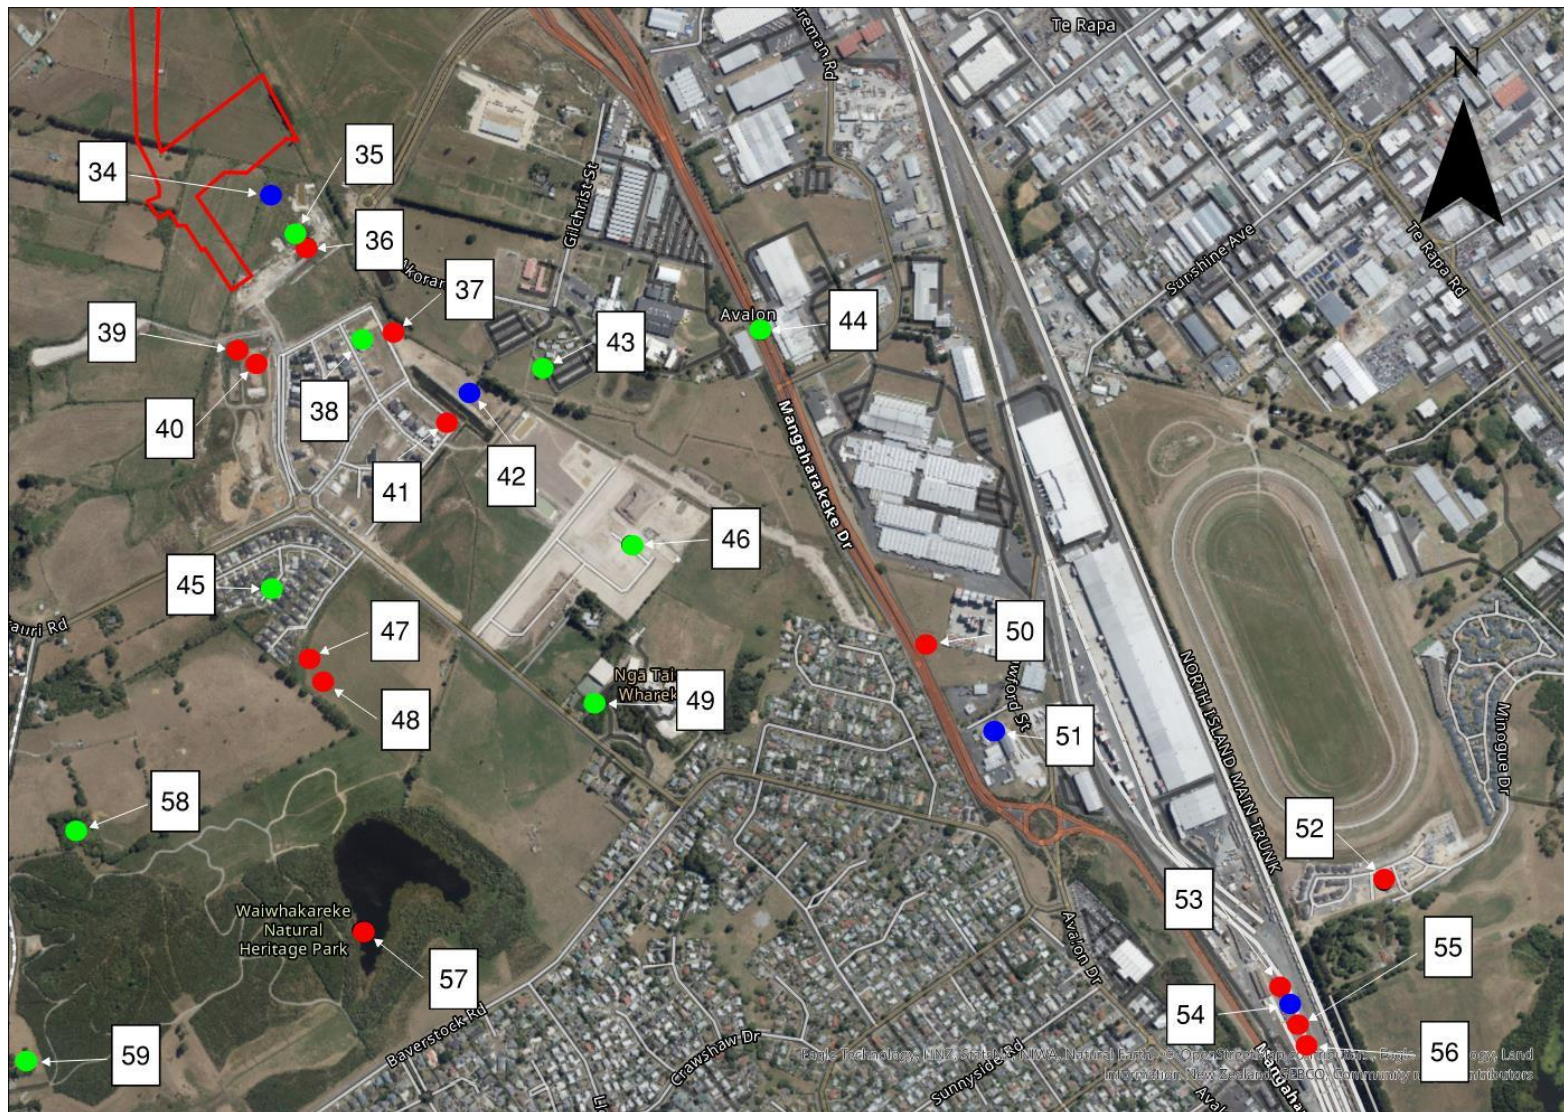
Consented activities with respect to the alignment. Image 2 of 2. Image Source @ WRC GIS

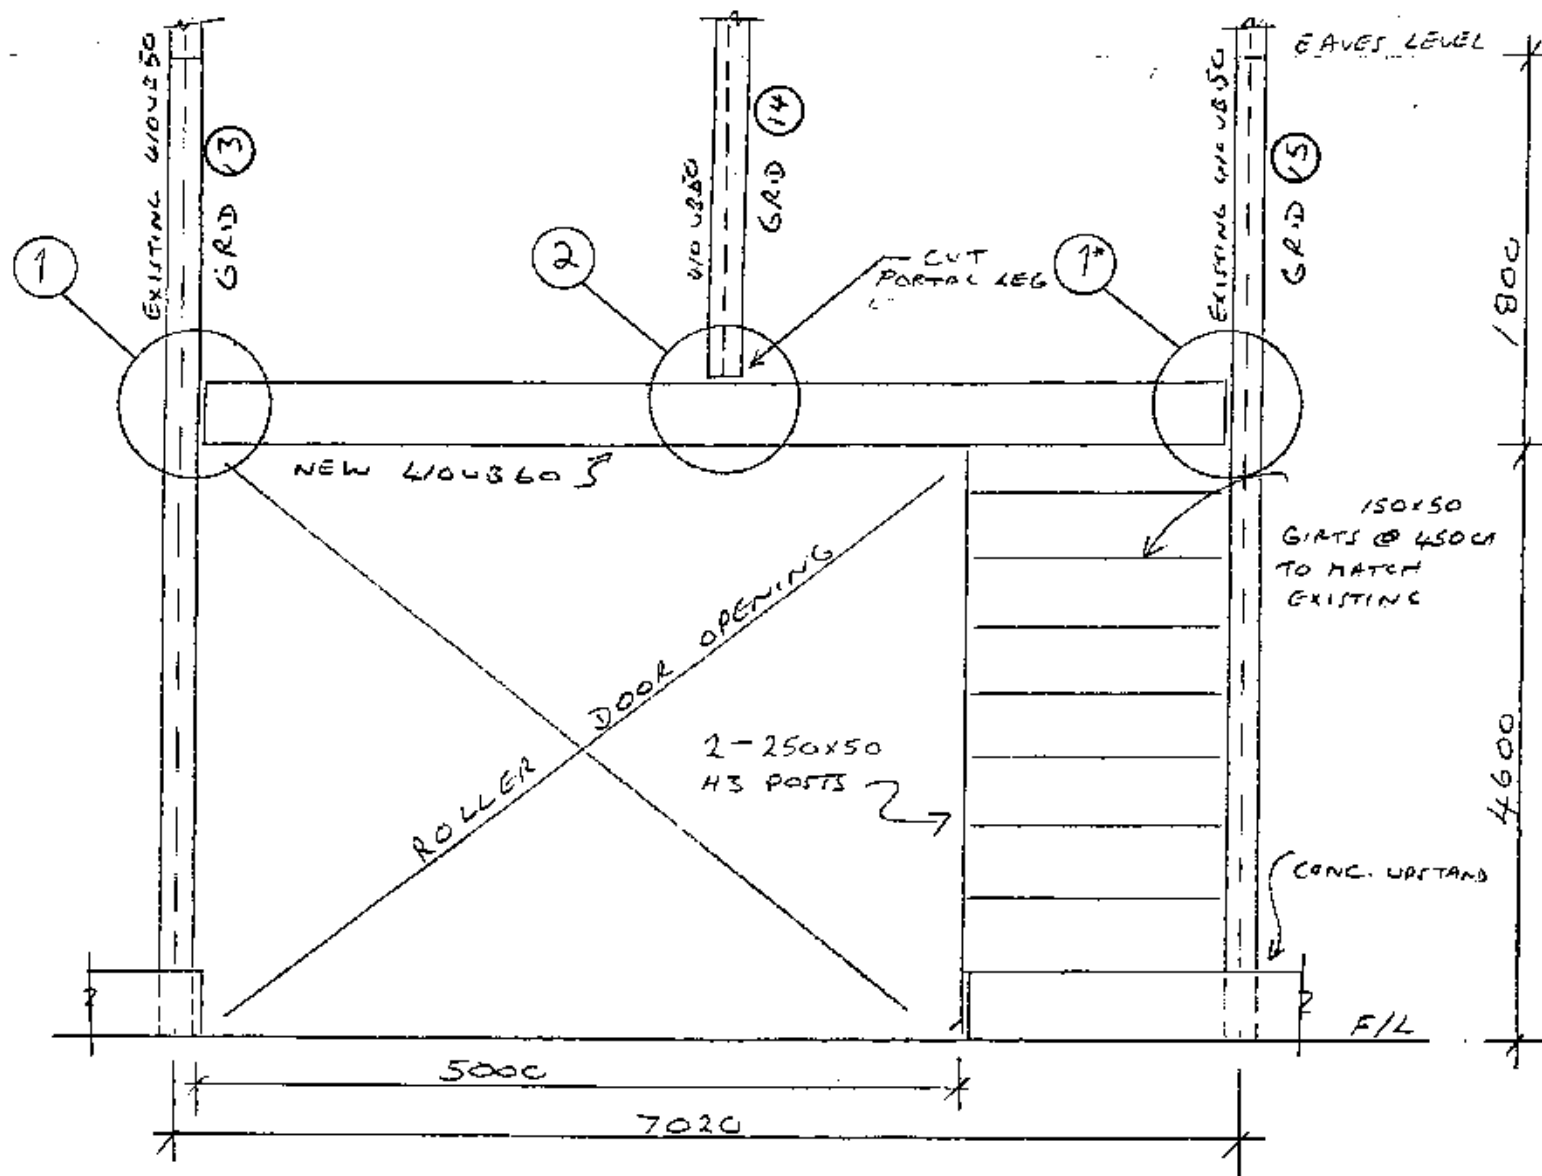
ELEVATION OF 5m WIDE ROLLER DOOR OPENING

Proposed 5m wide x 4.5m high Roller Door
across portal on grid line 14

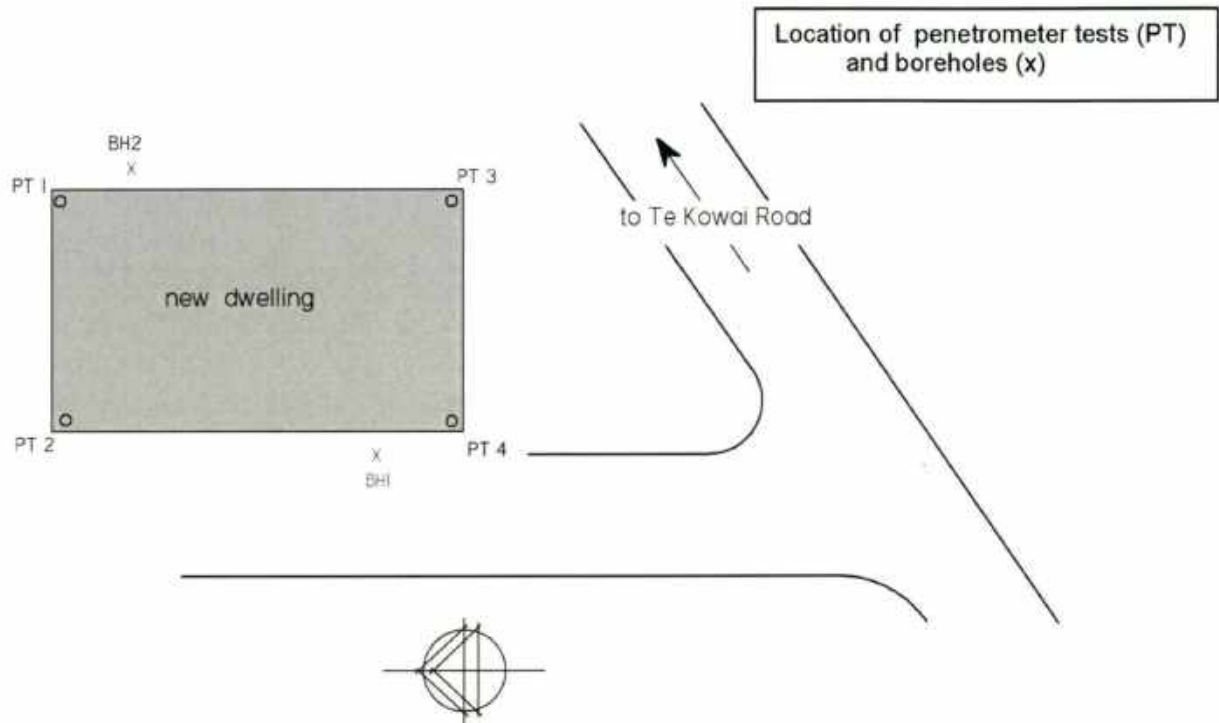
Borehole Log 1		Clarke Trust property	Date: 15 October 2010
	A _p	- TOPSOIL - friable dark brown, grass on topsoil	
300	B _w	- SILTS – pale -,sandy silt, friable moist	
500	B _t	- SILTS - pale, clayey , moist mottled	
		current water table	
800		- CLAYS – silty clays, light brown	
1200		- Borehole completed
