**Rotokauri Arterial Network Designation Notice of Requirement – Part 1 response to Section 92 further information request**

Attachment 1: Updated stormwater drawings CA-2400 - 2405

STORMWATER LAYOUT SHEET

# Supplementary Fauna Surveys

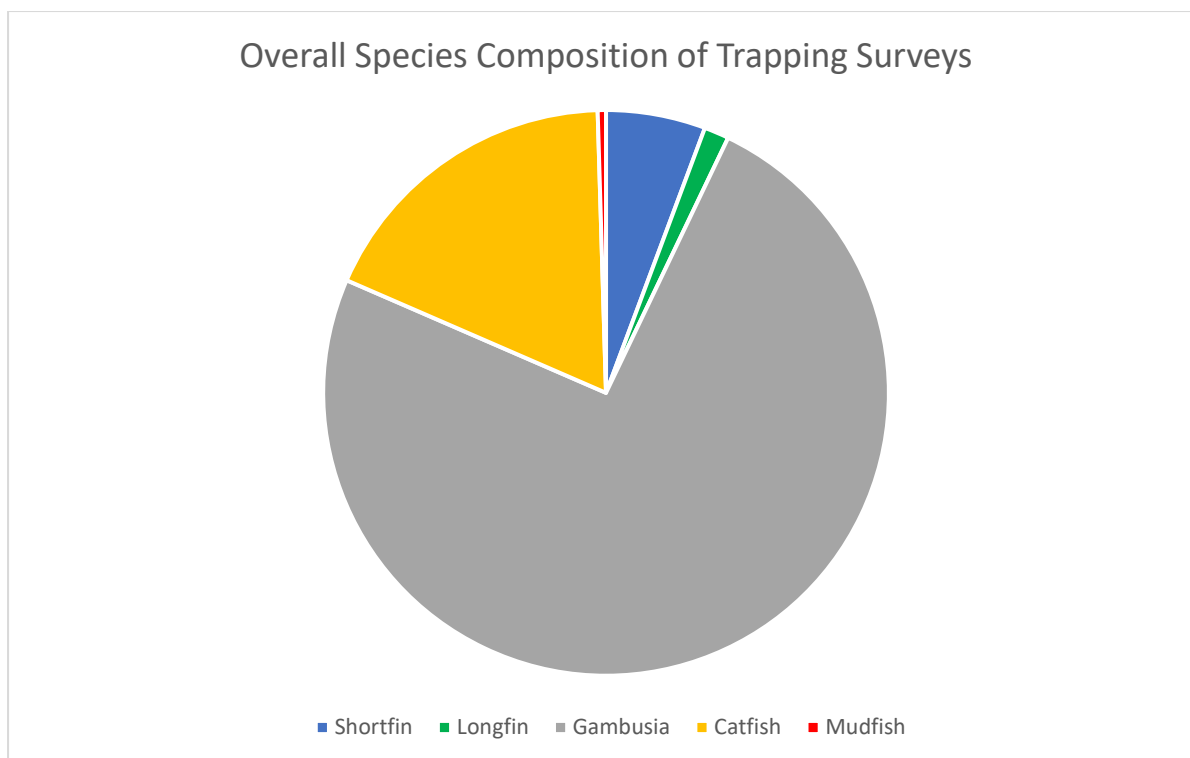
Figure 4: Species found during fish trapping

Two At-Risk species were found during trapping, but in low abundance (three longfin eels and one black mudfish). Other species found during trapping (shortfin eels and pest fish) are commonly found in artificial habitats with poor water quality such as the farm drains on-site. These species are widespread in the Waikato (based on NZFFD records and ENZL's experience). Overall, pest fish species dominated the catch (Figure 4) and of the native species found, the shortfin eel was the dominant species (Figure 5) as was expected for this habitat type.

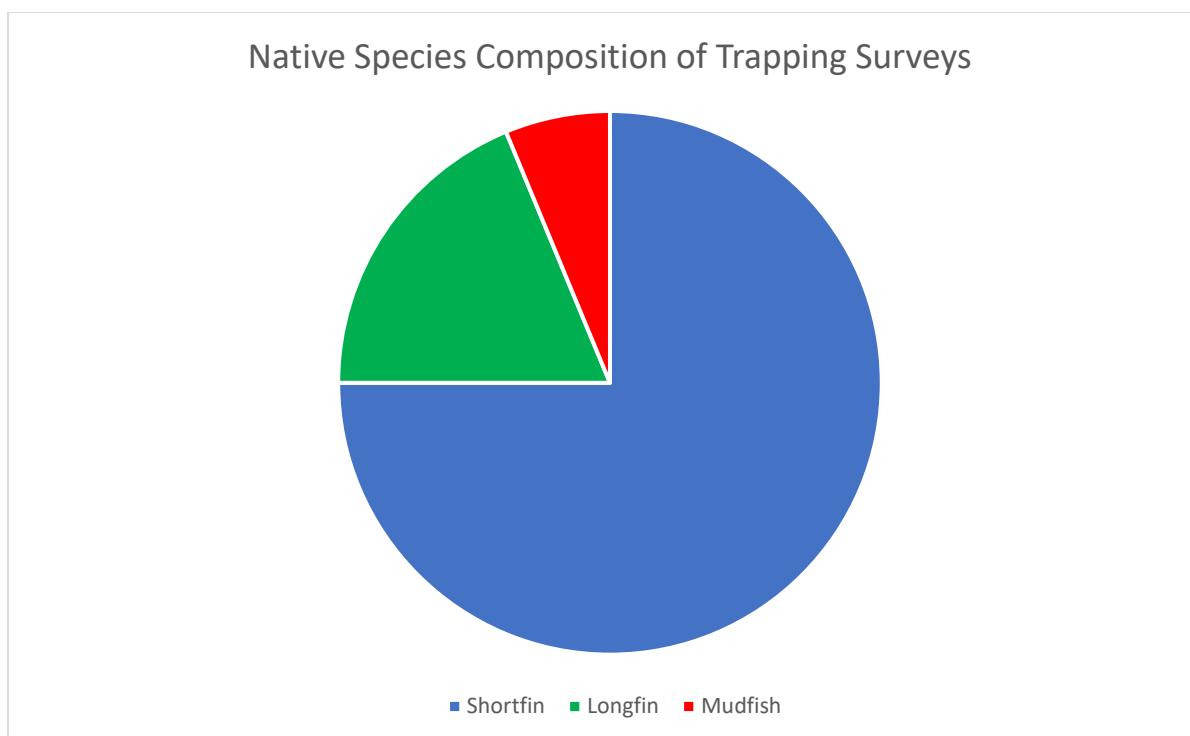
Figure 5: Native fish species found during fish trapping

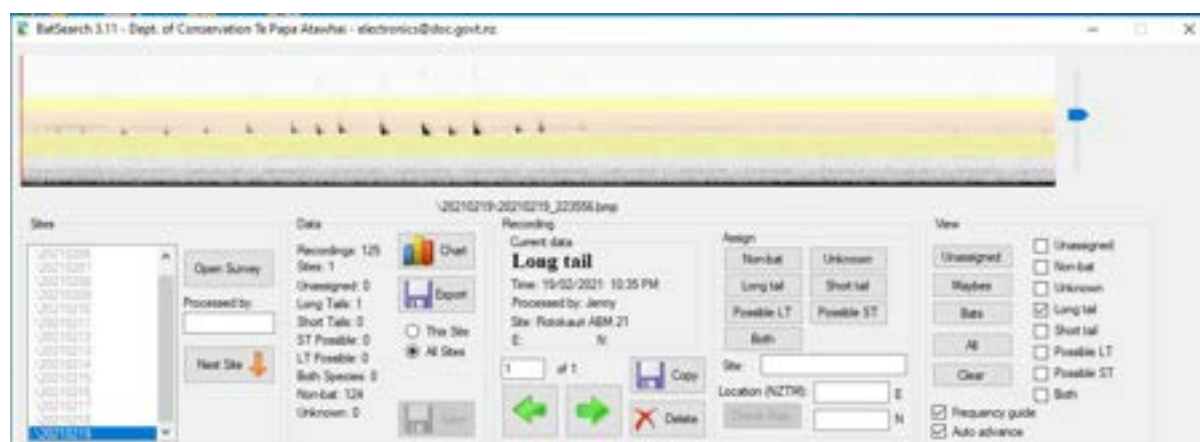
Figure 11 Long-tail bat pass detected at ABM Unit 21.

A single long-tailed bat pass was detected during the survey session at ABM Unit Number 21 (22:35 on the 19<sup>th</sup> of February 2021) (Figure 11, Figure 12). This result is reflective of the low levels of activity detected in previously completed surveys (refer to Section 3.2.1). The pass was considered a commuting call, and not a social call or feeding buzz. The subject ABM was positioned at a stand of mature macrocarpa trees (*Cupressus macrocarpa*), adjacent to a farm shed area. Several of these trees demonstrated roosting features suitable for bats (refer to Section 3.2.3); however, the timing of the pass (22:35) does not indicate roosting behaviour.
