ARCHAEOLOGICAL ASSESSMENT

RUAKIWI RESERVOIR

PREPARED FOR HAMILTON CITY COUNCIL
BY SIÂN KEITH

JUNE 2025

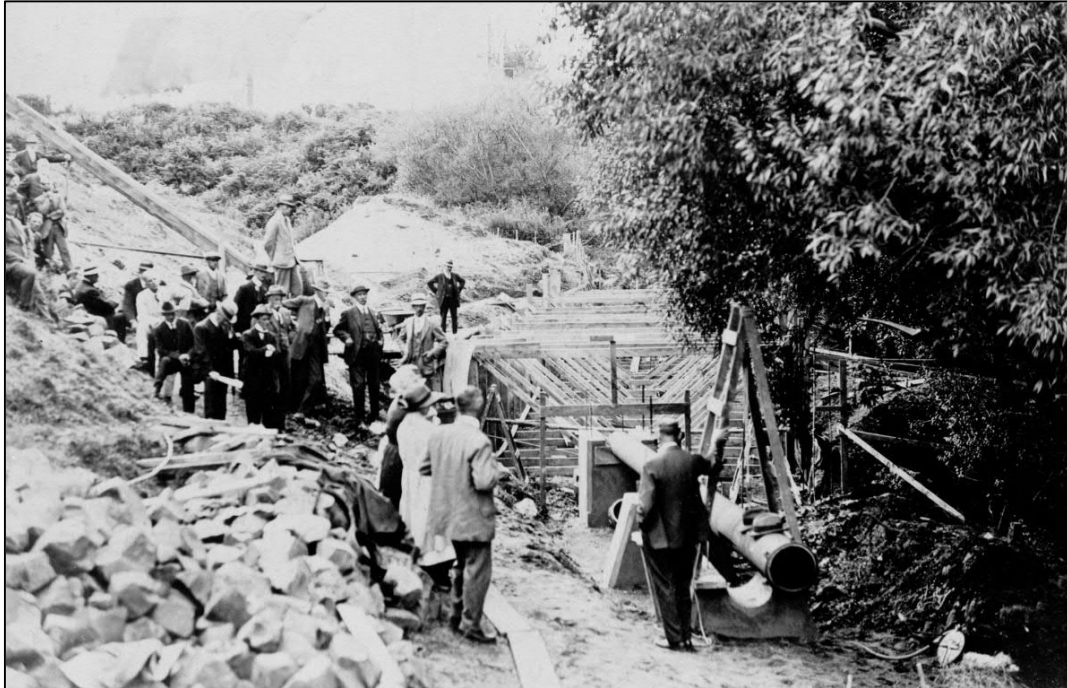
Figure 3: Hamilton waterworks - laying pipeline to reservoir (no date) (HCL_11584).

There are no known images of the first reservoir or images showing the construction of the second or third reservoirs. An undated image shows construction workers laying pipe to one of the reservoirs (Figure 3). There are many images of the third and current reservoir (Figure 4). There are no known contemporary reports on any archaeological findings during the formation of these reservoirs.

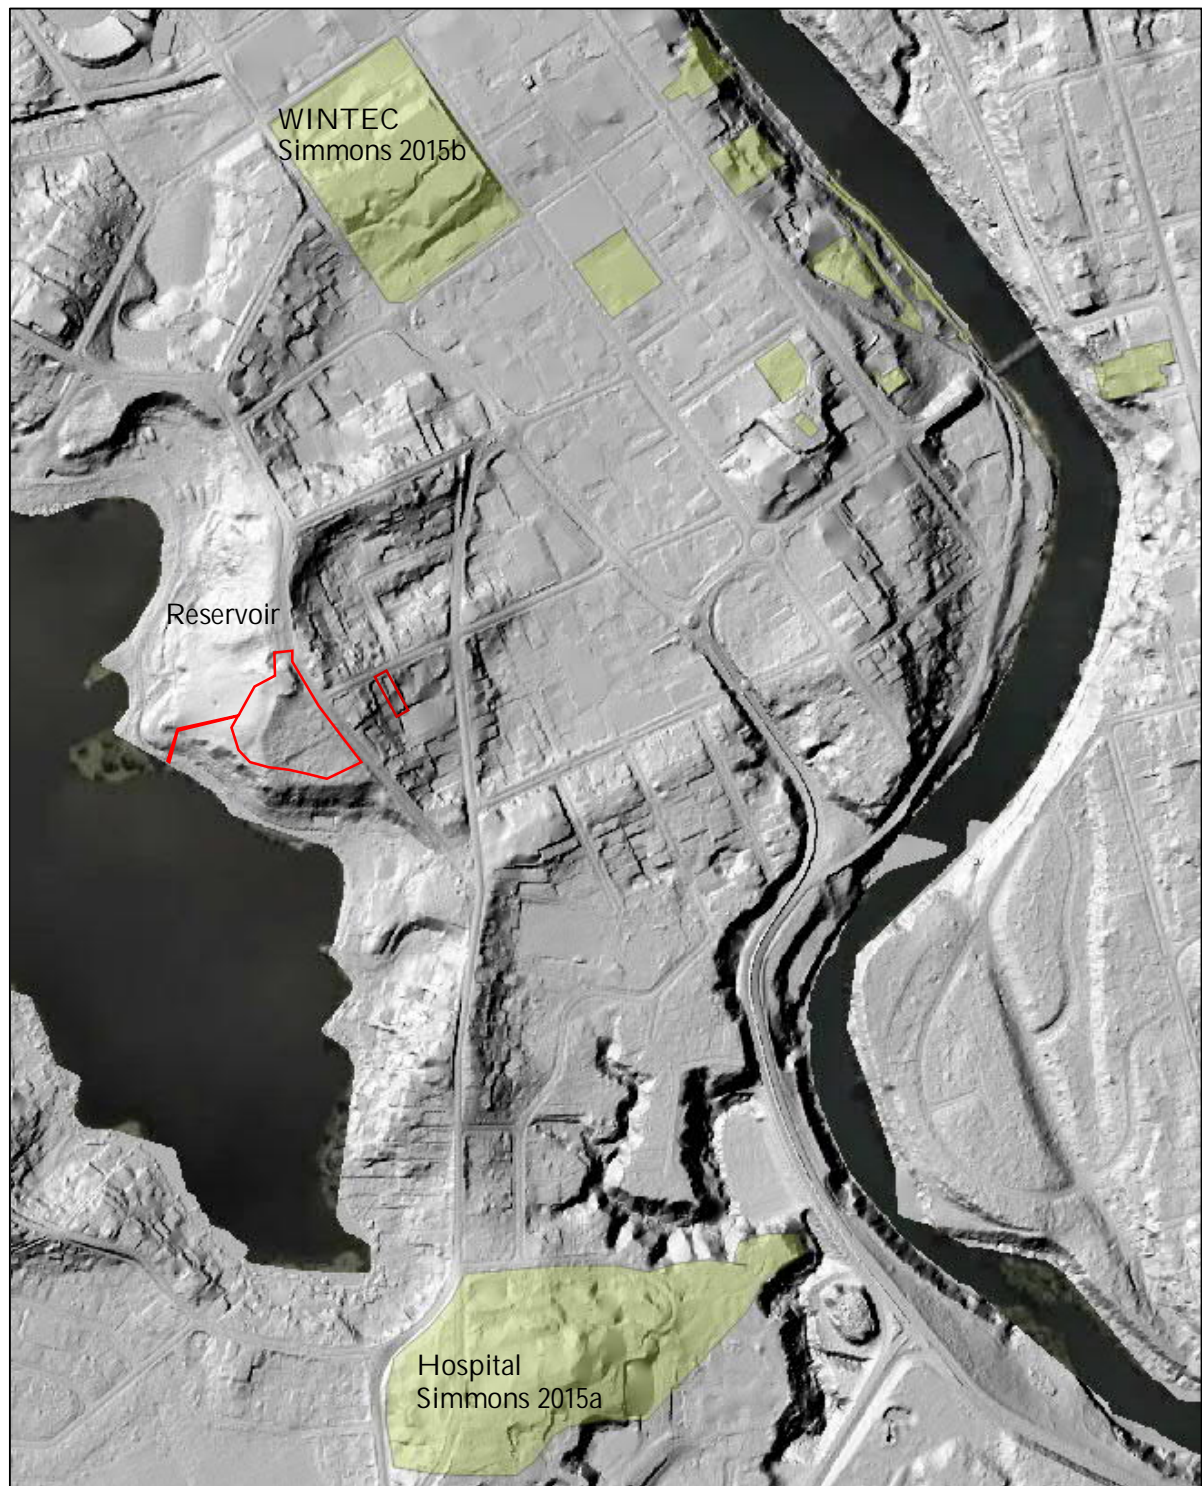
Figure 7: LiDAR showing the ridgeline and previous archaeological investigations at the Hospital and WINTERC sites in relation to the subject site (highlighted red).

Simmons monitored redevelopment works at the WINTEC city campus; this was similarly located on the ridgeline. Based on the information detailed by Mr Puke (from the NZAA file - see Section 5.1), this was the ridge top and would have been a focus of pre-European activity. Due to the fact that the campus has been subject to significant earthworks over the 20th century, Simmons considered that there was a low chance of identifying archaeological material. The only find was a deposit of ink bottles (Simmons 2015b).

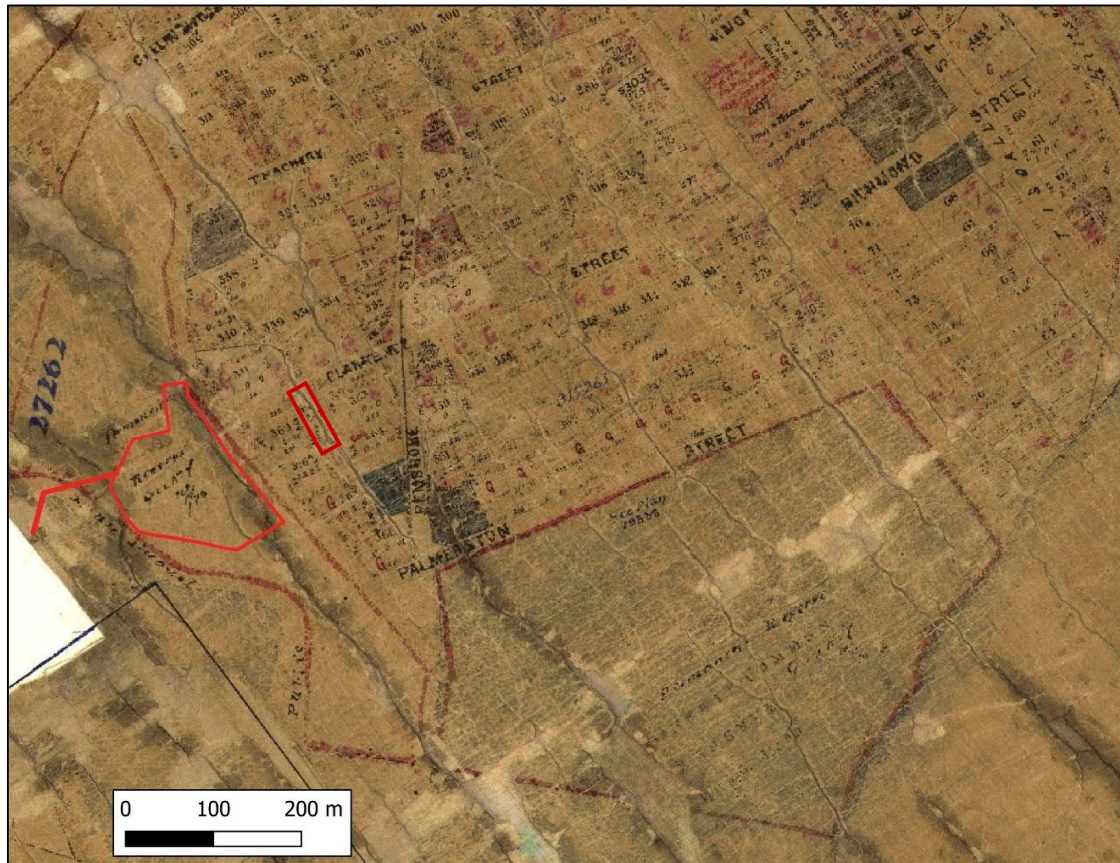
Figure 8: SO378 (1865). The annotation within the study area appears to say 'permanent raupo swamp'.

The initial survey plans of Hamilton from c.1865 do not provide evidence for landuse around the lake (Figure 9 - Figure 8). Clarence Street was surveyed but there are no annotations suggesting occupation from this time. The SO380 plan appears to show a trig station marked by a triangle with a connecting chain line, the trig was probably where the current water tower/s are located. A map of the Waikato from c.1873 shows a dwelling with the name *Jolly* annotated at the north side of the lake, one annotated *Cox* to the west and a stable to the south (Figure 10). The western side of the lake is shown as swamp. There are no features of archaeological interest identified within or close to the subject site.

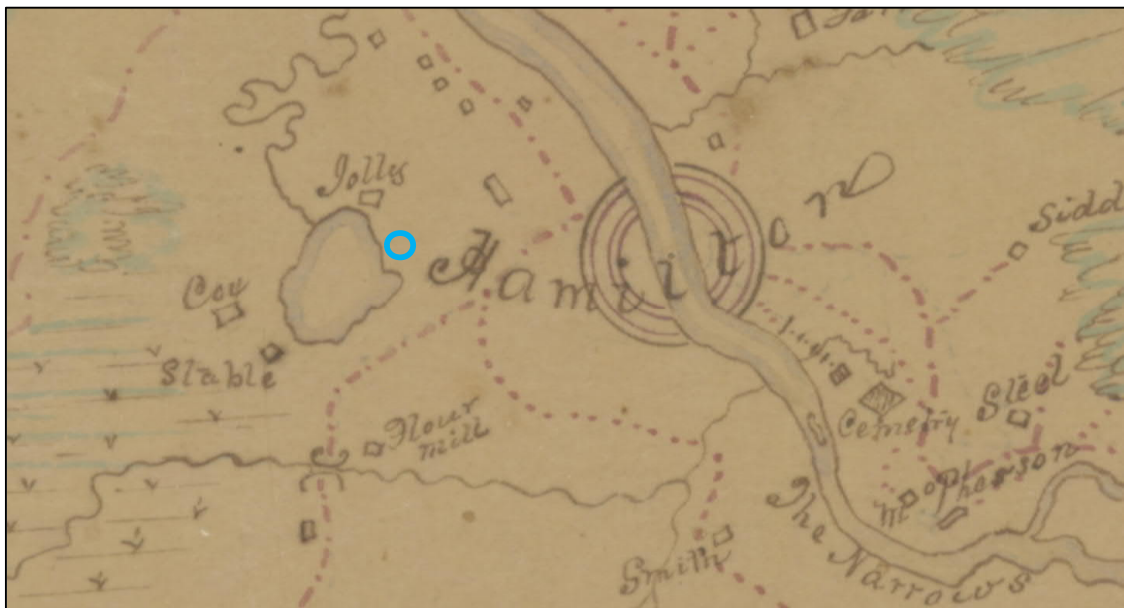
Figure 10: Extract of 'Captain Newell's Sketch Map of the Waikato'. 1874. Approximate location of study area highlighted blue.²⁸

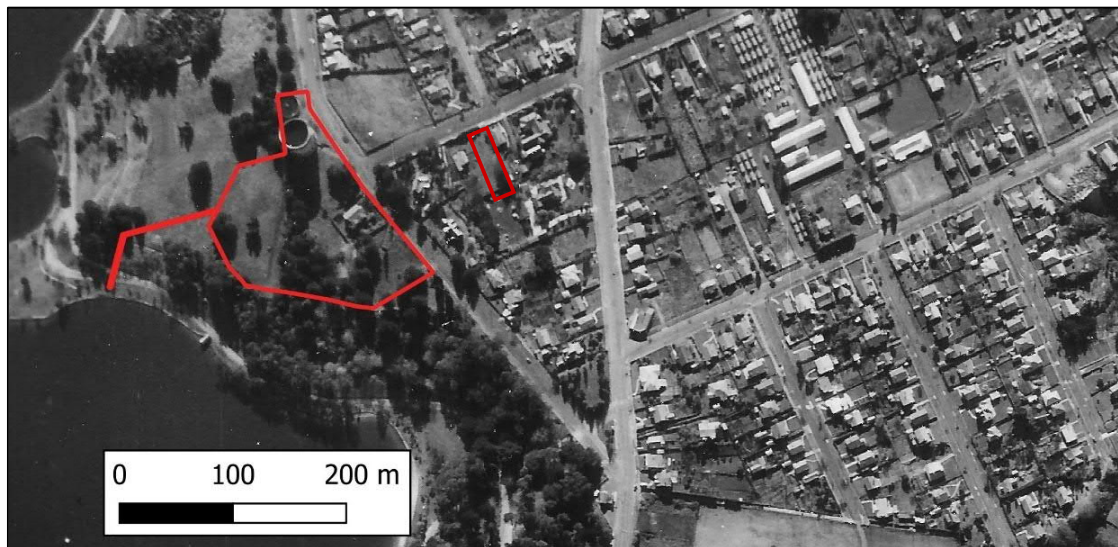
Figure 12: 1940s aerial image shows two water towers and dwelling (831-39 source: retrolens.nz).

The 1940s aerial photographs show the second and the third reservoirs and the Waddell dwelling (Figure 12). The adjacent reserve is planted in mature trees and there are maintained lawns. The pump station site remains undeveloped; a search of Google Earth indicates that the current dwelling has been in situ since at least 2008.

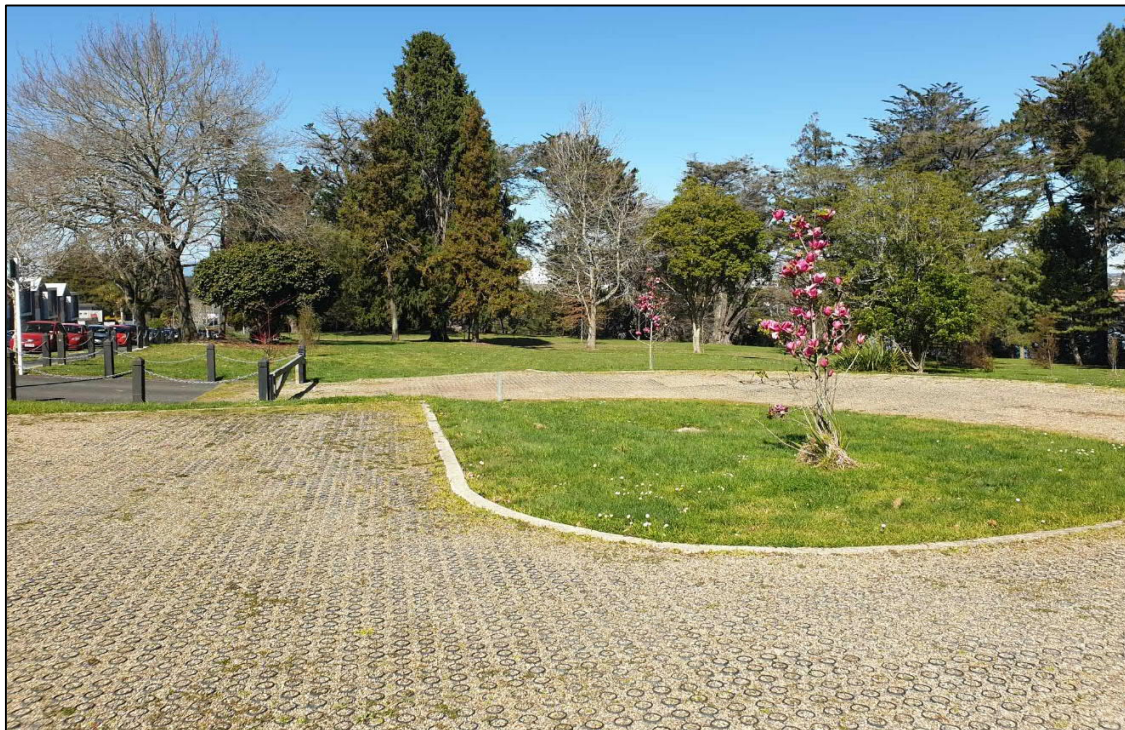
Figure 13: Photo taken across the location of the proposed reservoir, looking south.

Hand-held screw-augering was undertaken in the general location of the new infrastructure. This determined a soil profile of clay subsoil below topsoil. In the location of the former dwelling a mixed soil profile was noted, which was not unexpected. The reservoirs were briefly inspected. Of note there are substantial concrete foundations present between the two extant circular reservoirs. These must be related to the first reservoir which was demolished. No archaeological sites, features or deposits were identified during the field survey.

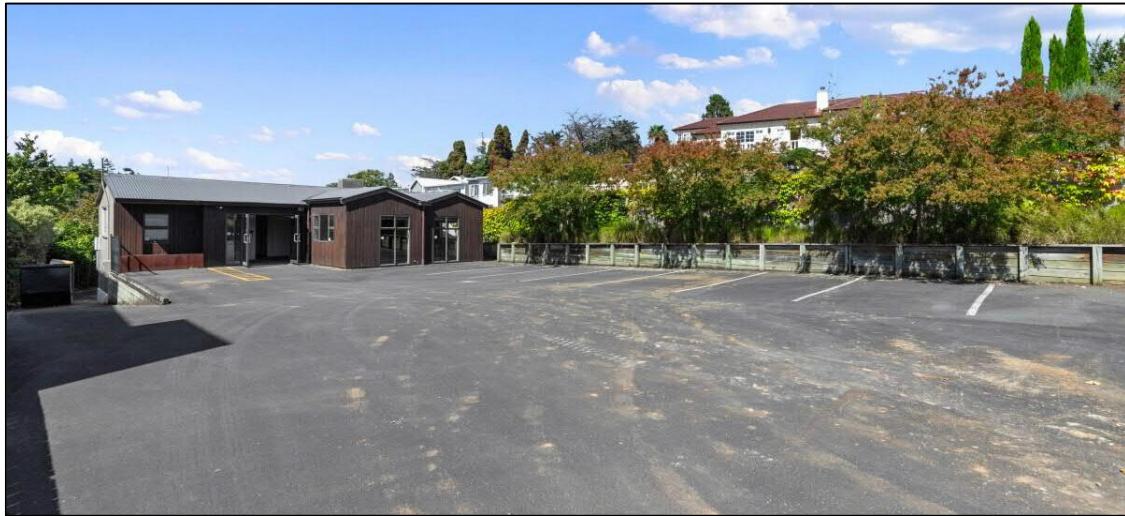
Figure 14: Image from the street of 139 Clarence Street.²⁹

No site survey has been undertaken to the proposed pump station site on Clarence St. There are no known risks associated with this section, furthermore the section is heavily developed with a complete covering of hard stand and a modern dwelling (Figure 14). This would hinder any archaeological survey.
