**TE RAPA RACECOURSE REDEVELOPMENT
KEN BROWNE DRIVE, HAMILTON**

GEOTECHNICAL INVESTIGATION REPORT

Waikato Racing Club

HAM2022-0030AB Rev.1

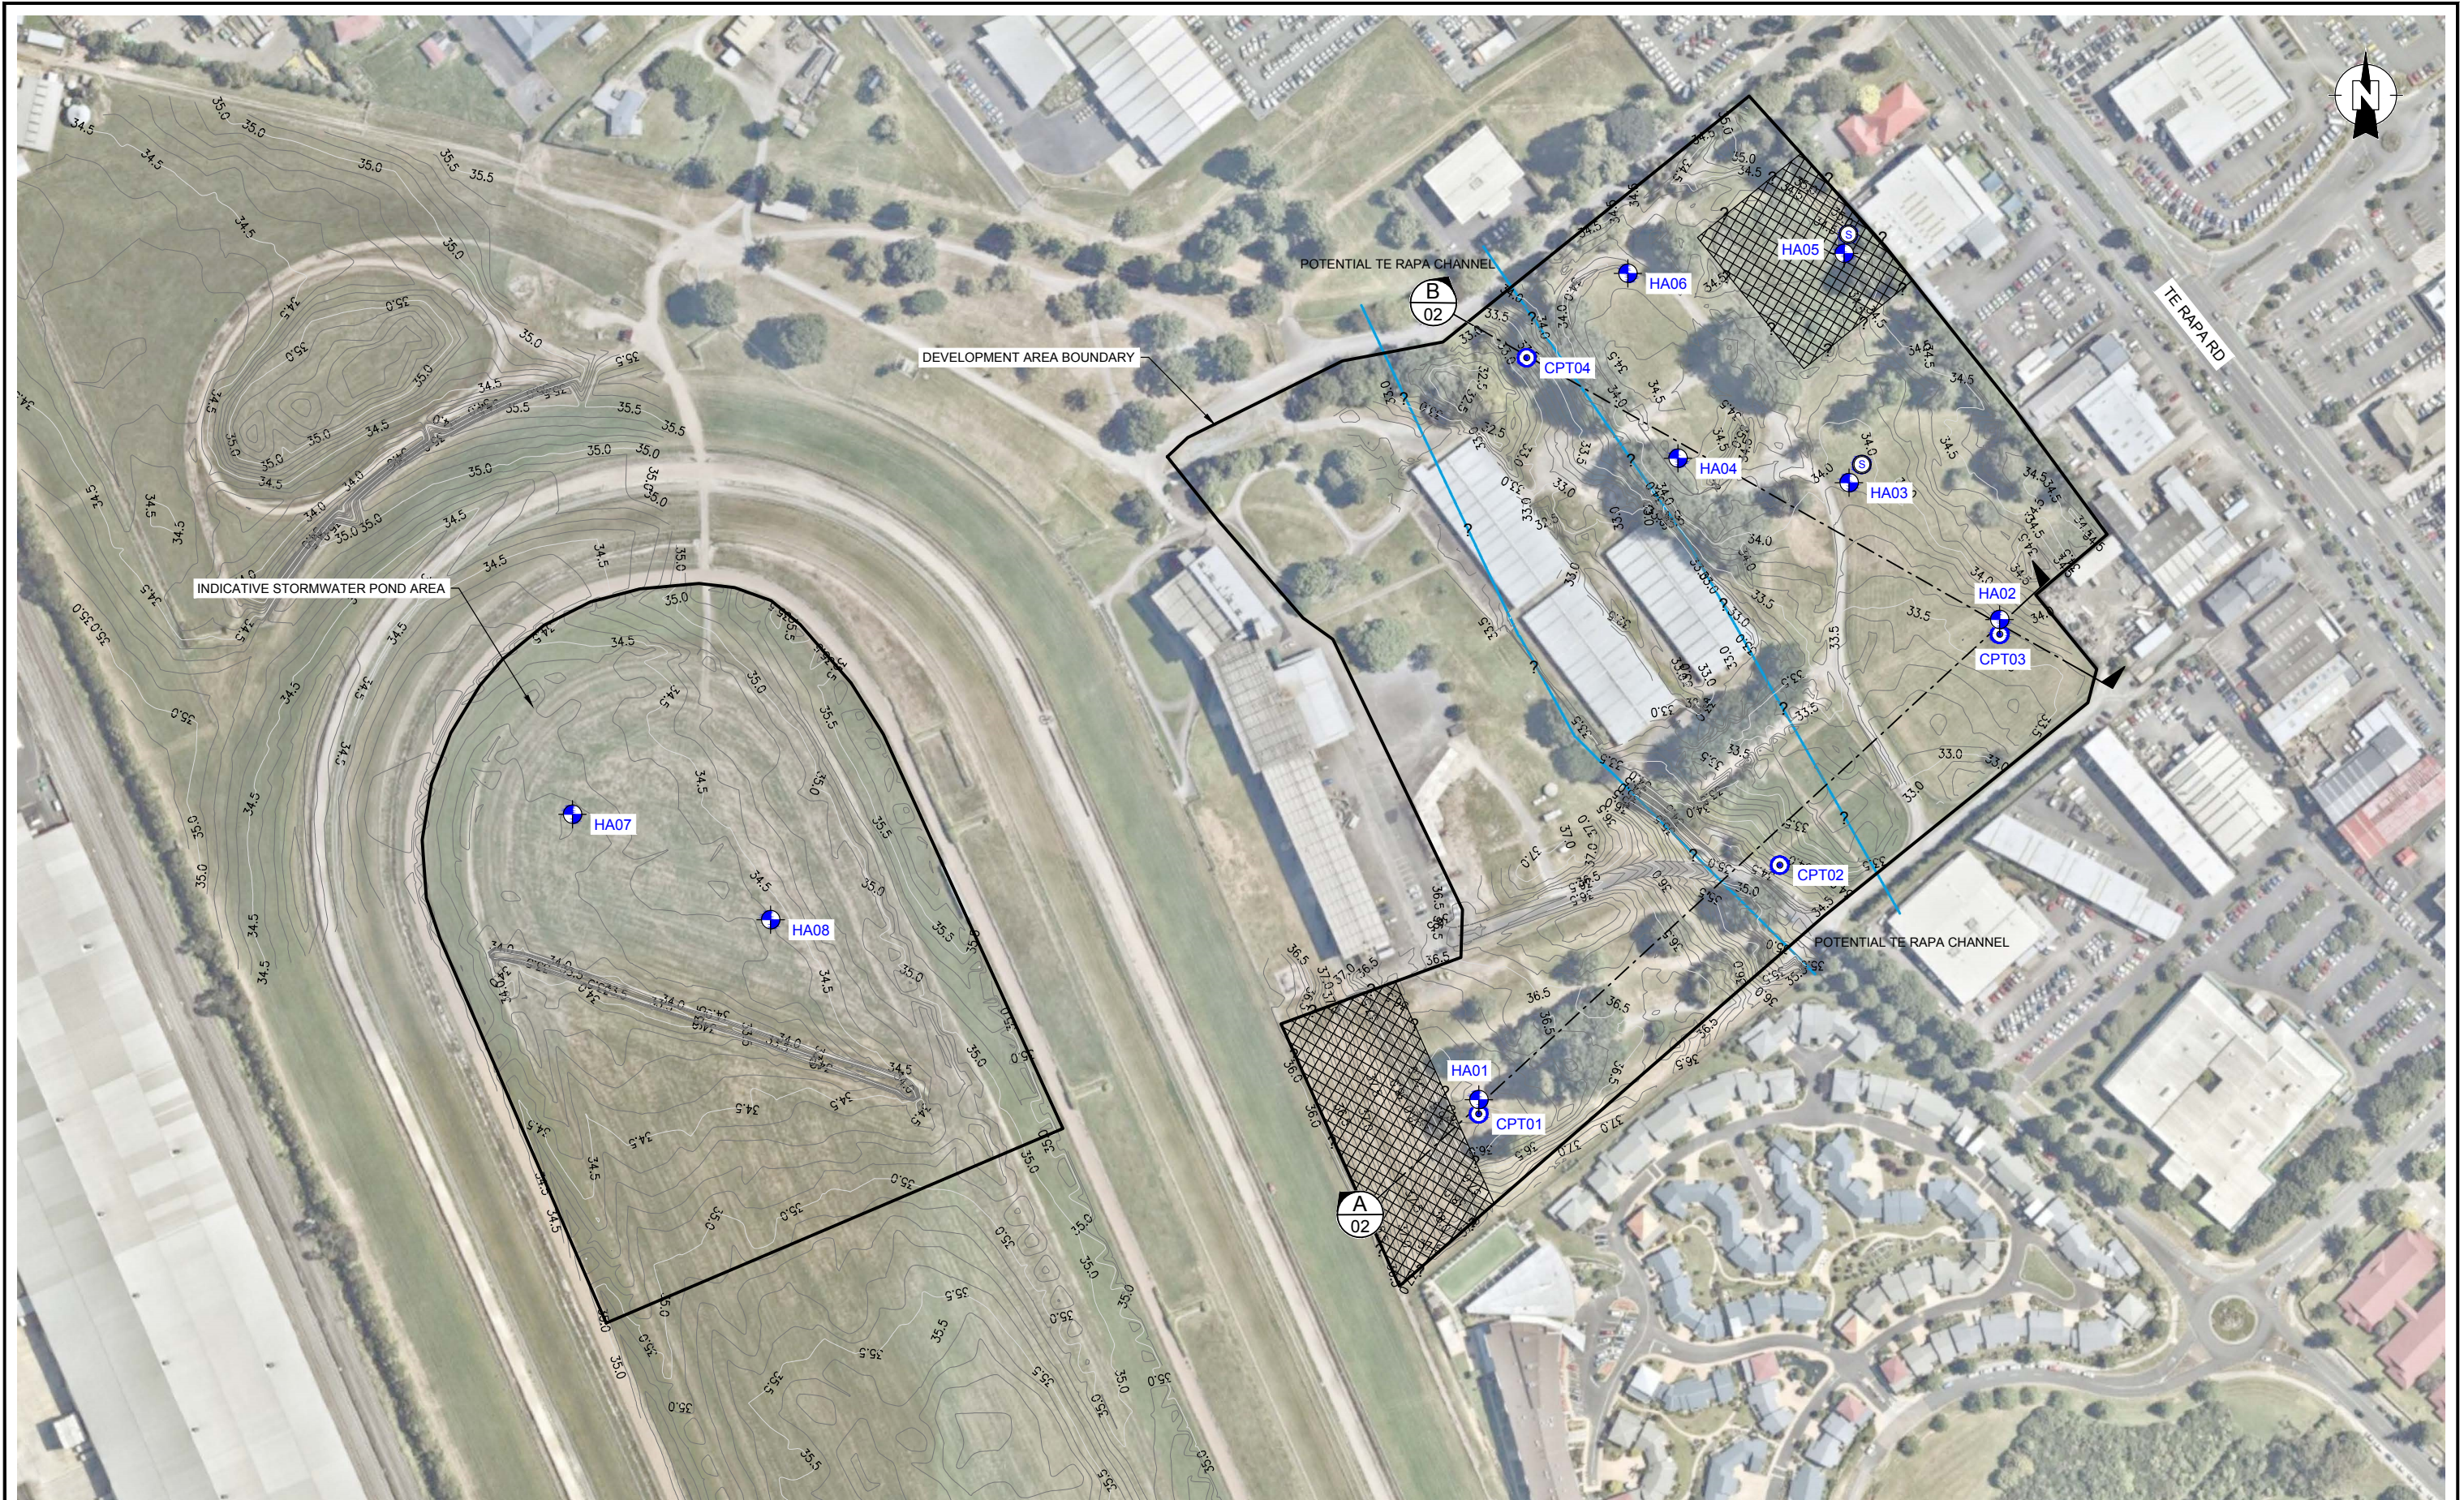
CLIENT:	TE RAPA WAIKATO RACING CLUB		DRAWN:	DE	PROJECT:	HAM2016-0109
PROJECT:	TE RAPA RACECOURSE REDEVELOPMENT HAMILTON, NZ		CHECKED:	JC	FIGURE:	01
TITLE:	SITE INVESTIGATION PLAN		REVISION:	0	SCALE:	1:2500
			DATE:	14.06.17	SHEET:	A3 L

- HA01 HAND AUGER (HA) LOCATION
- CPT01 CONE PENETROMETER TEST (CPT) LOCATION
- FALLING HEAD PERMEABILITY (SOAKAGE) TEST LOCATION
- POTENTIAL NON-ENGINEERED FILL LOCATIONS

- A walkover survey of the site by a CMW Engineering Geologist to assess the general landform and site conditions.
- Eight (8) hand auger boreholes, denoted HA01 to HA08, were drilled using 50mm diameter augers to depths of up to 2.2 metres below existing ground level (mbgl) to allow observation and sampling of the shallow soil profile. In-situ shear vane strength (VSS) measurements were recorded using a hand-held shear vane during the advancement of the hand auger boreholes. Additionally, dynamic cone (Scala) penetrometer (DCP) tests were carried out where coarse-grained soils were present.

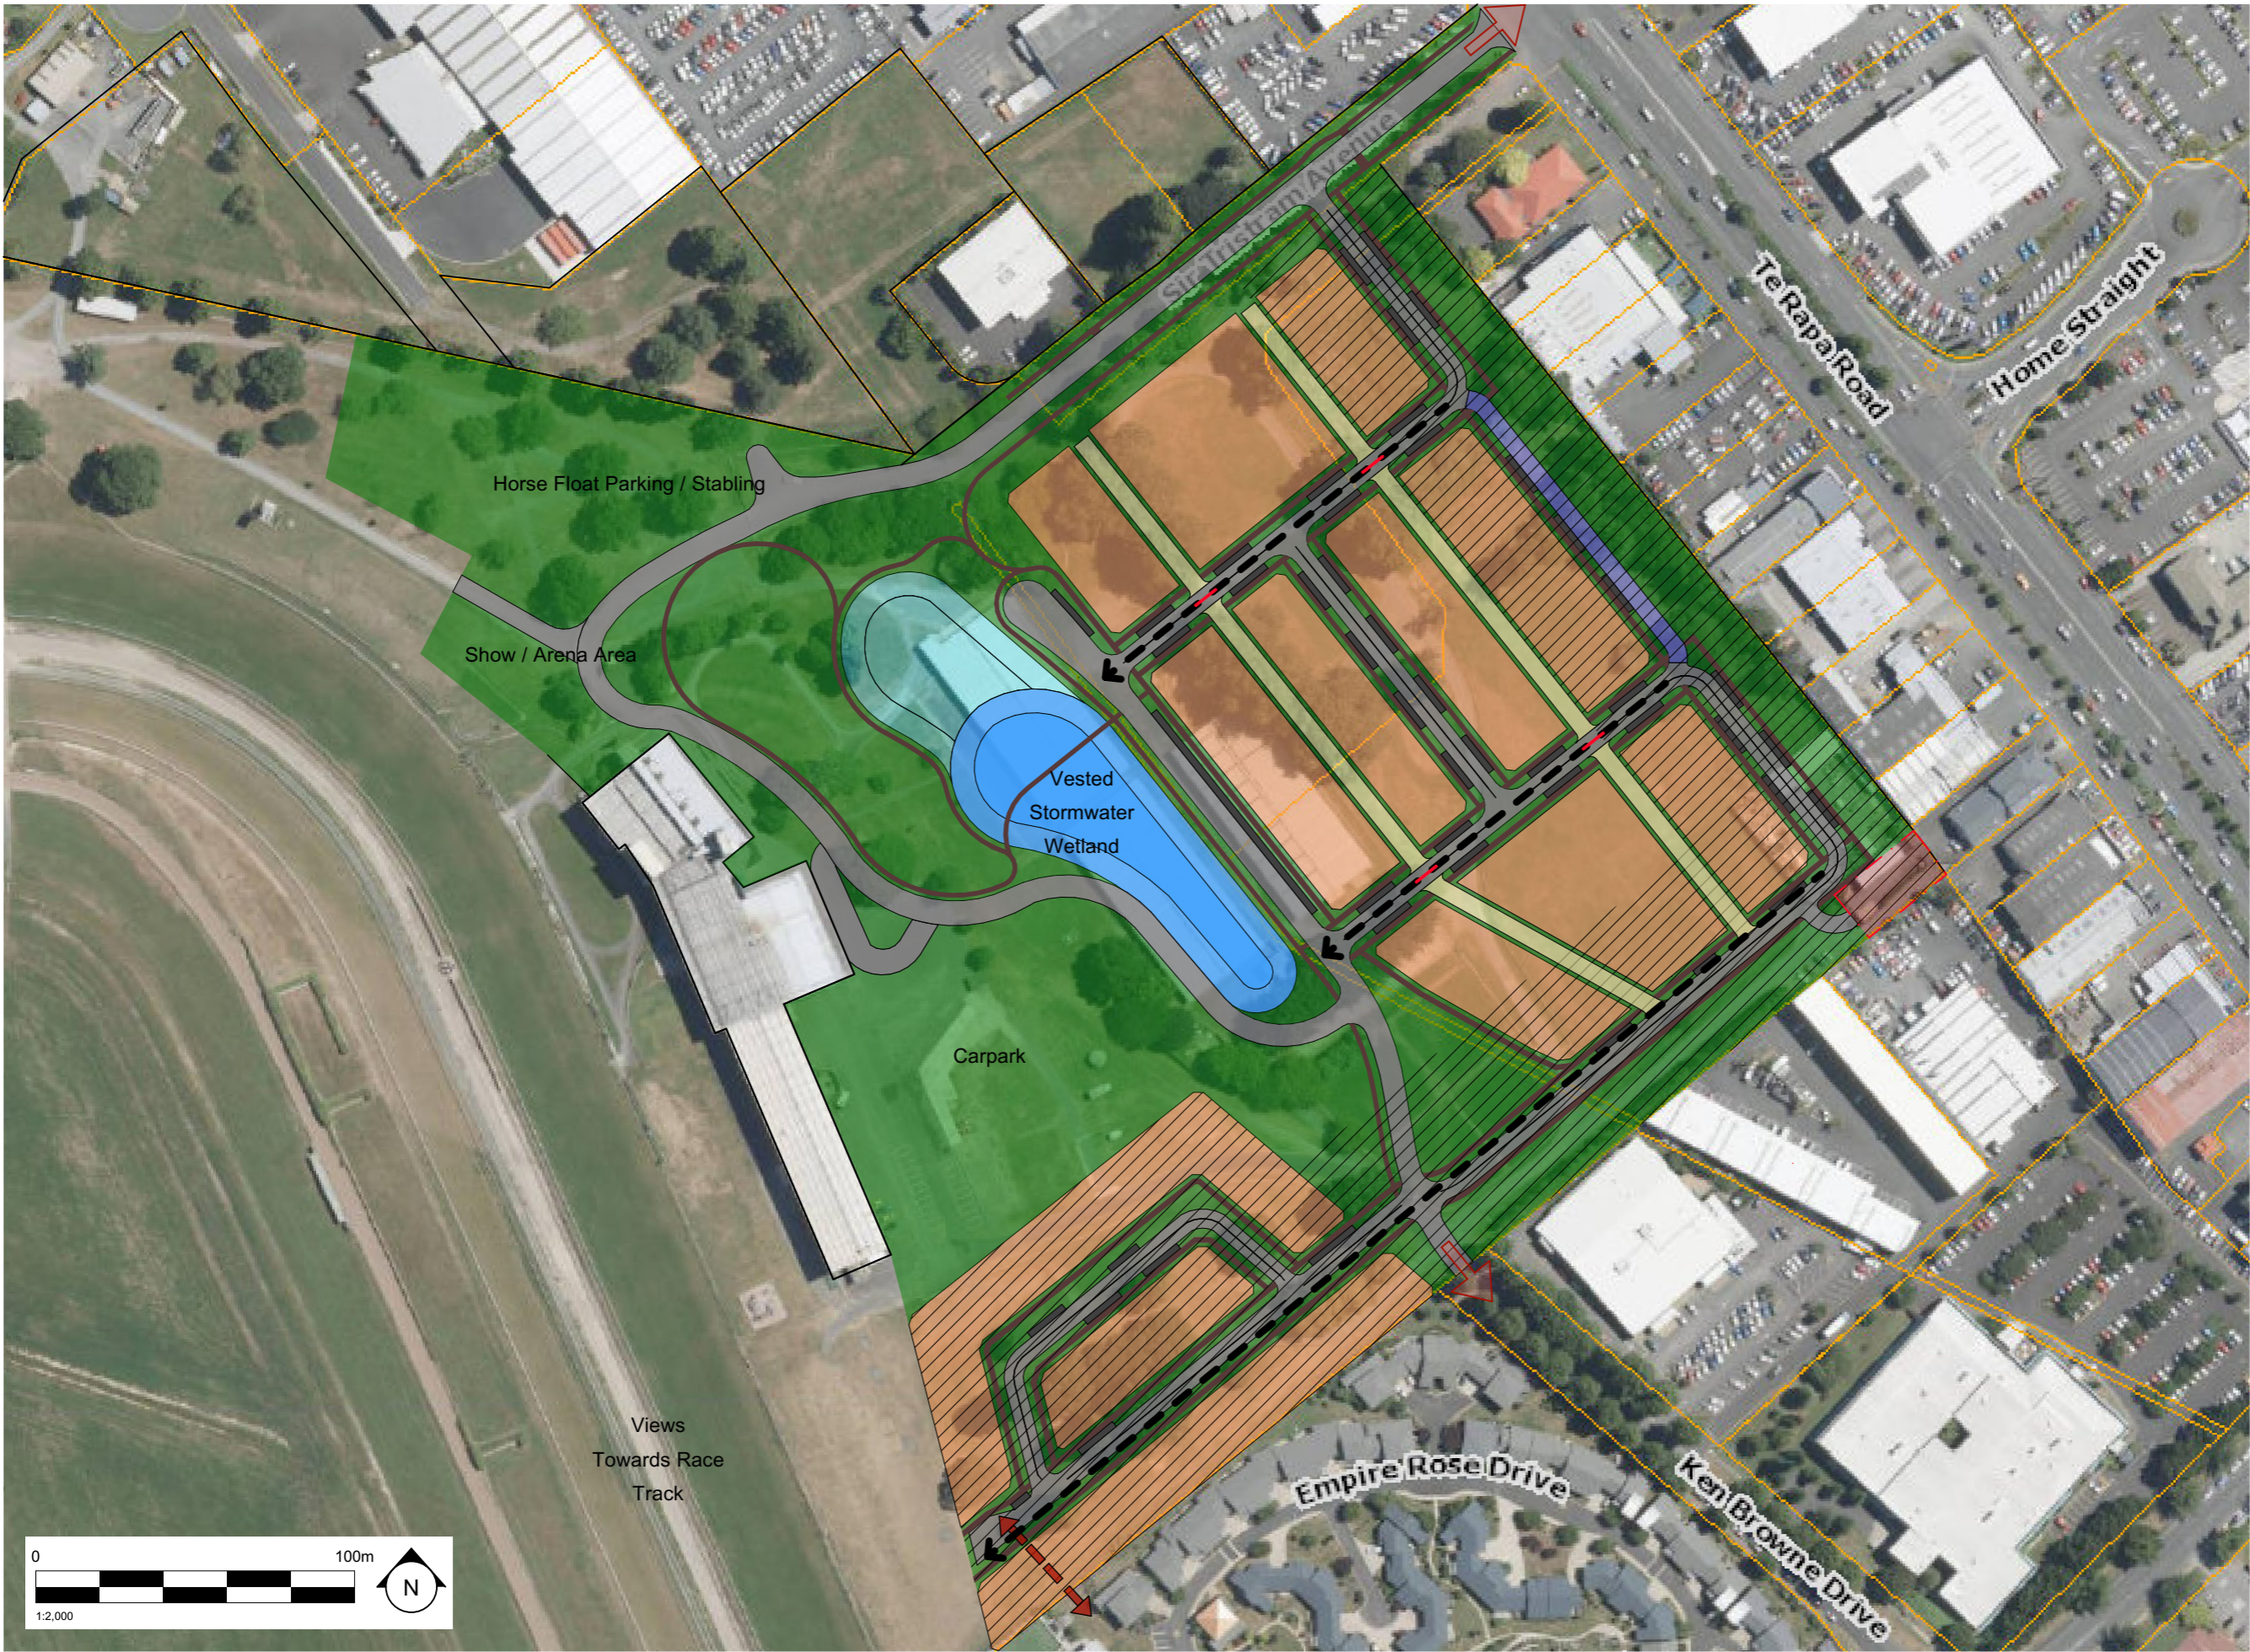
Appendix B: Chow Hill Concept Development Plan

- LEGEND
- OPEN SPACE
 - RESIDENTIAL USE
 - NOISE SENSITIVE AREA
 - TYPICAL STREET
 - MINOR STREET
 - REAR LANEWAY
 - EXISTING NEIGHBOURING VET CARPARK
 - PROPOSED WETLAND
 - PROPOSED WETLAND EXTENSION
 - FOOTPATH
 - REAR LANEWAY MEDIUM BARRIER
 - VIEWSHAFTS
 - POSSIBLE CONNECTION TO NEIGHBOURING DEVELOPMENT
 - ACCESS POINT

The Chow Hill concept plan (**Appendix B**) provided by Bloxam Burnett and Olliver Ltd (BBO), shows the proposed residential development to be located to the east of the current racetrack and existing stables. We understand that a mix of housing types is being considered, including detached dwellings, two and three storey duplexes, terraced housing, and three storey apartment blocks. The plan also shows associated roads, laneways, and footpaths.

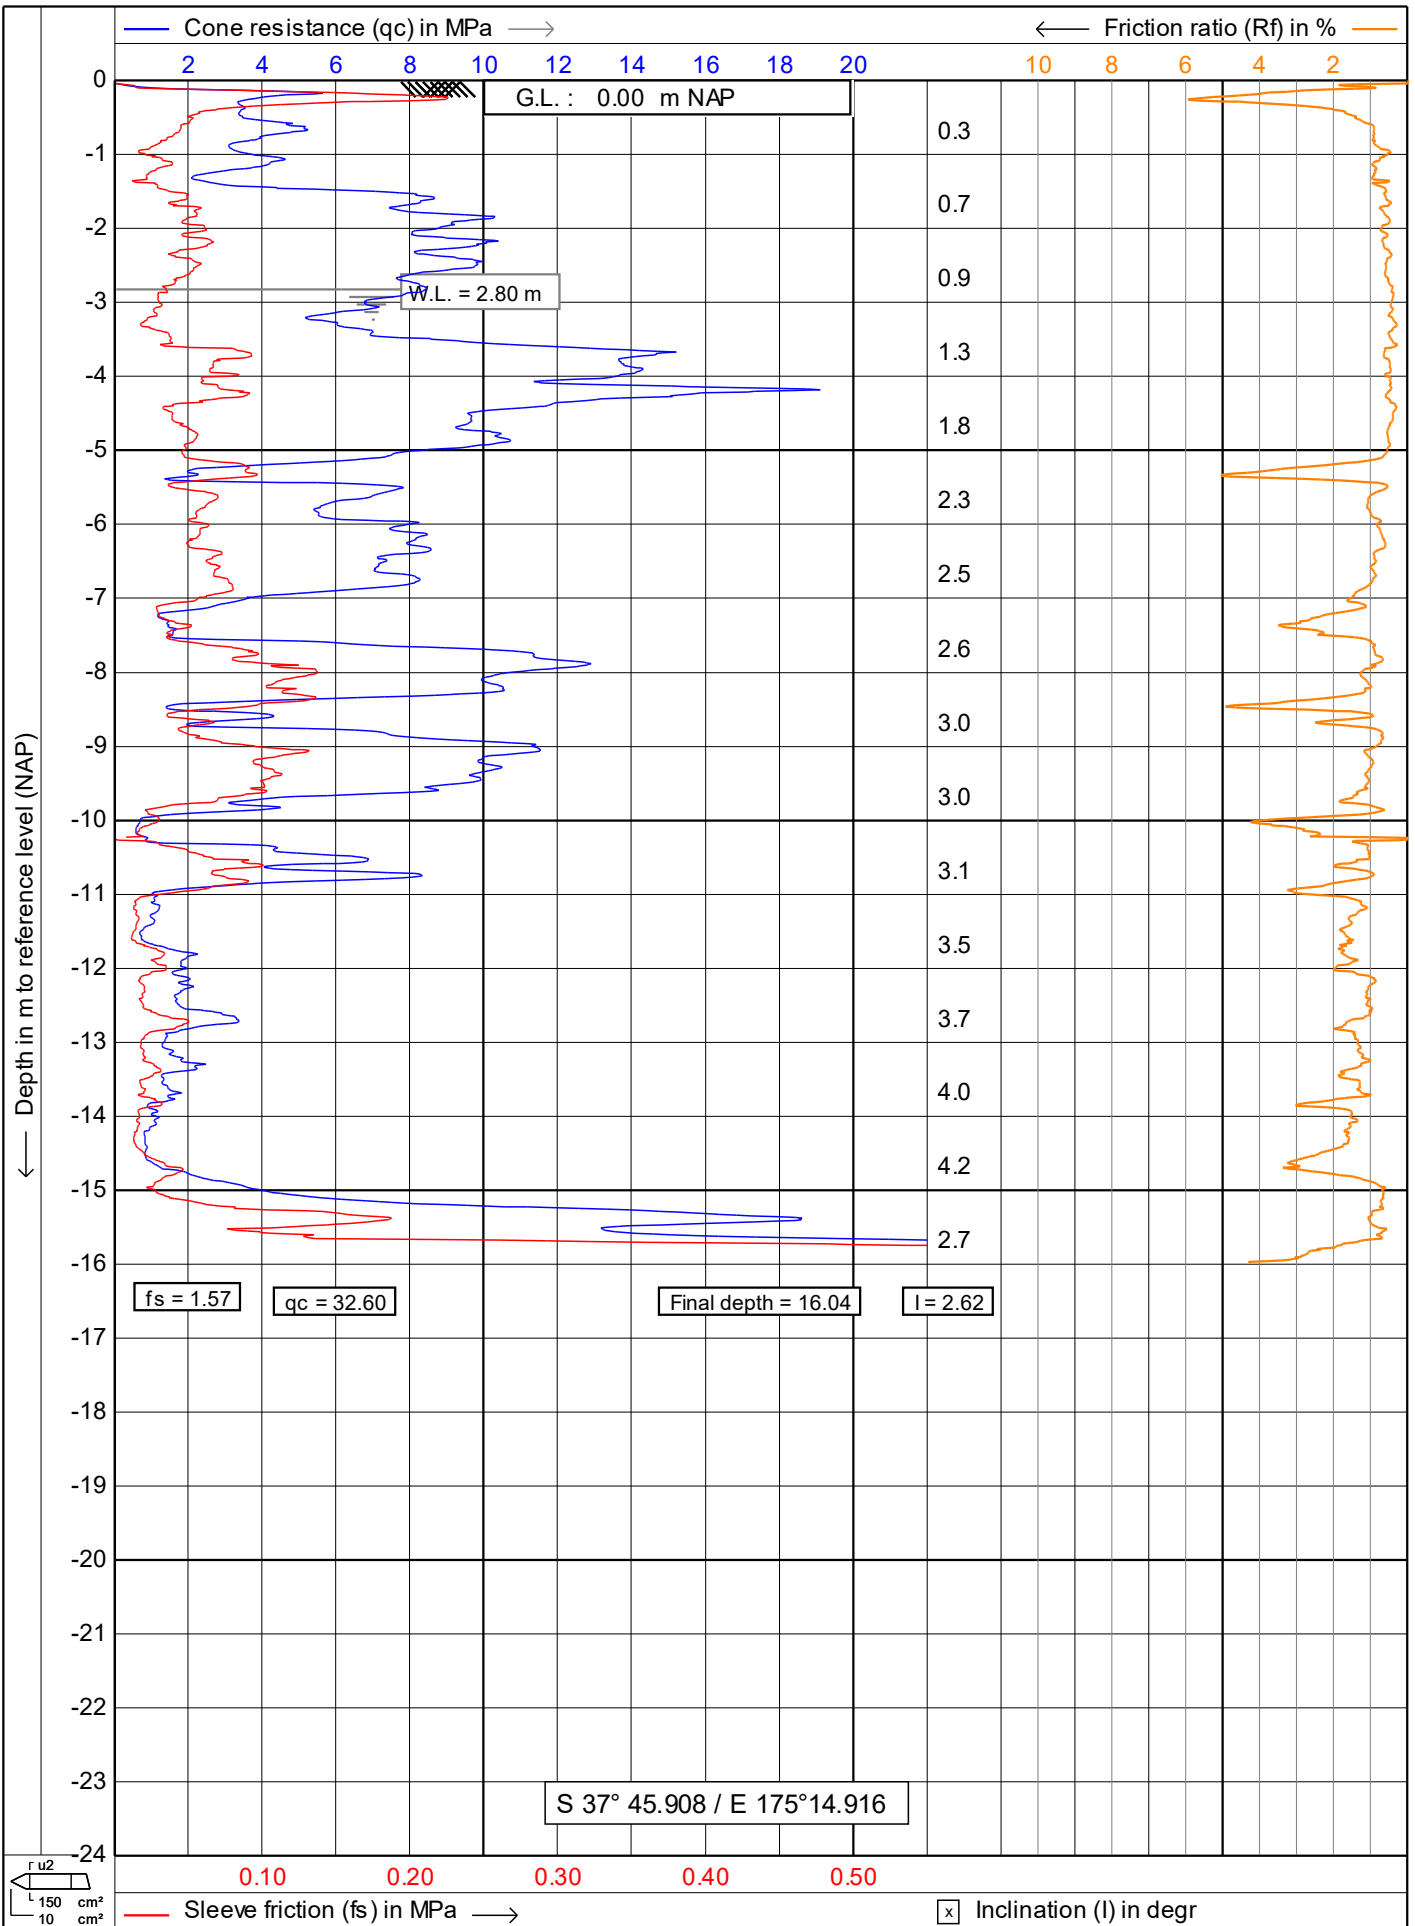
CPT no. : **CPT01** 1/15

CPT **it**

CONE PENETROMETER TESTING

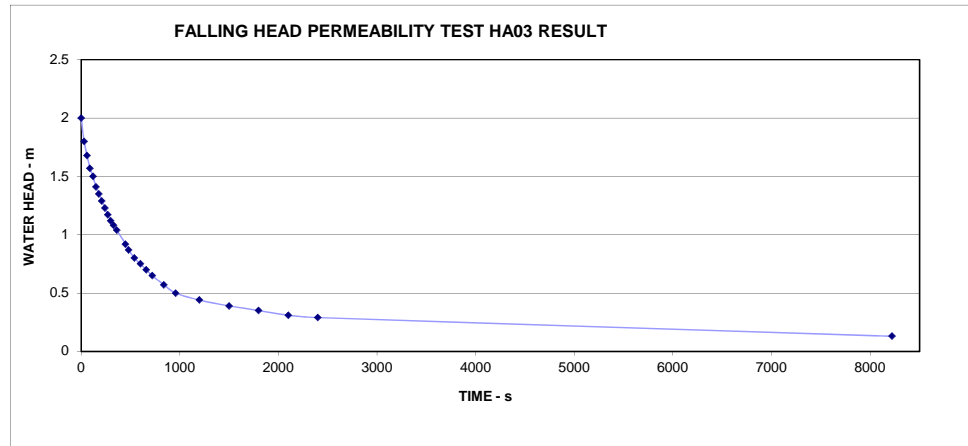
Refer to HA03 Engineering Log for soil description.
 Following presoaking of hole, groundwater was measured at
 2.78m below ground level.

Reference: Appendix 4, Control of Groundwater for Temporary Works (CIRIA Report No. 113)

Borehole diameter = 100 mm

Based on the falling head test results, seepage rates of between 1×10^{-5} m/sec to 5×10^{-6} m/sec were observed within the Hinuera sands and silty sands. Lower permeability values have been attributed to silt migration from the upper portion of the boreholes causing “caking” of the sides and base during testing. Seepage rates could be found to be an order of magnitude higher if more targeted testing is undertaken.

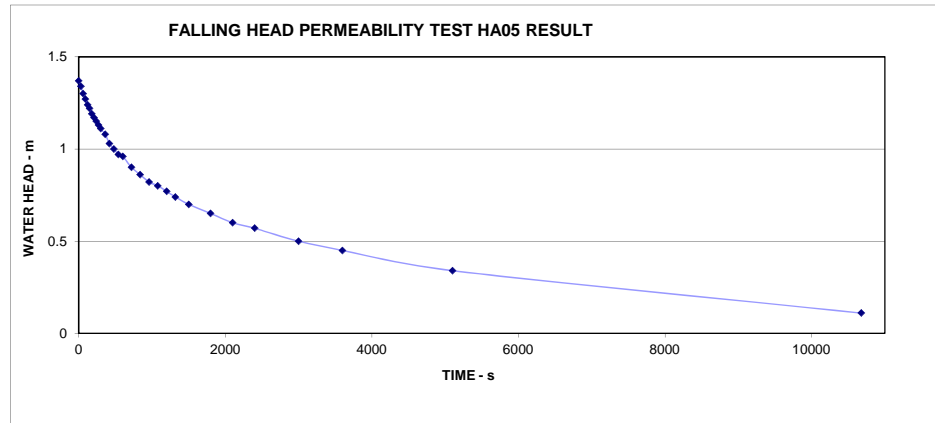
Refer to HA05 Engineering Log for soil description.
 Following presoaking of hole, groundwater was measured
 at 1.75m below ground level.

Reference: Appendix 4, Control of Groundwater for Temporary Works (CIRIA Report No. 113)

Borehole diameter = 100 mm

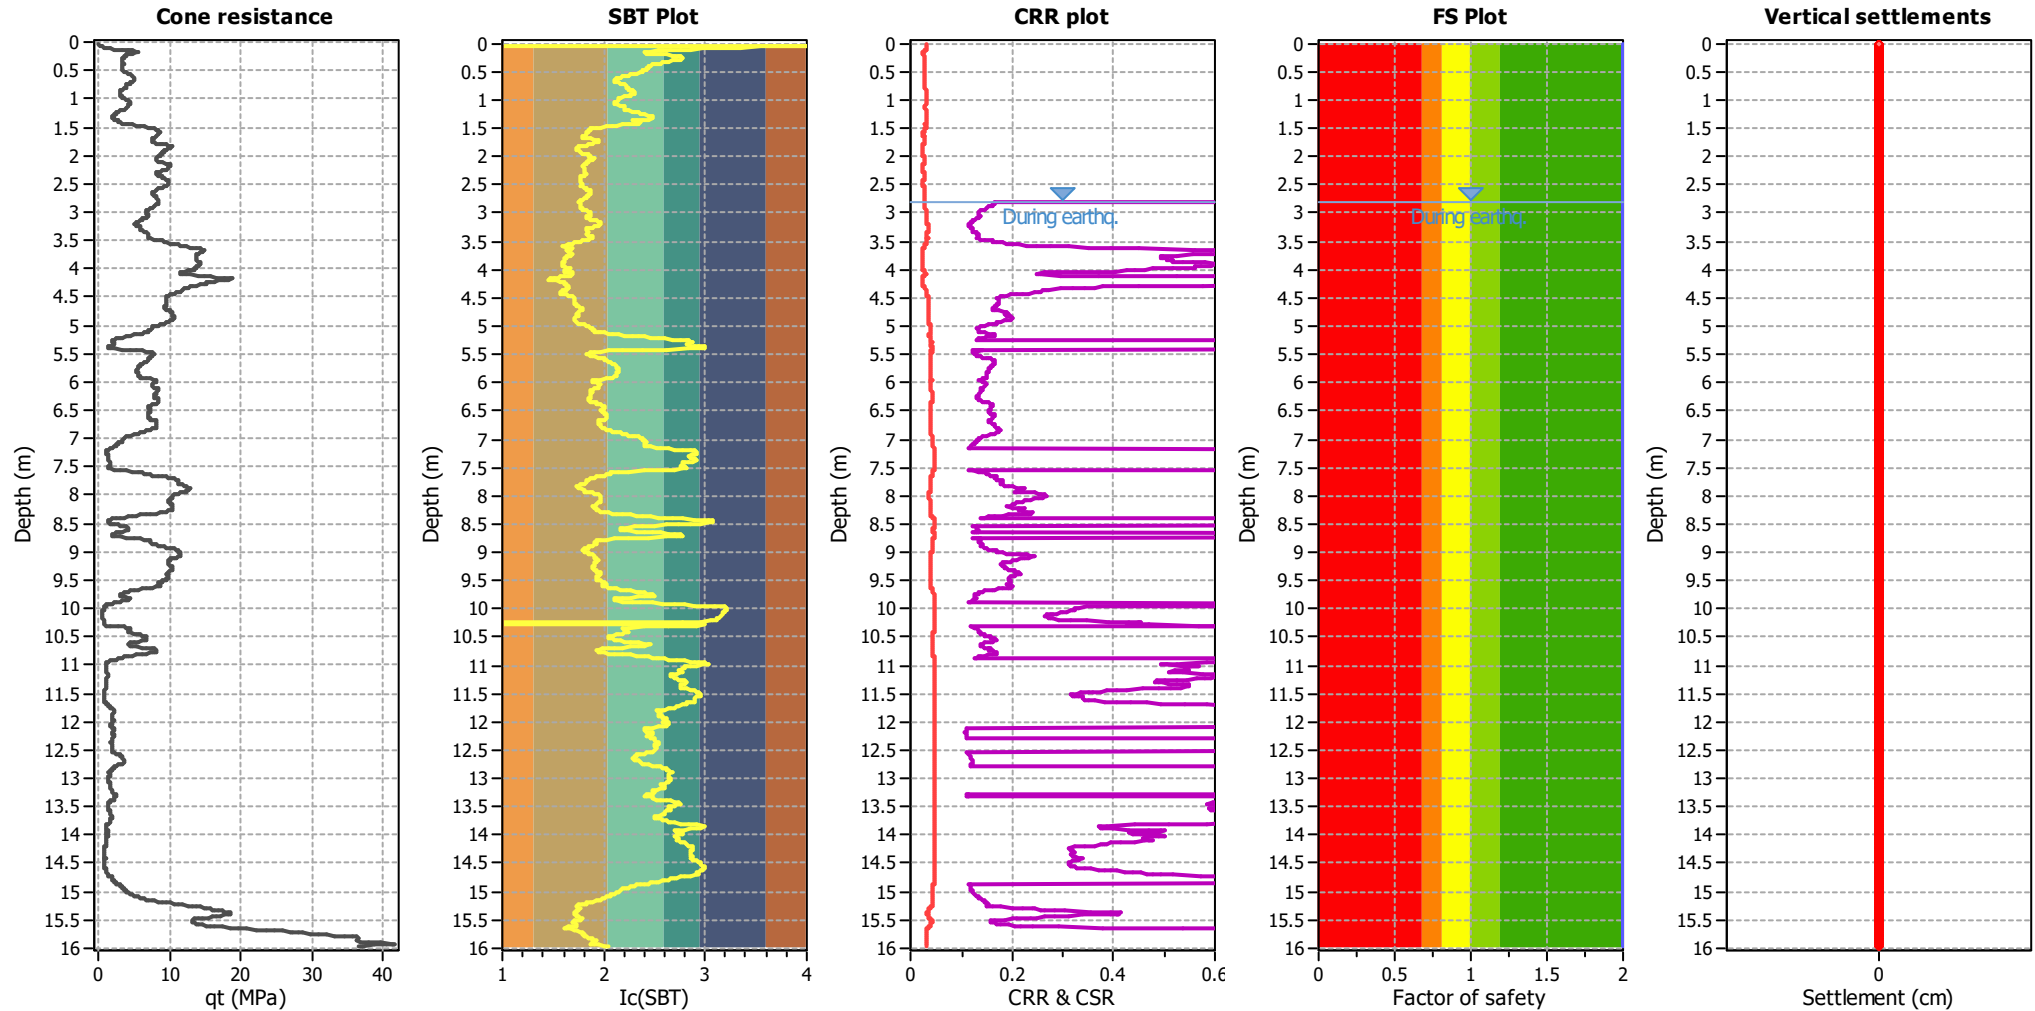
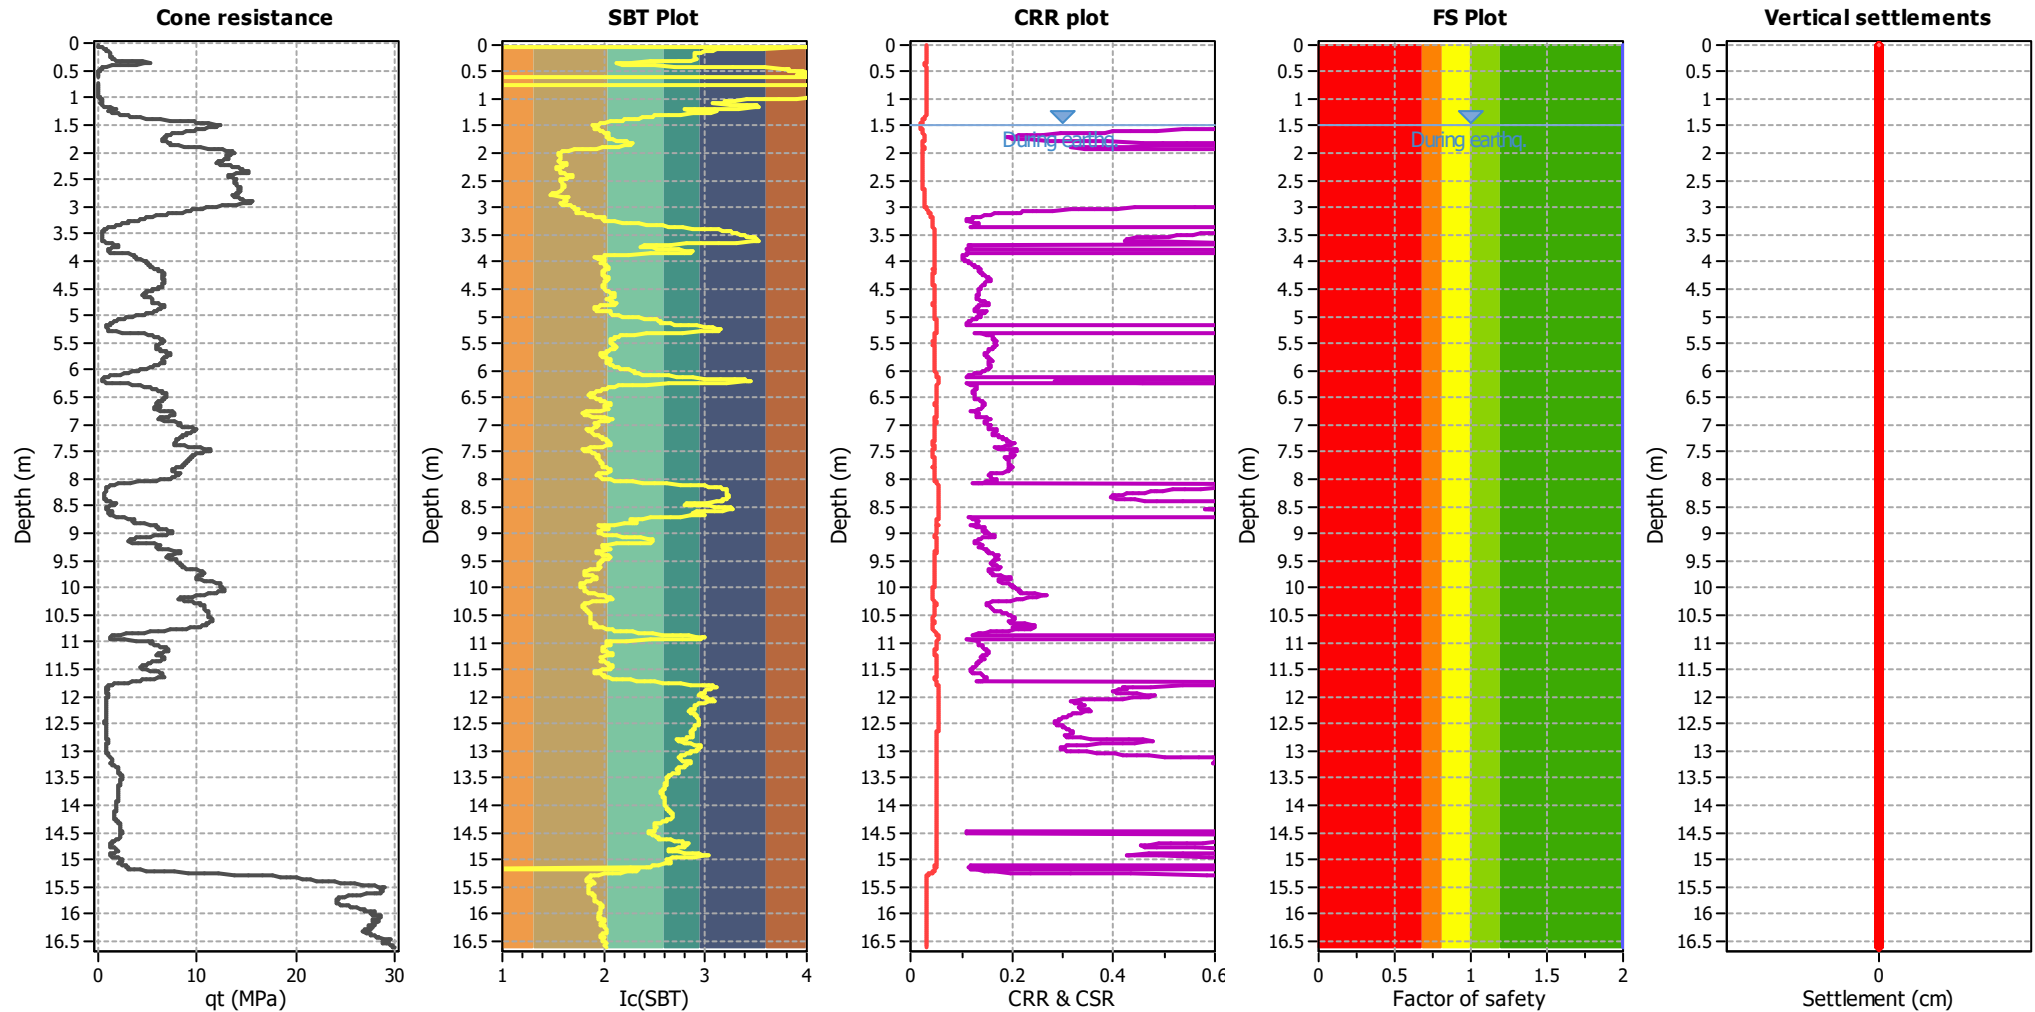
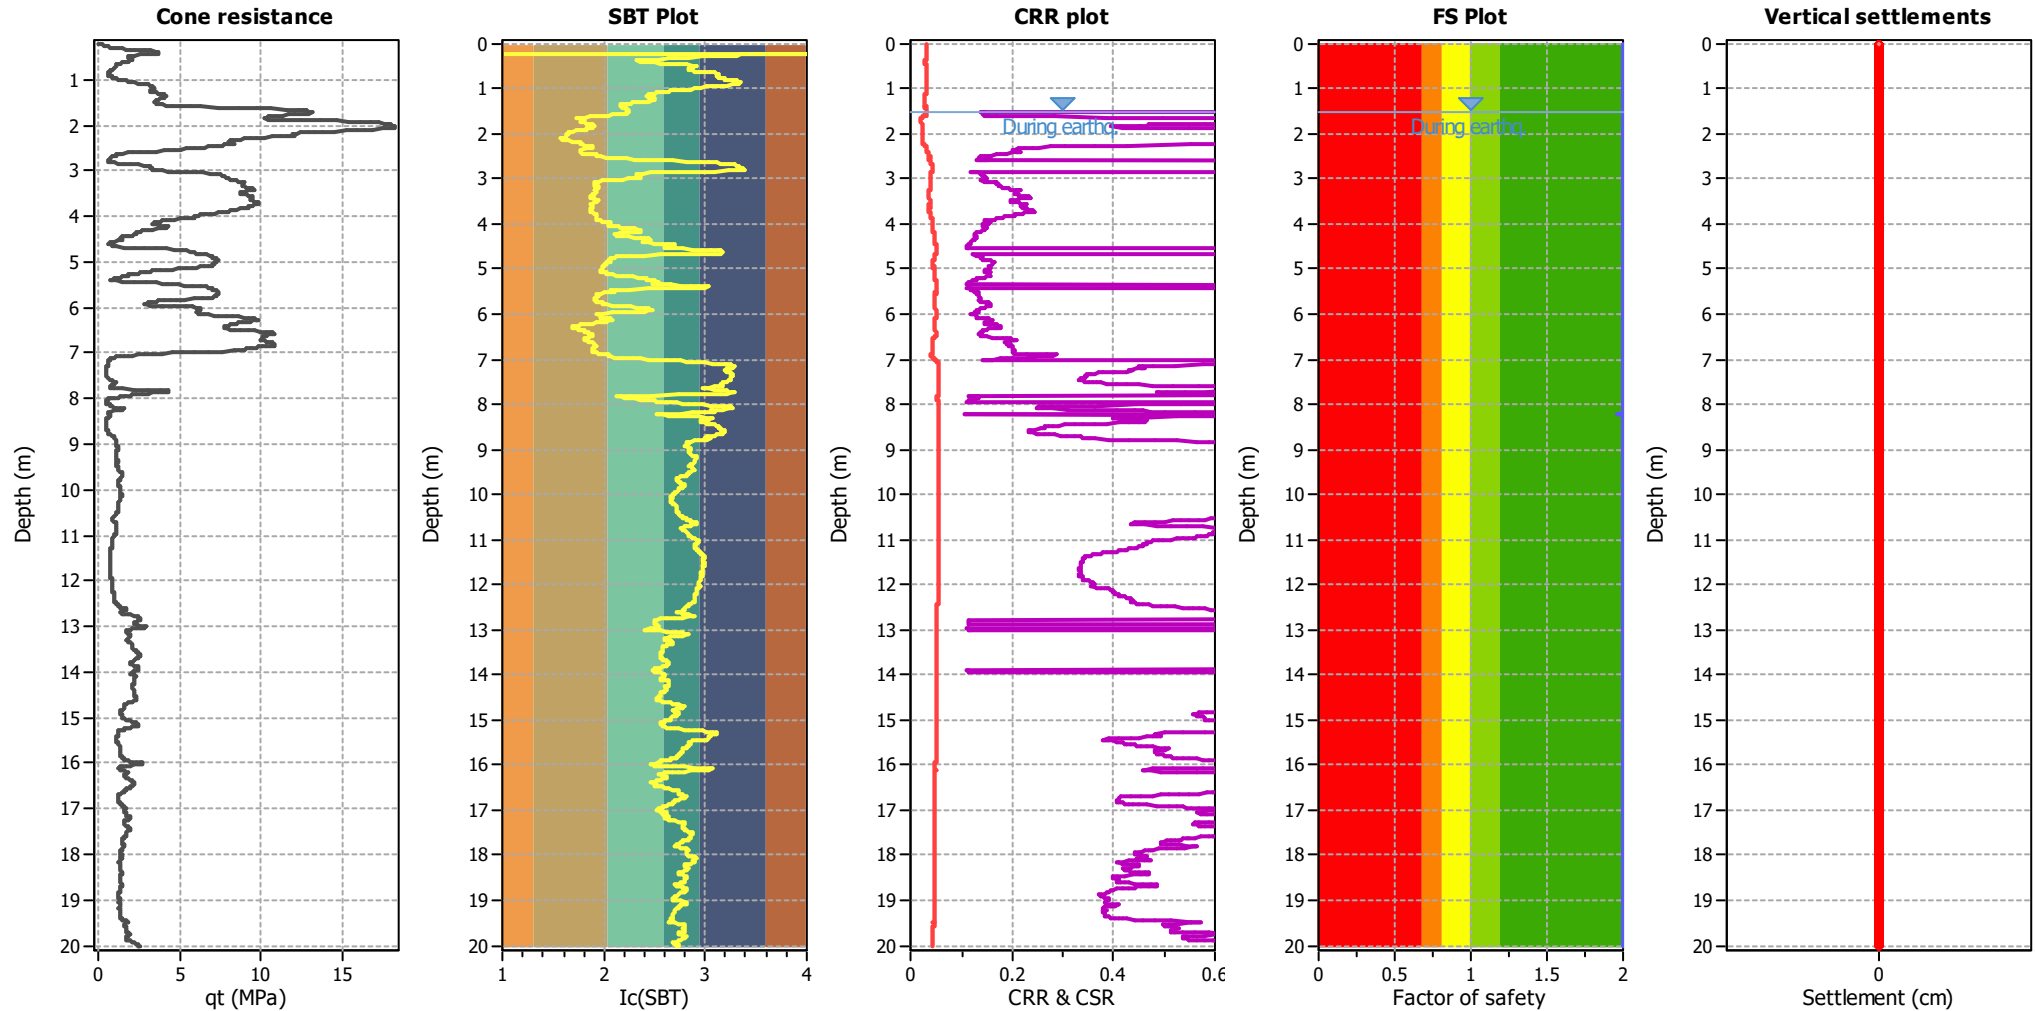
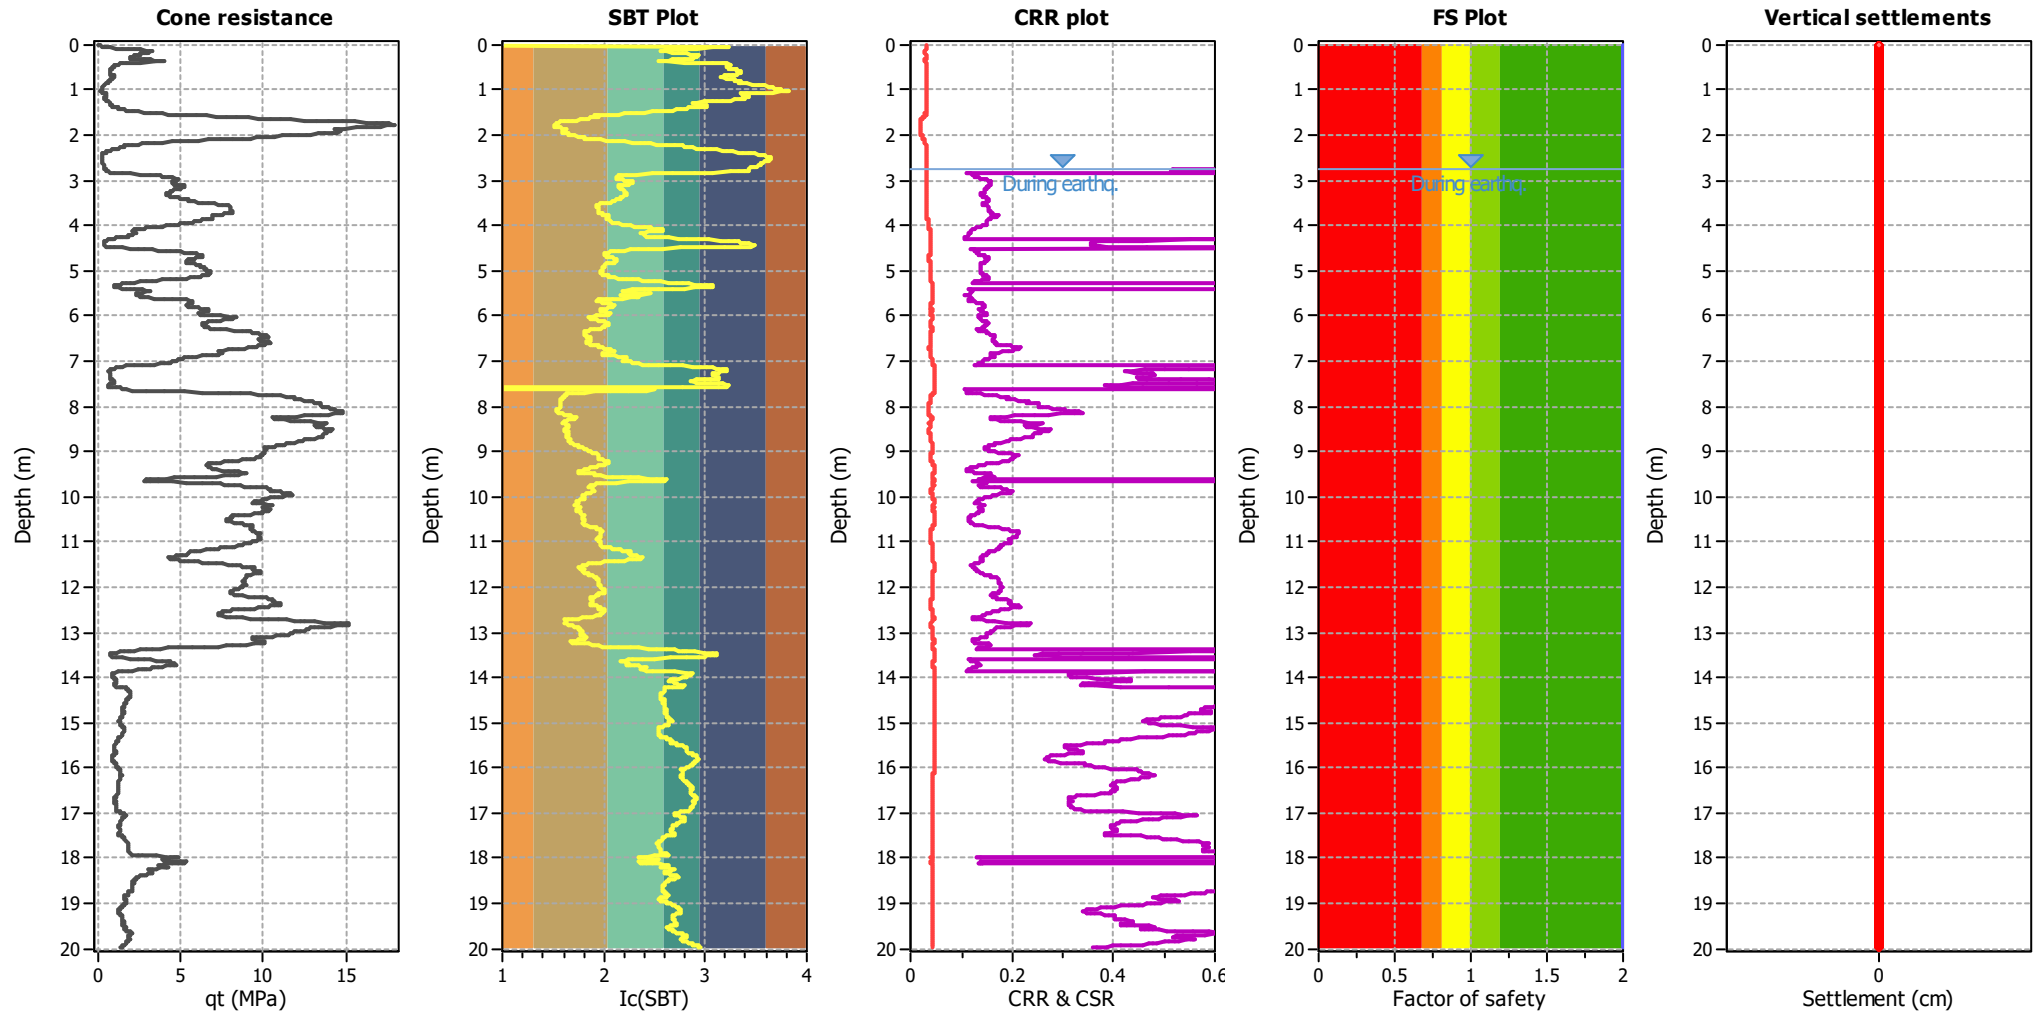
Appendix E: CLIQ Outputs

Analysis method:	B&I (2014)	G.W.T. (in-situ):	2.80 m	Use fill:	No	Clay like behavior	
Fines correction method:	B&I (2014)	G.W.T. (earthq.):	2.80 m	Fill height:	N/A	applied:	.
Points to test:	Based on Ic value	Average results interval:	3	Fill weight:	N/A	Limit depth applied:	No
Earthquake magnitude M_w :	5.90	Ic cut-off value:	2.60	Trans. detect. applied:	No	Limit depth:	N/A
Peak ground acceleration:	0.06	Unit weight calculation:	17.00 kN/m ³	K_0 applied:	Yes	MSF method:	I&B, 2008

Analysis method:	B&I (2014)	G.W.T. (in-situ):	1.50 m	Use fill:	No	Clay like behavior	
Fines correction method:	B&I (2014)	G.W.T. (earthq.):	1.50 m	Fill height:	N/A	applied:	.
Points to test:	Based on Ic value	Average results interval:	3	Fill weight:	N/A	Limit depth applied:	No
Earthquake magnitude M_w :	5.90	Ic cut-off value:	2.60	Trans. detect. applied:	No	Limit depth:	N/A
Peak ground acceleration:	0.06	Unit weight calculation:	17.00 kN/m ³	K_0 applied:	Yes	MSF method:	I&B, 2008

Analysis method:	B&I (2014)	G.W.T. (in-situ):	1.50 m	Use fill:	No	Clay like behavior	
Fines correction method:	B&I (2014)	G.W.T. (earthq.):	1.50 m	Fill height:	N/A	applied:	.
Points to test:	Based on Ic value	Average results interval:	3	Fill weight:	N/A	Limit depth applied:	No
Earthquake magnitude M_w :	5.90	Ic cut-off value:	2.60	Trans. detect. applied:	No	Limit depth:	N/A
Peak ground acceleration:	0.06	Unit weight calculation:	17.00 kN/m ³	K_o applied:	Yes	MSF method:	I&B, 2008

Analysis method:	B&I (2014)	G.W.T. (in-situ):	2.75 m	Use fill:	No	Clay like behavior	
Fines correction method:	B&I (2014)	G.W.T. (earthq.):	2.75 m	Fill height:	N/A	applied:	.
Points to test:	Based on Ic value	Average results interval:	3	Fill weight:	N/A	Limit depth applied:	No
Earthquake magnitude M_w :	5.90	Ic cut-off value:	2.60	Trans. detect. applied:	No	Limit depth:	N/A
Peak ground acceleration:	0.06	Unit weight calculation:	17.00 kN/m ³	K_o applied:	Yes	MSF method:	I&B, 2008

- Specific liquefaction analyses were undertaken for an IL2 structure, using the software package CLiq and the Boulanger and Idriss (2014) method. The cyclic stress ratio (CSR), being a function of the earthquake magnitude for the design return period event, was compared to the cyclic resistance ratio (CRR), being a function of the CPT cone resistance (q_c) and friction ratio (Fr).

- Free-field liquefaction induced settlements were determined in accordance with Zhang et al. (2002). With respect to liquefaction response, consideration was given to a 10m cut-off depth to estimate index settlements as per MBIE⁶ guidance (foundation technical categories). These were compared to liquefaction settlement estimates over the full depth range of the CPT's with a depth weighting factor (e_v) applied ranging from 1 at the ground surface to 0 at 20m depth.
