**Appendix I – Contamination Assessment**

## Preliminary Site Investigation (PSI) Report

Waikato Racing Club Incorporated

June 2017

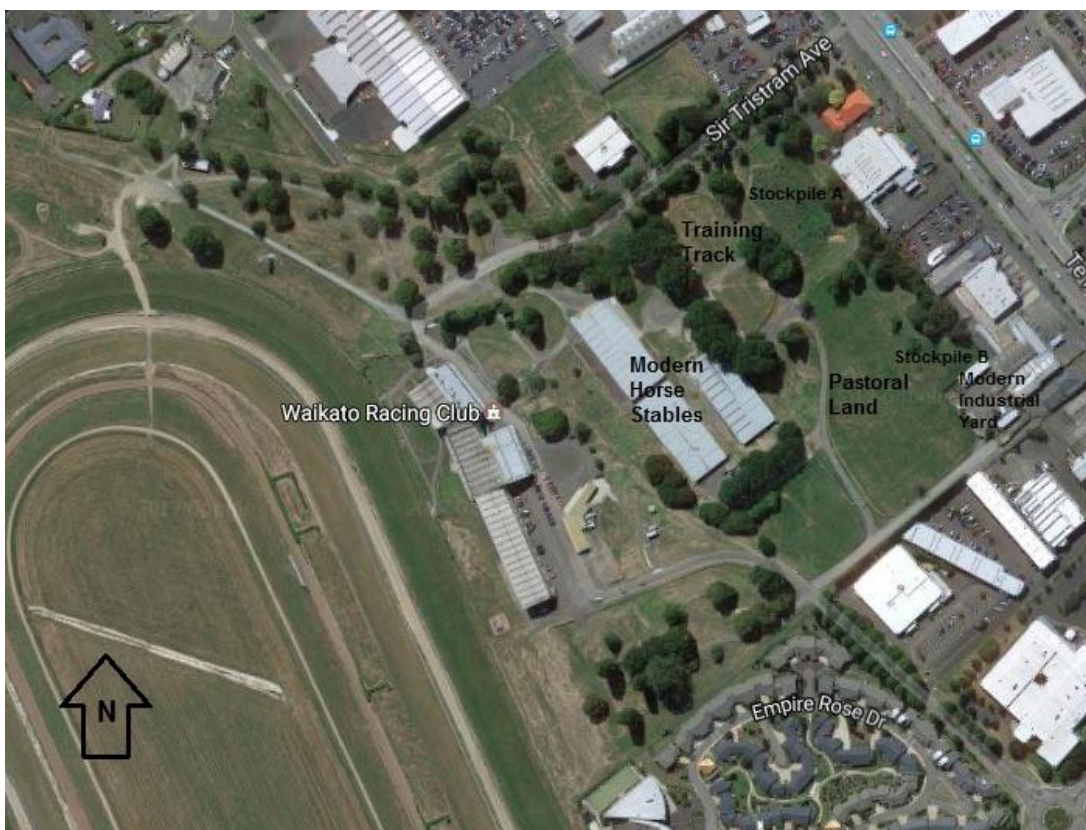
**Figure 2. Proposed residential zone change area in modern aerial photography (refer to Figure 1)**

The intended site for residential zone change exhibits flat contours, predominantly grassed land with buildings supporting the Te Rapa Racecourse activities (Figure 2). The geology of the site is based on alluvial pumice, silt, sand and gravel (Hinuera Formation), with potential isolated layers of peat.<sup>1</sup>

A modern industrial yard was developed before 2002 in the eastern corner of the site (Figures 2 & 3). The observed Stockpile B of soil may have been generated during construction of this yard (Figures 2 & 7). A second stockpile (Stockpile A) was created with topsoil removed from a recent industrial building development north of the Te Rapa Racecourse (Figures 2 & 7).

- (5) Perform validation soil testing of (1) remedial excavation margins and (2) any generated and existing (A & B in Figure 2) stockpiles prior to redistribution of soil. Display soil testing results in a SVR.

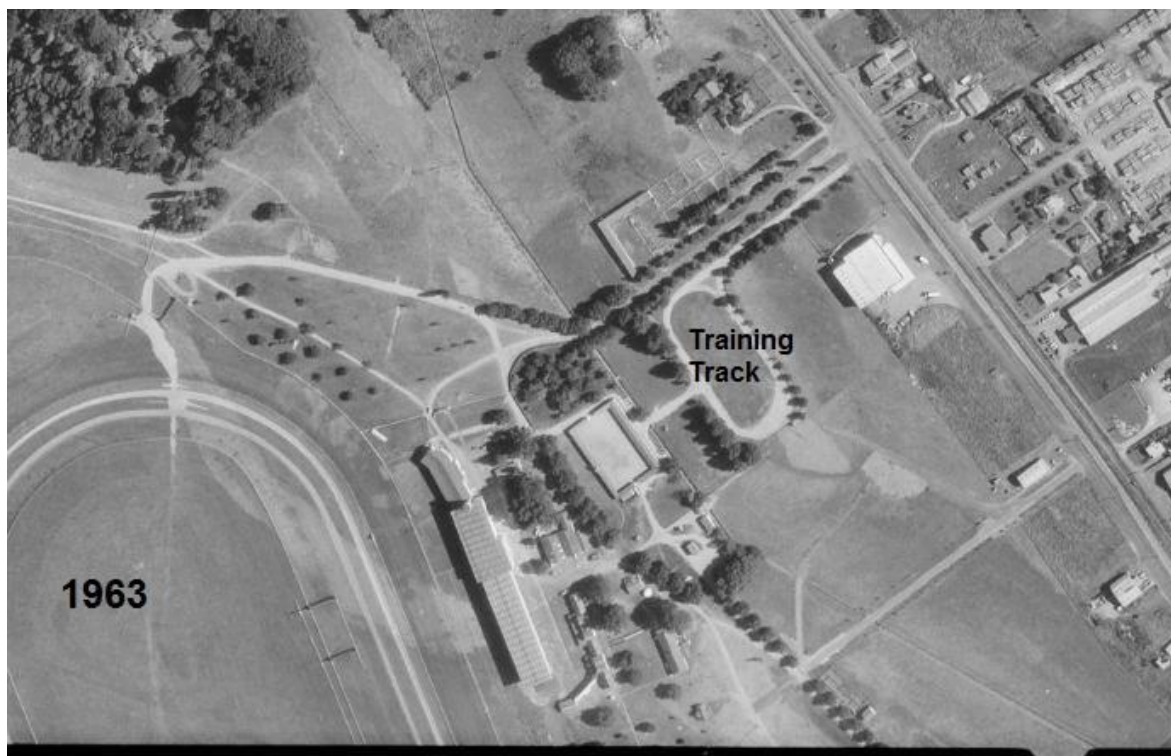
**Figure 5. Historical aerial photography (1963 & 1950) of proposed zone change location (refer to Figures 1 & 2)**

A review of historical aerial photography revealed the Te Rapa Racecourse was established before 1950 with small racetrack stands (Figure 5). Accessory buildings (since removed) and horse yards/stables were also established before 1950. The basis of the existing main racetrack buildings and stand were constructed before 1963, along with a horse training track (Figure 5). Two modern horse stables were constructed south of the original horse yards/stables between 1974 and 1979 (Figure 4). It is apparent that a third modern stable was constructed (at the site of an original horse yard/stable) before 1993 (Figure 3). The existing stables are of typical design featuring separate stalls for individual animals, constructed primarily with unpainted concrete walls and some painted timber (Figure 6).

Significant lead contamination from paint and building materials is often detected near old long-term buildings and structures. Soil adjacent to buildings is also potentially contaminated with chemicals and hydrocarbon fuels, particularly in storage areas or where equipment is washed. The historical racecourse accessory buildings and probable horse yards/stables observed in 1950 (Figure 5) appear to have remained at the site for a prolonged period (Figures 3-5).

- (2) Accurately determine the onsite location of historic building features at the site (see for example, the accessory buildings and probable horse stables present in 1950 (Figure 5)) and compare the locations with proposed residential construction areas.
