Tuumata Plan Change Area Rezoning – Private Plan Change

Ecological Impact Assessment
Prepared for TGH Ruakura Industrial Development Limited

8 November 2022

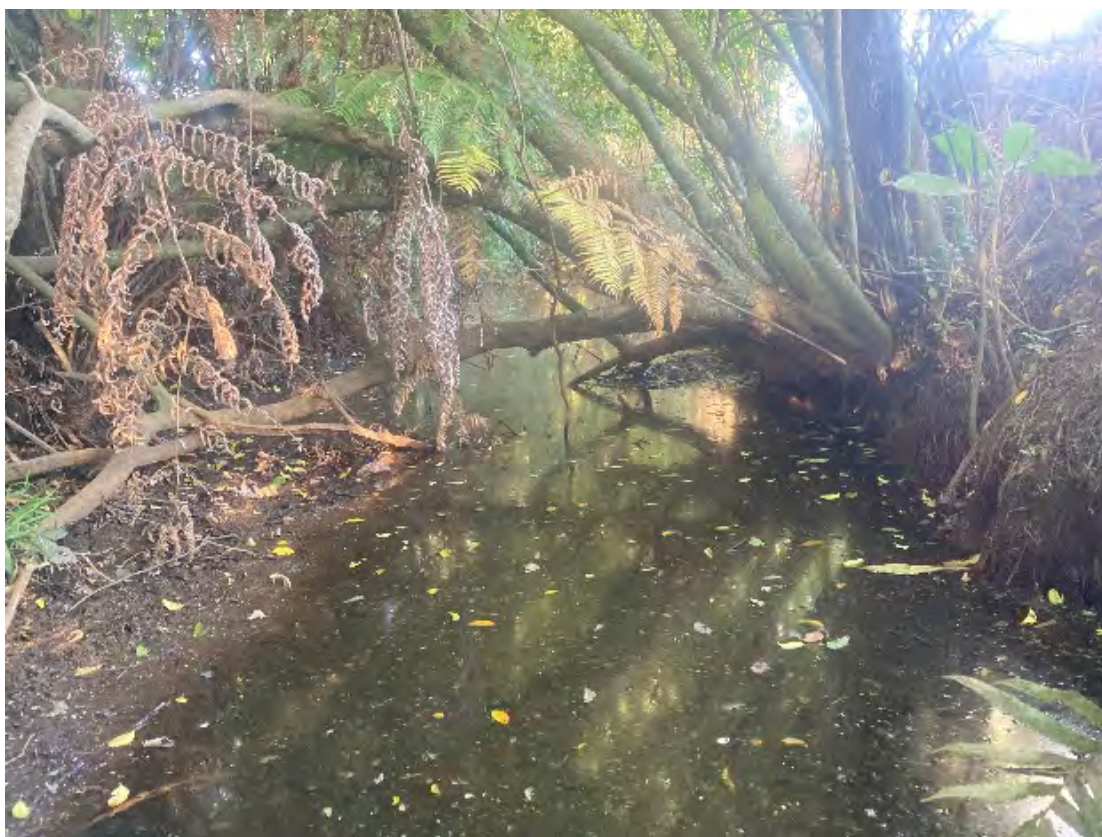
Figure 1: Upstream reach of Tramway Road drain, shaded canopy cover and oily sheen on surface of water.

Stream banks were mostly stable with no recent signs of erosion or slumping. Organic instream features such as woody debris and leaf litter were present. An oily sheen on the water surface was observed within the stagnant pools of water remaining in the drain.

Stream substrates were dominated by silt and mud, often with an organic overlay of leaf litter and/or woody debris. Aquatic macrophytes were present within the upstream section of the reach still containing standing water and included water pepper (*Persicaria hydropiper*) and water purslane (*Ludwigia palustris*) (Figure 2), with coverage of the water surface ranging from 75 to 100%. No periphyton was observed.

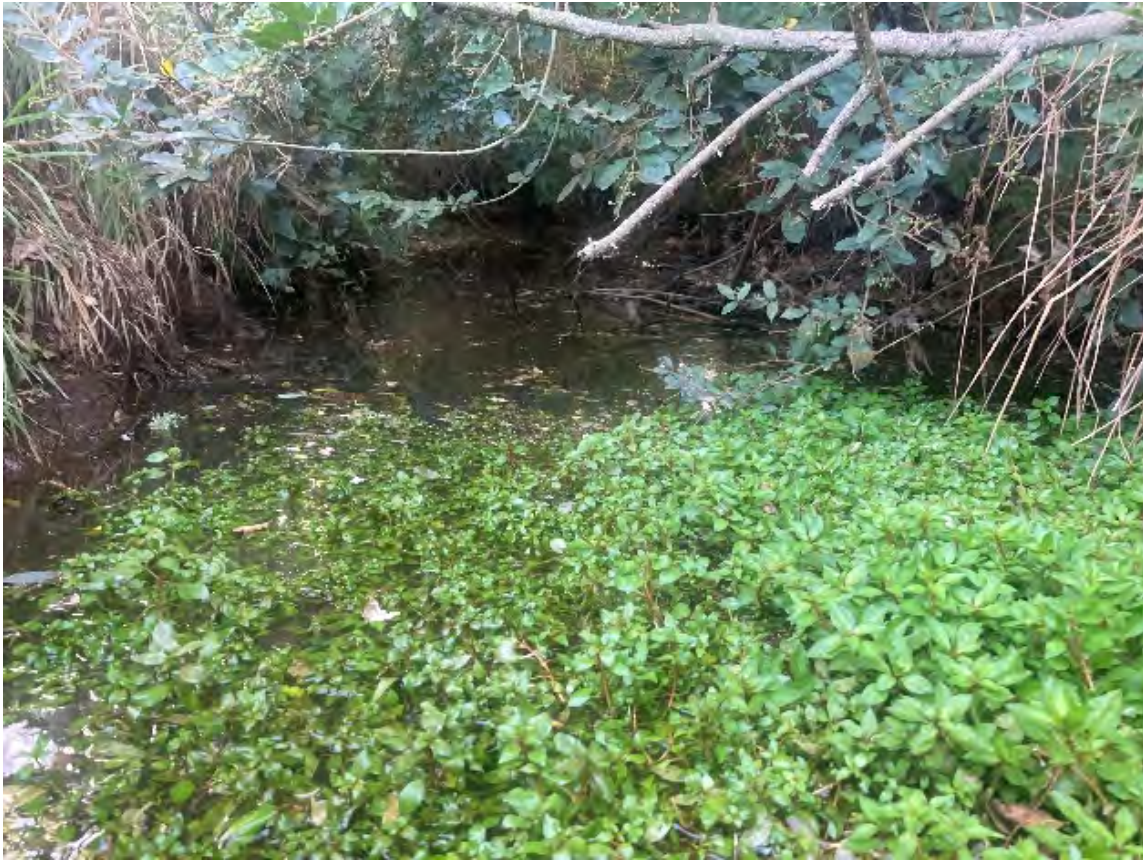
Figure 2: Macrophytes across upstream transect of Tramway Road drain.

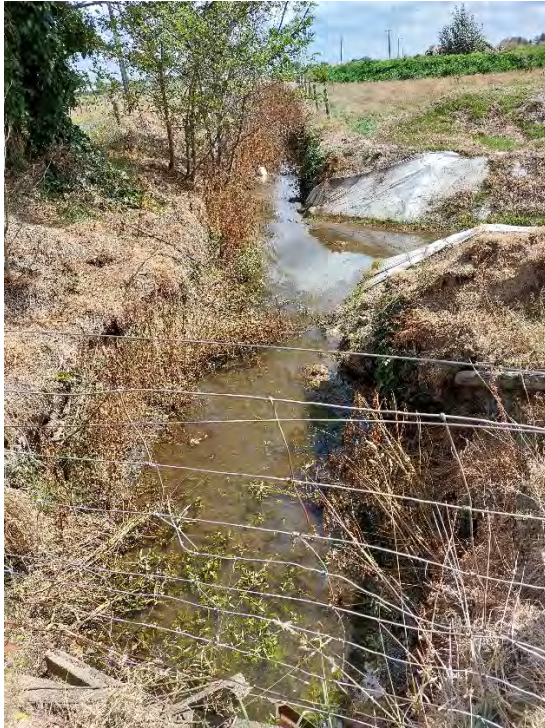
Figure 3: Powell's Road drain, artificial drain, uniform channel morphology & limited riparian vegetation, confluence with newly created canal for Powell's Road subdivision works.

intermittent flow regimes, limited riparian vegetation dominated by rank grasses and exotic vegetation such as English ivy and tree privet in some places. The drain has been described to be subject to disturbance by excavation, spraying and regular inputs of various contaminants, and to provide low habitat quality for aquatic organisms (Figure 4).

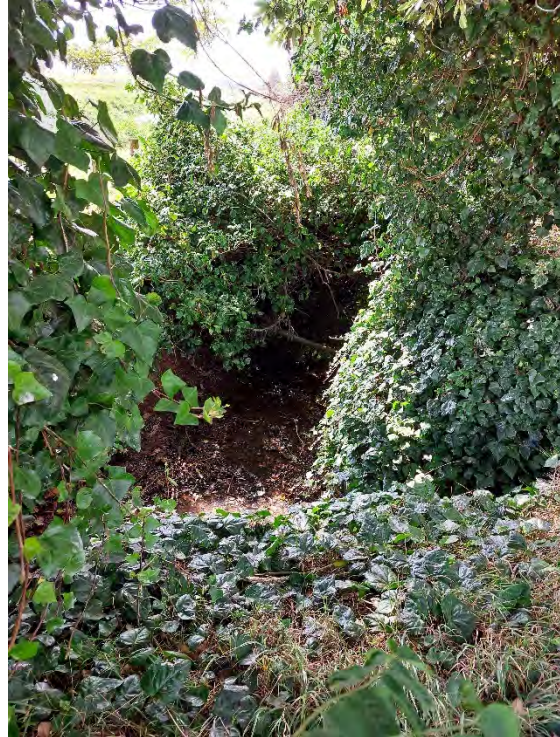
Figure 4: Powell's Road drain, upstream section dry at time of assessment.

Riparian vegetation along the Powell's Road drain is outlined in Section 4.2 and Appendix 3, and typically consists of rank grasses, with small areas of willow weed and weeds (e.g., blackberry) or exotic shelterbelt trees. Water pepper was observed within the dry bed of the channel at the upstream end of the reach.

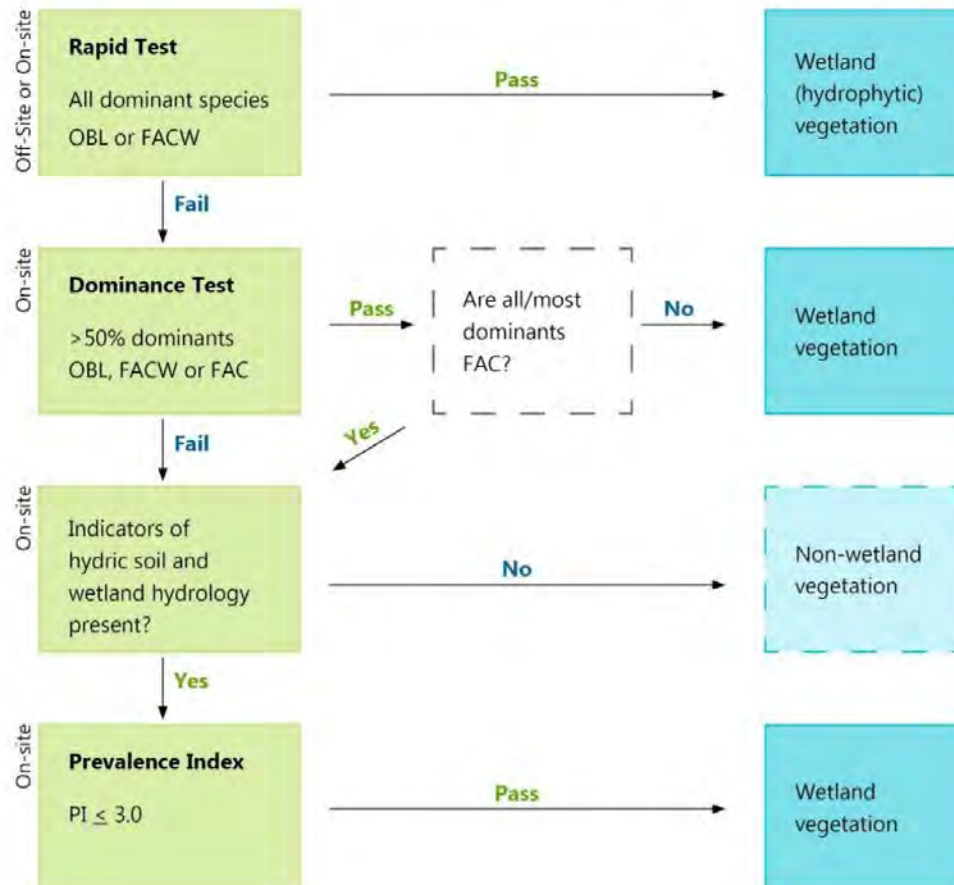
Appendix 2: Wetland delineation flow chart

Figure 1: Flow chart of steps for hydrophytic (wetland) vegetation determination. Wetland indicator status abbreviations: FAC= facultative; FACW = facultative wetland; OBL = obligate wetland.

During the desktop review of aerial imagery and the site visit on 15 March 2022, areas of putative wetlands were searched for. If putative wetlands were found, we followed the protocols outlined by the Ministry for the Environment (2020b) which is incorporated within the National Policy Statement for Freshwater Management (NPSFM) (Ministry for the Environment, 2020a) for determining the presence and extent of wetlands, the wetland delineation method. For ease of reference, Appendix provides the wetland delineation flow chart from the Ministry for the Environment. This method relies on vegetation plot sampling and hydrophytic vegetation determination tool outlined within Clarkson (2013), as well as an assessment of the presence of hydric soils and wetland hydrology (Ministry for the Environment, 2020; Ministry for the

- OBL: Obligate. Almost always is a hydrophyte, rarely in uplands (estimated probability >99% occurrence in wetlands)
- FACW: Facultative Wetland. Usually is a hydrophyte but occasionally found in uplands (estimated probability 67–99% occurrence in wetlands)
- FAC: Facultative. Commonly occurs as either a hydrophyte or non-hydrophyte (estimated probability 34–66% occurrence in wetlands)
- FACU: Facultative Upland. Occasionally is a hydrophyte but usually occurs in uplands (estimated probability 1–33% occurrence in wetlands)
- UPL: Obligate Upland. Rarely is a hydrophyte, almost always in uplands (estimated probability <1% occurrence in wetlands)

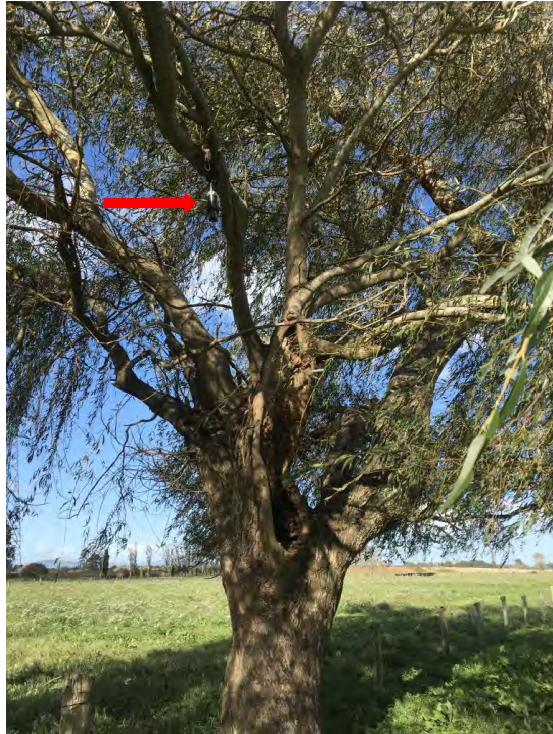
Figure 1: An acoustic recorder deployed in a crack willow with a large trunk cavity.

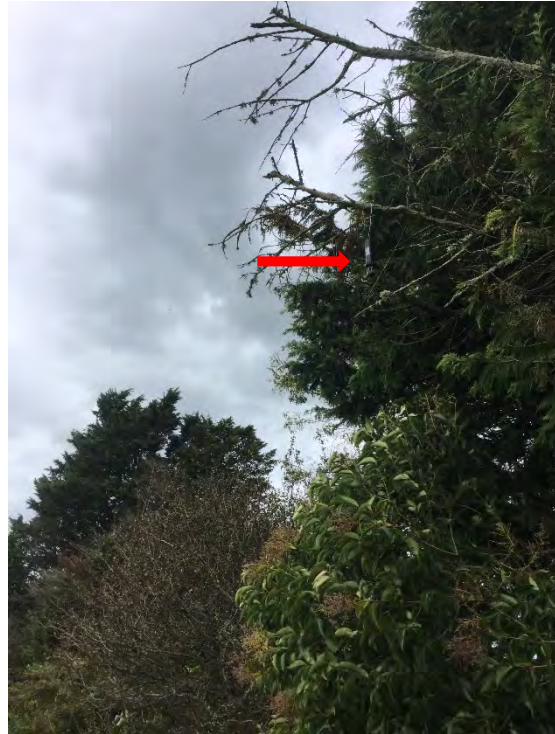
Figure 2: An acoustic recorder deployed along a shelterbelt.

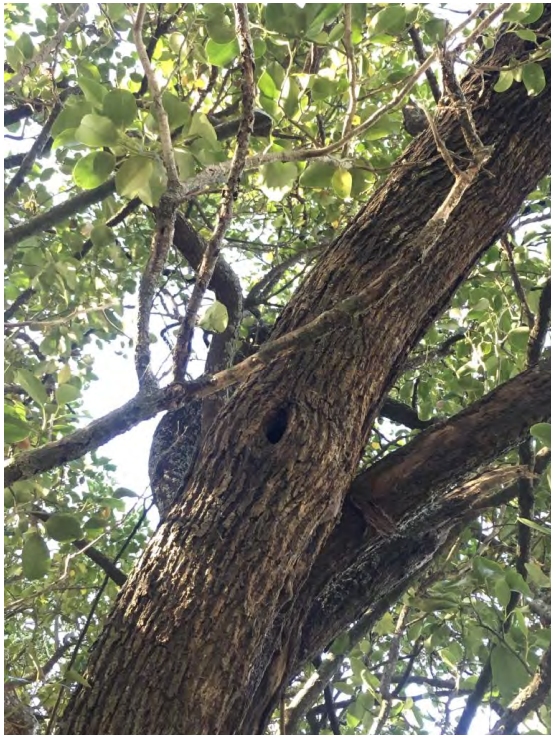
Figure 3: A cavity with a clear entrance in a very old *Griselinia littoralis* tree.

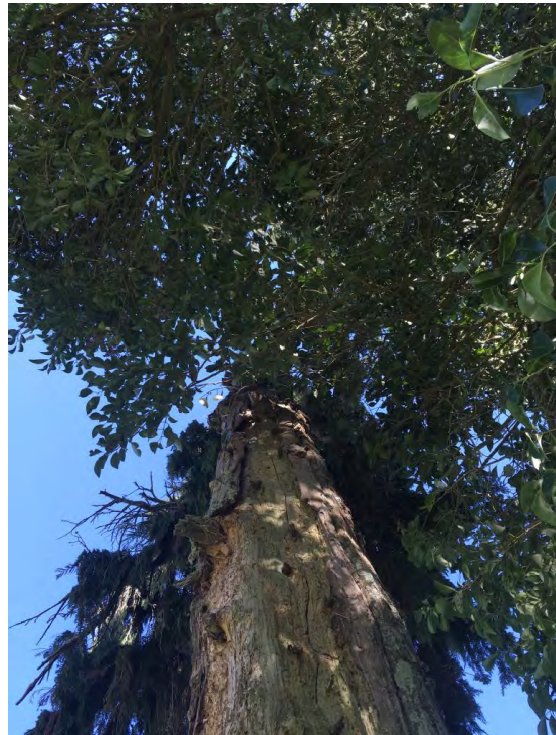
Figure 4: Loose bark on an unhealthy *Cupressus* tree.

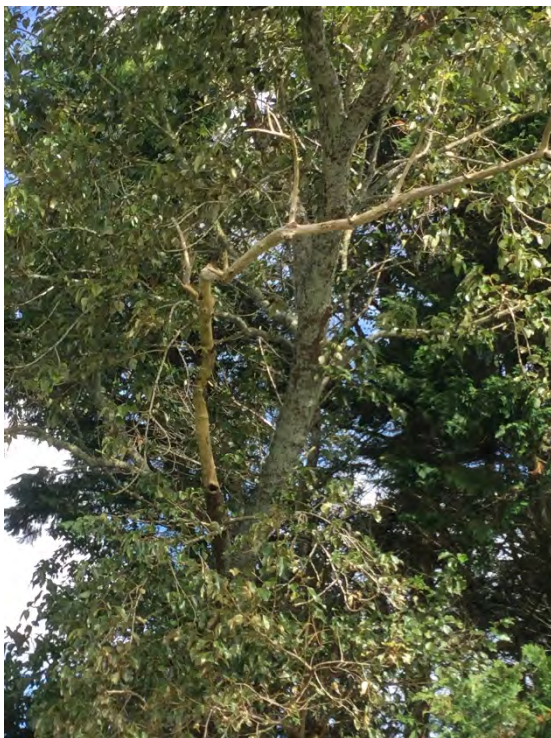
Figure 5: A cavity in a dead, hollow branch of a mature poplar tree.

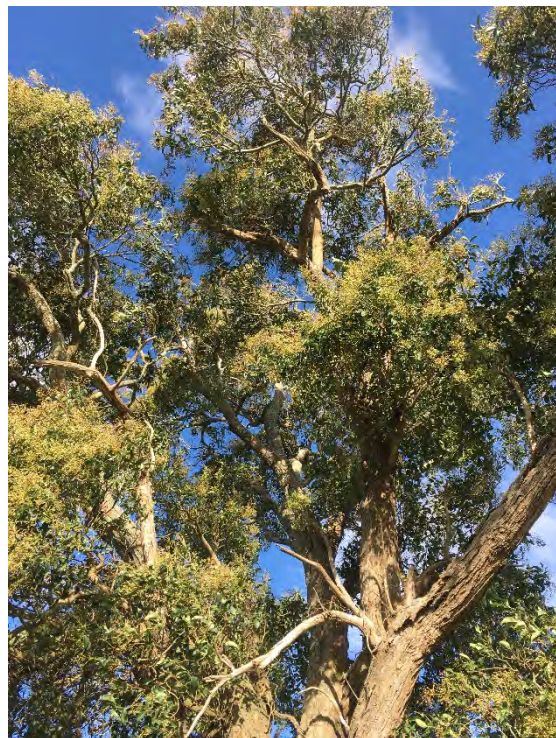
Figure 6: A very old tree *privet* containing multiple potential roost features including hollow limbs and loose bark.

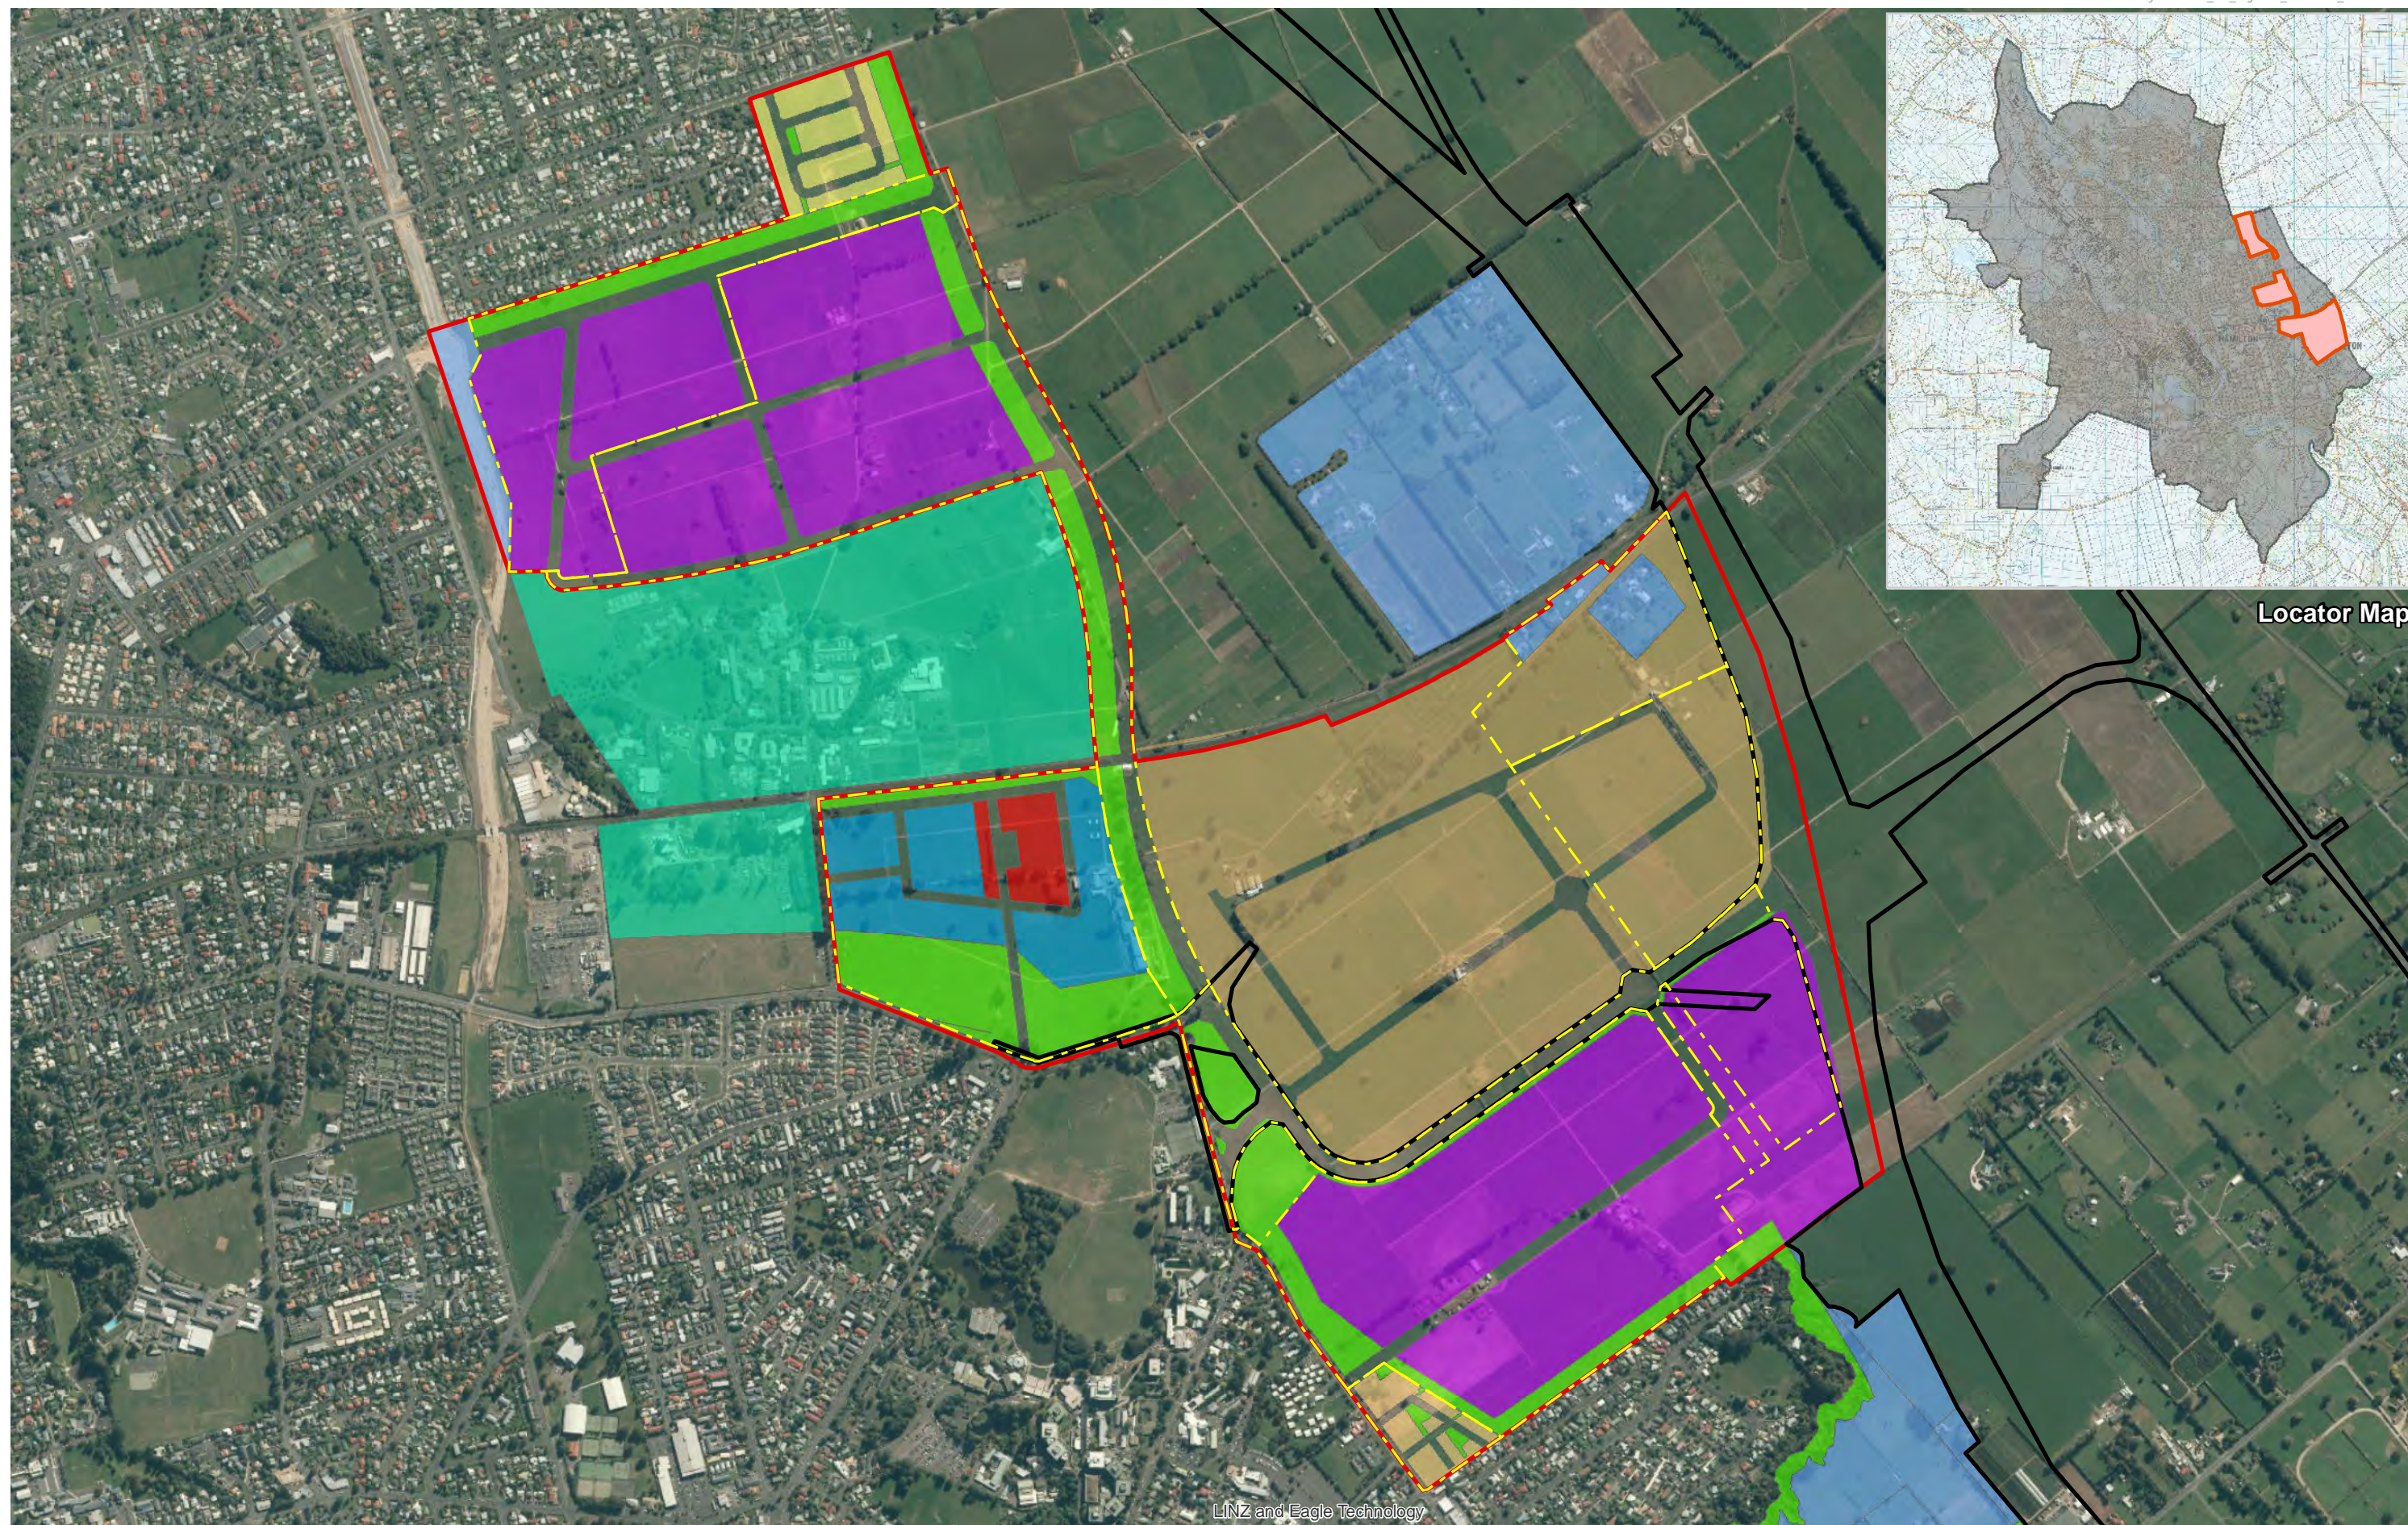
Figure 2: Potential lizard habitats within Ruakura South development footprint.
