Receiving Environment and Rapid Erosion Assessment

# Rotokauri North Sub-Catchment

Prepared for Hamilton City Council by Morphum Environmental Ltd  
September 2018

**Client Name:** Hamilton City Council  
**Project Name:** Rotokauri North Assessment  
**Project Number:** P01733  
**Document:** Receiving Environment and Rapid Erosion Assessment

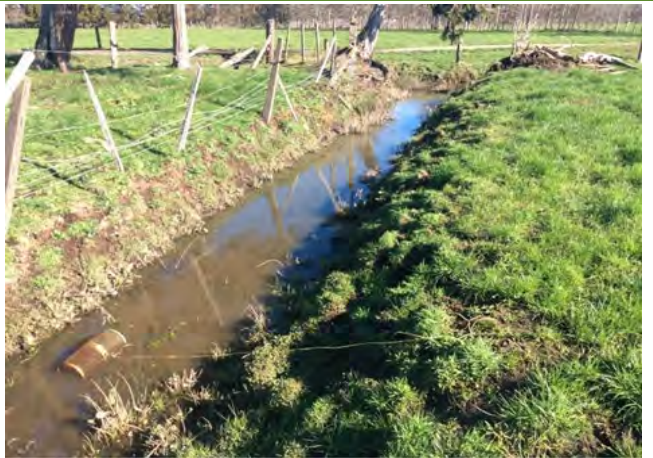
Site Code	Descriptions	
<b>RNDA1</b> (TEO_TRIB1_3)	Incised, straightened channel surrounded by dairy farm land. No significant riparian shading or in-stream woody debris. Floating duckweed mats present in stream channel.

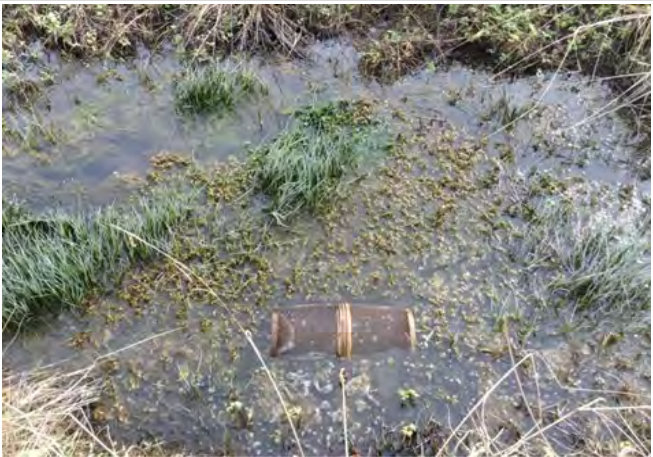
<b>RNDA2</b> (OHO_TRIB2_3)	Shallow, stagnant watercourse surrounded by harvested maize cropland. Riparian vegetation dominated by rank grasses.

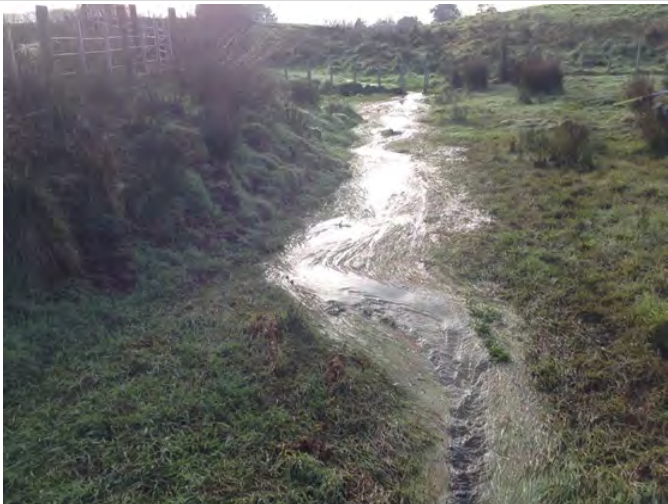
<b>OHOTE</b> (OHO_TRIB1_1)	Wetland-like characteristics. Channel dominated by floating sweetgrass.

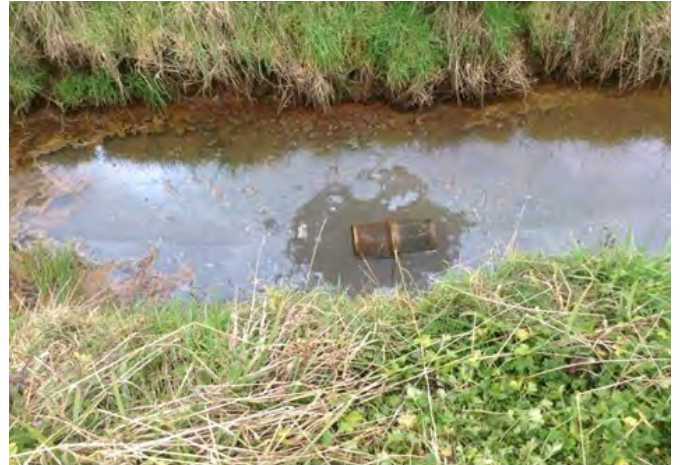
**TEOT1**  
(TEO\_MAIN\_26)

Incised, straightened channel.  
Macrophyte cover and  
overhanging rank grasses.

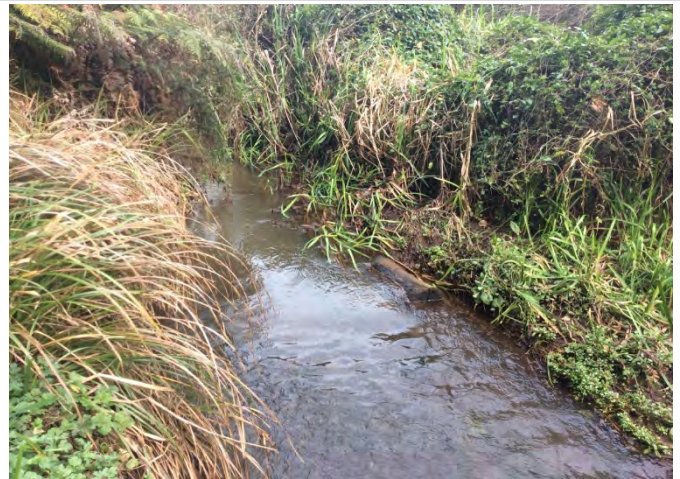
**TEOT2**  
(TEO\_MAIN\_1)

Wide and relatively deep  
downstream reach of Te  
Otamanui. Overhanging  
vegetation and canopy cover.

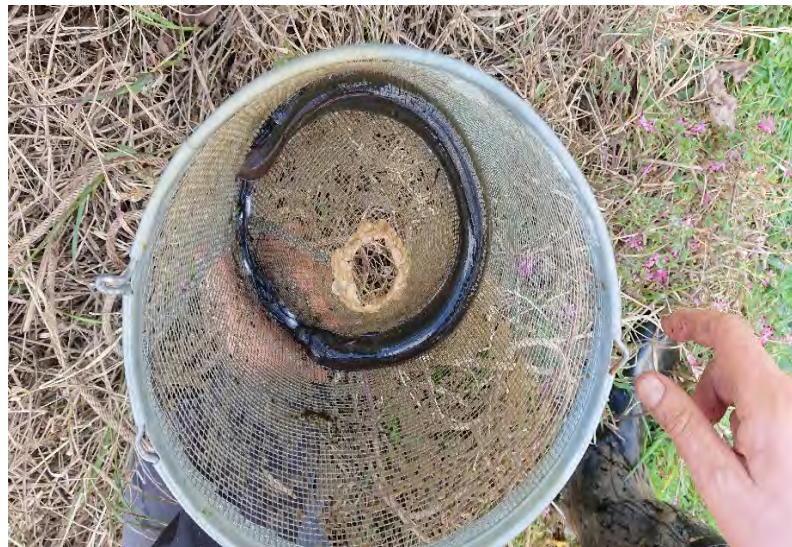
The survey did not identify any black mudfish at the four samples sites in the Rotokauri North sub-catchment. The invasive mosquitofish (*Gambusia affinis*) was abundant (> 100 individuals) throughout and captured in traps at all sites except RND2. A single native shortfin eel (*Anguilla australis*) was recorded at TEOT1 (Figure 22).

**Figure 8: Small shortfin eel and a number of mosquitofish captured in a Gee minnow trap at TEO1**

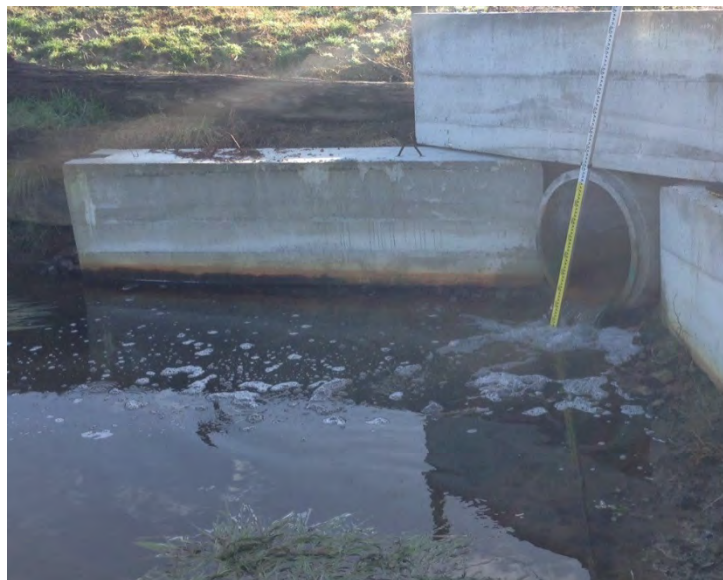
One of the most notable fish barriers present within the Rotokauri North sub-catchment is located on a downstream reach of the Ohote Stream (OHO\_TRIB\_1). The outlet of a private 1000 mm concrete culvert (ID: UNK026) is perched 0.35 m, forming a complete barrier to swimming and climbing species (depending on water levels). The structure impedes fish passage to more than 2 km of upstream reaches of the Ohote Stream.

**Figure 9: Fish barrier for swimming fish species located on the culvert outlet (Asset ID: UNK026)**

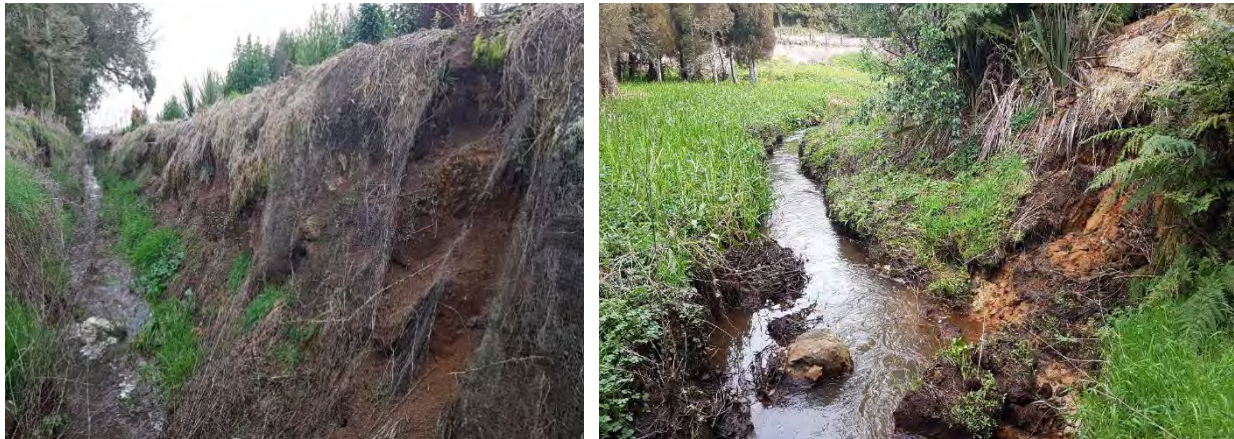
- The outlet at Horotiu Road (UNK107) is a near-vertical outflow draining from the main road. The discharge of flows from a height of approximately 2 metres into the stream channel below has caused severe erosion at the downstream end of the Te Otamanui stream. It is recommended that this infrastructure is upgraded or replaced with a design which mitigates channel erosion.

**Figure 10: Left: Erosion and coir lining on banks upstream of the Te Kowhai Road culvert (UNK031); Right: Erosion downstream of outlet UNK107**

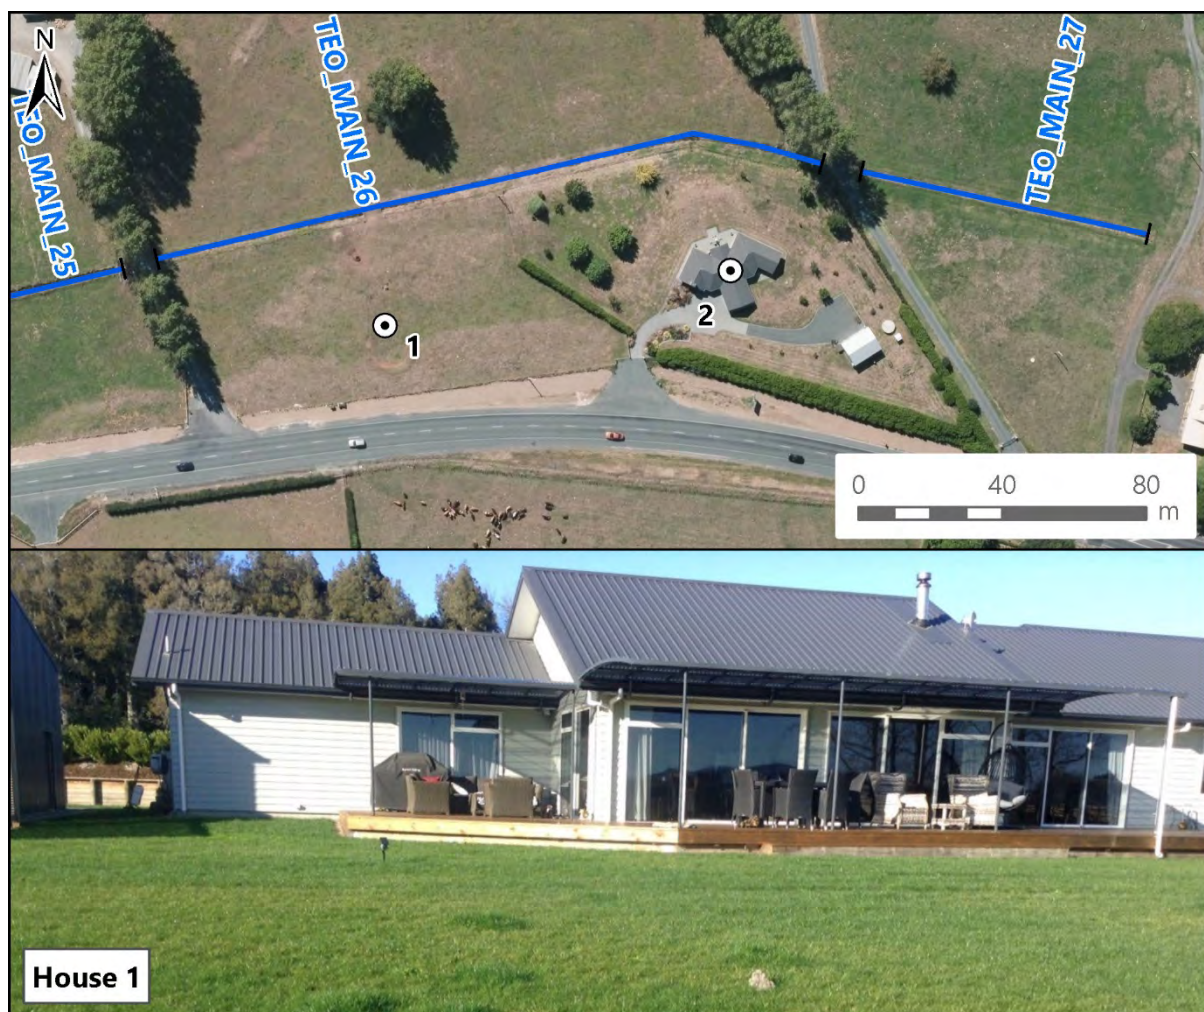
Figure 11: Results of Habitable Floor Level Surveying

As part of the watercourse assessment, Morphum conducted initial flagging of both habitable and non-habitable buildings that may potentially be at risk of flooding from increased flows. The assessment was a visual inspection only, using an inclinometer to identify building floor levels that were within 1.75 m elevation of the top of the bank. It is anticipated that this initial assessment will be used in conjunction with the flood assessment to identify areas for further investigation. All houses within the Rotokauri North development area were excluded from this assessment. As a result of the investigation, two houses were identified as being within 1.75 m of the top of the bank and are illustrated in Figure 10. The houses within this area require further investigation into the risk of flooding from development within the upstream catchment, however these are new dwellings, so a resource consent process is considered likely to have assessed flood levels.

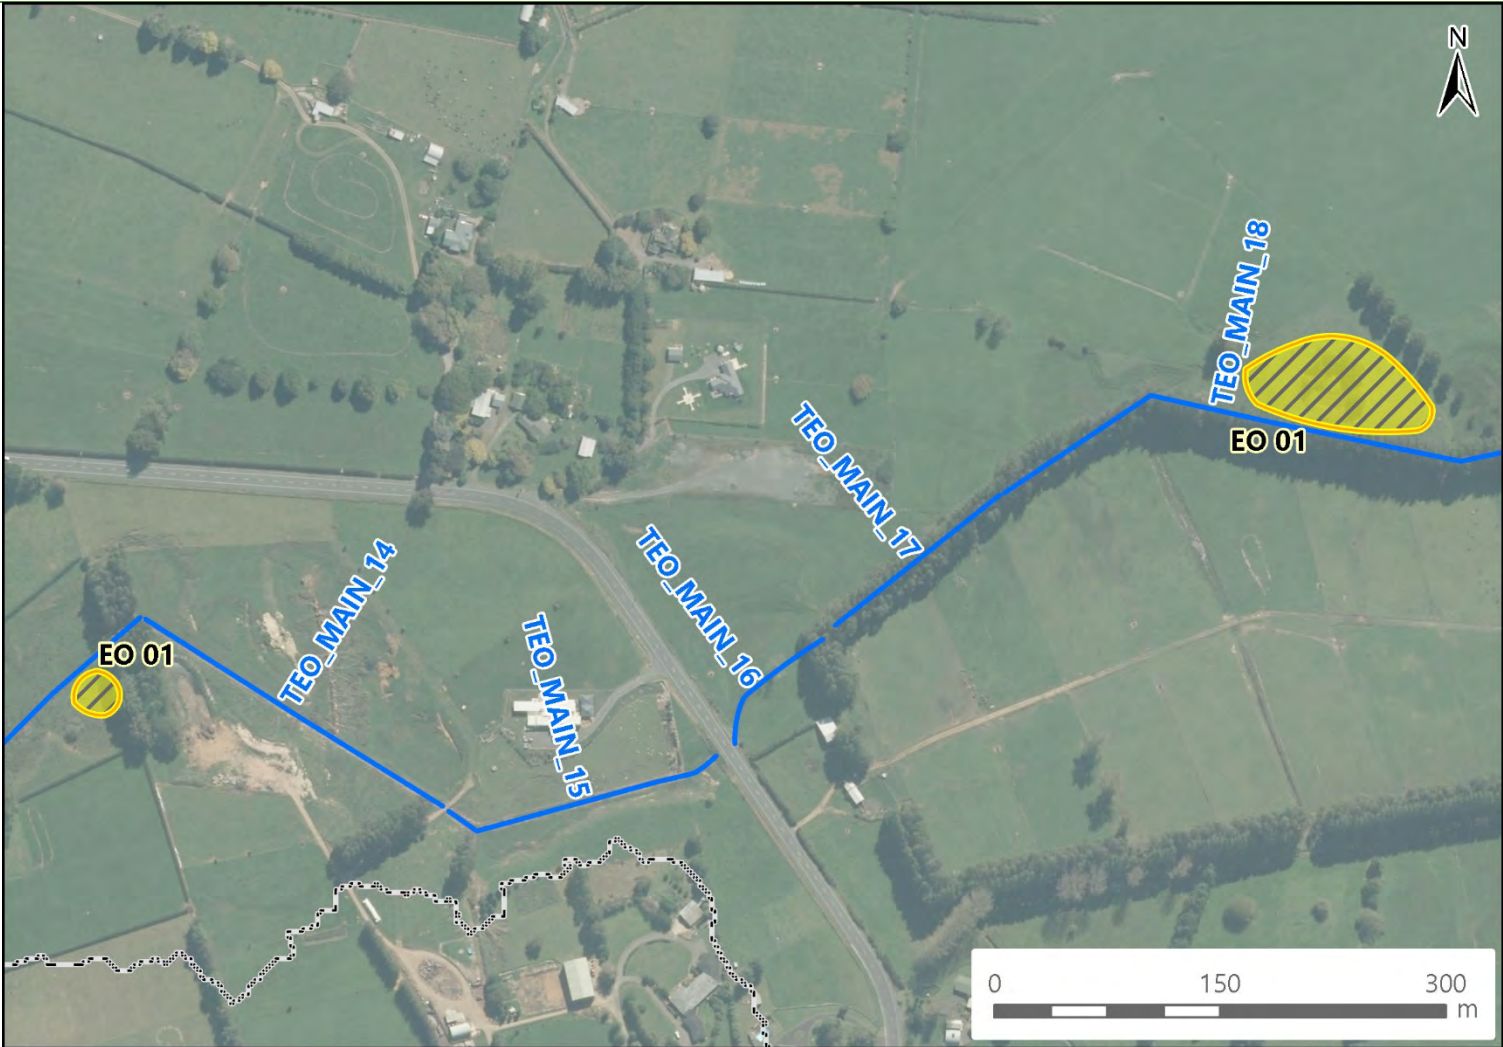
EO1- Wetland naturalisation and enhancement along mid-Te Otamanui Stream

**Location:** Upper Te Otamanui Tributary  
**Tributary ID:** TEO\_MAIN\_18 and TEO\_MAIN\_13  
**Ownership:** Private

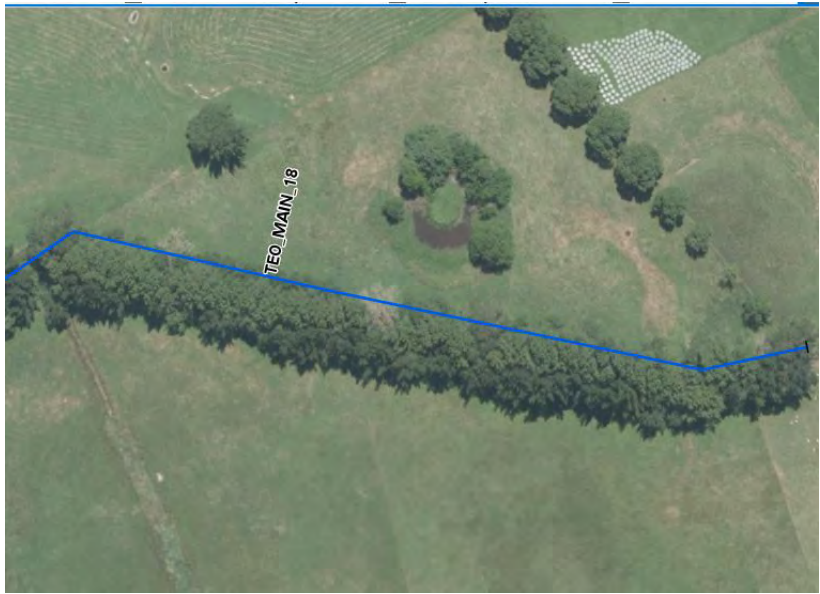
Artificial farm pond on TRB of TEO\_MAIN\_18 embedded in a natural palustrine wetland

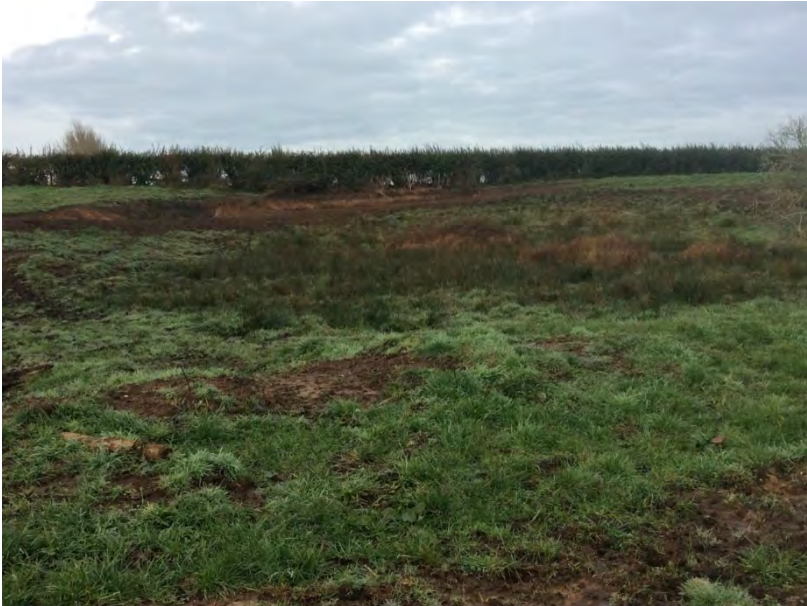
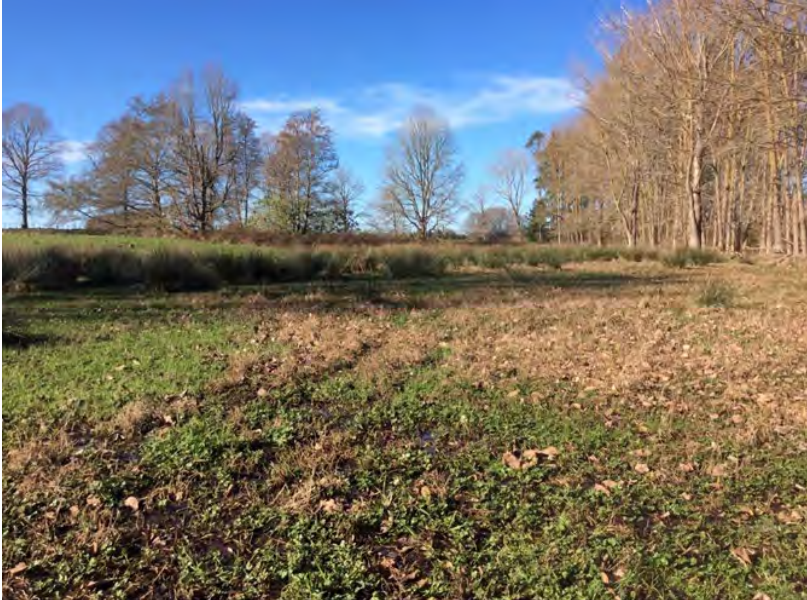
Palustrine wetlands heavily modified by stock damage and planted by pastoral grasses

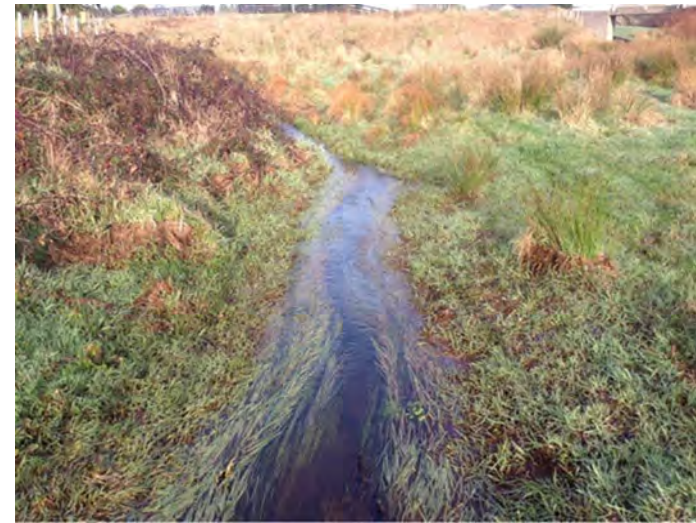
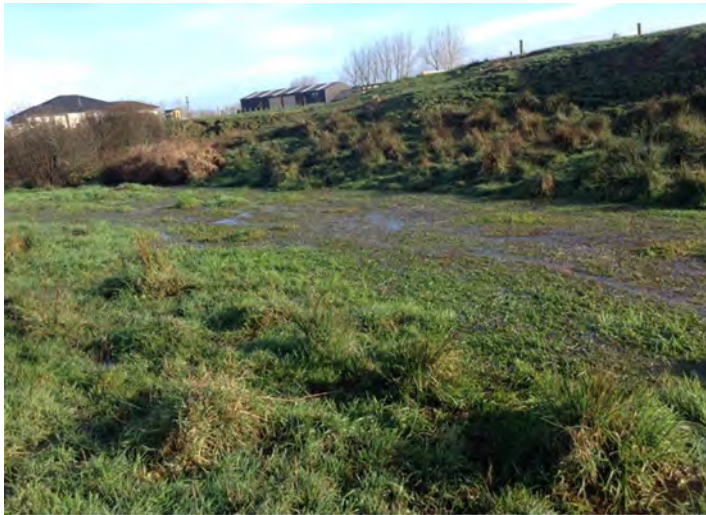
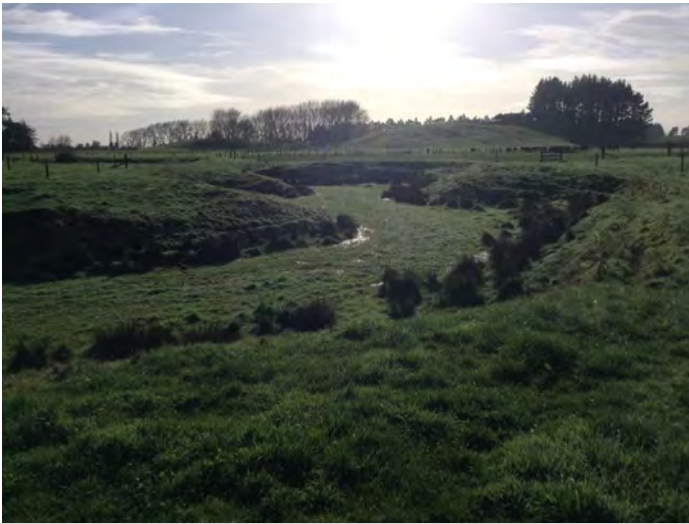
Riverine wetland-like reaches in the downstream reaches of the Ohote Stream

<b>Considerations</b> <ul style="list-style-type: none"><li>• Erosion and scour protection</li><li>• Weed removal and planting appropriate, eco-sourced vegetation</li><li>• Fish passage</li><li>• Maintaining conveyance capacity</li><li>• Flooding risk to reach directly downstream of the culvert</li></ul>	
<b>Enhancement Types</b>	<b>Stakeholders</b>
Naturalisation	Residents
Fencing/Stock Exclusion	HCC
Conveyance Improvements	Community groups
Aquatic Weed Control

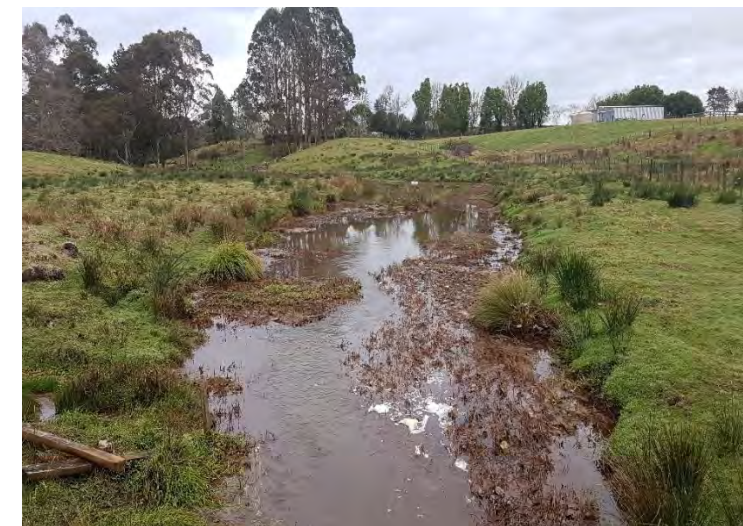
<b>Location:</b> Lower Te Otamanui Tributary	
<b>Tributary ID:</b> TEO_MAIN_8	<b>Ownership:</b> Private
<b>Priority Score:</b> 2	<b>Area:</b> 0.24 Ha
<b>Description</b> Artificial farm pond created through damming on private property. WRC Plan recognises farm damming as a permitted activity where it does not adversely impact neighbouring properties or increase erosion and flooding risk. The aesthetic farm pond has altered local hydrology and ecological processes. The reaches directly downstream of the pond are unstable, and highly prone to erosion. Opportunity to naturalise the pond, stabilise stream banks, remove fish barriers and enhance the riparian margins with native riparian vegetation. The pond is on private property and therefore requires co-operation with landowners for stream management and remediation works.	
<b>Considerations</b> <ul style="list-style-type: none"><li>Maintenance required for conveyance efficiency</li><li>Downstream effects of naturalising pond to a stream channel</li><li>Erosion and scour protection</li><li>Remediation of fish barrier</li><li>Earthworks required for re-shaping of channel</li><li>Weed and pest control</li></ul>

Artificial pond

<b>Enhancement Types</b> Conveyance Improvements Fish Barrier Erosion Protection Weed Control and Planting	
<b>Stakeholders</b> HCC Residents

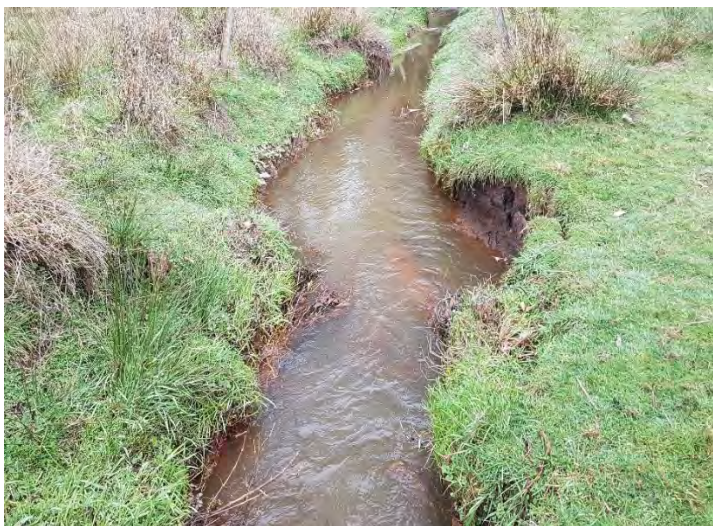
Downstream reach erosion

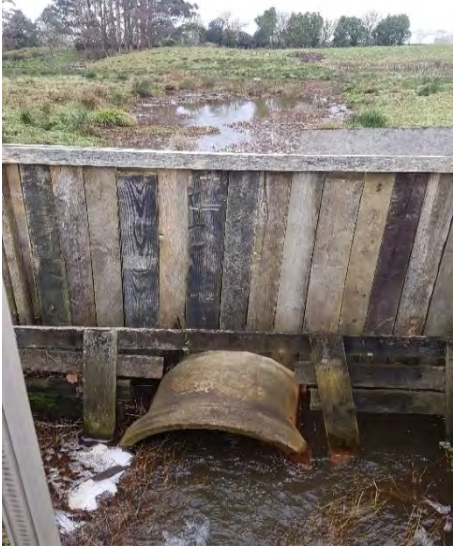
Culvert requiring remediation upstream of pond

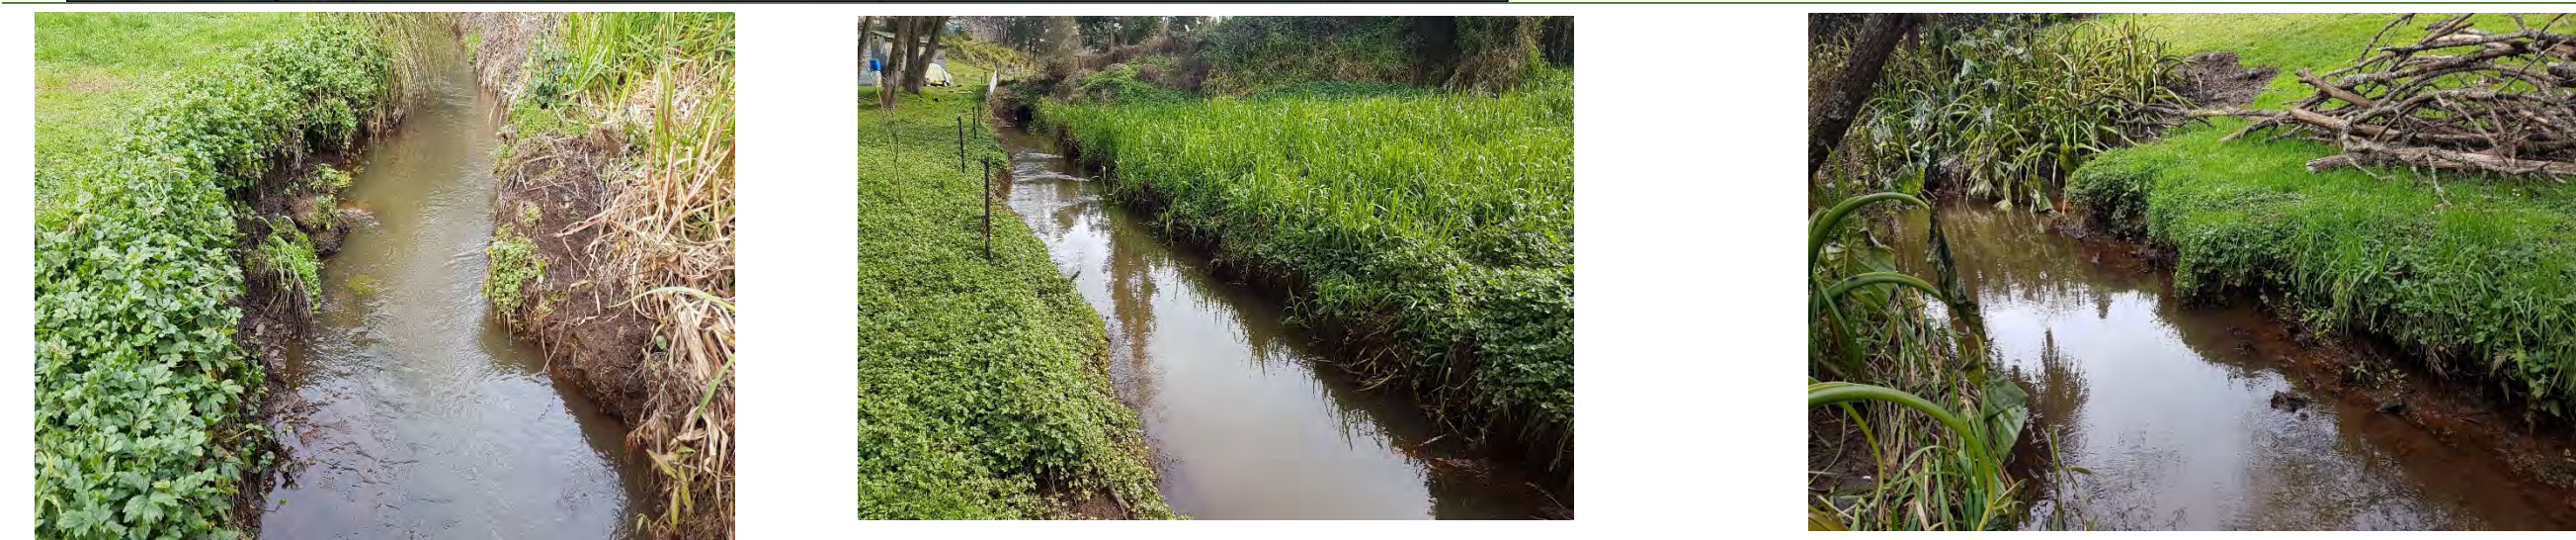
Downstream reaches of the Te Otamanui Stream, creating dominated by low growing exotic plant species

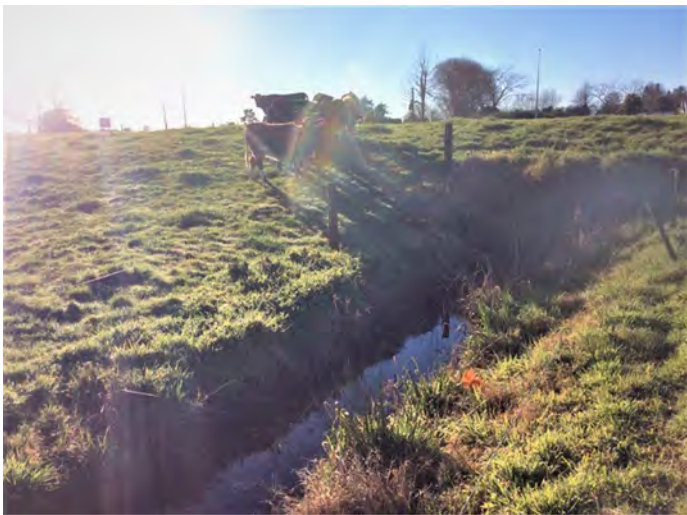
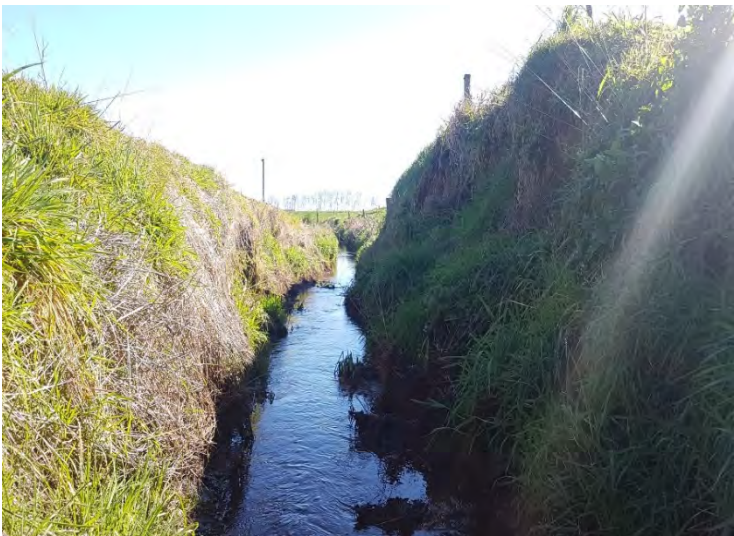
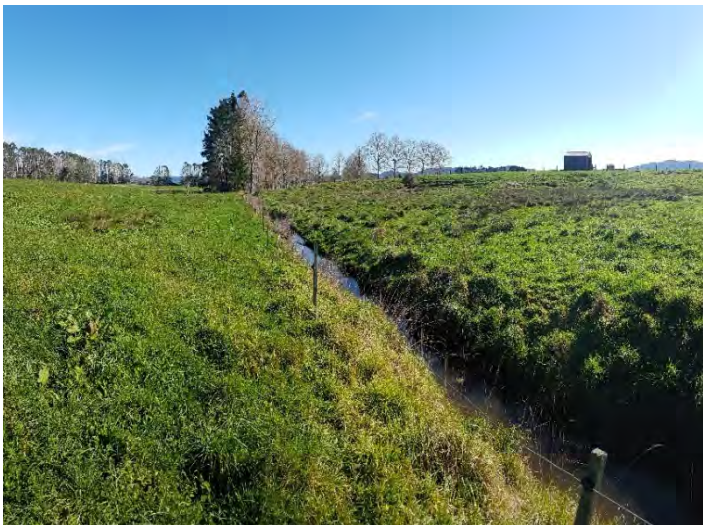
Upper Te Otamanui Tributary reaches with no riparian cover, stock access and high erosion susceptibility

<b>Considerations</b> <ul style="list-style-type: none"><li>• Maximising riparian buffer width to reduce extent of edge habitat</li><li>• Maintaining required conveyance capacity through floodplain appropriate species</li><li>• Maintenance of channel to mitigate flood risks</li><li>• Linking any remnant vegetation patches to minimise impacts of fragmentation</li><li>• Long term maintenance requirements</li></ul>	
<b>Enhancement Types</b> <ul style="list-style-type: none"><li>Weed Control and Planting</li><li>Erosion Protection</li><li>Fencing/ Stock Exclusion</li></ul>	<b>Stakeholders</b> <ul style="list-style-type: none"><li>HCC</li><li>Residents</li></ul>
