Receiving Environment and Rapid Erosion Assessment

# Rotokauri North Sub-Catchment

Prepared for Hamilton City Council by Morphum Environmental Ltd  
September 2018

**Client Name:** Hamilton City Council  
**Project Name:** Rotokauri North Assessment  
**Project Number:** P01733  
**Document:** Receiving Environment and Rapid Erosion Assessment

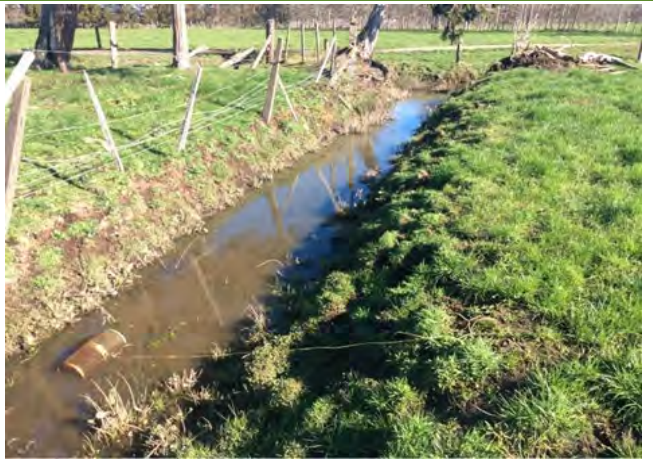
Site Code	Descriptions	
<b>RNDA1</b> (TEO_TRIB1_3)	Incised, straightened channel surrounded by dairy farm land. No significant riparian shading or in-stream woody debris. Floating duckweed mats present in stream channel.

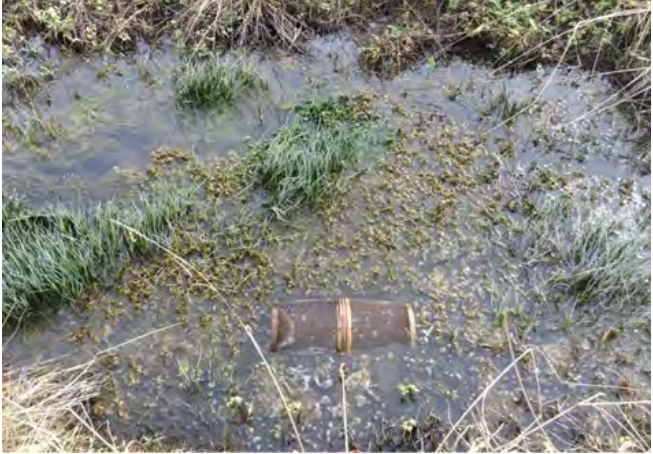
<b>RNDA2</b> (OHO_TRIB2_3)	Shallow, stagnant watercourse surrounded by harvested maize cropland. Riparian vegetation dominated by rank grasses.

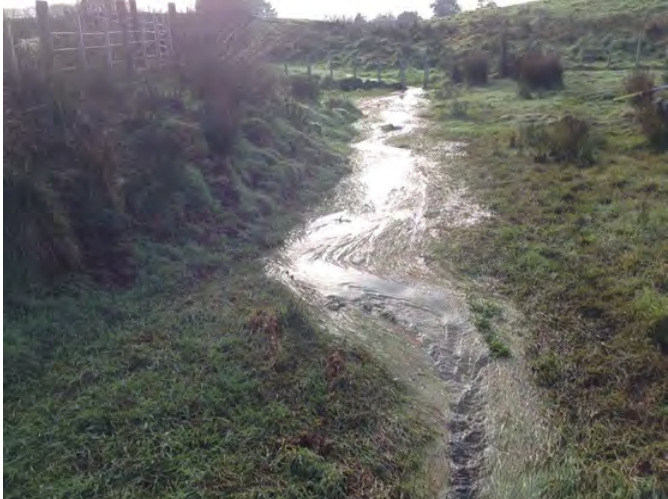
<b>OHO TE</b> (OHO_TRIB1_1)	Wetland-like characteristics. Channel dominated by floating sweetgrass.

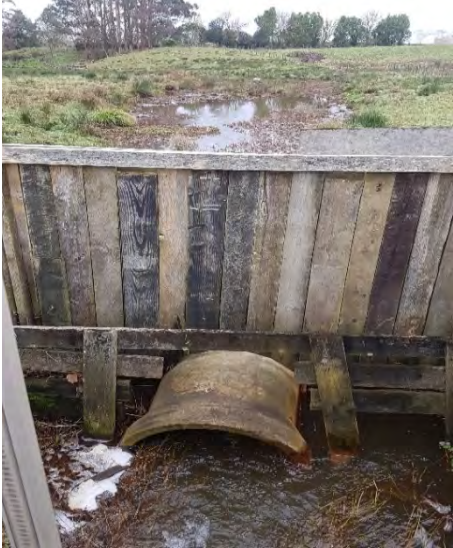
Culvert requiring remediation upstream of pond

<b>Location:</b> Lower Te Otamanui Tributary	
<b>Tributary ID:</b> TEO_MAIN_8	<b>Ownership:</b> Private
<b>Priority Score:</b> 2	<b>Area:</b> 0.24 Ha
<b>Description</b> Artificial farm pond created through damming on private property. WRC Plan recognises farm damming as a permitted activity where it does not adversely impact neighbouring properties or increase erosion and flooding risk. The aesthetic farm pond has altered local hydrology and ecological processes. The reaches directly downstream of the pond are unstable, and highly prone to erosion. Opportunity to naturalise the pond, stabilise stream banks, remove fish barriers and enhance the riparian margins with native riparian vegetation. The pond is on private property and therefore requires co-operation with landowners for stream management and remediation works.	
<b>Considerations</b> <ul style="list-style-type: none"><li>Maintenance required for conveyance efficiency</li><li>Downstream effects of naturalising pond to a stream channel</li><li>Erosion and scour protection</li><li>Remediation of fish barrier</li><li>Earthworks required for re-shaping of channel</li><li>Weed and pest control</li></ul>

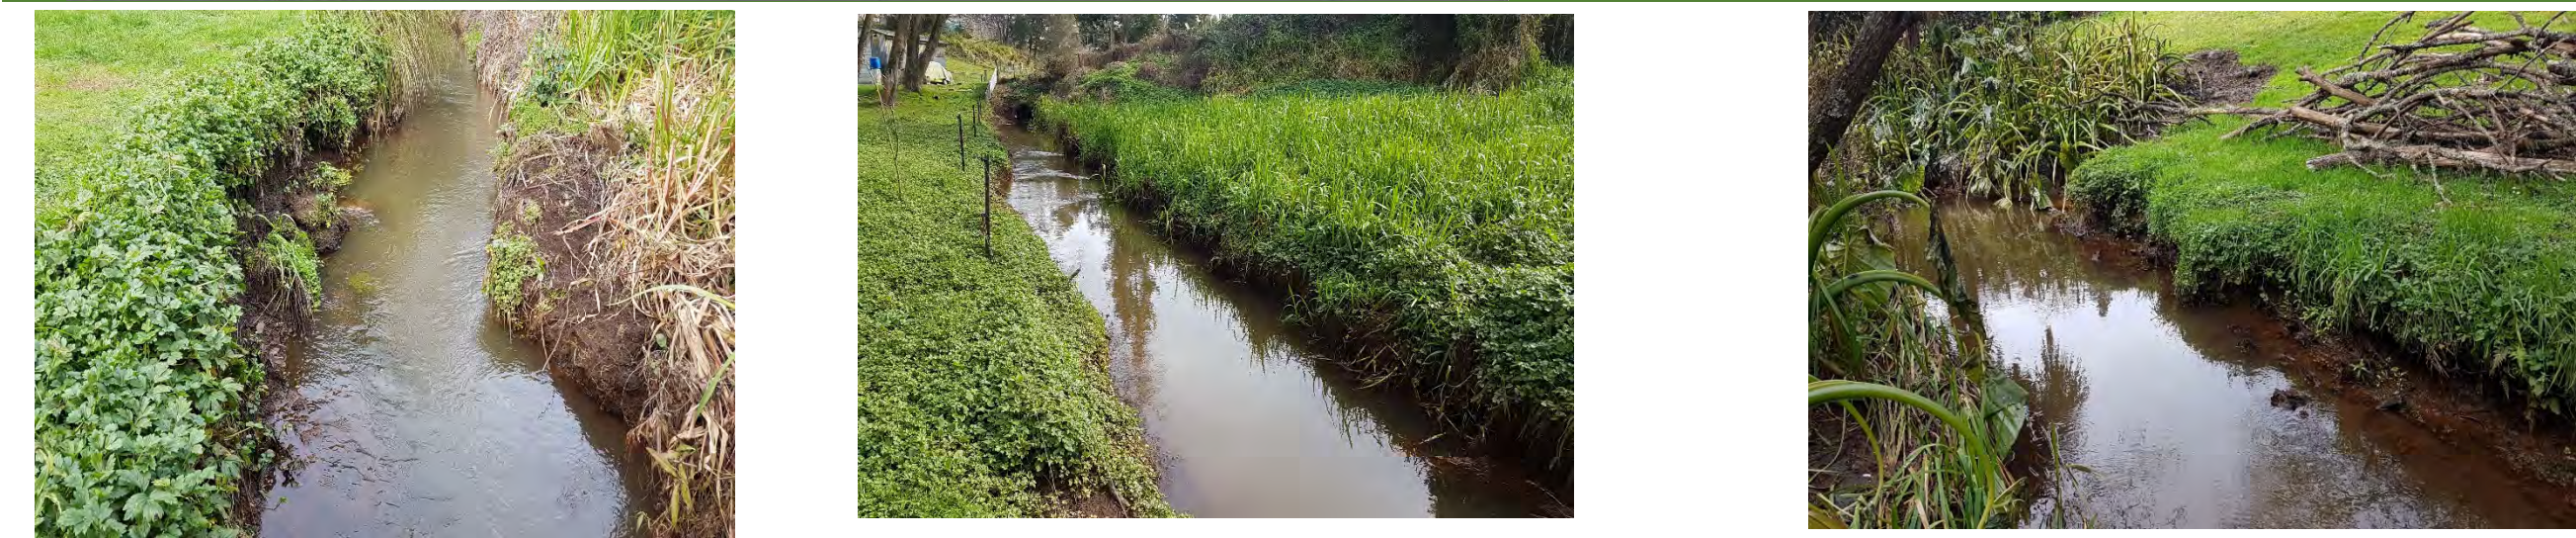
Downstream reaches of the Te Otamanui Stream, creating dominated by low growing exotic plant species

<b>Location:</b> Lower Te Otamanui Tributary							
<b>Tributary ID:</b> TEO_MAIN_1 to TEO_MAIN_8	<b>Ownership:</b> Private						
<b>Priority Score:</b> 2	<b>Area:</b> 0.74 Ha						
<b>Description</b> <p>This enhancement opportunity augments erosion mitigation works previously outlined in this report. In addition to the minimal works required to address current erosion mitigation issues, there is an opportunity to improve the ecological outcomes by maximising riparian buffer to the recommended 20 metre width.</p> <p>Opportunity to create wider set-backs with exclusion fencing and native vegetation riparian buffers. The larger-scale management approach mitigates further risk whilst enhancing the stream habitats. Privately owned land. Enhancement and stream management in these receiving environments will therefore require landowner co-operation. There are also opportunities to create community projects which encourage community engagement.</p>							
<b>Considerations</b> <ul style="list-style-type: none"><li>• Maximising riparian buffer width to reduce extent of edge habitat</li><li>• Maintaining required conveyance capacity through floodplain appropriate species</li><li>• Linking any remnant vegetation patches to minimise impacts of fragmentation</li></ul>							
<b>Enhancement Types</b>

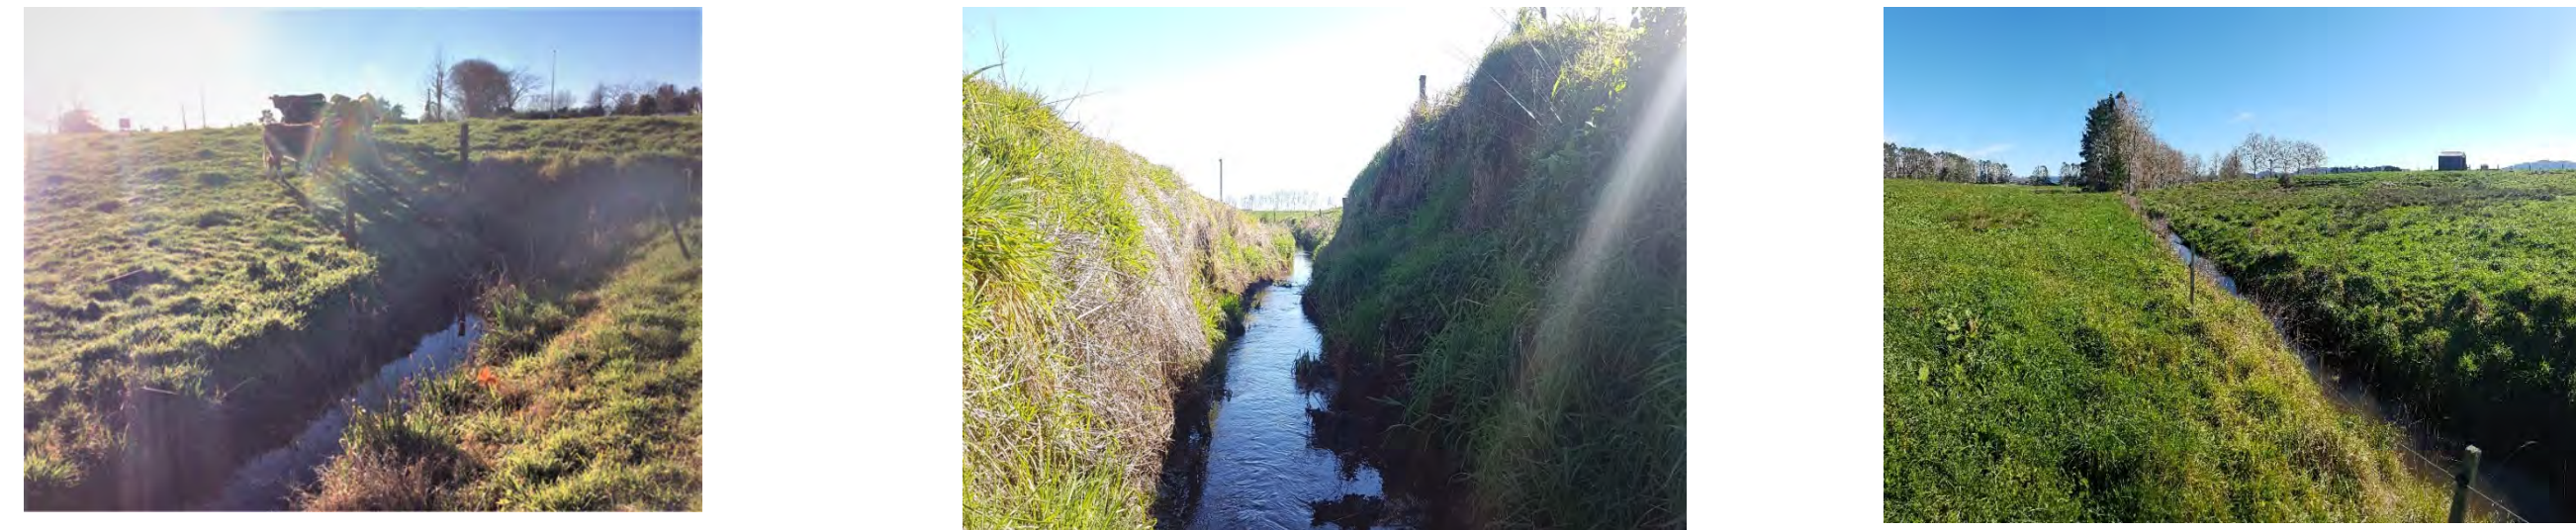
Upper Te Otamanui Tributary reaches with no riparian cover, stock access and high erosion susceptibility

<b>Location:</b> Upper Te Otamanui Tributary	
<b>Tributary ID:</b> TEO_MAIN_9 to TEO_MAIN_28	<b>Ownership:</b> Private
<b>Priority Score:</b> 3	<b>Area:</b> 5.94 Ha
<b>Description</b> <p>This enhancement opportunity augments erosion mitigation works previously outlined in this report. The Te Otamanui Tributary consists of heavily modified reaches with stock damage on stream banks, poor water quality and little to no riparian cover. As an alternative to <i>ad-hoc</i> localised erosion mitigation works exclusively in highly prone reaches, there is an opportunity to create set-backs with exclusion fencing and 20 metre riparian buffers along the Te Otamanui Tributary. The larger-scale management approach mitigates further risk whilst enhancing the stream habitats.</p> <p>Privately owned land. Enhancement and stream management in these receiving environments will therefore require landowner co-operation. There are also opportunities to create community projects which encourage community engagement.</p>

<b>Considerations</b> <ul style="list-style-type: none"><li>• Maximising riparian buffer width to reduce extent of edge habitat</li><li>• Maintaining required conveyance capacity through floodplain appropriate species</li><li>• Maintenance of channel to mitigate flood risks</li><li>• Linking any remnant vegetation patches to minimise impacts of fragmentation</li><li>• Long term maintenance requirements</li></ul>	
<b>Enhancement Types</b> <ul style="list-style-type: none"><li>Weed Control and Planting</li><li>Erosion Protection</li><li>Fencing/ Stock Exclusion</li></ul>	<b>Stakeholders</b> <ul style="list-style-type: none"><li>HCC</li><li>Residents</li></ul>
