**IN THE MATTER** of an application to **HAMILTON  
CITY COUNCIL** for private plan  
change 7 to the operative  
Hamilton City District Plan by  
**GREEN SEED CONSULTANTS  
LIMITED**

## **STATEMENT OF EVIDENCE OF TERESA (TERRE) NICHOLSON**

- 1.8 I was initially engaged by Green Seed Consultants Limited ("**GSCL**") to conduct a preliminary site investigation ("**PSI**") with limited sampling across the entire planned development site to evaluate potential risk to human health from the planned urban development. I am the author of the PSI report that was filed in support of the private plan change application to Hamilton City Council dated 11 July 2018.
- 1.9 The PSI identified dwellings and farm sheds present across Stage 1 of the development. The majority of the land was used for grazing. The remaining stages of the development had farm sheds, rubbish pits, a junk yard, and a disused milking shed present.
- 1.10 In July 2019, I was engaged to conduct a detailed site investigation ("**DSI**") of these targeted locations listed in the PSI as having the potential to cause soil contamination.

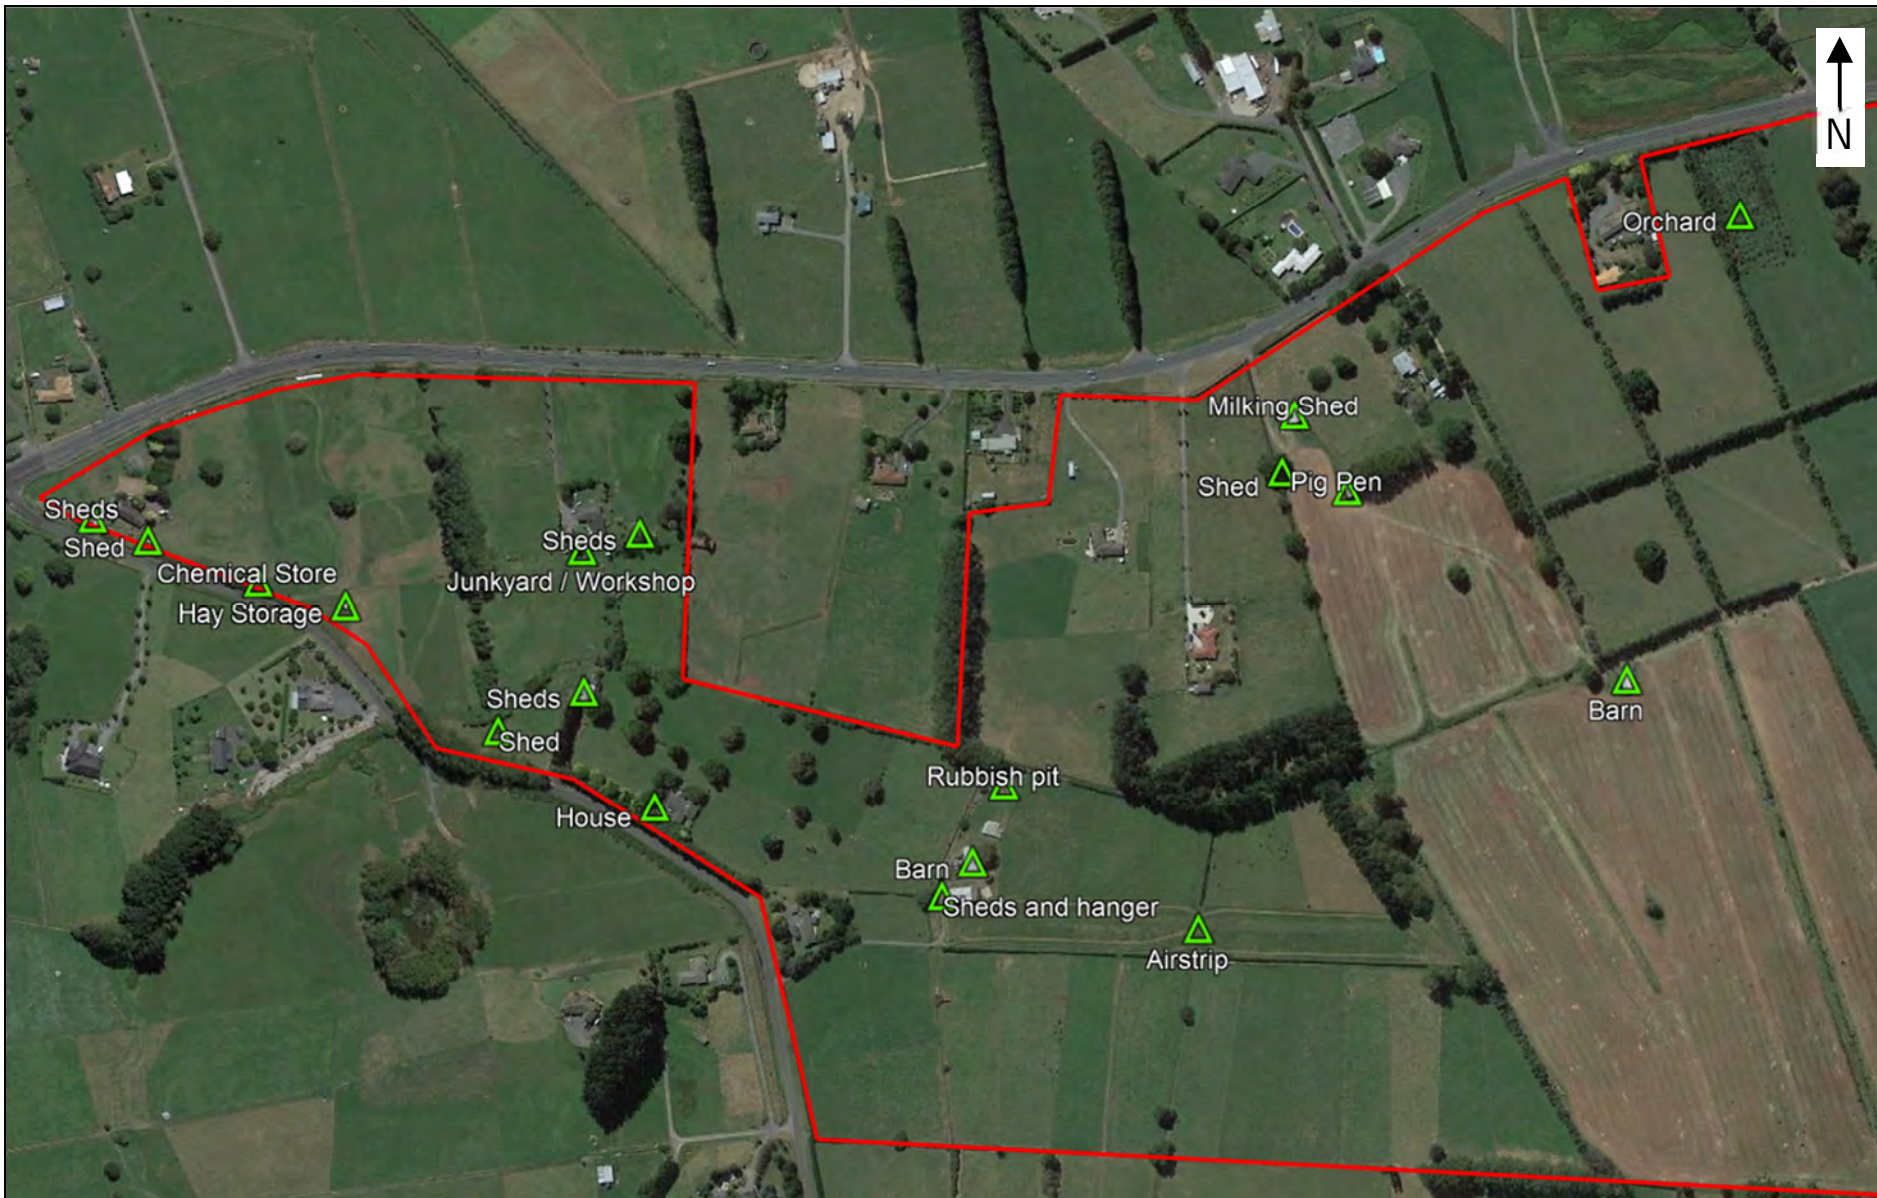
Figure 1A

- 4.8 The outcome of the PSI were findings that additional investigation was warranted for:
- (a) Site buildings, such as farm sheds and barns where lead-based paint, asbestos, or hazardous substances could be present;
  - (b) Potential HAIL activities, such as junkyards and rubbish disposal areas; and
  - (c) Pastures where superphosphate fertiliser could lead to elevated cadmium in soil.
- 4.9 **Attached** Figures 1A (**Appendix 1**) and 1B (**Appendix 2**) show areas identified by the PSI as parcels where potentially contaminating activities could be present.

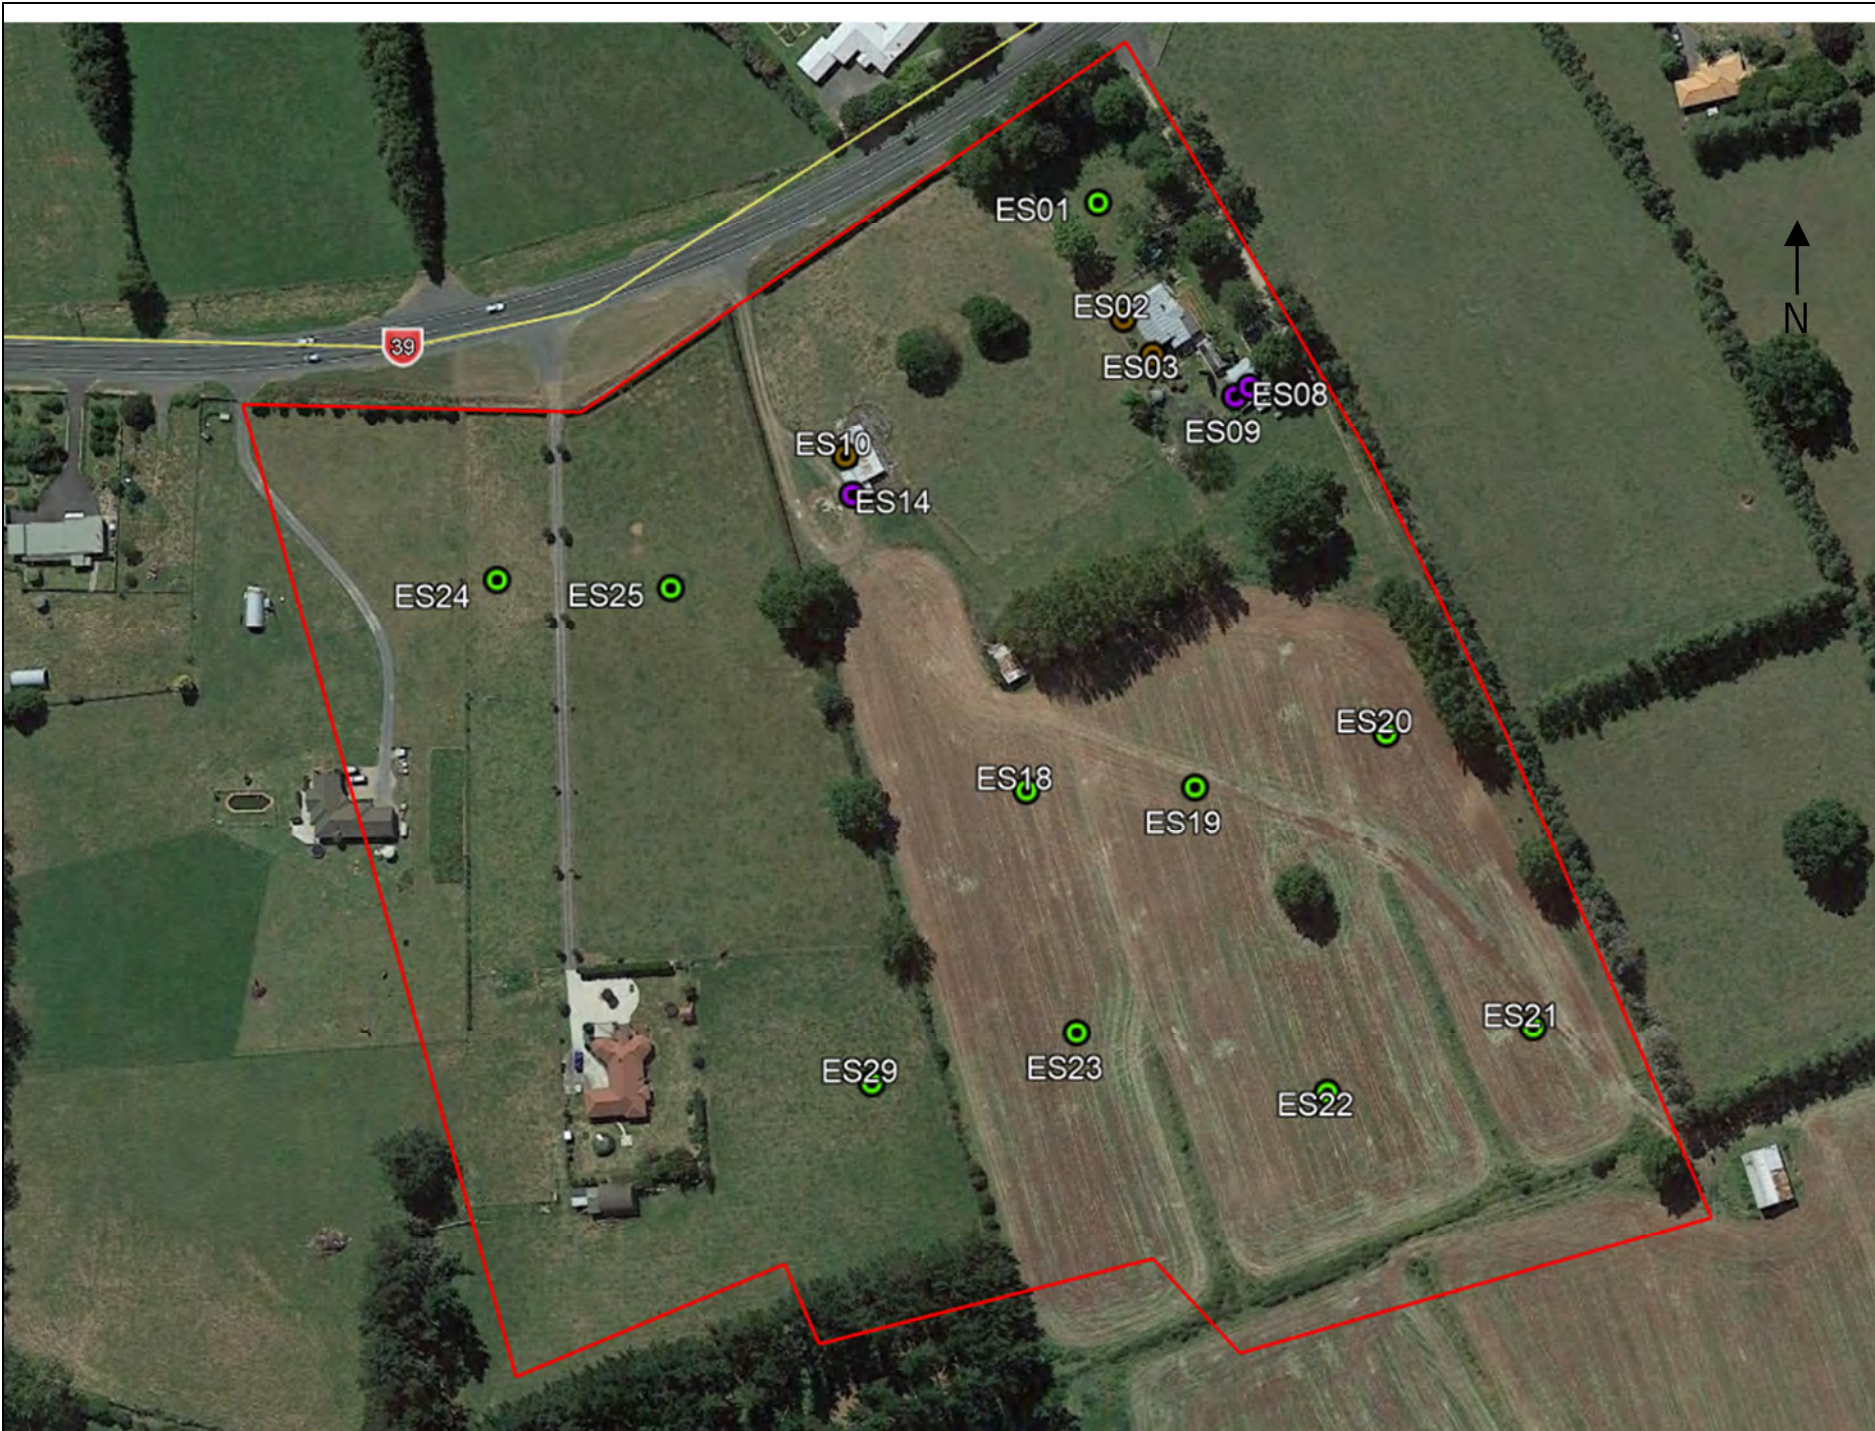
Figure 2A

- 5.1 The 2019 DSI was conducted for a portion of Stage 1 of the project (see **attached** Figures 2A (**Appendix 3**) and 2B (**Appendix 4**)) and focused on potentially contaminating activities. In this portion of Stage 1, the contaminating activities were primarily associated with building materials (lead-based paint and asbestos), persistent pesticide mixing at farm sheds, and hydrocarbons from fuel storage. Cadmium was also evaluated across the site.

5.9 Lead was found above guideline values in three samples, all of which are associated with two sheds. These two sheds are designated "pieces of land" under the NESCS.

6.1 Prior to development of the PC7 land, we recommend that the lead-impacted soil from around the two sheds be removed and properly managed on site or disposed of off-site.
