ROTOKAURI NORTH SHA

LIQUEFACTION HAZARD STUDY

PROJECT NO: HD631
GREEN SEED CONSULTANTS
LIMITED
REFERENCE: LHS01
12 JUNE 2019

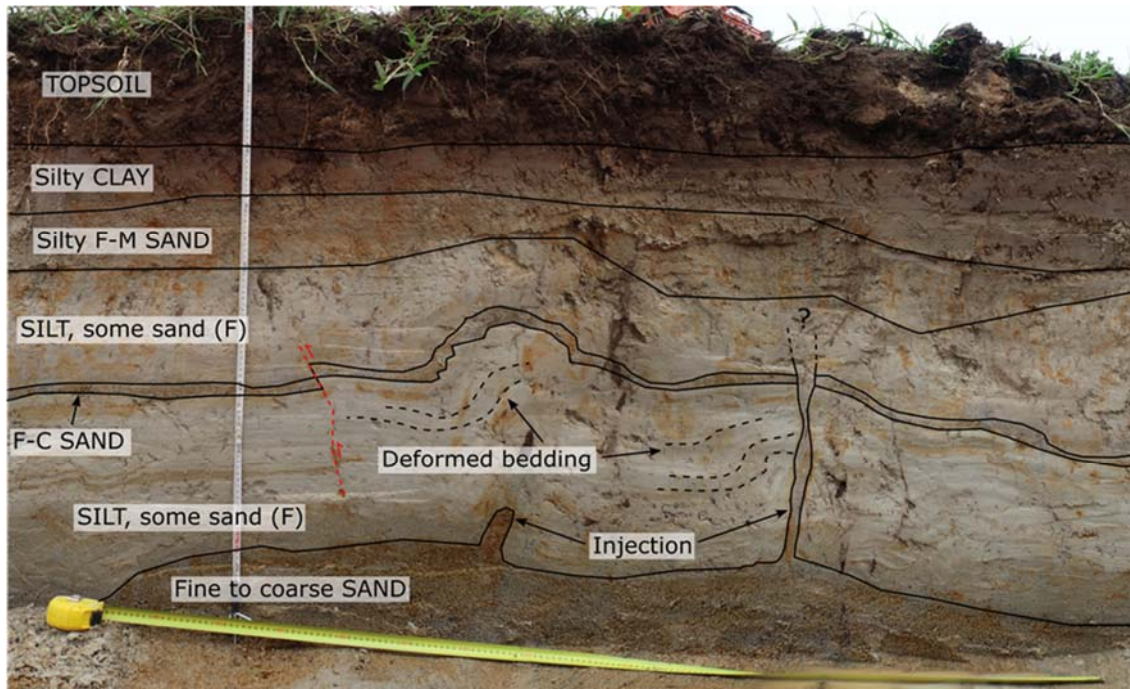
Figure 1: Annotated photo showing paleoliquefaction features encountered in TP04.

Features which we have interpreted as paleoliquefaction structures were encountered in Trench 4. The features encountered included injection structures and soft sediment deformation. Annotated photos are included below in Figure 1 and Figure 2.

- Injection structures
 - originate from a fine to coarse sand
 - consist of fine to medium sand
 - are sub-vertical features which persist for up to 480 mm height
 - up to 30 mm wide
 - one injection displayed upwards fining
 - did not appear to reach the surface
- Soft sediment deformation
 - Included bedding deformed adjacent to, and above, injection features
 - small-scale reverse faults hosting 25 mm of offset

Our initial assessment found that an unmodified assessment using CPT data in the Plains materials reported a liquefaction hazard that should correlate with widespread surface disruption (high LSN). Our paleoliquefaction trenching found two, relatively small features, that did not appear to reach the surface. The features were only found in one location. While there are likely to be other features that

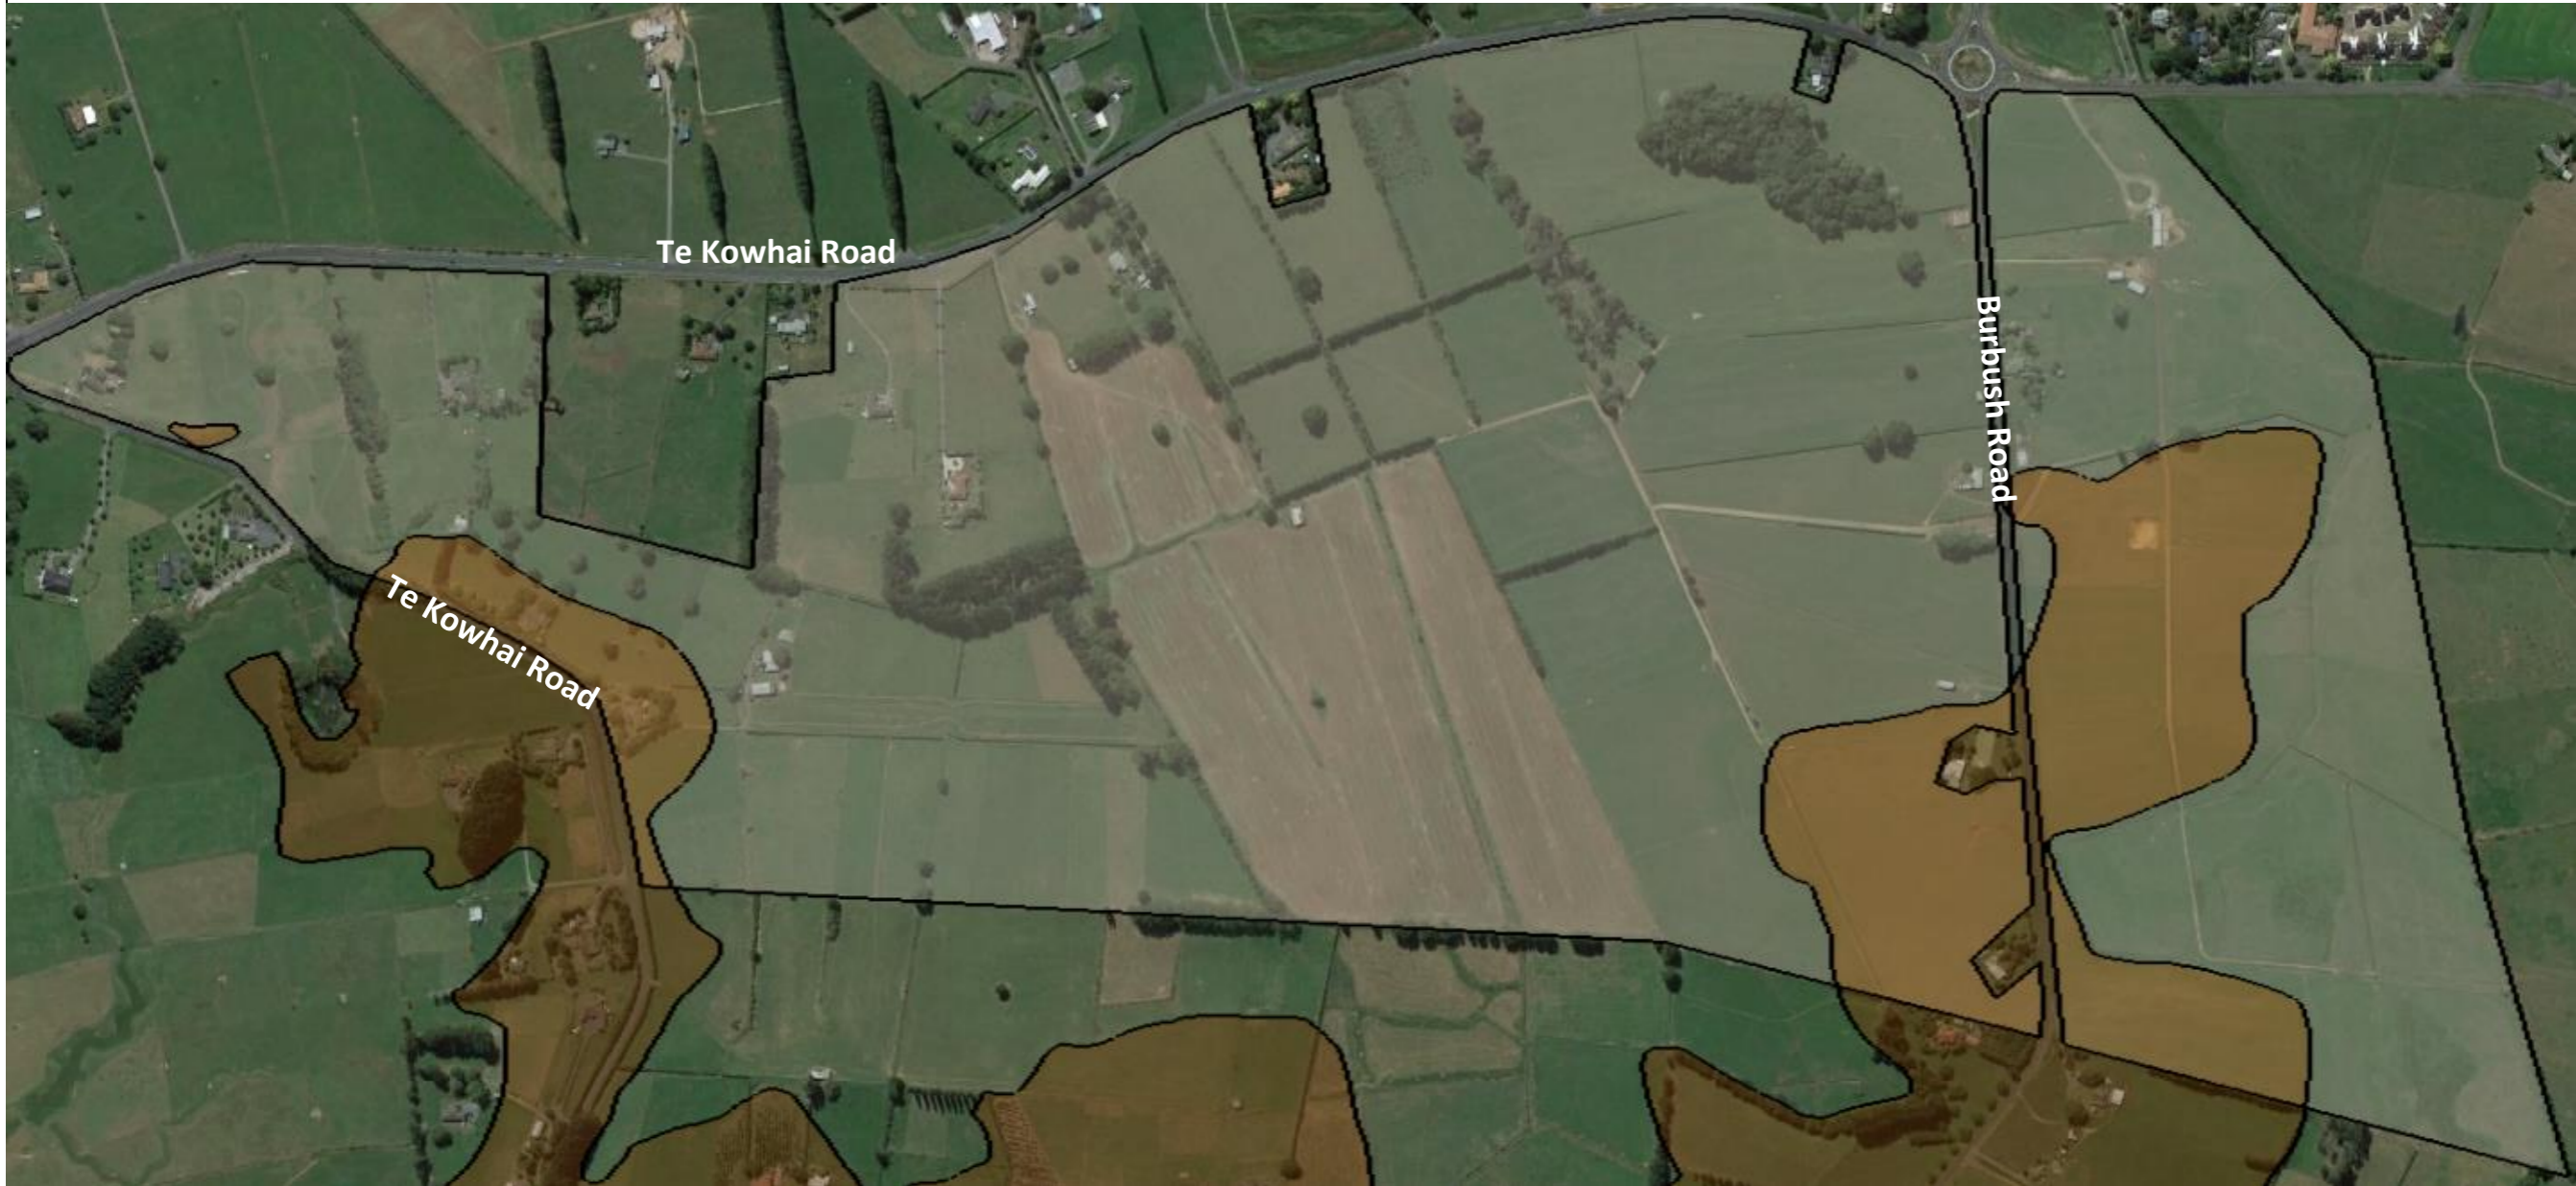
PROJECT:	Rotokauri North SHA
PROJECT NO:	HD631
CLIENT:	Green Seed Consultants Ltd
TITLE:	Geotechnical Investigation Locations
SCALE:	NTS
Drawing No:	HD631/01
Drawing by:	SA
Revision No:

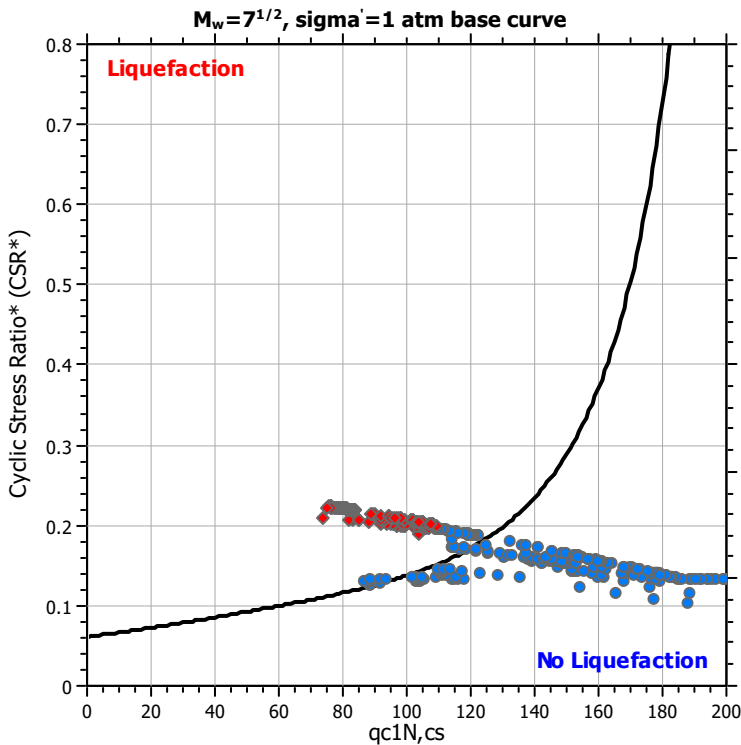
Analysis method:	B&I (2014)	G.W.T. (in-situ):	0.10 m	Use fill:	No	Clay like behavior applied:	Sand & Clay
Fines correction method:	B&I (2014)	G.W.T. (earthq.):	0.50 m	Fill height:	N/A	Limit depth applied:	Yes
Points to test:	Based on Ic value	Average results interval:	3	Fill weight:	N/A	Limit depth:	10.00 m
Earthquake magnitude M_w :	5.90	Ic cut-off value:	2.60	Trans. detect. applied:	Yes	MSF method:	Method
Peak ground acceleration:	0.22	Unit weight calculation:	Based on SBT	K_σ applied:	Yes

Zone A₁: Cyclic liquefaction likely depending on size and duration of cyclic loading
 Zone A₂: Cyclic liquefaction and strength loss likely depending on loading and ground geometry
 Zone B: Liquefaction and post-earthquake strength loss unlikely, check cyclic softening
 Zone C: Cyclic liquefaction and strength loss possible depending on soil plasticity, brittleness/sensitivity, strain to peak undrained strength and ground geometry

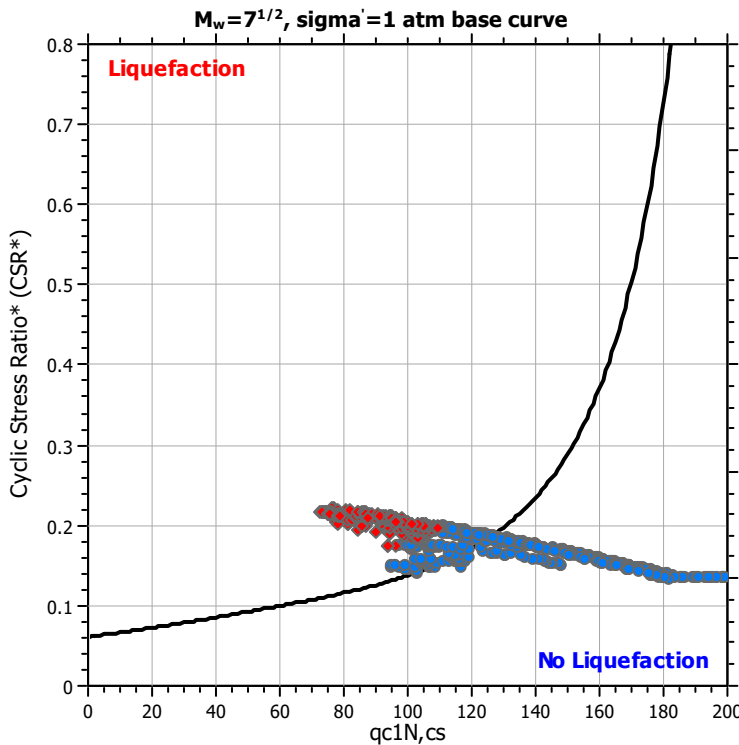
Analysis method:	B&I (2014)	G.W.T. (in-situ):	0.40 m	Use fill:	No	Clay like behavior applied:	Sand & Clay
Fines correction method:	B&I (2014)	G.W.T. (earthq.):	0.50 m	Fill height:	N/A	Limit depth applied:	Yes
Points to test:	Based on Ic value	Average results interval:	3	Fill weight:	N/A	Limit depth:	10.00 m
Earthquake magnitude M_w :	5.90	Ic cut-off value:	2.60	Trans. detect. applied:	Yes	MSF method:	Method
Peak ground acceleration:	0.22	Unit weight calculation:	Based on SBT	K_σ applied:	Yes

Zone A₁: Cyclic liquefaction likely depending on size and duration of cyclic loading
 Zone A₂: Cyclic liquefaction and strength loss likely depending on loading and ground geometry
 Zone B: Liquefaction and post-earthquake strength loss unlikely, check cyclic softening
 Zone C: Cyclic liquefaction and strength loss possible depending on soil plasticity, brittleness/sensitivity, strain to peak undrained strength and ground geometry

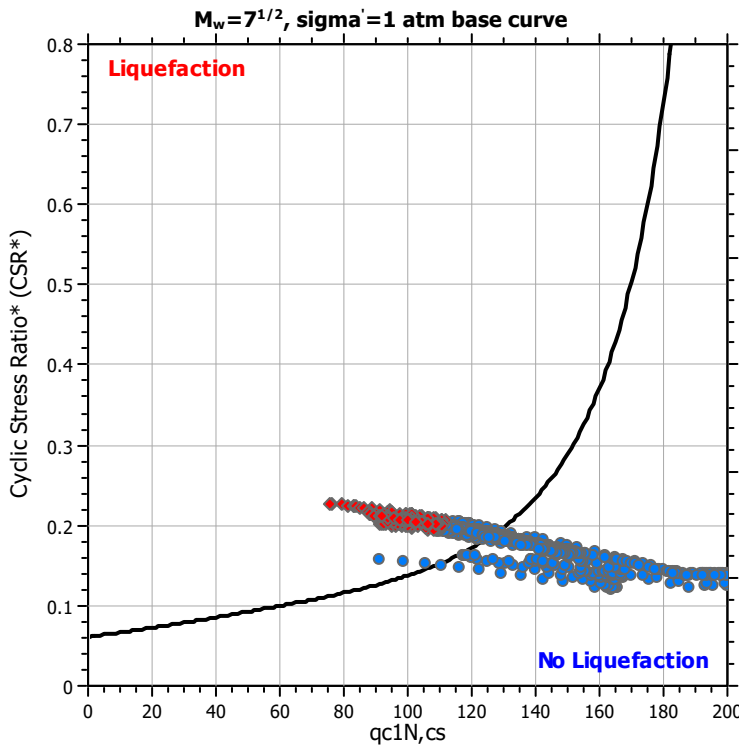
Analysis method:	B&I (2014)	G.W.T. (in-situ):	0.30 m	Use fill:	No	Clay like behavior applied:	Sand & Clay
Fines correction method:	B&I (2014)	G.W.T. (earthq.):	0.50 m	Fill height:	N/A	Limit depth applied:	Yes
Points to test:	Based on Ic value	Average results interval:	3	Fill weight:	N/A	Limit depth:	10.00 m
Earthquake magnitude M_w :	5.90	Ic cut-off value:	2.60	Trans. detect. applied:	Yes	MSF method:	Method
Peak ground acceleration:	0.22	Unit weight calculation:	Based on SBT	K_σ applied:	Yes

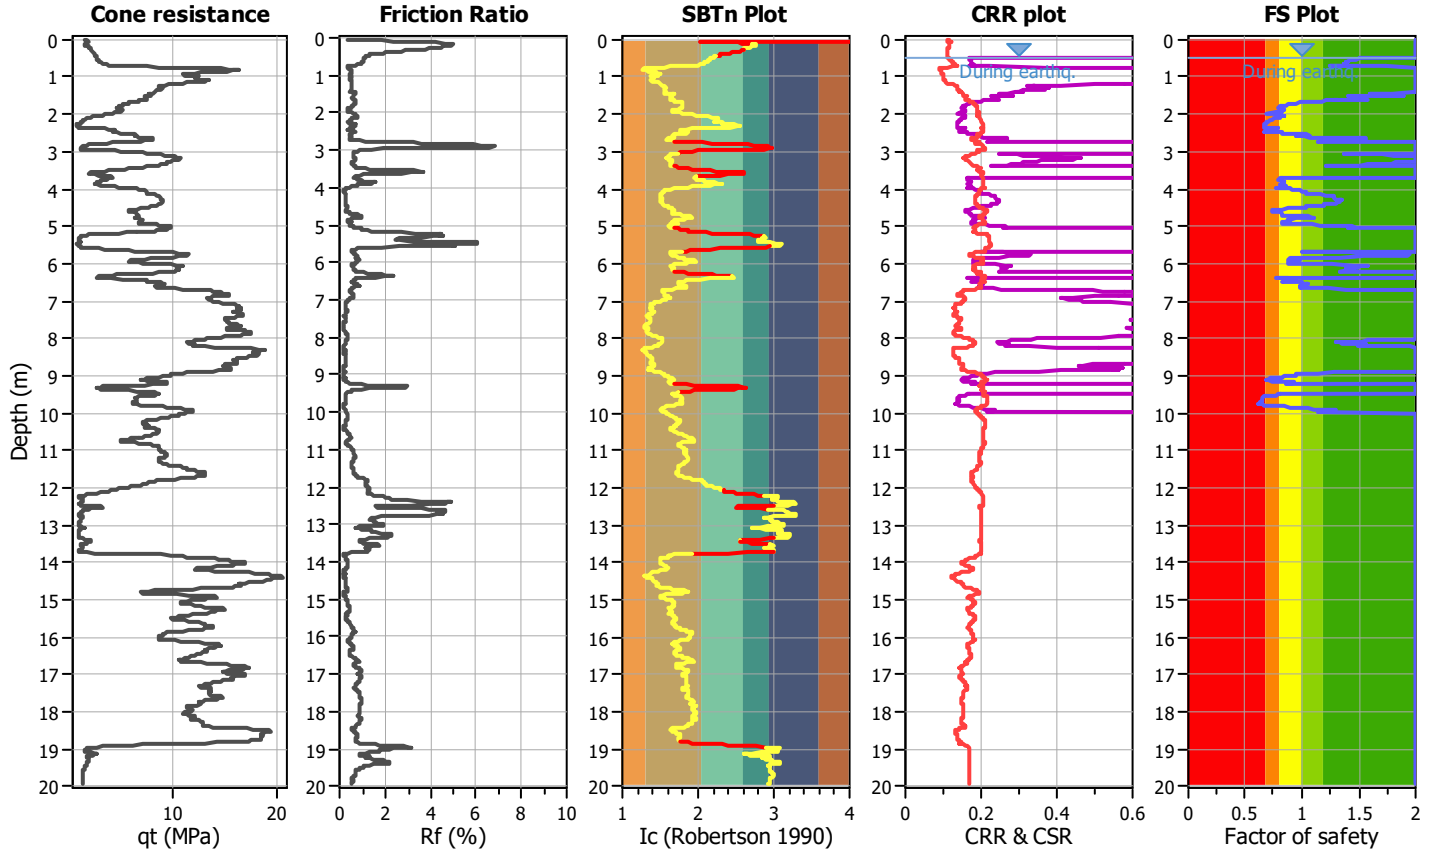
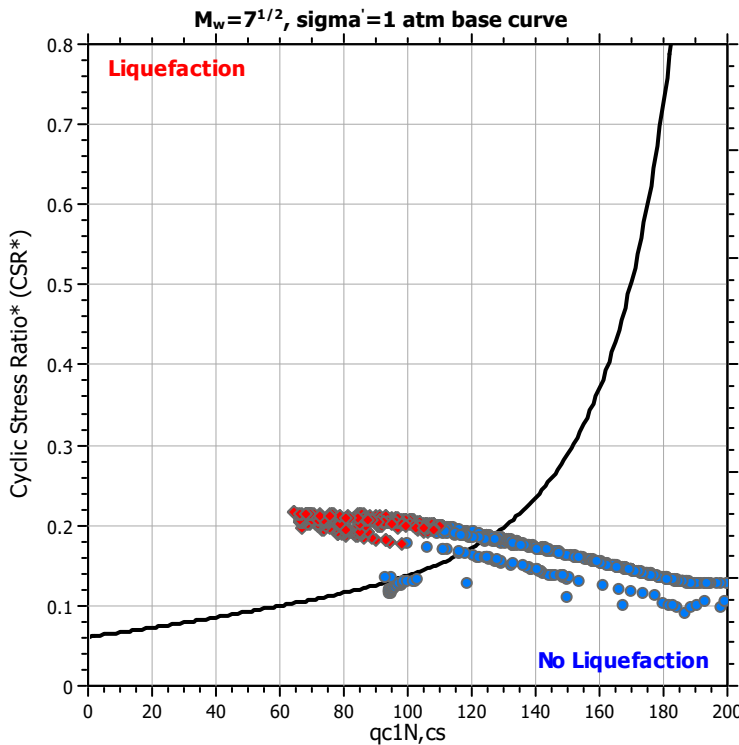
Analysis method:	B&I (2014)	G.W.T. (in-situ):	1.10 m	Use fill:	No	Clay like behavior applied:	Sand & Clay
Fines correction method:	B&I (2014)	G.W.T. (earthq.):	0.50 m	Fill height:	N/A	Limit depth applied:	Yes
Points to test:	Based on Ic value	Average results interval:	3	Fill weight:	N/A	Limit depth:	10.00 m
Earthquake magnitude M_w :	5.90	Ic cut-off value:	2.60	Trans. detect. applied:	Yes	MSF method:	Method
Peak ground acceleration:	0.22	Unit weight calculation:	Based on SBT	K_σ applied:	Yes

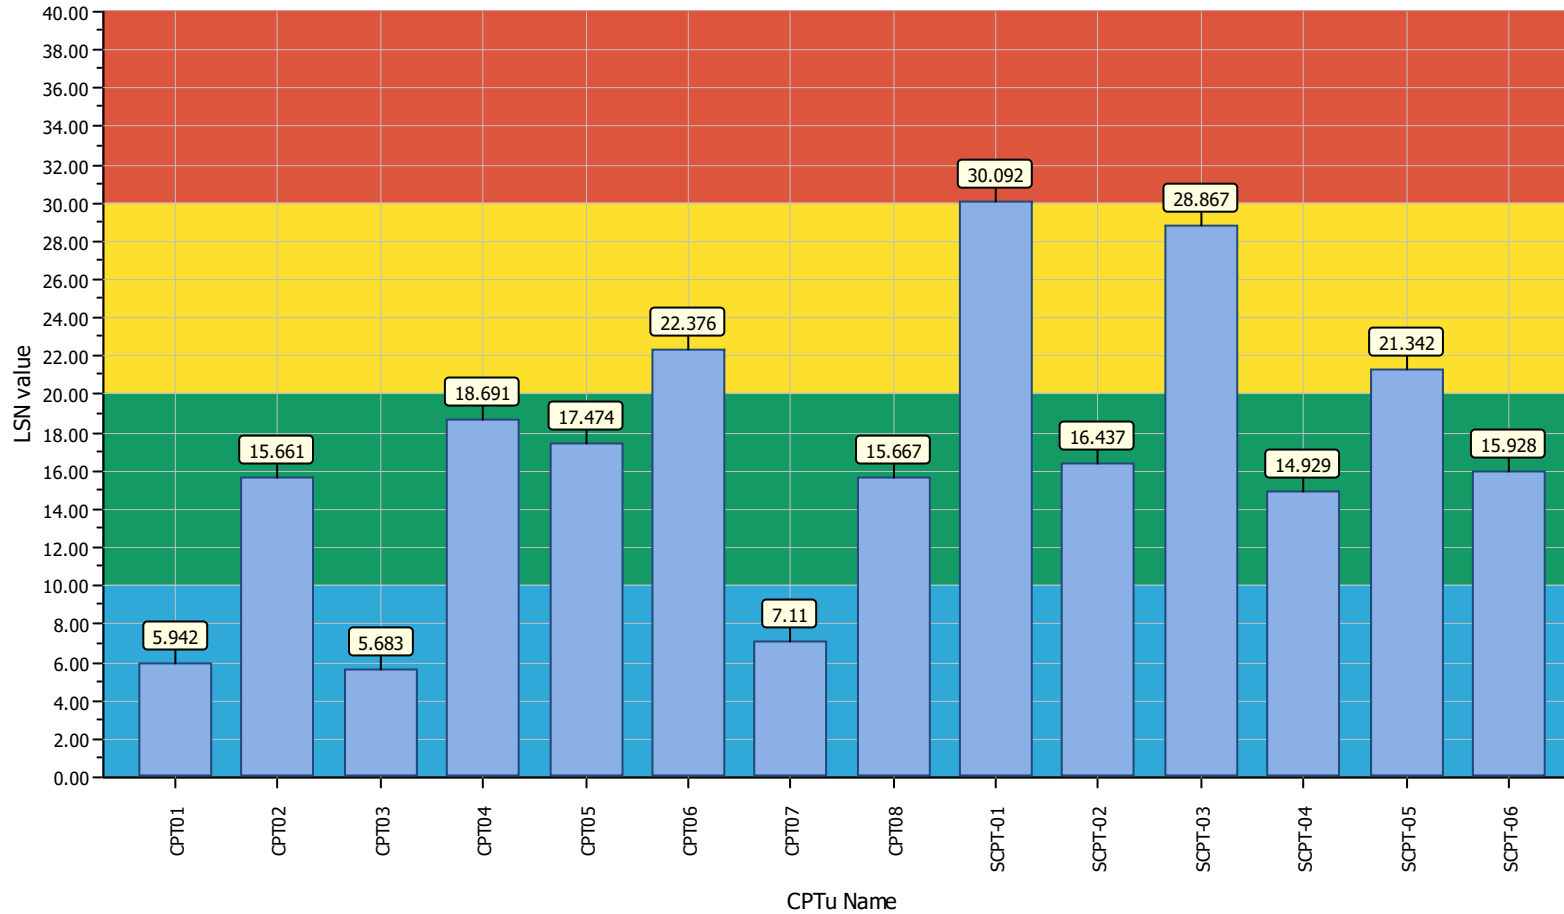
Overall Liquefaction Severity Number report

LSN color scheme

The liquefaction severity number (LSN) is an estimate of the anticipated expression of liquefaction at the surface and is useful for hazard screening purposes. LSN is grouped into ranges to provide guidance on the anticipated performance levels of a site in an earthquake. In general terms, increasing LSN represents increasing anticipated expression of liquefaction. A LSN of less than 10 presents insignificant anticipated expression and over 50, a severe anticipated expression.

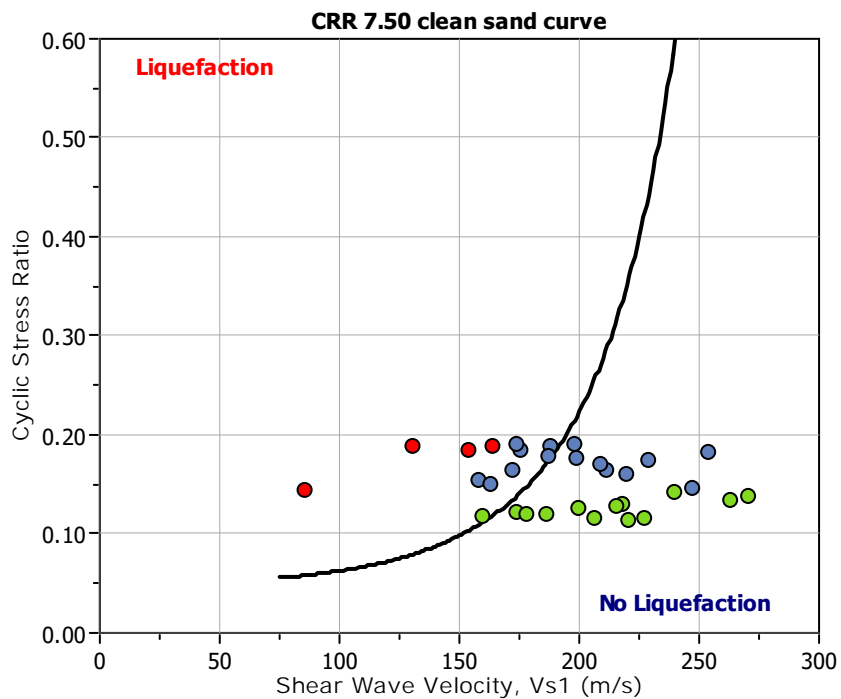
Calculation method: Kayen et. al (2013)
G.W.T. (in-situ): 0.40 m
G.W.T. (earthq.): 0.50 m
Earthquake magnitude M_w : 5.90
Peak ground acceleration: 0.22g

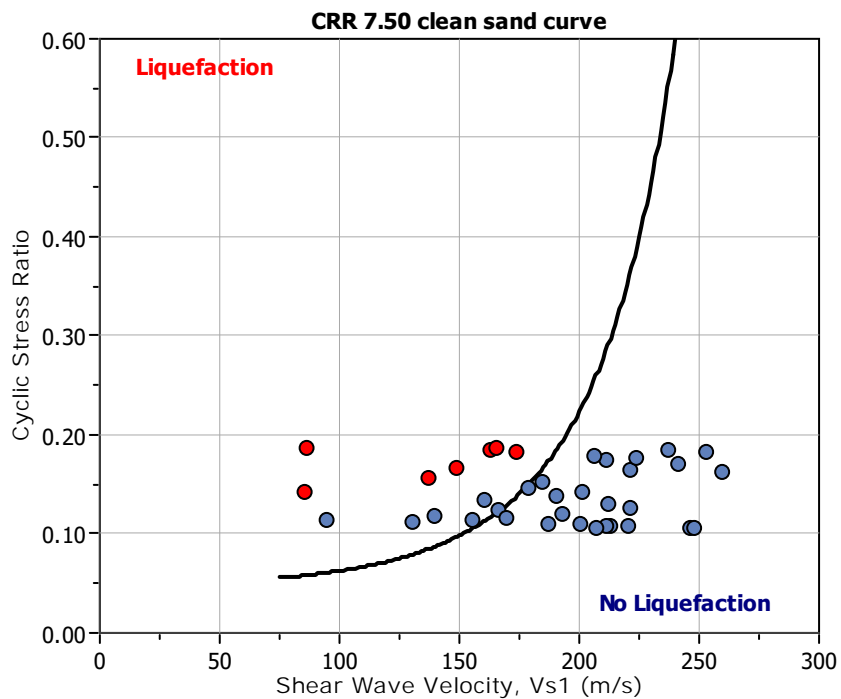
Calculation method: Kayen et. al (2013)
G.W.T. (in-situ): 0.50 m
G.W.T. (earthq.): 0.50 m
Earthquake magnitude M_w : 5.90
Peak ground acceleration: 0.22g

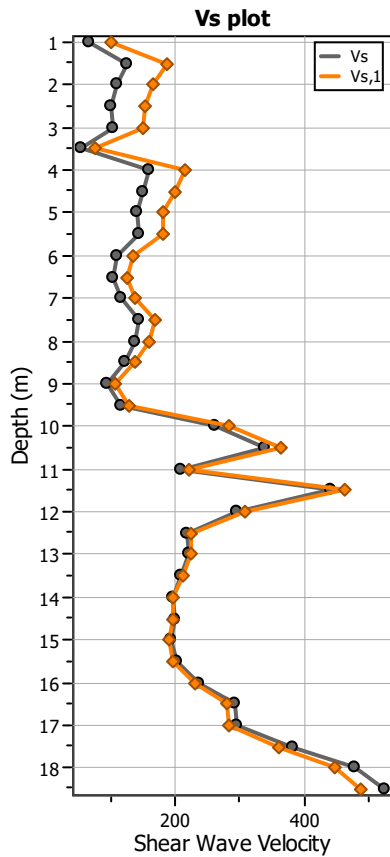
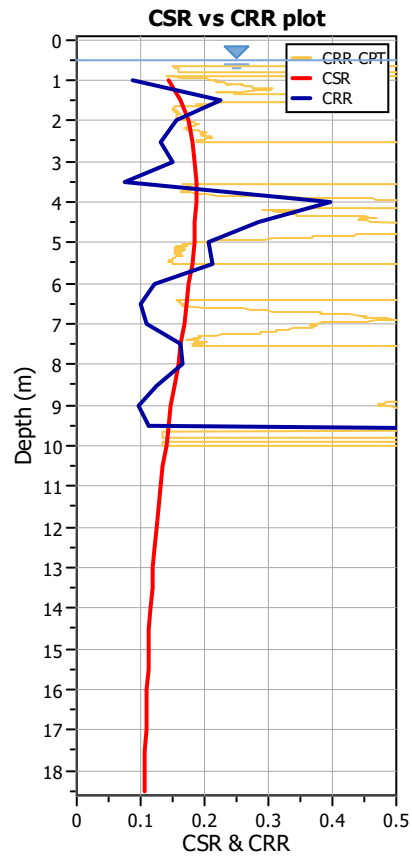
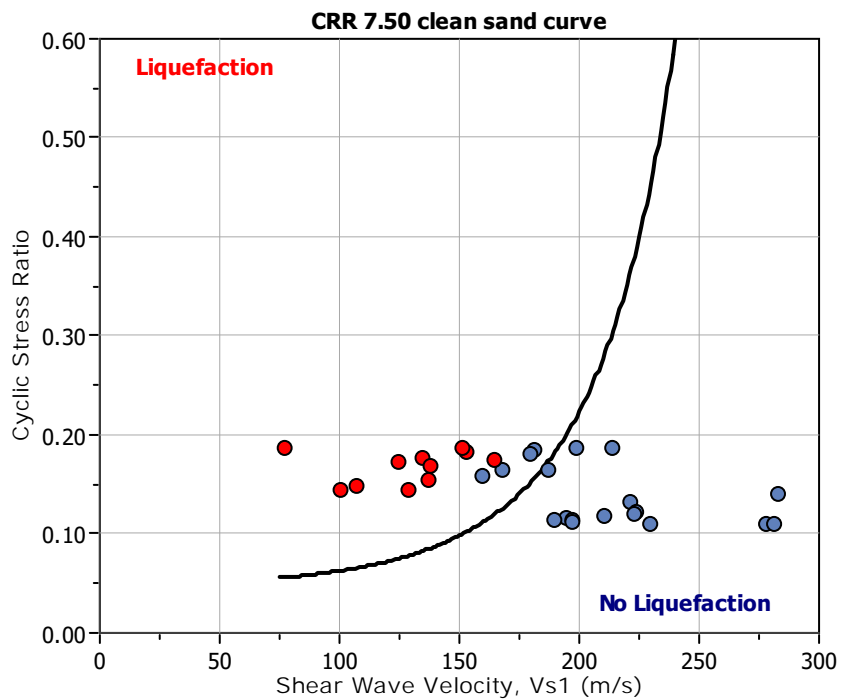
:: Input parameters and analysis properties ::

Calculation method: Kayen et. al (2013)
G.W.T. (in-situ): 0.20 m
G.W.T. (earthq.): 0.50 m
Earthquake magnitude M_w : 5.90
Peak ground acceleration: 0.22g
