## Sare Crescent HHA – Full Statement

- Surveyed in 1949, construction completed by 1953

- Located within the 5<sup>th</sup> extension, 1949

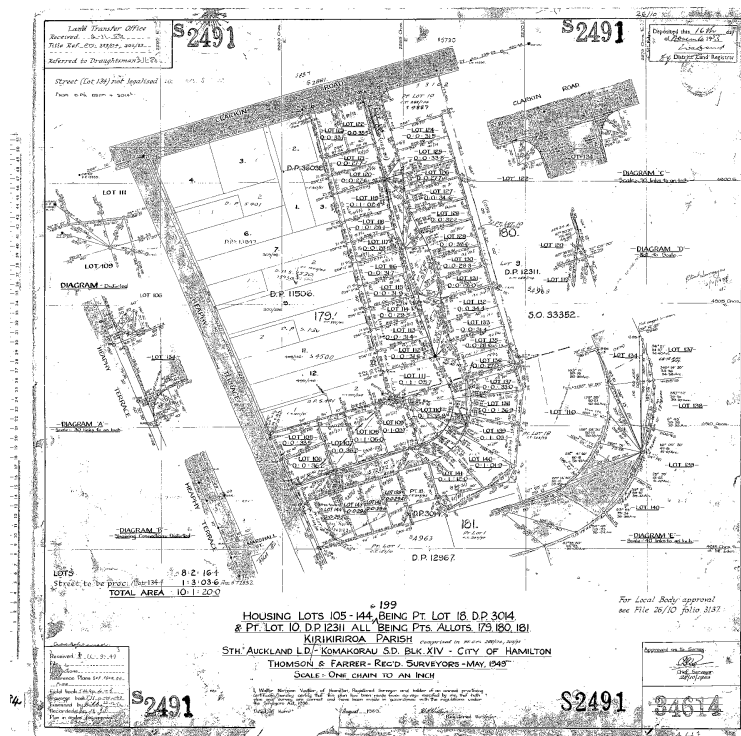
Figure 42 Subdivision of Sare Crescent in 1949 (LINZ, DPS2491)

The land of Sare Crescent was surveyed for subdivision in August 1949.<sup>1</sup> Lot sizes and shapes are more varied than other earlier State housing subdivisions, and range in size from 750m<sup>2</sup> to 1,000m<sup>2</sup> (¼ acre), positioned along a curvy street. Aerials show construction completed on both sides of street by August 1953.<sup>2</sup>

The land of Sare Crescent was surveyed for subdivision in August 1949. Lot sizes and shapes are more varied than other earlier State housing subdivisions, and range in size from 750m<sup>2</sup> to 1,000m<sup>2</sup> (¼ acre), positioned along a curvilinear street. Aerials show construction completed on both sides of street by August 1953.

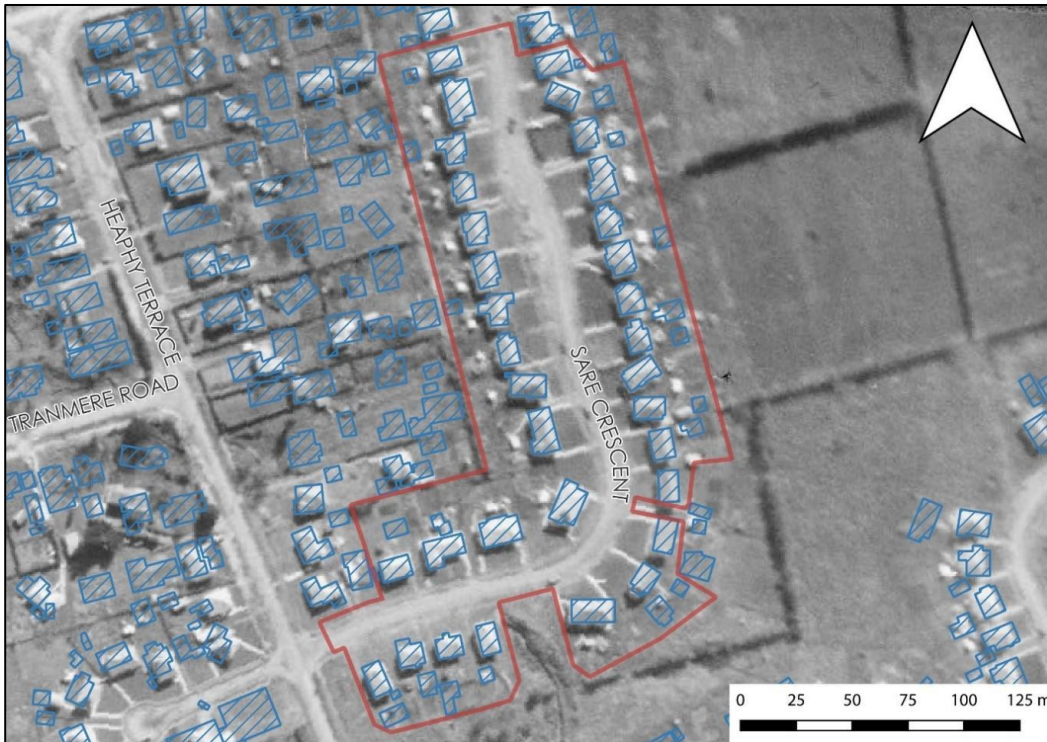
Figure 43 Aerial dated 1953 showing Sare Crescent HHA (in red) with current building outlines (in blue),
