Building/ Site Name: Former names:
Hamilton Borough Pumping Station Hamilton City Waterworks
Waikato Outdoor Education Centre
Address:
(100) Hillsborough Terrace/Cobham Drive

1902-3 Hamilton Borough Council Pumping Station & Works
1956 HCC Waterworks Building
Later additions excluded.

Architect /Designer/ Engineer/Builder:
1902-3 Engineer: Henry H. Metcalfe/Builder: Michael J Keane 1956 Architect Aubrey de Lisle or Errol Care-Cottrell (not confirmed)
Building type/s & Current use
Industrial buildings & infrastructure/ vacant
Visible materials & Heritage fabric if known
Plastered concrete; wooden t&g soffits, steel-framed windows, Internal: wooden trusses and roof lining, concrete floor Evidence of outlet pipe

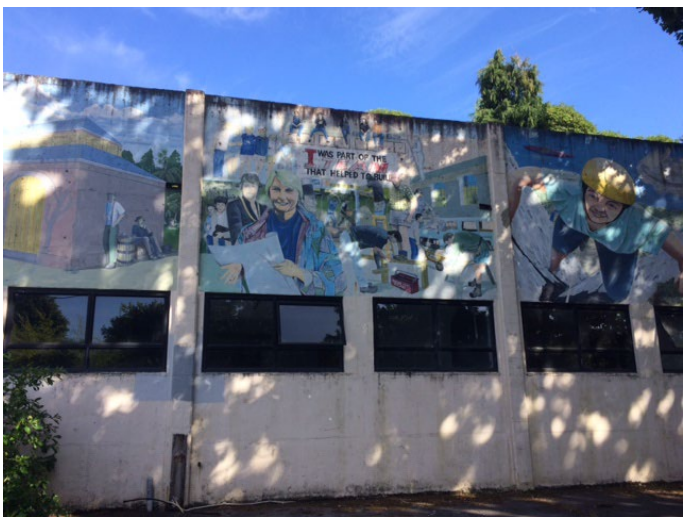
The eastern façade has been painted with a historic timeline. 2024.

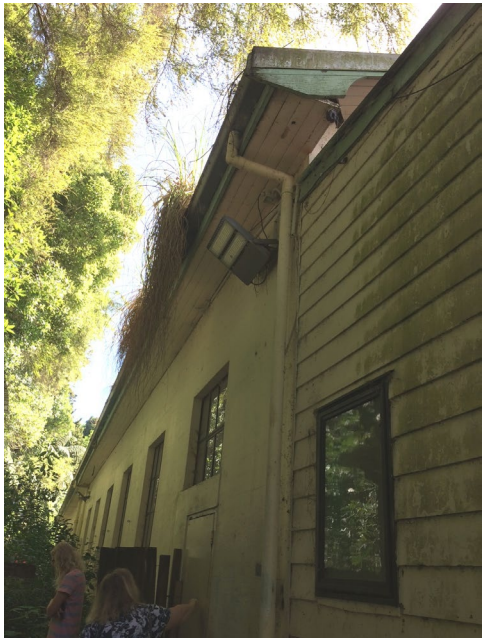
The western façade. 2024.

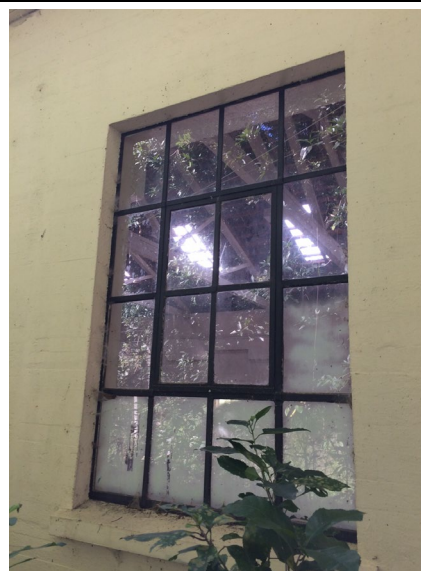
One of the steel-framed windows. 2024

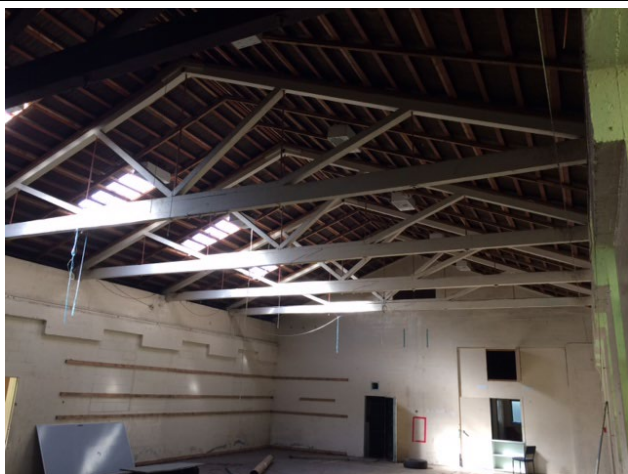
Interior view of roof trusses.

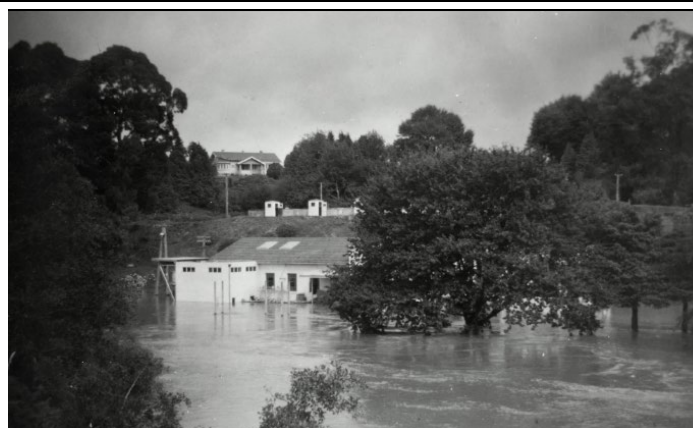
This photo taken during the 1958 flood shows two buildings – at right is a Modernist building (this has 'Hamilton City Waterworks 1956' on its parapet) while the one at left shows early 20th century steel joinery with sills. The settling tanks are on the upper terrace. HCL_09312

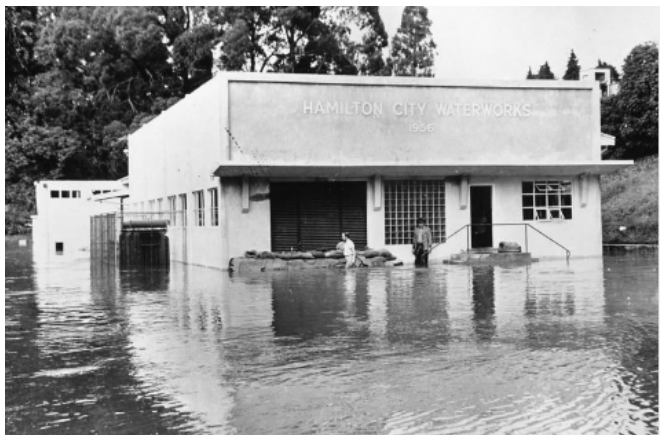
The 1956 building (above) with "Hamilton City Waterworks 1956" on its parapet, in the 1958 flood. Old 1902 pumphouse is behind. HCL_09310

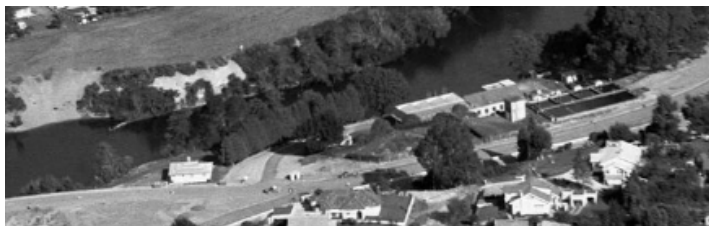
An aerial photo taken c.1963 when Cobham Drive was under construction shows the buildings from the west. HCL_07657 (cropped).

The smaller buildings at the site today include a concrete building (noted as 'garage' in the 1990s) which is located in the northern corner near the security gates. There is also a very old tree located to the immediate north of the garage that could be over approximately 130 years old and can be seen in the c.1963 aerial.
