Heating System

DESCRIPTION OF HEATING SYSTEM

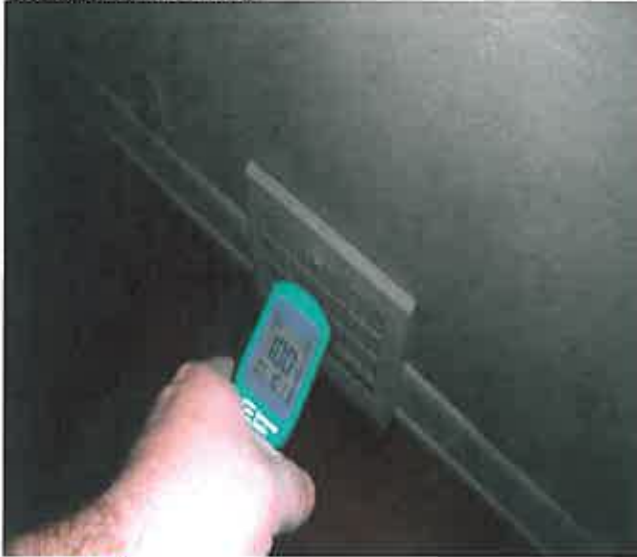
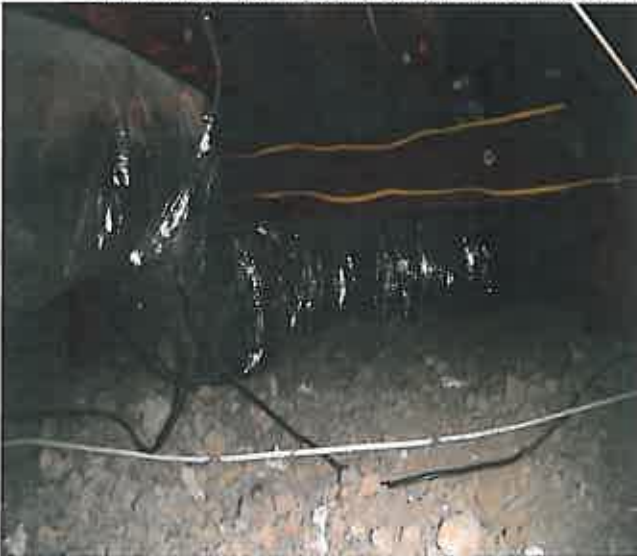
Supply Air Ductwork

Where visible the supply-air ductwork for the heating system appeared to be in generally good condition. The following observations were noted.

- ☒ **Improve:** Several supply air ducts in the crawl space were observed to be laying in the dirt. This can cause rapid deterioration from moisture contact. The duct should be raised and strapped to maintain clearance from the dirt.

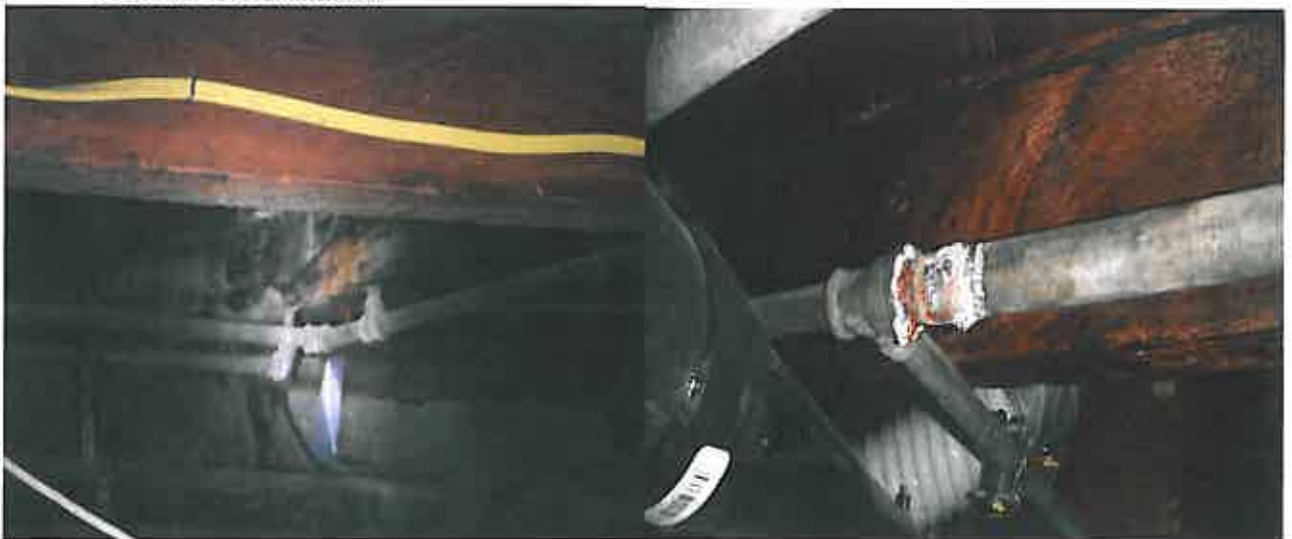
- ☒ **Improve:** Significant corrosion on the exterior of the supply piping with leakage was observed in the crawl space. The level of damage indicates the need for immediate repairs. Evaluation and repair by a qualified plumbing contractor is recommended.

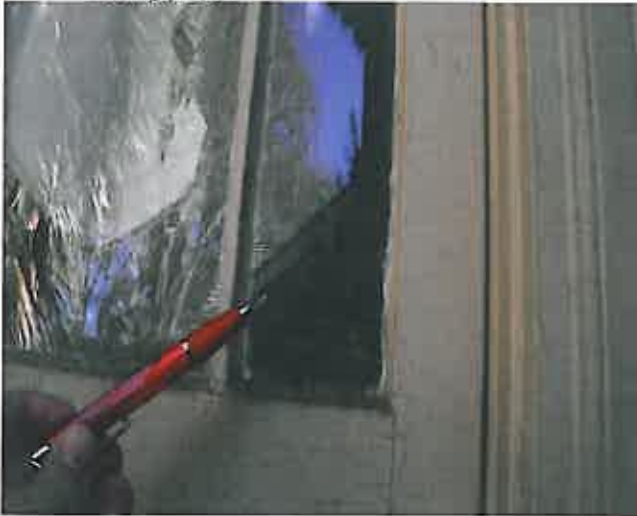
- ☒ **Safety Issue:** The window glass at the window was found to be cracked. Damaged glass is considered a safety issue and requires immediate attention. Consulting with a qualified glazier (window repairman) for repairs is strongly recommended.

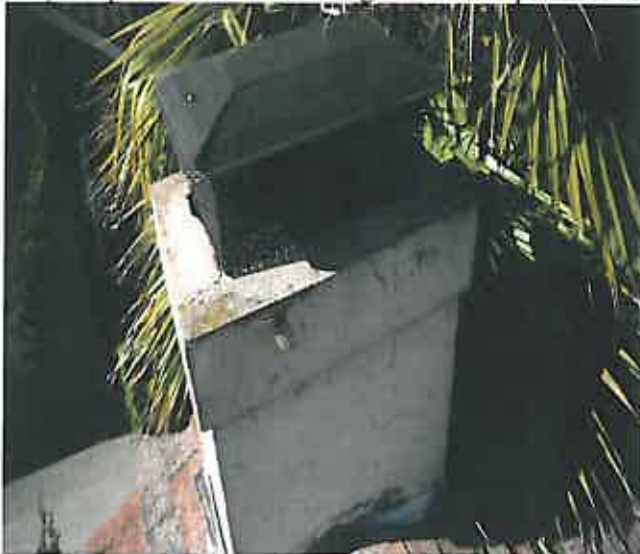
Masonry Chimney

The masonry chimney was examined at the base, above the shoulder and a pressure test (Pushing on the chimney from the roof) was performed. The following observations pertain to the chimney.

- ☒ **Improve:** The mortar cap at the top of the masonry chimney has several minor cracks. While this damage is considered to be minor, and commonly found, the cracks should be sealed to prevent moisture intrusion into the brick and mortar. Repairs by a masonry contractor or other qualified trades person is recommended.

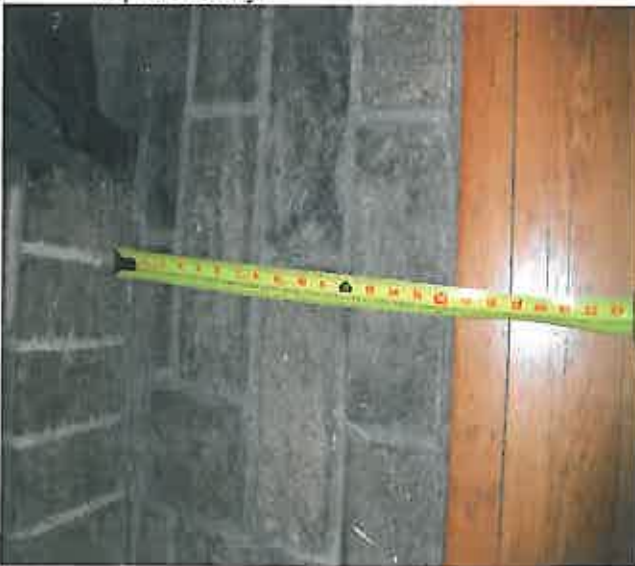
- ☒ **Improve:** The hearth outside the fireplace is not large enough to reduce the risk of fire, should hot embers manage to escape from the fireplace. At least 17 inches is recommended. This situation should be altered for improved safety.

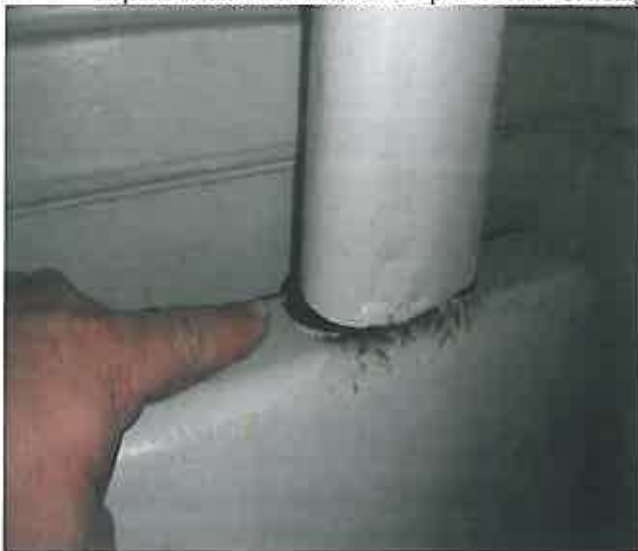
Exhaust Fan

- ☒ **Monitor:** With a gas appliance installed within the kitchen it is recommended that a hood or exhaust fan be considered, not only to ventilate kitchen odors to the exterior of the home but to also eliminate the build up of dangerous exhaust gases. Up grades are recommended.
- ☒ **Safety Issue:** The slope of the exhaust vent pipe for the gas oven does not appear to be sufficient to allow for the safe flow of exhaust gases to the exterior. *A poorly sloped vent pipe can leak exhaust gasses and is considered a safety issue. This condition requires immediate action.* Repairs are strongly recommended.
- ☒ **Safety Issue:** The gas exhaust flue is disconnected and leaks dangerous exhaust fumes. This is a safety issue. Repairs to correct this condition per the local building authorities guidelines are strongly recommended.
