# **Detection of asphalt roads degradation** using Deep Learning applied to Unmanned Aerial Vehicle imagery

Adama Coulibaly <sup>1,2</sup> Ibrahima Ngom<sup>2</sup> Jean-Marie Dembélé<sup>1</sup> Ibrahima Diagne<sup>2</sup>

<sup>1</sup>University Gaston Berger, Saint Louis/Senegal <sup>2</sup>Ecole Supérieure Polytechnique, Dakar/Senegal

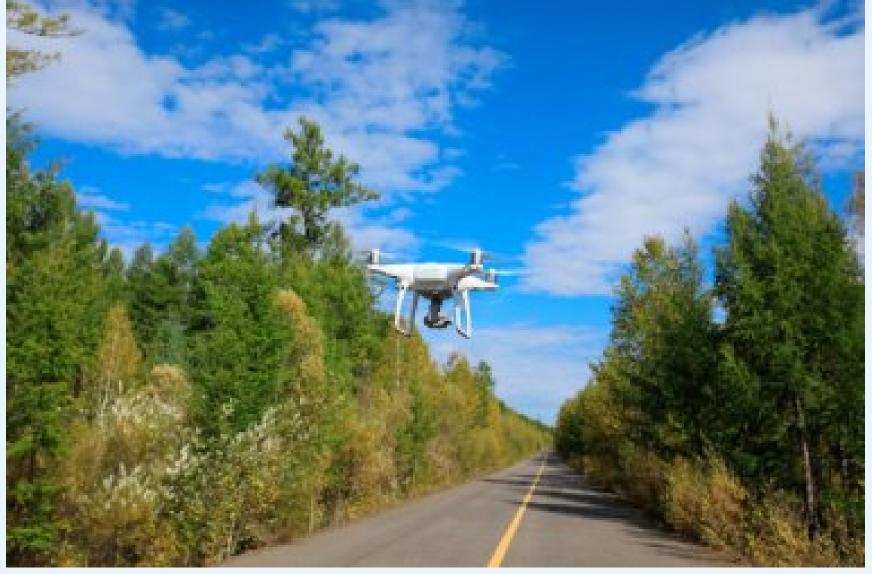
#### Figure 3. UAV collecting data

• **DJI Phantom 4 RTK UAV:** data collection;
