**ULTRASONIC-ASSISTED RETRIEVAL OF A SEPARATED ENDODONTIC FILE: A  
CASE REPORT****<sup>1</sup>Dr. Kailash Attur, <sup>2</sup>\*Dr. Palak Chhaya, <sup>3</sup>Dr. Nikunj Patel and <sup>4</sup>Dr. Manali Parmar**<sup>1</sup>Professor and HOD, Department of Conservative Dentistry and Endodontics, Narsinhbhai Dental College and Hospital, Visnagar.<sup>2,4</sup>Post Graduate Student, MDS, Department of Conservative Dentistry and Endodontics, Narsinhbhai Dental College and Hospital, Visnagar.<sup>3</sup>Professor, MDS, Department of Conservative Dentistry and Endodontics, Narsinhbhai Dental College and Hospital, Visnagar.

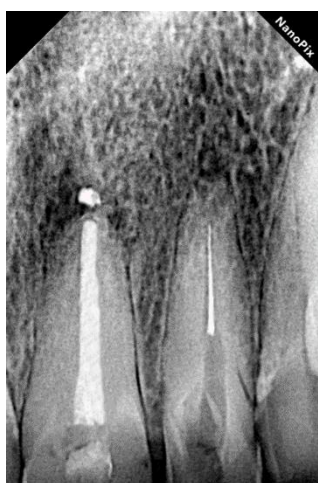
Figure 1: Pre operative radiograph

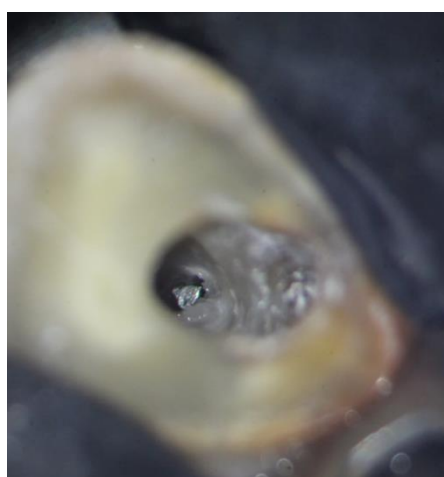
Figure 2: Image of separated instrument viewed under magnification

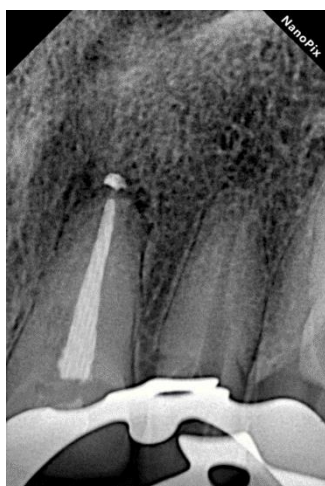
Figure 3: Post retrieval radiograph

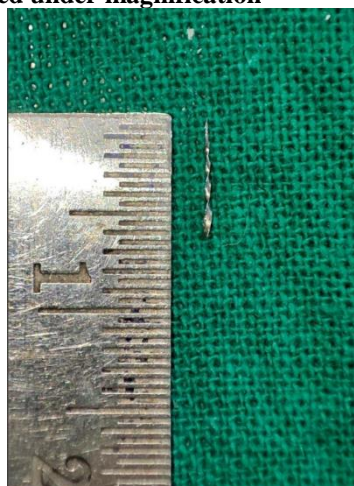
Figure 4: length of separated instrument

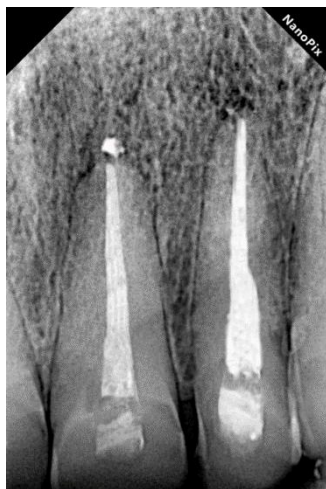
**Figure 5: Post operative radiograph**
