of a type of advance-warning triangle pursuant to Regulation number 27.

Approval number: E4-27R-032736

TECHNICAL REPORT

Uniform provisions for the approval of advance-warning triangles

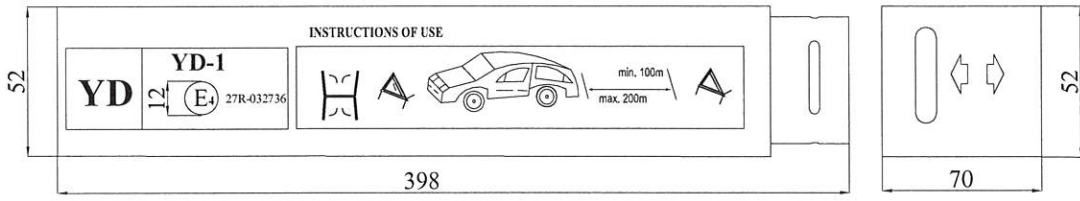
Construction	Material	Remarks
Lens	PMMA POLYESTER	-
Housing	ABS POLYESTER	-
Reflector	PMMA POLYESTER	-
Fluorescent	PVC POLYESTER	-
Protective cover	PP POLYESTER	INSTRUCTIONS OF USE INSCRIBED ON THE COVER
