# Health Monitoring of Structures Using Modern Tools

P. B. R. Dissanayake

**Abstract:** The health monitoring of old structures is an essential part in Civil Engineering. In Sri Lanka, there are a variety of old structures such as stupas, ancient monuments, buildings, bridges, and dams. Some of these structures (e.g. Stupas) are more than 2000 years old and are national treasures. Other old structures such as buildings, bridges, etc are nearly 100 years old and most of them dates back to British colonial period. Interestingly, these are still used in social life. Hence, appraisal of these structures considering future existence and use is important at the national level. But this is often difficult owing to the lack of defined methods. This paper describes how health monitoring can be done using analytical and experimental considerations. In this context, three cases studies; namely, an old building, an old reservoir and an old bridge, in relation to load carrying capacity and displacements are used as illustrative examples.

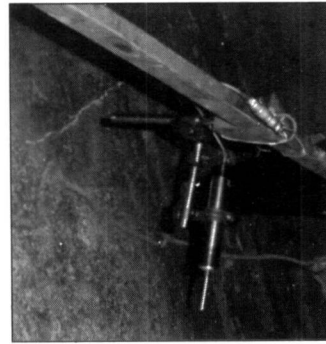
The CDP-50 displacement transducer, shown in Figure 1, is a compact displacement transducer that is very easy to operate. Its large output and excellent consistency ensure high-precision

Figure 1: CDP 50 Displacement Transducer

measurements, while it can be used for both static and dynamic measurements.

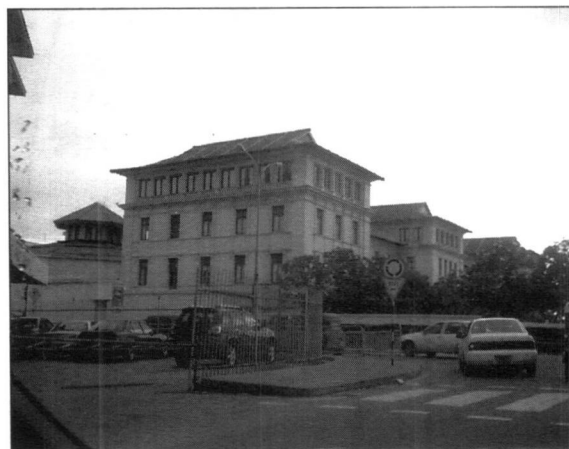
The selected structure for the health monitoring is a part of the Galle Face Hotel in Colombo. It is a steel framed structure having four storeys, constructed in the 1880's [4]. Figure 4 shows an outside view of the building.

As the building is on the seafront, heavy corrosion has taken place in structural components such as columns and beams. Recently, the building was rehabilitated with some structural repair and modifications such as welding plates at places where there is loss of material due to corrosion [5]. The objective of the study was to find out whether the original building could safely be used with these modifications.

Figure 4: An outside view of the building

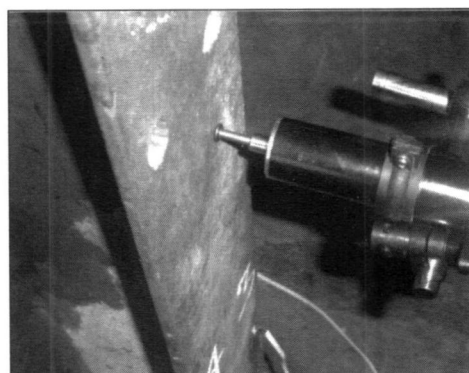
Towards this objective, load testing of the building was carried out. Displacement transducers were fixed to flange plates of the several columns as shown in Figure 5, and strain gauges were also attached to the repaired sections as indicated in Figure 6. Displacements and strains were measured with imposed loads on floors, and were interpreted through the Data Logger TDS-303.

Figure 5: Displacement transducers in measuring displacement

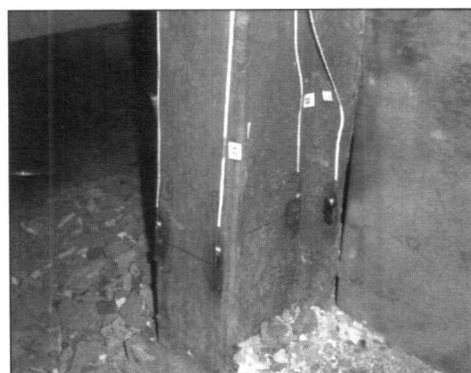
Figure 6: Strain Gauges attached to the columns of the wall

From the observed strains at some selected locations and computed stresses, it was seen that in some repaired sections of the columns, stresses are not evenly distributed. This may be due to the uneven connections and stiffness variations of the connections, giving rise to unsymmetrical bending of the connected plates

of the repaired sections. This will give rise to bending in other parts of the column as well. Except at one location at the repaired section of a tested column, stresses found under the applied loading were low.

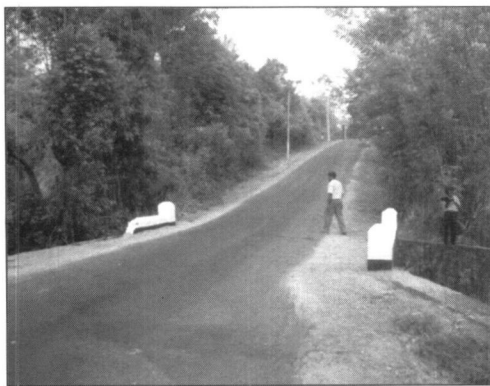
The bridge (43/2) situated Naula-Elhera-Kalugaga (B312) road was evaluated for its current conditions. It is a reinforced concrete deck bridge with random rubble masonry abutments and it was constructed in 1979. Views of the bridge are as shown in Figures 7 & 8.

Figure 7: A View of the case study bridge (bridge Number 43/2) in B312 route

Underneath the bridge deck, reinforcement has been exposed and corroded heavily. There is a need to estimate the current condition of the bridge over the normal traffic flow of this bridge.

This bridge was evaluated to check for its current serviceability conditions. Strain gauges were attached and response of the bridge was measured due to actual vehicle passage. In addition, with the experimental findings, theoretically with the use of structural reliability

theory, current condition of the bridge was estimated. Table 1 shows the results of the reliability calculations [8]. From these analyses, it was found that currently the condition of the bridge is satisfactory even though corrosion has been on reinforcements.

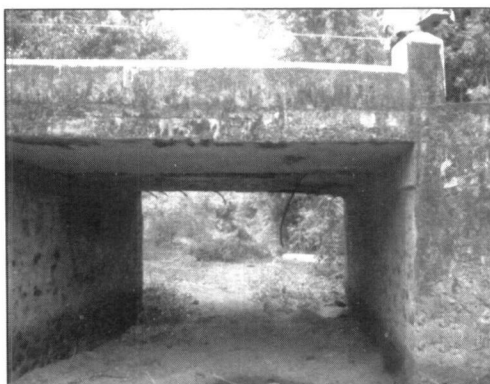
Figure 8: A side view of the case study bridge
