# Lightning Protection of Stupas in Sri Lanka

Joseph Rohan Lucas

**Abstract:** Lightning is a weather-related phenomenon with dire consequences for tall structures. The lightning protection adopted in Sri Lanka in stupas in ancient times, from the third century was adequate, as no lightning damage to stupas have been recorded in early times. However, the present restoration of lightning protection may be inadequate as recent strikes have been detected due to improper new practices due to an absence of detailed recording of the lightning protection in ancient times. This paper discusses the lightning protection of stupas, especially of Ruwanwelisaya from ancient times to the present, tracing the history of lightning protection from the Mahawansa and the Culawamsa. While the bulk of the lightning energy probably went through the stupa in ancient times, the modern protection tends to bring the energy to earth through the surface of the stupa and the compound at the bottom which can cause disastrous effects. Monitoring is recommended to be undertaken to see whether the dissipation of bulk of the lightning energy is through the stupa itself, even in the present day, or along the surfa

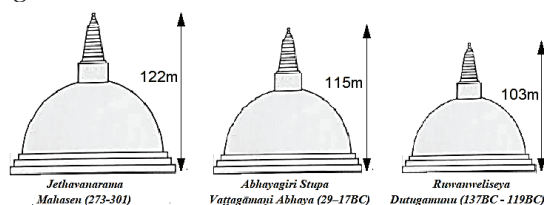
Figure 2 - Heights of Ancient Stupas in Sri Lanka

The next largest of ancient structures in the world are the stupas in Sri Lanka [2] shown in figure 2.

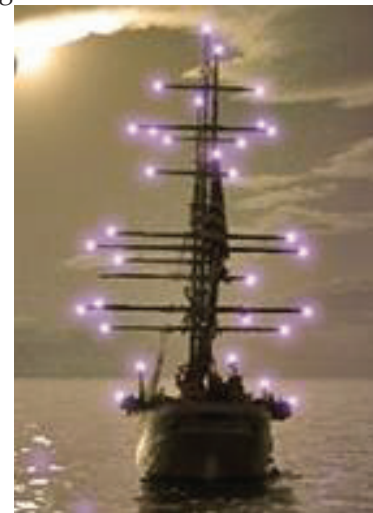
Figure 3 - St. Elmo's Fire

Figure 3 shows a sailing ship, which were the tallest objects in the ocean. These ships are known to have showed a glow at the sharp points in the masts during thunderstorms

known as St. Elmo's fire [3]. St. Elmo's fire is a form of corona, giving a bright bluish violet visible glow.

This corona occurs during thunderstorms from tall, sharp pointed objects such as lightning rods, masts on ships, and spires. It is thus reasonable to assume that protection from lightning would have been foremost in the minds of early kings who built tall structures to the Gods and those sailors caught at sea during thunderstorms.

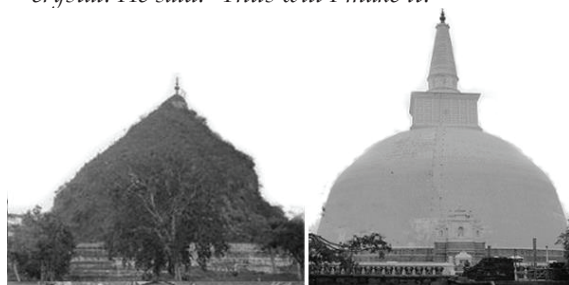
**Figure 4 - Ruwanwelisaya: In 1809 and now**

Figure 4 shows a picture of the Ruwanwelisaya taken around 1809 in a somewhat dilapidated condition and a more recent picture of it after renovation, with both pictures showing the vajra chumbaka (or lightning protection) installed at the pinnacle.

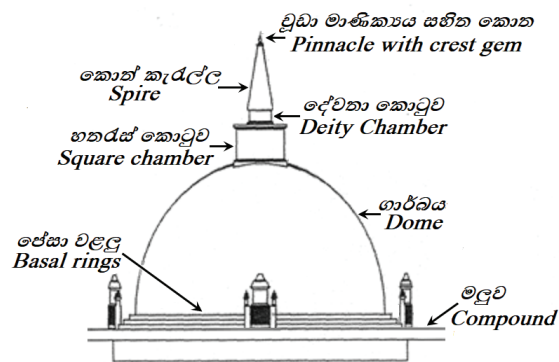
Figure 5 - Details of Ruwanweliseya

Figure 5 shows the various parts of the stupa, from the ChudaManikkya (the large gemstone placed at the pinnacle of a stupa), to the KothKeralla, the Devathakotuwa, the hatareskotuwa, the Gharbaya, the PesaValalu to the Maluwa and the base below it [12]. The corresponding Sinhala terms are also included on the figure, as those terms describe the stupa more accurately. According to the Mahawansa (Culawamsa) [13], King Sangathissa I (243 - 247 AD) has installed a Lightning Protection system "Vajra Chumbaka" to the Ruwanweliseya. The Culawamsa Chapter 36:64-65 records it as follows "Thus crowned did Sangha Tissa reign four years in stately Anuradhapura. He set up a parasol on the Great Thūpa and gilded it, and moreover the king put four great gems, each worth a hundred thousand (pieces of money), in the middle of the four suns, and put upon the spire of the thupa a precious ring of crystal (Vajra Chumbaka)". Then King Datusena (461- 478 AD) had installed the Vajra Chumbaka again to Ruwanweliseya, Jetavanaramaya and Abhyagiriya as stated in Culawamsa Chapter 38 Clauses 73-74 "Having undertaken renovations in the viharas here and there, he had some fine stucco work executed for the wall of the (Relic) house. (In the same way) he had valuable stucco work made for the three big cetiyas and put up a golden umbrella as well as a ring for protection against lightning.". It is also stated that King Mahanaga (561 - 564 AD) had also rectified the lightning protection systems of the 3 main stupas. Culawamsa Chapter 41 Clause 95 states this as follows "He decorated the three great cetiyas with stucco work and (put up) a protecting ring (against lightning). He also repaired the elephant terrace and the paintings."

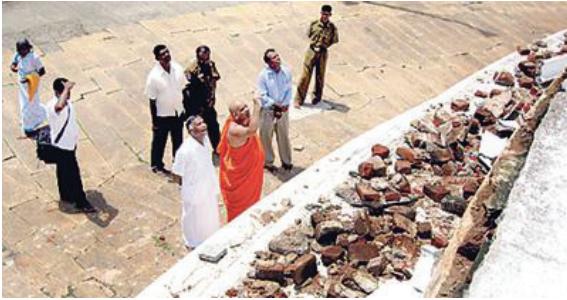
**Figure 6 - Damage to Mihintale Stupa by Lightning [18]**

In this instance, the stupa's crest gem, terrace and the pinnacle have been severely damaged. It has been stated that the lightning protection system has been in a faulty condition during the damage. The copper tape of lightning down conductor had been cut and removed by thieves in the stretch from the basal rings to the grounding point. Thus, lightning which struck the pinnacle, not only damaged the unprotected components at the top, but brought the lightning discharge down to the basal rings where it got dissipated due to the lack of a path to proceed. This tells us a lesson that, in interfering with existing systems, due care must be taken to understand concepts and ensure that stresses are not transferred elsewhere.

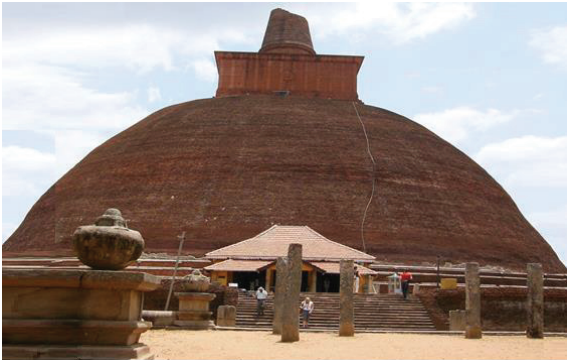
**Figure 7 - Jetavanaramaya Stupa Showing Cable**

Figure 7 shows the Jetavanaramaya stupa, constructed between 273 and 301 AD, which was originally 122 m in height. With ravages of time, it now stands at 71 m with part of the pinnacle missing. In August 2011, lightning struck the remaining top of the Kothkerrella, and grounded through the electrical cable installed to illuminate the Stupa damaging the electrical panel at the base. Why did this happen? Probably because those who installed the wiring, and the lighting did not consider the possibilities of induced effects from a direct lightning strike. This too tells us to be careful in additions that may affect the lightning protection of the stupa.

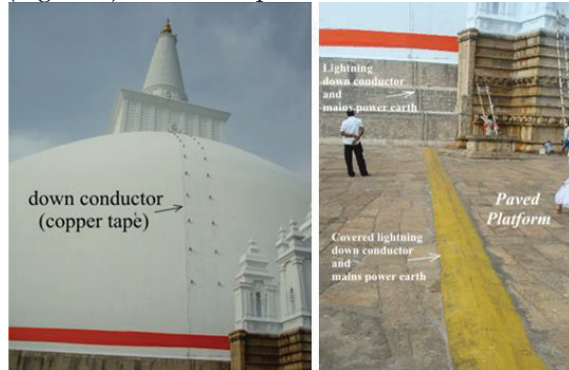
**Figure 8 - Path of Lightning along Down-Conductor and Paved Platform**

Around 1956, during a restoration of the Maha Stupa, a lightning conductor had been installed at the very top and a single copper down conductor had been taken along the surface of spire, deity chamber, square chamber, the dome, the basal rings and the paved platform (Figure 8) and the elephant wall.

When a high current flows into the earth due to lightning, a rise in the ground potential in the immediate neighbourhood occurs. The lightning down conductor of the Ruwanwelimahastupa is taken across the stone paved platform (Figure 8), where large numbers of persons congregate to pay homage to the Ruwanweliseya. Having large lightning currents flowing along this single path could cause excessive potentials to be developed across the stretched feet of persons standing in the vicinity (step potential) [22]. Rajapaksha et al.[23] have also presented possible lightning hazards to humans near giant ancient stupa. Fortunately, due to the low earth electrode resistance, the buildup of voltage at the compound is low and no incidents of injury due to step-potentials have been reported.

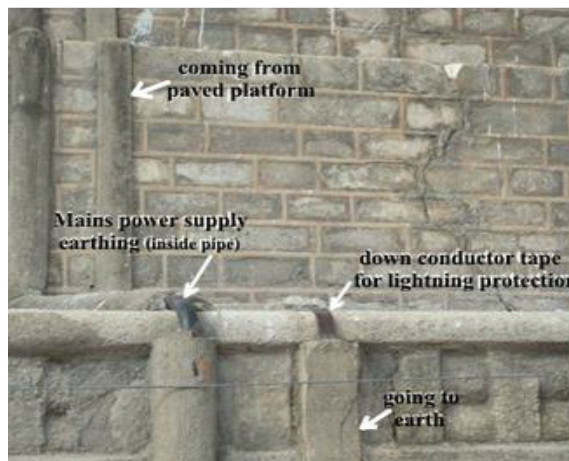
**Figure 9 - Earthing Points Coming out of the Elephant Wall**

Outside the elephant wall, the point where the down-conductor comes out was visible and accessible (Figure 9). However, it appears to go well into the ground soon afterwards and the position of the earthing could not be located even through a reasonable amount of digging.

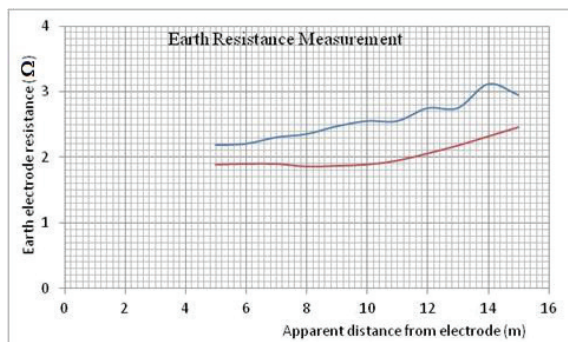
**Figure 10 – Resistance Measurements on the Lightning Earth Electrode**

The maximum position of the potential electrode was limited by the length of the wire provided with the instrument. In order to ascertain the validity of the measurements, additional readings were taken along the path of measurement at 1 m intervals. A plot of this is given in Figure 10.

According to normal theory, the measured value of earth electrode resistance would be zero towards the electrode being measured, rising to a flat value in the mid region, corresponding to the actual earth electrode resistance of the measured electrode, and finally rising up again to a relatively high value near the driven current electrode (in this case at 23 m). It must be realised that the distances shown in Figure 10 are not exact distances from the electrode as the exact position of the electrode could not be accurately determined. However, the flat region at a distance of 10 m to 12 m seems to indicate that the value at this distance would be the actual reading of the earth electrode resistance and seems to have a value of around 2 to 2.5  $\Omega$ , and the exact location of the earth electrode is not of much concern to the measurement.

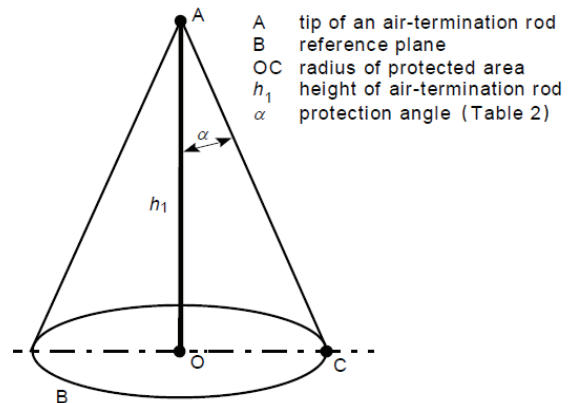
Figure 11 - Volume Protected by Air Termination Rod [24]

IEC standard 62305 on Protection against lightning - Part 3: Physical damage to structures and life hazard[24] deals with the protection of structures such as stupas. For structures which are not very high, less than about 60 m, a simple conical method of determining the required external lightning protection is generally considered adequate [Figure 11].

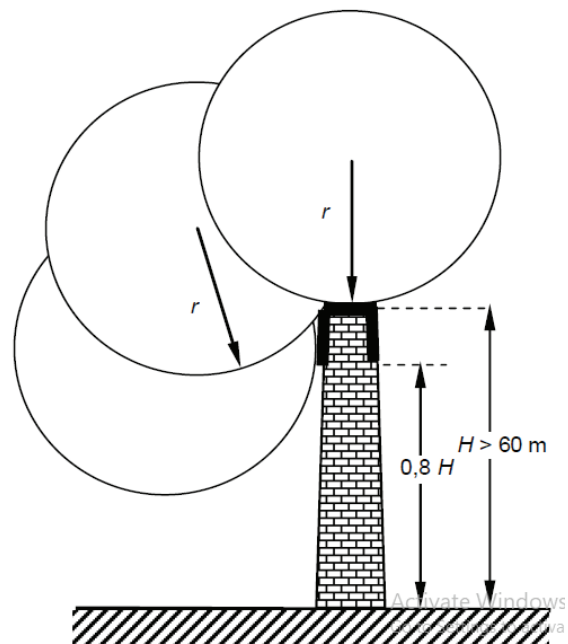
Figure 12 - Protection According to Rolling Sphere Method [24]

Thus, the usual method of determining the protection for such structures is to use the rolling sphere method (Figure 12) of

determining the required protection [24]. This is based on the fact that lightning comes down from cumulonimbus clouds in steps of around 50m dependant on the charge on the down-coming leader.

Thus, when the tip of the down-coming leader is around 50 m from the ground, it can virtually strike any object within a radius of 50 m. This gives rise to a 50 m radius rolling sphere. Depending on the class of lightning protection required, rolling sphere radii of 20 m, 30 m, 45 m and 60 m may be selected as specified in Table 2 of the standard.

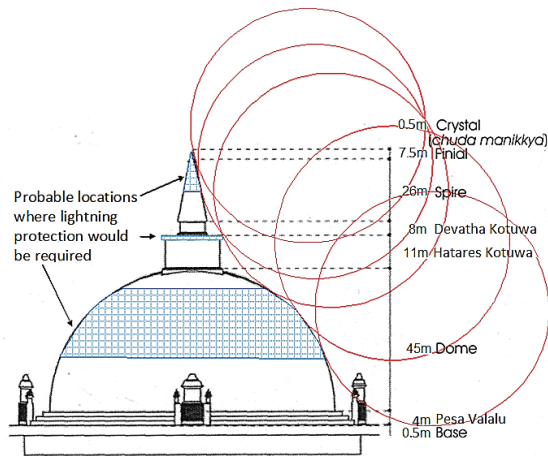
**Figure 13 - Determination of Areas to be Protected using the Rolling Sphere Method**

method requires that a sphere of radius 20 m (for class I) be rolled all over the surface of the structure to be protected, and where the sphere touches the surface of the structure, protection needs to be provided (Figure 13).

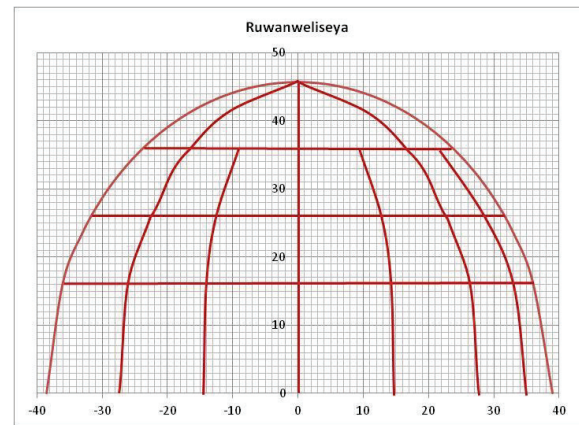
**Figure 14 - Location of Copper Tape Mesh on Dome**

Based on the rolling sphere method, it is seen that, not only the top portion of the spire would need protection, but so would be the perimeter of the top of the square four-sided tee, and a part of the dome would all need to be protected. If the protection of the dome area is considered, the protective copper tapes would probably take the form shown in Figure 14.

This would be very unlikely to be the best form of protection of the Ruwanweliseya from a lightning strike.

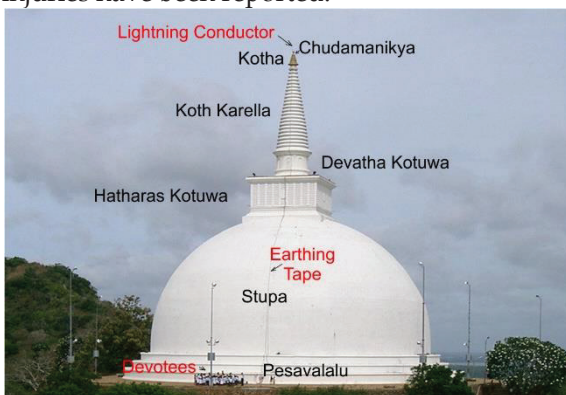
**Figure 15 - Ruwanwelisaya with Devotees Standing next to Down Conductor**

Studies on lightning protection have shown that earthing tapes beyond about 50m in length are ineffective in earthing a lightning installation on account of the high inductance. Thus, the present method of earthing using a single lightning down conductor on the surface of the Ruwanwelisaya Stupa would probably dissipate only a small fraction of the energy to the external earthing point. It could also be prone to cause harm to persons in the neighbourhood of the tape across the stone paved platform than providing useful earthing as seen by devotees gathered near the down conductor (Figure 15). Fortunately, no such injuries have been reported.
