A Risk Analysis of Landslides on the Morawaka “Kanda” Area in the Matara District of Sri Lanka

S.Wijeratne

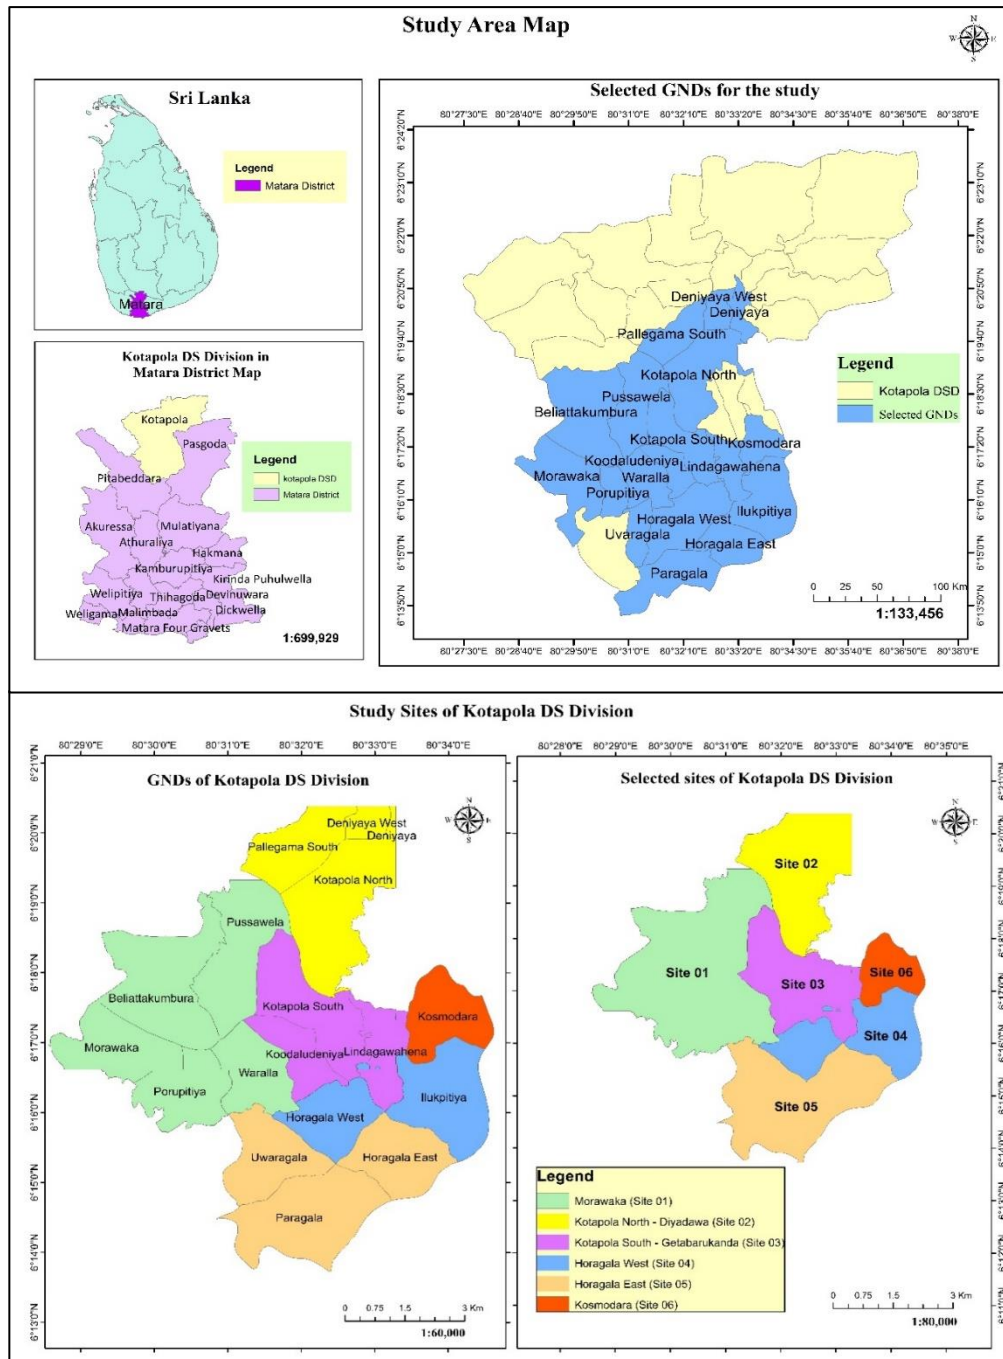
Figure 01: The Study Area map

division area covers about 175.5 km² of land (Divisional Secretariat, Koptapola, 2021) and considering the landslide affected areas, six sites have been selected out of this Divisional Secretariat division for the study.

They are Morawaka Kanda (site 01), Kotapola North (site 02), Kotapola South (site 03), Horagala West (site 04), Horagala East (site 05) and the Kosmodara (site 06). Among these, Morawaka Kanda in site 01, Diyadawa in site 02, Gatabaru Kanda in site 03, Horagala West in site 04, Horagala East in site 05 and Kosmodra in site 06 are the specific selected areas given special attention based on the highest elevation and severe affected areas. They are identified as the study sites with the intention of finding out whether there is a further risk for landslides. Figure 01 shows the GN Divisions and selected sites of the Kotapola DS Division for the study. It is located within the coordinates from 6° 13' 20" N to 6° 22' 30" N and from 80° 28' 30" E to 80° 35' 30" E and this area covers about 76.5234km² land extent, out of 175.5 km² land of the Kotapola DS Division.

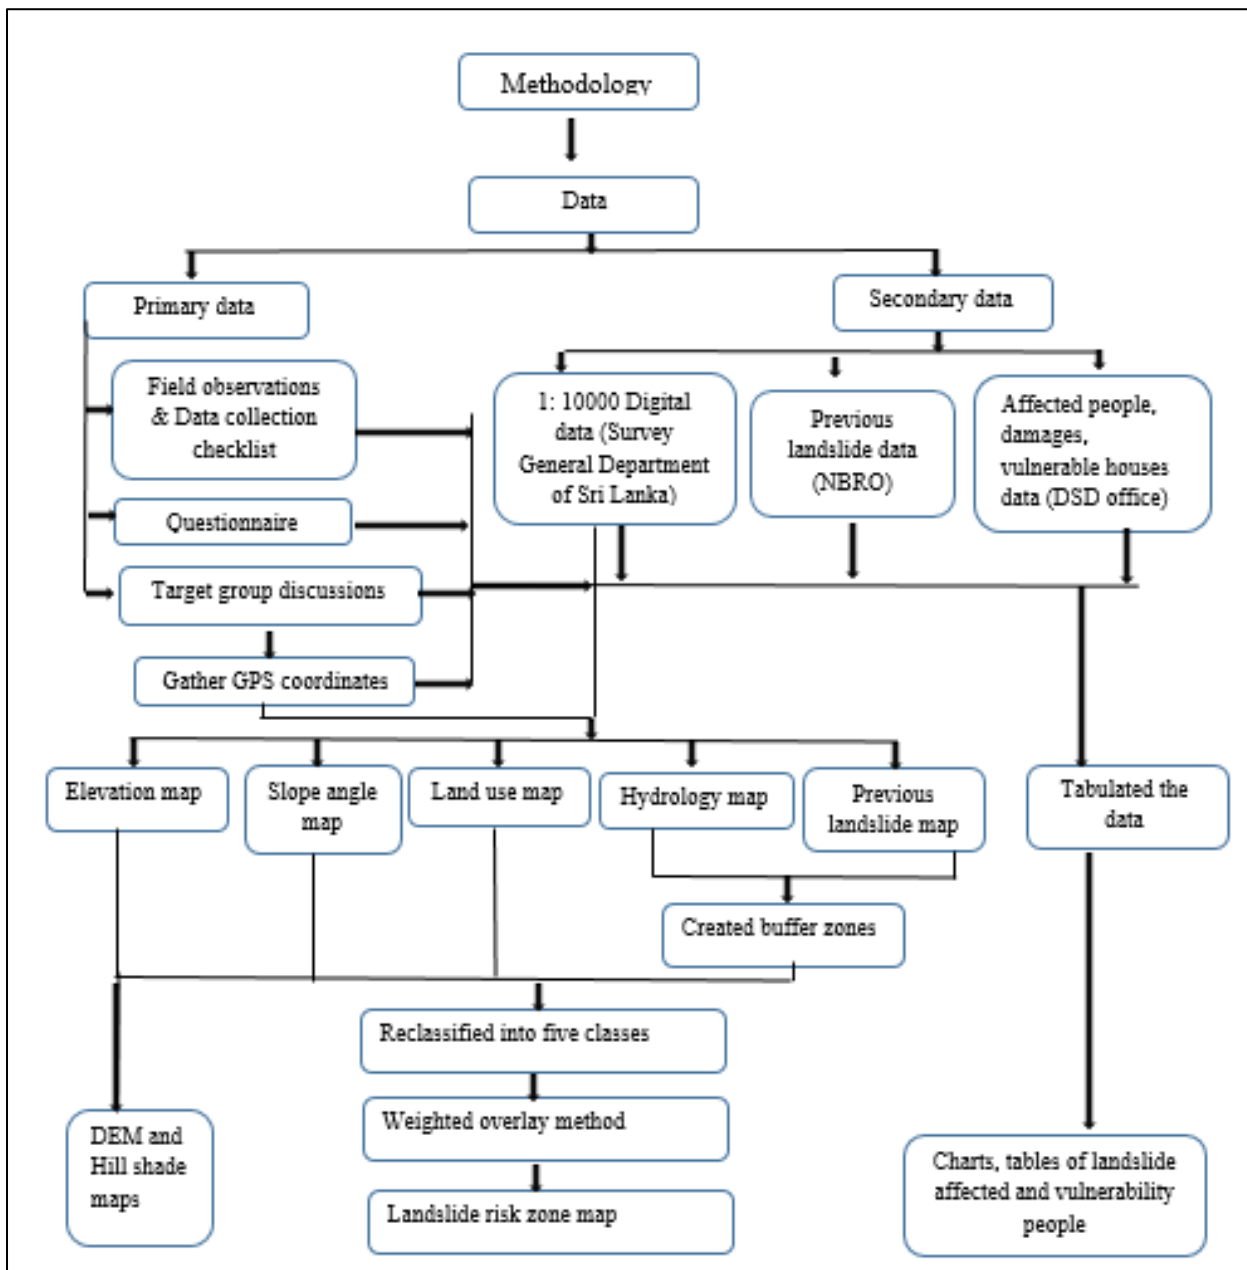
Figure 02-Research Methodology

This study on the "Risk Analysis of Landslides in Morawaka "Kanda" Area in Matara District of Sri Lanka" was carried out based on a field survey and remote sensing methods. The questionnaire survey, group discussions and field measurements are the main activities for the field surveying. GIS technology was used to analyse the collected data (figure 02). The field surveys and observation of this research was focused on the data collection of landslide risks using a data collection sheet and questionnaire.

The data collection sheet was used to collect the physical measurements in the study area. There is an extensive influence from morphologic features such as relief, slope, and soil types, to differentiate the landslide process and landslide risk. These morphometrics and changes can be determined from the field measurements and observations. A data collection sheet was applied in order to collect data on geology, geomorphology, lithology, land use pattern etc. and the data of relief, soil and rocks, geological factors, water drainage were collected using the data collection sheet. These physical measurements were taken for the calculation and identification of the factors that caused to an increased landslide risk in this area.

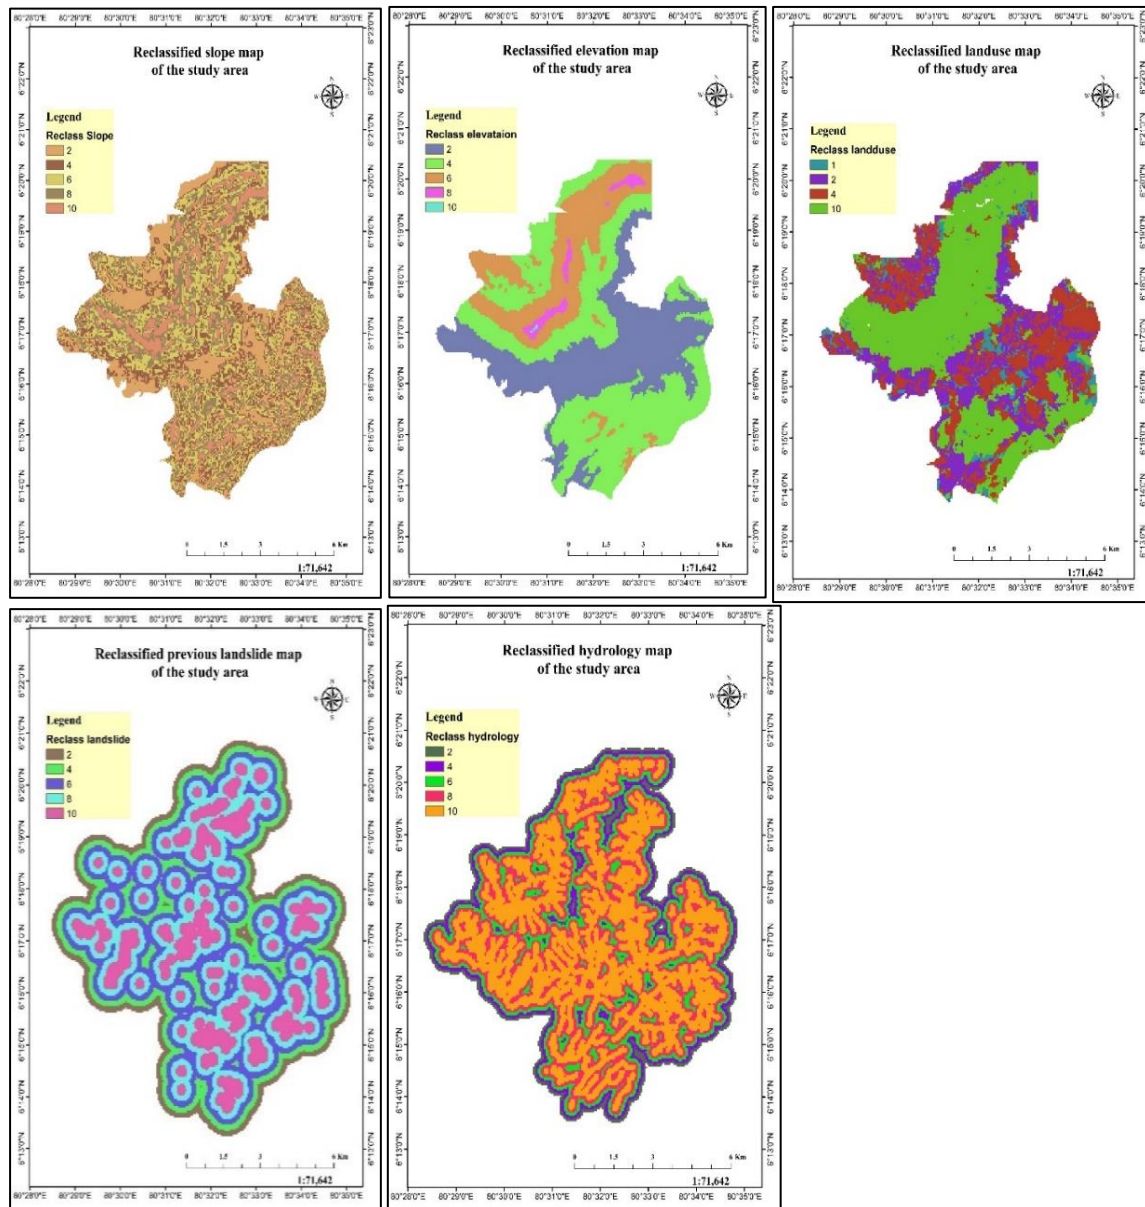
Figure 03: Reclassified maps of land use, elevation, slope angle, hydrology and previous landslides. Source: Prepared by the author using satellite data taken by the Survey Department, 2021.

Then, buffer zones were created surrounding the previous landslide areas with 200 meter intervals using the multiple ring buffer tool. Further, the buffer zone was created with 100 meter intervals to measure the distance from the stream. After creating these buffer zones reclassified into five new classes considering the proximity to water bodies or former landslides. The land use map also reclassified into five classes and a new score were assigned, according to the most affective land use type. Figure 03 shows the reclassified maps drawn to determine the weighted of land use, the elevation, slope angle, hydrology and previous landslides.

All reclassified layers of land use, elevation, slope angle, hydrology and previous landslides were overlaid by using the weighted overlay method giving the influence values in each factor. 30% for elevation, 25% for slope, 20% for land use, 15% for hydrology and 10% influence value for previous landslides were used to create the

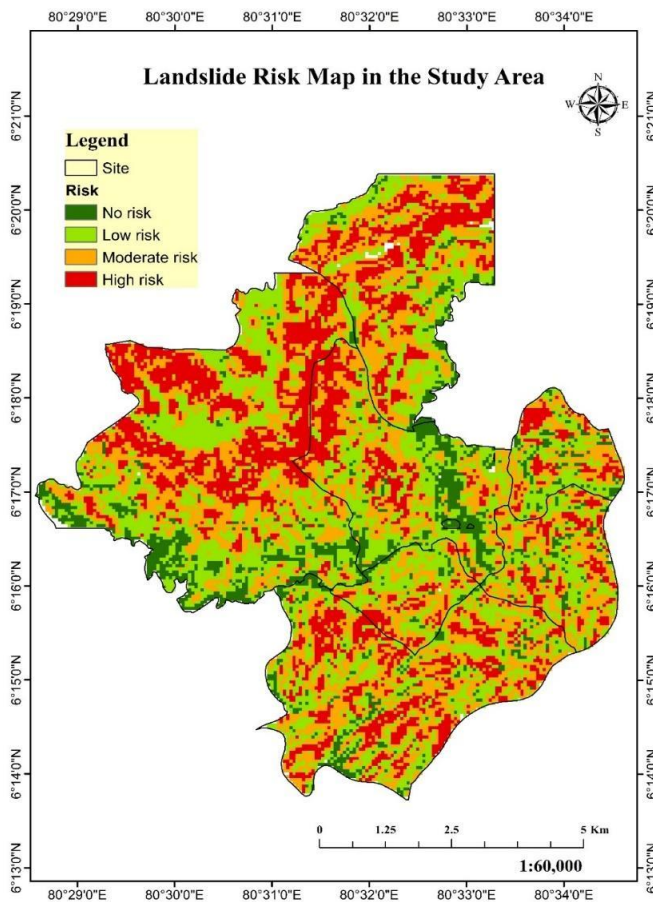
Figure 04: Landslide risk of the study area
Source: Prepared Using satellite data taken by the Survey Department of Sri Lanka, 2022

the criteria that are used to assess the landslide risk. Apart from this, in this research, five causative factors were used to compile the landslide risk map in the study area. The elevation, slope angle, land use, distance from previous landslides and distance from water resources are the factors used for the analysis and each factor is weighted based on the weight system used by NBRO (Pushpakumara et.al.2013). Table 01 shows the weights given in each factor to identify the potential risk areas and risk level. As shown in figure 04, the landslide risk zonation map is the result of the analysis carried out in the raster data model using the weight values of the obtaining factors using Arc GIS software and the risk areas which were identified using these criteria were further classified into four groups as high risk, moderate, low risk and no risk areas (Figure 04).

The following table 02 shows the total land extent of risk areas in this study area. According to the following table, there is a high landslide risk in 24% of land and it covers nearly 18 km² in this study area. According to the risk map, high risk zones are located throughout the entire area including Morawaka, Gatabaru Kanda, Diyadava, Horagala and Kosmodara. The right bank of the Morawaka Kanda landslide path in 2017, the upper part of Gatabaru Kanda, Deniyaya Watta in Diyadawa, Kohila watta-Henyaya in Horaga West were identified as high risk areas. These high-risk areas are approximately located in the high

elevation and consists of higher slope angles. Most of the above high-risk areas are occupied by tea or other cultivation and cleared areas as well as most of the previous landslides are reported in these areas.

The land extent of moderate and low risk is nearly 64% of the total area in this study area. When considering about the moderate landslide risk, the areas covered 24.14km² land and are

distributed in the entire area. These moderate risk areas can be identified with a medium range of elevation and by improper land use practices in this area. Kotapola North, Morawaka and Horagala East areas have more moderate landslide risk areas than the other areas. Approximately, 55% of the lands in the study area tend to be high and moderate areas.

There is 25.85 km² land for low landslide risk and it is represented by the dark green colour in the following map. The low-risk areas can be identified in low elevation areas with low slope angles. According to the following map, most of the low-risk areas can be shown in the settlement areas which have gentle slopes and undulating terrain. There is no risk for landslides in nearly 7.84km² land in this study area. The south part of the Morawaka area, the east part of Diyadawa and the middle part of Getabaru Kanda area have low or no risks for landslides. Most of these areas can be identified in lowlands with flat terrain.

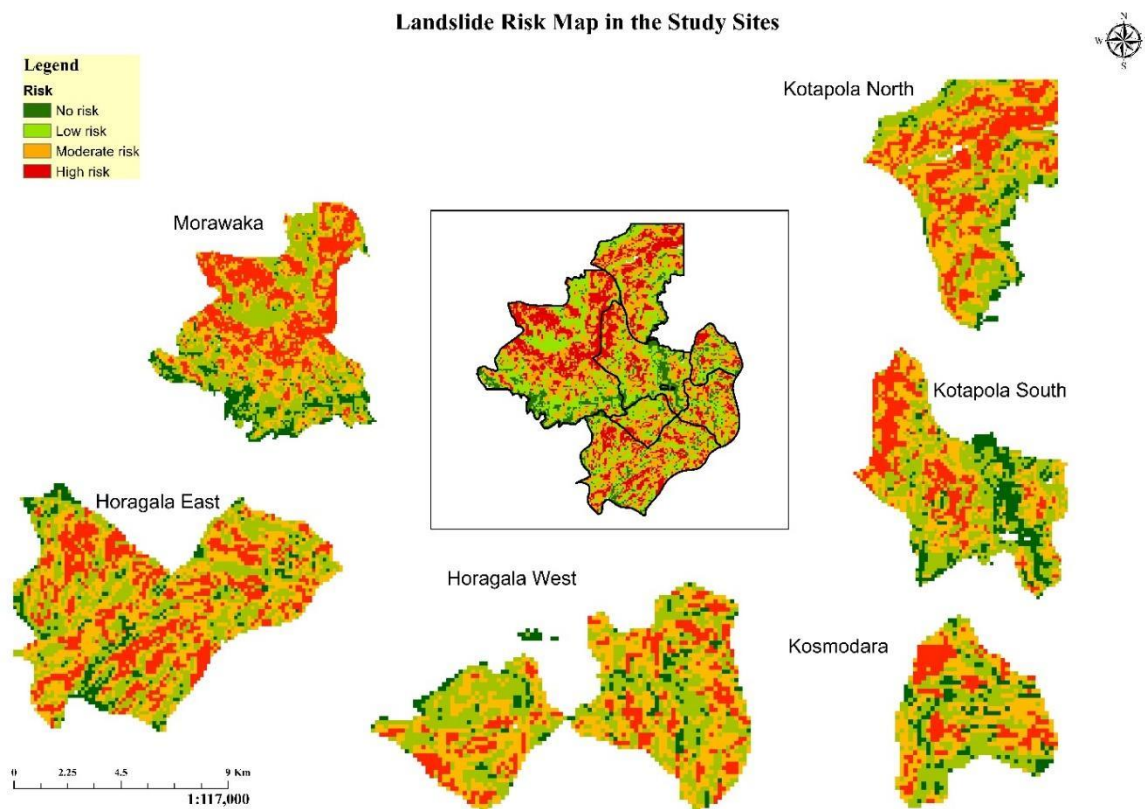
Figure 05: Landslide risk map in each site

When considering about the landslide risk in each area of this study area, the risk level of each site is varying from place to place. The above figure 05 shows the landslide risk of each site in this study area. According to the following table 03, it can be identified that the land extent of risk in each site is different. The largest amount of land is in the Morawaka kanda site area and it covers about 26.92km² land. The high risk in this area is about 7.53km² in extent, while nearly 12 km² land is in a

low risk or no risk level. According to the following table there is approximately the same land extent for high, moderate and low risk. However, mostly the top of the right bank of the Morawaka Kanda landslide path in 2017 and the surrounding hillside area is in the high-risk zone for future landslides. The foot of the Morawaka mountain and its surrounding flat and undulating lands are in a moderate or low risk zone for landslides.

The Horagala East site covers an area of 10.96 km² out of the total area of the study area and 27% of the area is in the high-risk zone. The upper part of the Horagala highland area is in a very high risk and it covers nearly 3km² land. The surrounding areas of the high-risk zone are in a moderate risk, and it represents 36% of the total land of the Horagala East site. Further, there are very few areas that are not prone to landslides in this area as 9% out of the total land.

When compared to the other areas, the Horagala West and Kosmodara area has more moderate risk zones for landslides. 42% land is in the moderate risk zone, and it covers nearly 1.2km² land in Kosmodara out of the study area. However, the Kosmodara area has more than 60% moderate and high-risk areas and the safe area has been less than 8% of the total area. The Horagala West site has more low risk areas and safe areas than the high-risk area for landslides. The mountain peaks in the Horagala West area and the surrounding area are risk zones for high and medium level landslides and that area is nearly 60% of the total area in Horagala West.

that consists of this study area. Approximately 70% of the land is in moderate and high risk in the Kotapola North site and it covers more than 9km² land out of the total land in Kotapola North. According to the above figure 19, most of the high and moderate risk areas are located on the steep slope areas with a high elevation. However, the east part and the south part of the Diyadawa area in Kotapola North has a low risk or no risk for landslides because there are more flat and low elevation areas. The Kotapola South area has more than 20% land in the high risk zone while 30% land is in a moderate risk. According to the above map, it can be clearly recognized that there are more high-risk zones in the western half than the eastern half of the Horagala west area. There are more no-risky areas in the eastern ward of this area, and it covers 15% of land.

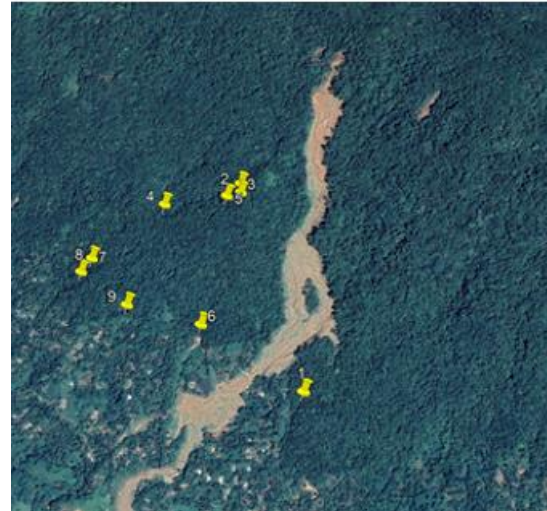
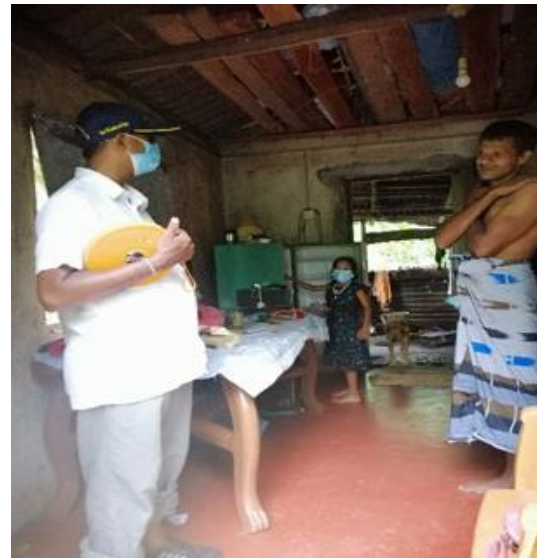
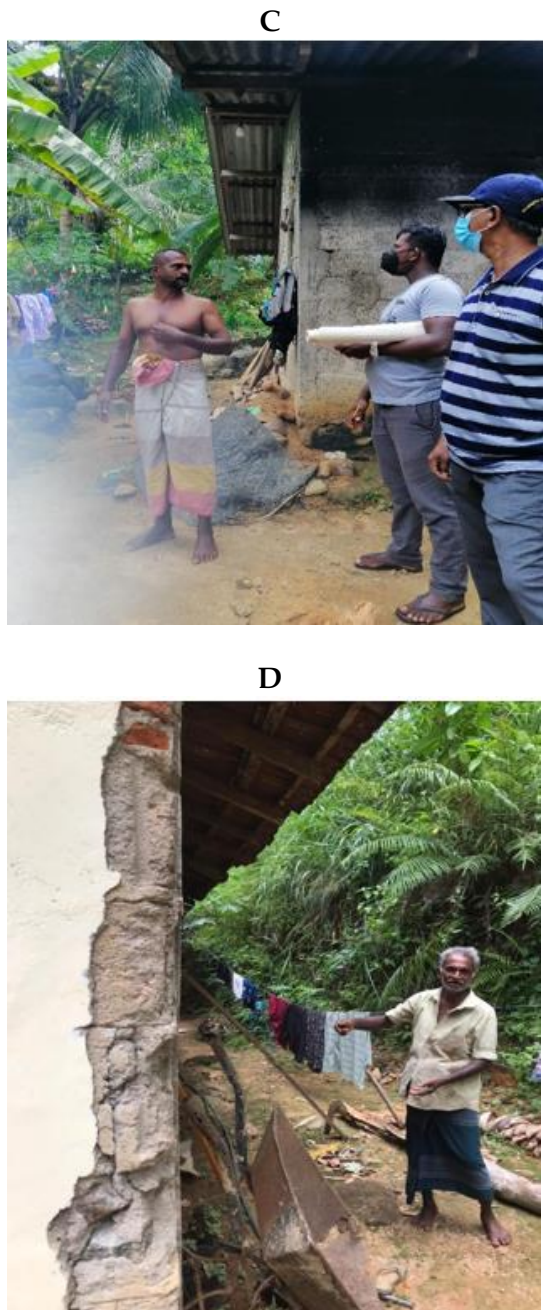
Figure 06: Houses for the landslide risk in the study area

be identified at high risk. 50% of them are distributed in Morawaka Kanda and Yati Horagala. For example; the houses which belong to J.Y.Samantha, W.G.Nandawathi and Upali can be identified as high risk in Morawaka Kanda (Figure 06). Apart from this, the NBRO has identified nine landslide risk houses and locations in this area (figure 06 - A).

The houses which belong to Mr. H.K.Siripala, R.Dilip Rangana at Kohilawatta-Henyaya in Horagala West are also high risk houses with the crack of house walls, situated in higher slopes towards the stream valley and the emerging of springs on the ground in rainy periods. Although, the residents of these houses were informed to leave these houses, still they are living there, due to no safe places being provided yet. Accordingly, the people living in the risk area responded that unsafe areas is the most prominent factor for the future vulnerability for landslides. There are 21 responses for reluctance to move to safe areas while 31 respondents believe carelessness and negligence are also major causes for future vulnerability.

- A. Risky houses in right bank of the Morawaka Kanda
- B. Risky house belong to the J.Y. Samantha in Morawaka Kanda
- C. Risky house belong to S.Jayasinghe in Diyadawa
- D. Risky house belong to Sunil in Horagala West

Most of the houses in this study area, are built without obtaining approval from any authorized institutions and most are built on very steep slopes and in high elevation areas. Further, most households use their land for agricultural purposes such as tea, citronella, coconut, fruits and pepper.
