# A Fatal Case of Accidental High-Voltage Electrocution

Case Report

High voltage electrical injuries are relatively uncommon but exhibit a high rate of mortality. A body of a 39-year-old electrician who had died while working on high tension cables was brought for post-mortem examination. The autopsy revealed first and second-degree burns, exfoliated skin and crocodile flash burns around the neck. There was a penetrating skull fracture with exposed brain and surrounding charring. Microscopic examination revealed evidence of electrocution in the skin and myocardium. Cause of death was stated as multiple injuries following high voltage electrocution. Detailed history, scene visit and proper postmortem examination with histological and toxicological analysis are recommended prior to concluding the cause of death as electrocution

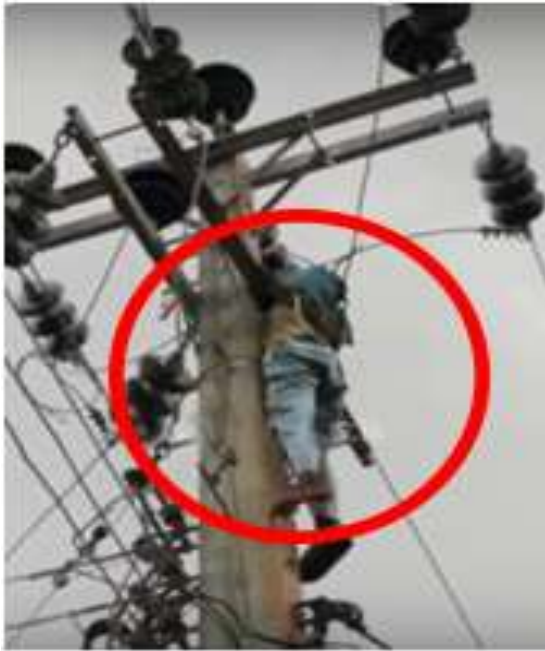
A body of a 39-year-old male, electrician of power supply line maintenance service was brought for the postmortem examination to the mortuary of a tertiary care hospital. According to the investigating police officer that the victim was attending to repair work on a high tension cable post near the city. He was not wearing Personal Protective Equipment (PPE), other than the antiskid belt. The electricity line was switched on while the repair was in progress due to miscommunication, then disconnected soon when short-circuit has been noticed. The victim had suffered high tension shock and died at the scene, but remained attached to the post through supporting protective belt (Fig. 01).

Figure 01: Position of the body at the scene showed direct contact of the head, neck and left shoulder with the electric line.

Complete and properly wearied PPE (including insulated safety gloves, Arc flash clothing, boots, Hearing protective devices, safety belts etc.) Minimize the severity of the injuries if a person accidentally contacts with high tension wires, but in this case, the diseased was only with anti-skid belts and gloves.

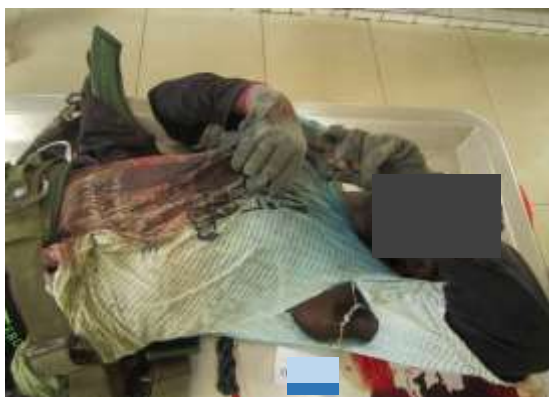
The autopsy revealed that the deceased was 68 inches (174 cm) in length, weighing 65kg, average built and well-nourished male. Protection belts were clipped around the hip and chest, while underlying apparels were ignited and soaked with blood at several areas (Fig. 02). Rigor mortis was fully established and the postmortem lividity was fixed and confined mainly on lower extremities and back aspect of the body.

Figure 02: Body with protection belt and burnt clothing

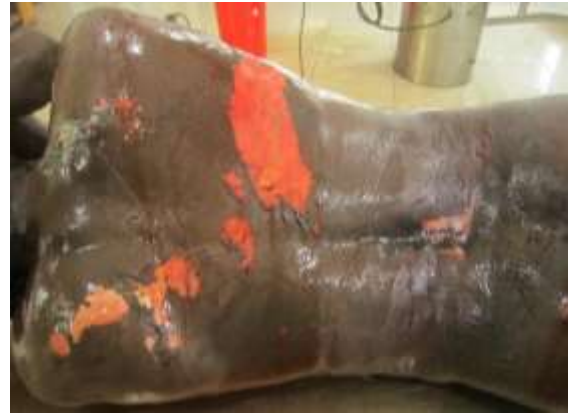
External injuries of multiple first and second degree burn with exfoliated skin were seen on the back of the body (Fig. 03). Electrical burn marks were seen on the limbs (Fig. 04) and soles (Fig. 05).

Figure 03: Burns with exfoliation of the skin

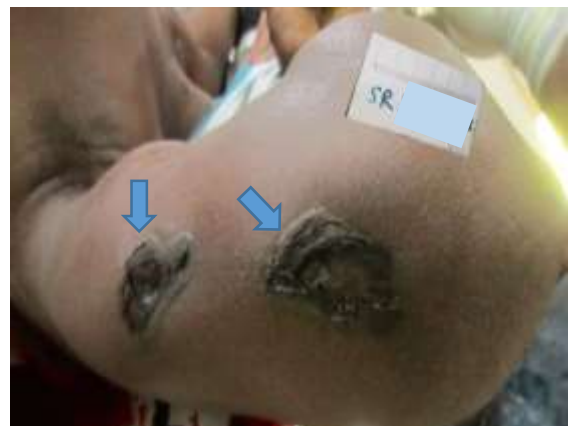
Figure 04: Two Electric burn marks on the upper arm showed by arrows

Electrical burns occur due to the conversion of electric current to heat within the body, and this can be either entry or exit marks. According to the circumstantial evidence, the diseased had been contacted with the current wire that carries about 33000V of high voltage for few minutes as the protective belts worn by the deceased has prevented him from thrown away effect. The prolong contact has lead the electric mark at the contacted site (entry mark) to be unrecognizable and the area around the nape of the neck was charred with burning of the scalp and the skull bone in the occipital region. Multiple electrical marks were identified during the autopsy of the victim, and they were confined to the upper limbs and sole. Those marks showed the characteristic appearance of dry, firm to hard craters with ragged edges.

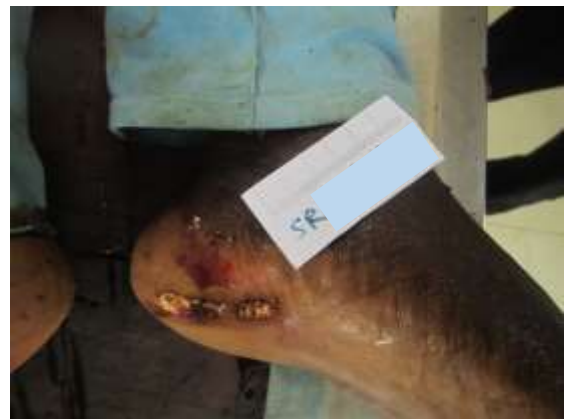
Figure 05: An elongated burn mark on the sole

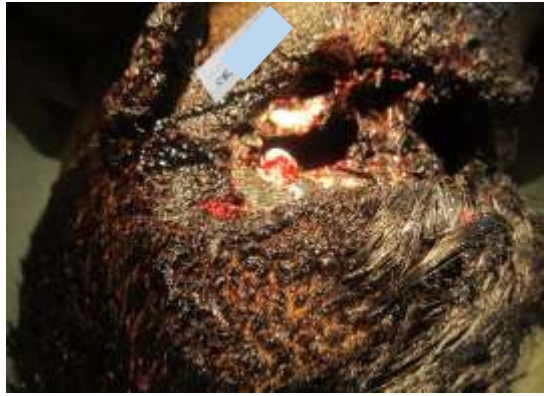
Multiple punched out lesions (crocodile flash burns) were noted over the nape of the neck (Fig. 06). A penetrating fracture of the skull of about 7cm x 5cm due to the burning of the scalp and the underlying occipital bone was present and the brain was exposed through the charred wound (Fig. 07). Hair around the wound and eyebrows were singed. Internal organs were congested and the heart was cyanotic and rigid. The brain was mildly edematous with congested vessels.

Figure 06: Crocodile flash burns on the nape of the neck

Another type of electric mark is a spark burn which occurs with the presence of a gap between the skin and the conductor. In high voltage electrocution, multiple spark burns crack into the victim causes a large area of tissue damage and give rise to 'crocodile skin' appearance, here it was seen around the contacted site; the nape of the neck. There were 1<sup>st</sup> and 2<sup>nd</sup> degree burns also with flash effect over the back of the body and also singeing of hair and eyelashes due to the short range flashes.

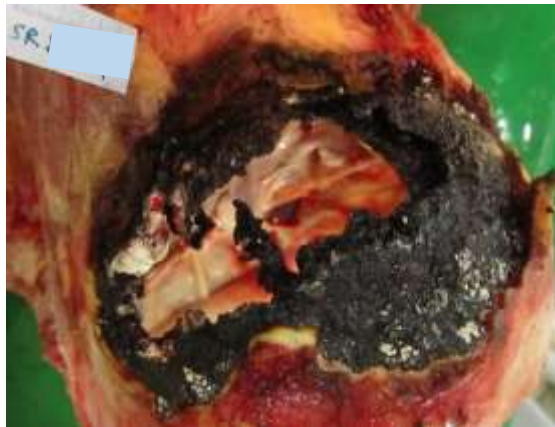
Figure 07: Penetrating deficiency of the skull

The distinguishable finding of this case is a large penetrating skull fracture associated with direct damage of the brain. High-voltage electrocution injuries are a serious problem with potential for both immediate and delayed neurologic sequelae in survivors.<sup>[10]</sup> It is possible that even if the pathway of electricity does not directly cross the brain, cortisol and the excitatory neurotransmitter glutamate may still be stimulated via the physical and psychological trauma and the "excitatory" impact of the electrical insult.

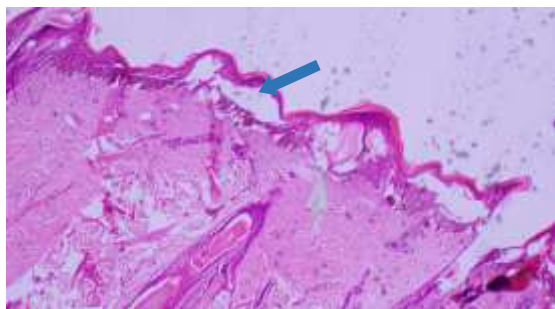
Microscopic examination of the burnt skin showed sub-epidermal separation, coagulative necrosis of epidermis (Fig. 08) with nuclear palisading appearance (Fig. 09), distortion of architectural arrangement of hepatocytes (Fig. 10), and while embedded foreign bodies probably originated from metallic components were revealed under polarizing light (Fig. 11).

Figure 08: Microphotograph of epidermal separation with micro blisters indicated by an arrow. H&E x 100

Microscopic examination of skin around the burnt area was done with normal Haematoxylin & Eosin (H&E) staining and showed characteristic subepidermal separation, nuclear streaming and Separation of the epidermis is due to micro blisters that formed during the cooking effect of tissues with the strong heat and the large vacuoles also identified within the epidermal layer. High-temperature burns denature the collagen materials in the skin which then responsible for the bluish staining of it in H&E staining. Elongated and tightly packed nucleus in the basal layer of epidermis causes streaming of the nuclei which give rise to nuclear palisading effect and by far it is the most characteristic histological feature seen in electrical burns and seen in the majority of cases.<sup>[6,7]</sup> But these nuclear changes are not specific for electrocution as it may also find in cauterization, freezing, blunt injuries and blisters formation following barbiturate poisoning. Coagulative necrosis of dermo-epidermal cells presents in 60% of electrocuted deaths.<sup>[7]</sup> Volatilized metal particles from the conductor can also be specifically identified in the contact site histology specimens with polarizing light (Fig. 10). In this study, all the above mentioned histological changes were present in the skin.

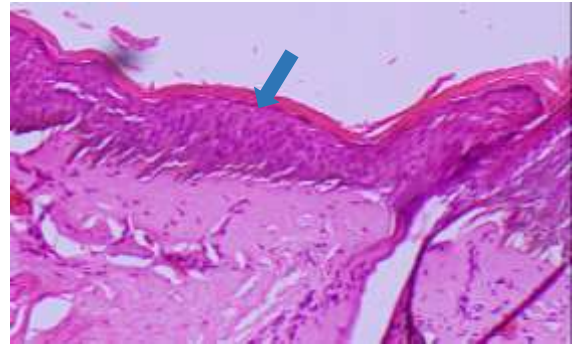
Figure 09: Microphotograph of nuclear palisading indicated by an arrow. H&E x 100

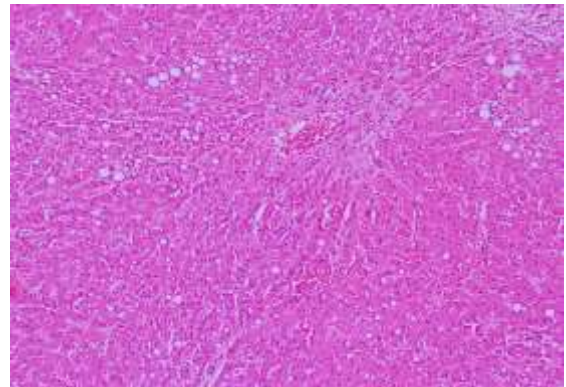
Figure 10 Microphotograph of distortion of liver architecture H&E x 40

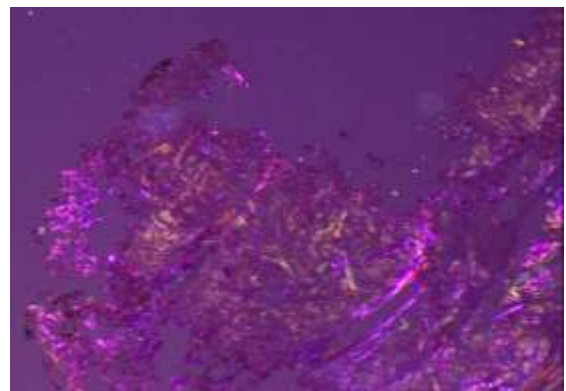
Figure 11: Microphotograph of foreign bodies under polarizing light x 100

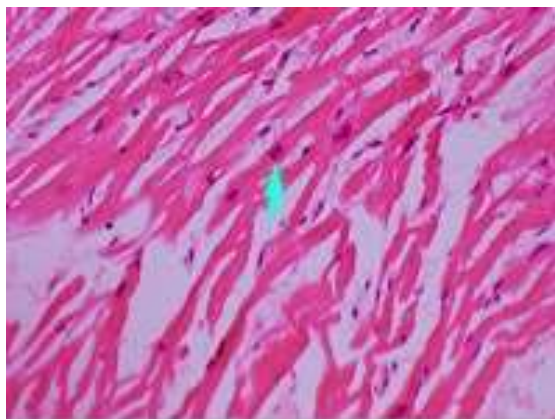
The sections of the heart showed myofibril necrosis with square expression of nuclei (green arrow in Fig. 12) and alternative appearance of a bundle of hyper contracted-hyper distended myocytes were the predominant features (Fig. 13).

Figure 12: Microphotograph of square-shaped nuclei with necrosis of myocytes indicated by arrow H&E x 100

Electrical injuries lead to myocardial damage is either due to direct cellular damage or provoking cardiac arrhythmias. Ventricular fibrillation is the most common mechanism of death identified in electrocution. Necrotic and fragmented myocardial cells with round or square shaped nuclei were seen in the microscopic section of the diseased heart, and this with the absence of cellular reaction suggests an instantaneous death. This feature of myofibre breakdown was seen in 90% of cases in a study conducted by Vittorio Fineschi et al.<sup>[8]</sup> Intermittent bundles of hyper-contracted myocytes were visible with wavy contraction bands suggestive of contraction band necrosis.<sup>[7,8]</sup> Interstitial haemorrhages also are seen intermittently in microscopy. The two latter described features are not commonly seen in histology.

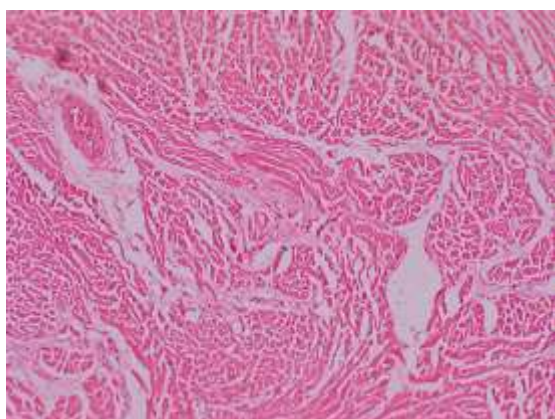
Figure 13: Microphotograph of hyper-contracted bundles of myofibrils H&E x 40

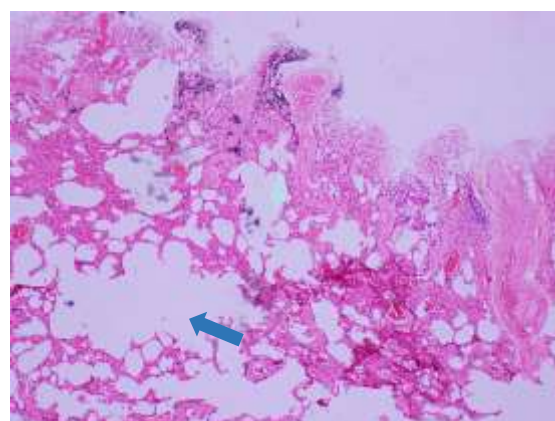
Massive alveolar destruction is seen in lung histology (Fig. 14). Liver and brain sections showed congestion with some architectural disturbance in histology.

Figure 14: Microphotograph of the destruction of alveoli indicated by an arrow. H&E x 40
