Identification of the Vehicle of a Hit-and-Run Accident Based on Patterned Evidence

Keywords: Hit and run, run over, Tractor-trailer.

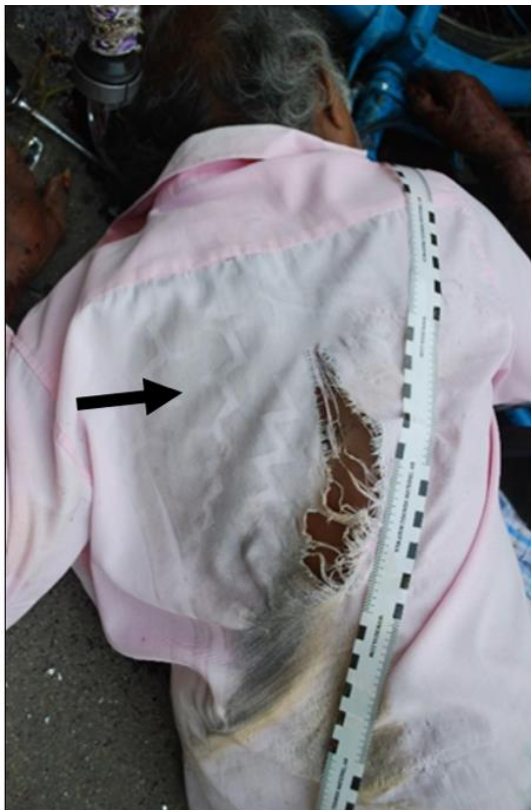
At the autopsy, there was an imprint mark resembling to tire on the left side of the back side of his shirt with a tear parallel to the mark (Fig 01). Just below the tear (blue arrow), there were two dark friction marks (Red arrows) on the back of the shirt (Fig. 02). Underneath this tear there were two elongated friction abrasions (Red arrows) situated on the back of his body (Fig 03). However, there were no paint, grease, glass fragments, etc. on the body or on the clothing.

Figure 01. Photograph of the back of the body showing a tire tread mark (Black arrow)

In this case, a very clear tire mark was situated on the back of his shirt. According to the Government Analyst Department report, the tire imprint (pattern evidence) on the shirt was compatible with the right rear tire of the trailer. Further, the absence of paint or grease on the body suggested that the floorboard of the offending vehicle could be higher.

According to the Government analyst's opinion, the tire mark on the shirt was compatible with the tire tread pattern of the right rear tire of the tractor-trailer. In run-over injuries, tire tread marks do not invariably occur, but if they do, it may be on the clothing and or on the skin [4]. The width in between two parallel abrasions on the back of the skin were compatible with the width of the right rear trailer tire and the body gets sandwiched between the road surface and the tire resulting the tire imprint, tear, and friction marks on the shirt, the two abrasions on the back of his body and multiple postero-lateral rib fractures due to a run over by the alleged tractor trailer. The cause of death was given as multiple injuries to the head and chest due to run-over injuries by a moving vehicle.

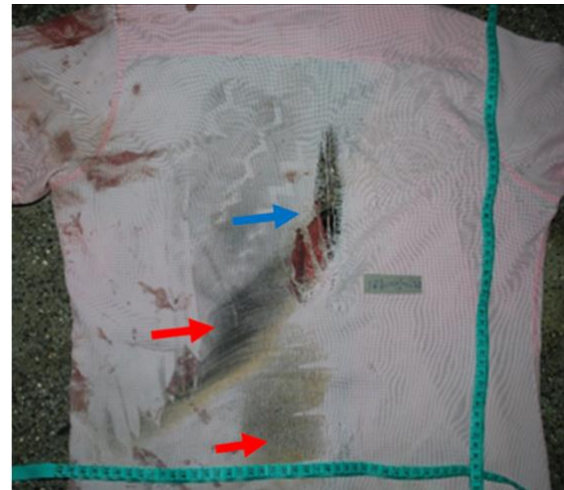
Figure 02. Just below the tear (blue arrow), 02 dark friction marks (red arrow) were found

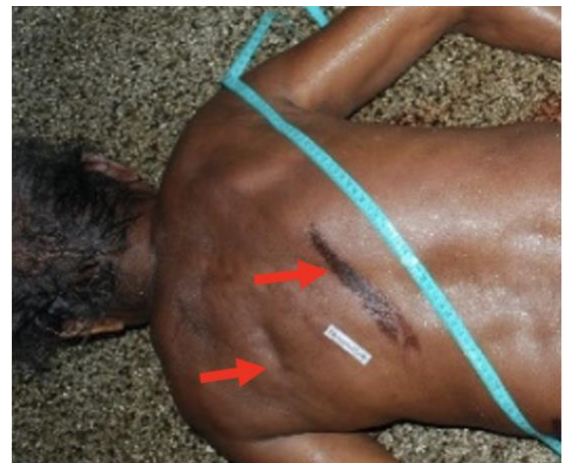
Figure 03. Two parallel imprint abrasions (red arrows) placed obliquely on the back of the chest

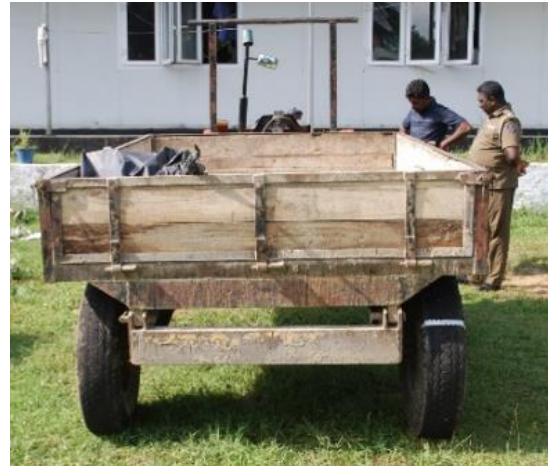
Later, the driver and tractor with the trailer were taken into custody on a tipoff and the driver was a 53-year-old male (Fig. 07).

Figure 07. The tractor with the trailer
