ENHANCING ESTHETICS WITH METAL -FREE PROSTHESIS - CASE REPORTS

This case report series describes prosthodontic rehabilitation of patients with missing anterior teeth with ridge defect and posterior teeth with failed orthodontic treatment using zirconia based all-ceramic bridge restoration.

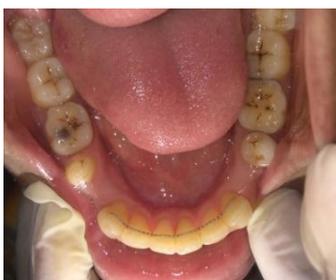
Fig 2(a) Pre operative photograph.

A 29-year-old female patient reported with chief complaint of poor esthetic appearance due to missing teeth. On examination it was found that patient had missing right and left mandibular first premolars.(Fig 2)(a)

The patient gave a history of orthodontic treatment for correction of bimaxillary protrusion with extraction of mandibular ist premolars, but distilisation of canines was not achieved to an extent to bridge the edentulous space

left after extraction. The treatment plan to replace missing 34,44 with zirconia based bridges was formulated as the patient had higher demands for esthetics.

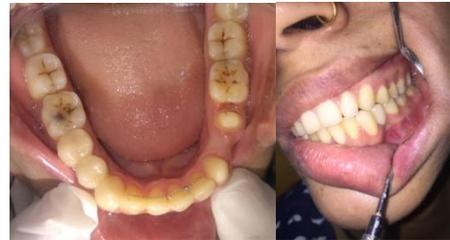
Fig 2 (b & c) Tooth preparation irt 33,35 and cementation.

Diagnostic impressions were made and poured in dental stone. Tooth preparation was done quadrant wise. First tooth preparation of 33,35 was done to receive all ceramic crowns (Fig 2 (b)).

The equigingival shoulder finish line was prepared for 33 and 35. The overall reduction of 2 mm and Incisally, 1.5–2 mm reduction was made so as to provide esthetic prosthesis. Gingival retraction was done with the retraction cord. The final impression was made in elastomeric impression material with double mix technique. The stock metal tray was loaded with putty impression material, and impression was made with retraction cord in place and the thermoplastic sheet over the teeth. Once set thermoplastic sheet was removed from the impression. The light body impression material (Aquasil), was manipulated as per the manufacturer's instruction. Impression was loaded with light body impression material. Retraction cord was removed and light body impression material was syringed on the margins of the prepared tooth and the impression was made. Shade selection was done with the 3D Master shade guide (VITA). The provisional restoration was relined with the tooth colored acrylic resin and was cemented with non eugenol temporary cement (GC) Final prosthesis was fabricated in Zirconia and then cemented with resin based luting cement.(Fig 2(c) Similarly rehabilitation was done on contralateral side of same arch. (Fig 2 (d & e)).
