Retrofitting of RC Beams Using FRP and FRCM

Abstract

Keywords: Fibre Reinforced Polymer, Fibre Reinforced Cementitious Matrix, Retrofitting, Reinforced Concrete Beam, T-beam

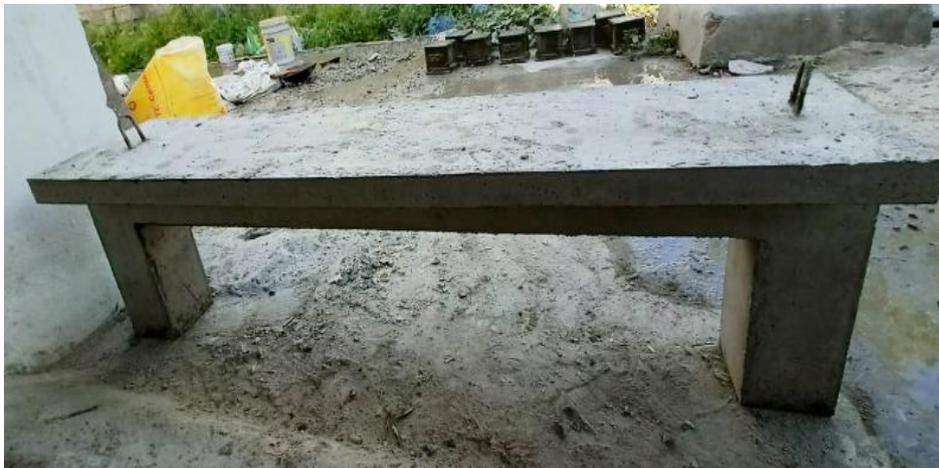
Figure 4. T-Beam and C-frame specimen.

Materials such as cement, fine and coarse aggregates were used for the trial mix and a proper mix design was framed according to the design provisions [12]. Then the materials were weighed, batched, and mixed and finally, the desired concrete mix was achieved. For each batch of mix sample, cubes of size 100 mm were cast for determination of compressive strength, i.e., two numbers of 100 mm cubes. The specimens were cured by covering the concrete surface with wet gunny bags and allowed to cure for 28 days. After curing, the beams were exposed to the atmosphere till they were wrapped with FRP and FRCM using wrapping agents, and testing was carried out (Figure 4).

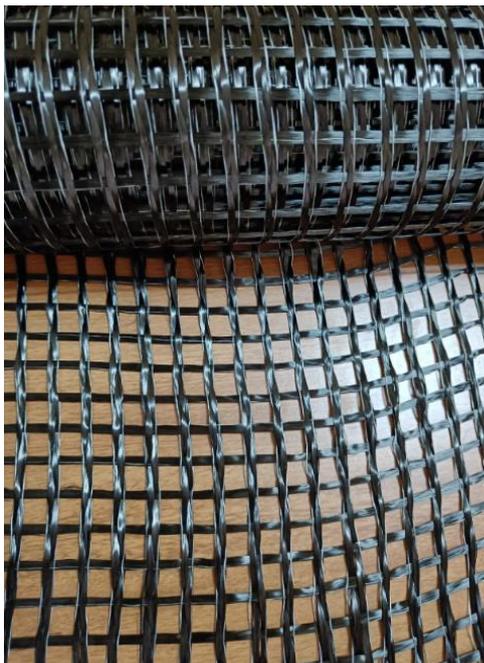
Figure 5. FRCM mesh used in the present study.

Before applying FRCM, the surface was grooved for proper adhesion. In the first specimen, a base layer of cementitious mortar ($1700 \text{ mm} \times 500 \text{ mm}$) was applied Figure 6(a), followed by carbon fibre mesh (Figure 5) and Figure 6(b) and a final mortar layer in Figure 7(a). The second specimen had mortar applied in $300 \text{ mm} \times 500 \text{ mm}$ sections on each side, with carbon fiber mesh and 100 mm FRCM strips (Figure 8). The third specimen had a longer first mortar layer ($700 \text{ mm} \times 500 \text{ mm}$) on each side, two layers of carbon fibre mesh, and 100 mm FRCM strips (Figure 9). Specimens two and three focused on support spans for shear strengthening and flexural failure study.

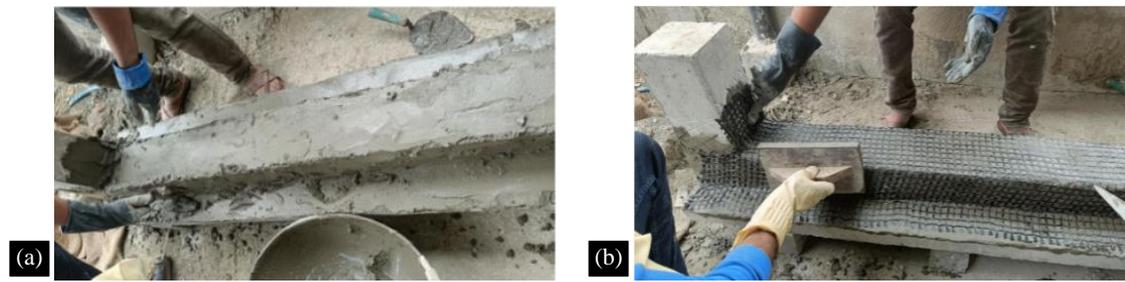
Figure 6. (a) Application of first layer of mortar and (b) Placing of fibre mesh.

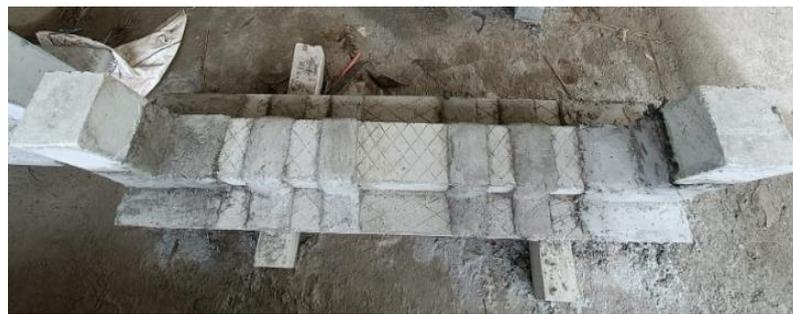
Figure 8. Application of FRCM in one layer-strip form.

The beam was applied with one layer of FRCM in strip form at regular intervals of 100 mm spacing.

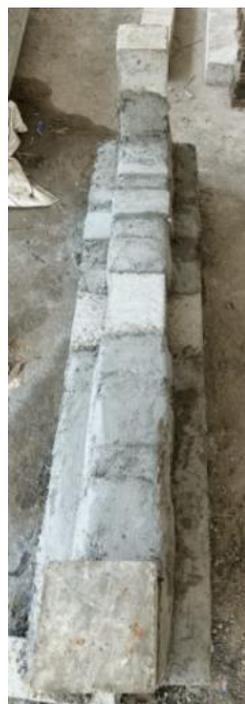
Figure 9. Application of FRCM in two layers.

Beam with two layers of FRCM in support spans.

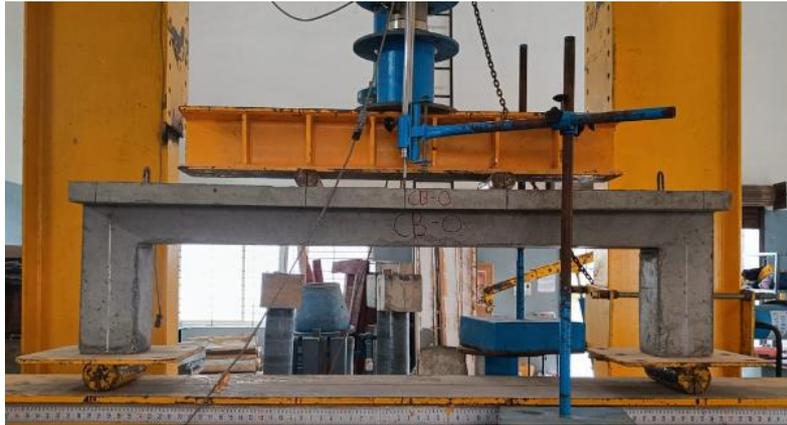
Figure 11. Set-up of control beam specimen (CB-0).

The specimens were tested in the loading frame fixed with a hydraulic jack of maximum loading of 2000 kN. In the present testing, a loading jack of 1000 kN capacity with a 500 kN load cell was used. Two-point loading method of testing was adopted. At every 0.1 sec interval, loads and corresponding deflections were recorded using a Linear Variable Differential Transformer (LVDT).

The control beam is a normal concrete beam that is subjected to two-point loading till beam failure is observed. This specimen was used as a comparison for all the other beams which were retrofitted (Figure 11). Curing was done for seven days and testing was done after that period.

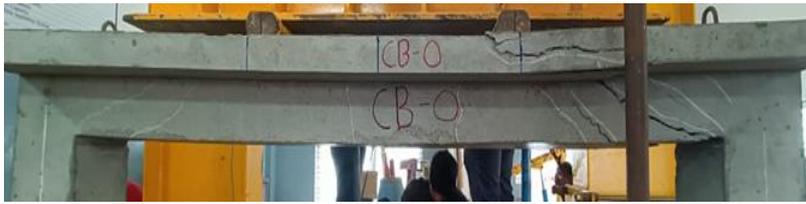
Figure 12. Close-up view of shear cracks in specimen CB-0.

The control beam has undergone shear failure. Shear cracks and minute flexural cracks have been noted at the bottom of the beam (Figure 12). Therefore, it is a combination of shear and flexure failure. This could likely be attributed to inadequate shear reinforcement, deficient load carrying capacity, or insufficient confinement of the beam's concrete, indicating a compromised ability to withstand the applied loads and resulting in a combined failure scenario.

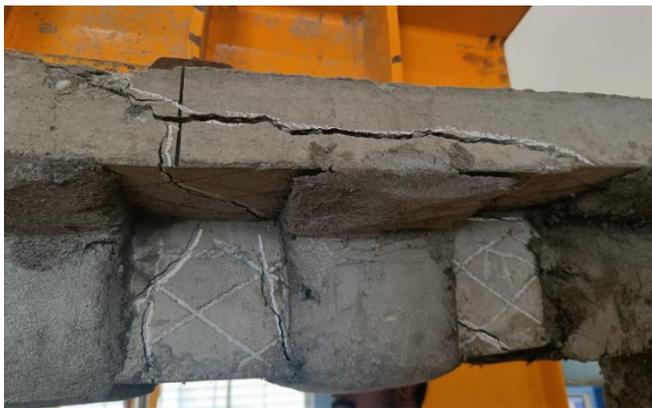
Figure 14. Shear cracks in specimen FRCM-1L-S.

In this specimen, shear failure had taken place. Shear cracks have occurred in the support span (Figure 14). Debonding has taken place in the slab element. The shear cracks in the support span might indicate a deficiency in shear reinforcement or inadequate transfer of shear forces within the structure.

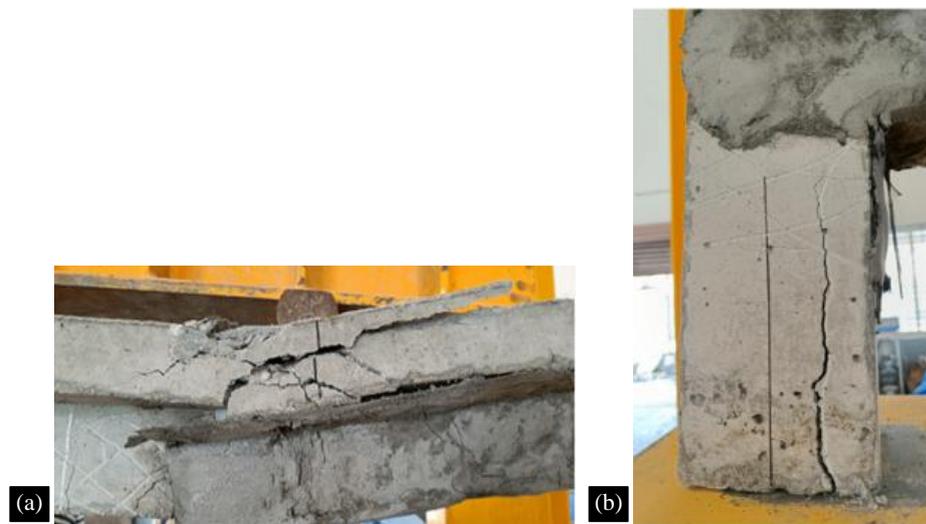
Figure 15. Debonding of the slab and column element in specimen FRCM-2L.

In this specimen, slight flexural and shear cracks have appeared due to inadequate reinforcement in both flexural and shear directions, or insufficient structural stiffness. Debonding has taken place in the slab and column portion (Figure 15) possibly due to poor adhesive bonding or inadequate surface preparation.
